National Transportation Safety Board

HWY24MH005

TECHNICAL RECONSTRUCTION

Group Chair's Factual Report

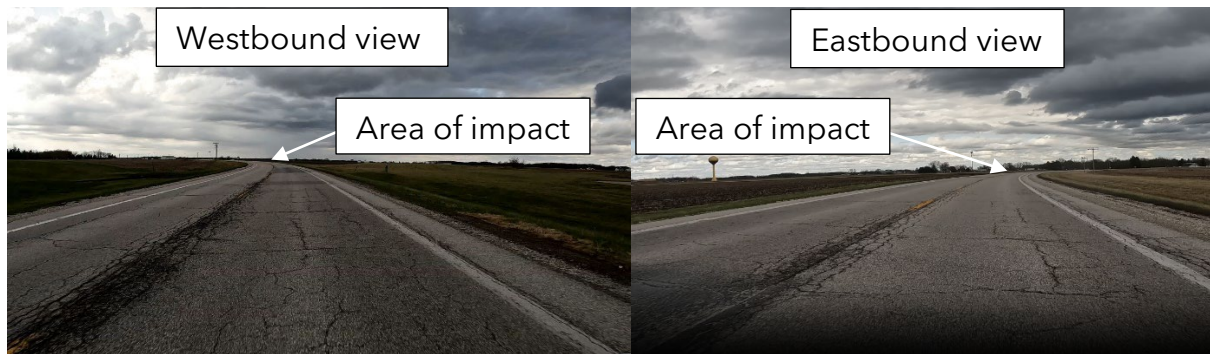
The eastbound and westbound approaches, along U.S. Route 24, were straight before transitioning into the sweeping curve. The curve was 2,863 feet long having an approximate radius of 2,865 feet.¹ The crash event occurred approximately 985 feet into the curve, when traveling east to west. Figure 2 below contains two images depicting the westbound (left) and eastbound (right) approach to the crash location. As can be seen there were no obstructions impeding the visual line of sight in either direction.

Figure 2. Two images depicting each approach to the crash location.

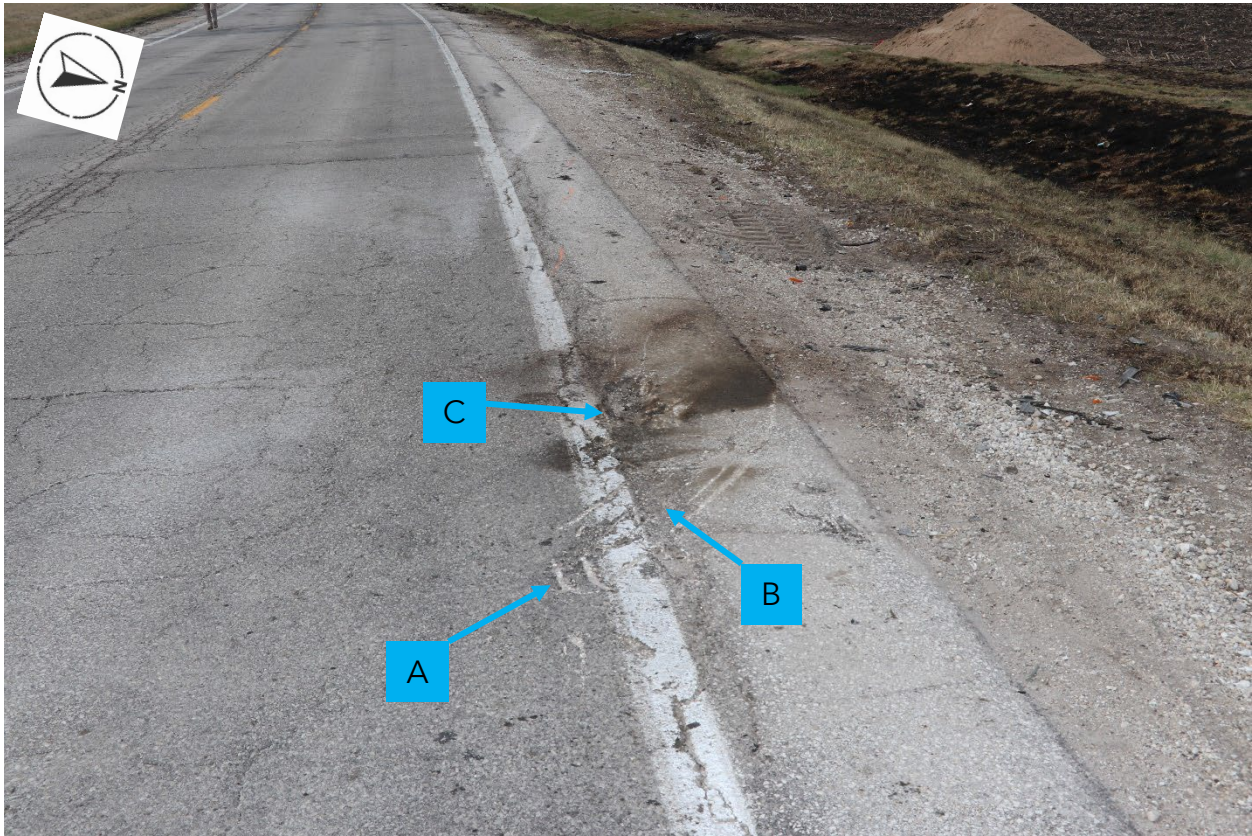
The area of impact (AOI) was established at a location where several scrape, gouge marks, and friction marks were identified along the westbound side of U.S. Route 24. The marks began with two parallel gouge marks (A) adjacent to the white edge line, within the westbound lane, measuring approximately one foot in length. The two gouge marks transitioned to five parallel gouge marks (B) that crossed the white edge line onto the shoulder. The five gouge marks were at an approximate angle of 35 degrees relative to the westbound lane and varied in lengths. Continuing west, there was a large gouge that measured about two feet in length and seven inches wide (C). The large gouge paralleled the white edge line and was also where the scorching of

the asphalt began. The scorching ended at the edge of the asphalt. Figure 3 is a photograph depicting the scrape, gouge marks, and scorching described above.

Figure 3. Photograph showing the scrape/gouge marks and scorching on the asphalt.

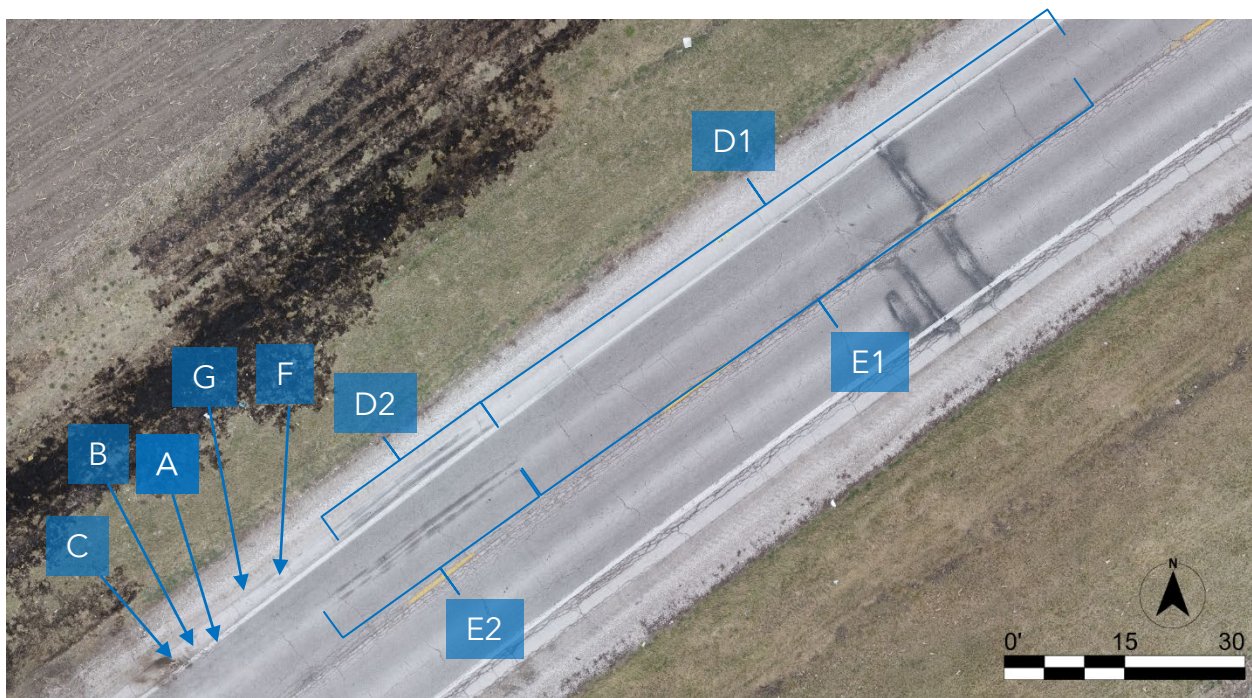
Figure 4. Selected image from the orthomosaic created from NTSB sUAS project.

Figure 4 is an image obtained from the two-dimensional orthomosaic created from the three-dimensional point cloud with the marks labeled for reference. East of the area of impact, were two sets of dual linear tire friction marks that paralleled each other. Both sets began within the westbound lane, the northern set of friction marks (D) measured approximately 113 feet, crossed the white edge line, and terminated on the paved portion of the westbound shoulder. The southern set of friction marks (E) measured about 118 feet and terminated within the westbound lane. The two sets of tire friction marks traveled at an approximate 4-degree angle tangent to the curve. At their onset, the intensity of the friction marks was faint becoming darker approximately 85 feet west of the onset. Where the friction marks became darker each set transitioned from two friction marks to four friction marks in each set which continued to their termination. West of the set (D) friction marks were two additional tire friction marks on the paved shoulder. The first friction mark (F) measured approximately three feet in length. The second friction mark (G) measured about eight feet in length. Table 1 lists the labeled friction marks along with their measurements.

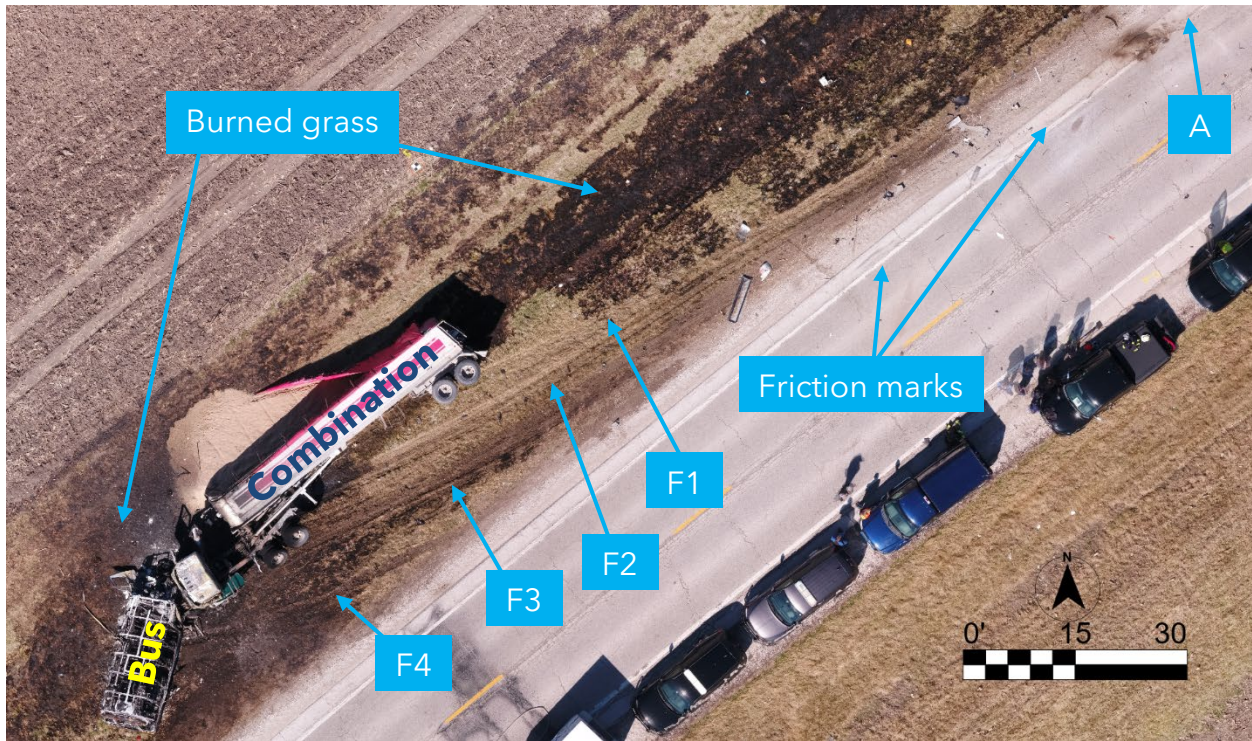
Figure 5. Selected image from the orthomosaic image created from ISP sUAS project.

West of the AOI were additional tire friction marks and furrows angled from the westbound travel lane toward the right roadside. ISP identified and marked, with orange spray paint, a set of tire friction marks that began around the scrape/gouge marks within the westbound travel lane. The intensity of the friction marks was light as they transitioned from the roadway over the concrete asphalt shoulder to the aggregate shoulder section at an approximate 8-degree angle relative to the roadway. Two additional parallel tire friction marks were identified approximately 50 feet west of the AOI, along the asphalt shoulder. The friction marks each measured about seven feet in length and were consistent with damaged tires.

Continuing westward, the friction marks transitioned to furrows in the grass lined drainage channel. There were four distinct areas of prominent furrows that continued at the approximate 8-degree angle relative to the roadway. Three of the furrows terminated at the combination's position of final rest with the fourth terminating at the bus. From north to south, the furrows measured approximately 75 feet, 98 feet, 73 feet and 42 feet. Figure 5 is a selected image of the orthomosaic obtained from the ISP sUAS project identifying friction marks and furrows west of the AOI.

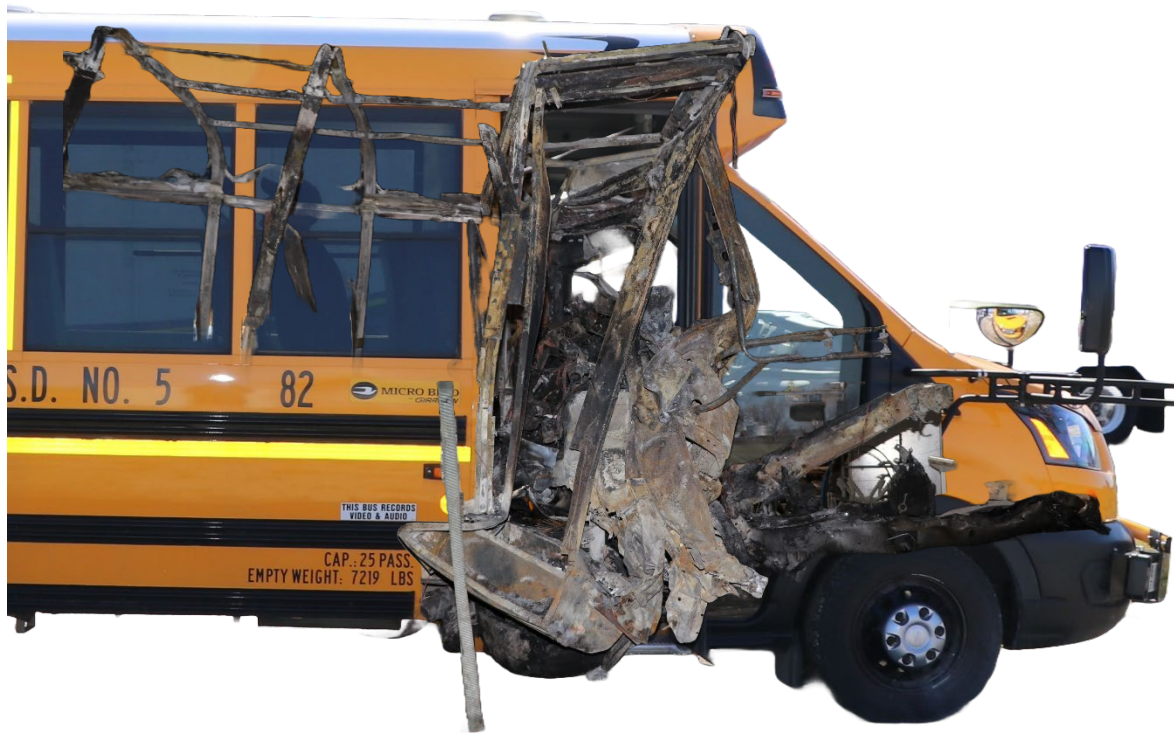
The front of the bus sustained extensive direct contact damage across its full width. The engine and all components within the engine compartment were torn from the frame rails and displaced rearward. Both front wheels, suspension system, and steering components including control arms and sway bars were all displaced rearward. The left-front tire was displaced rearward under the driver's seat with the right-front tire displaced rearward under the loading/unloading steps. The firewall had been displaced rearward into the driver seat and loading/unloading area of the bus displacing both rearward. The bus sustained extensive thermal damage encompassing the entire vehicle.

Figure 6 is two photographs of the right side of the bus. An image of the crash involved bus has been overlaid atop the exemplar bus depicting extensive damage to the front of the bus.

Figure 6. Two photographs, one of the damaged and one of the undamaged bus.

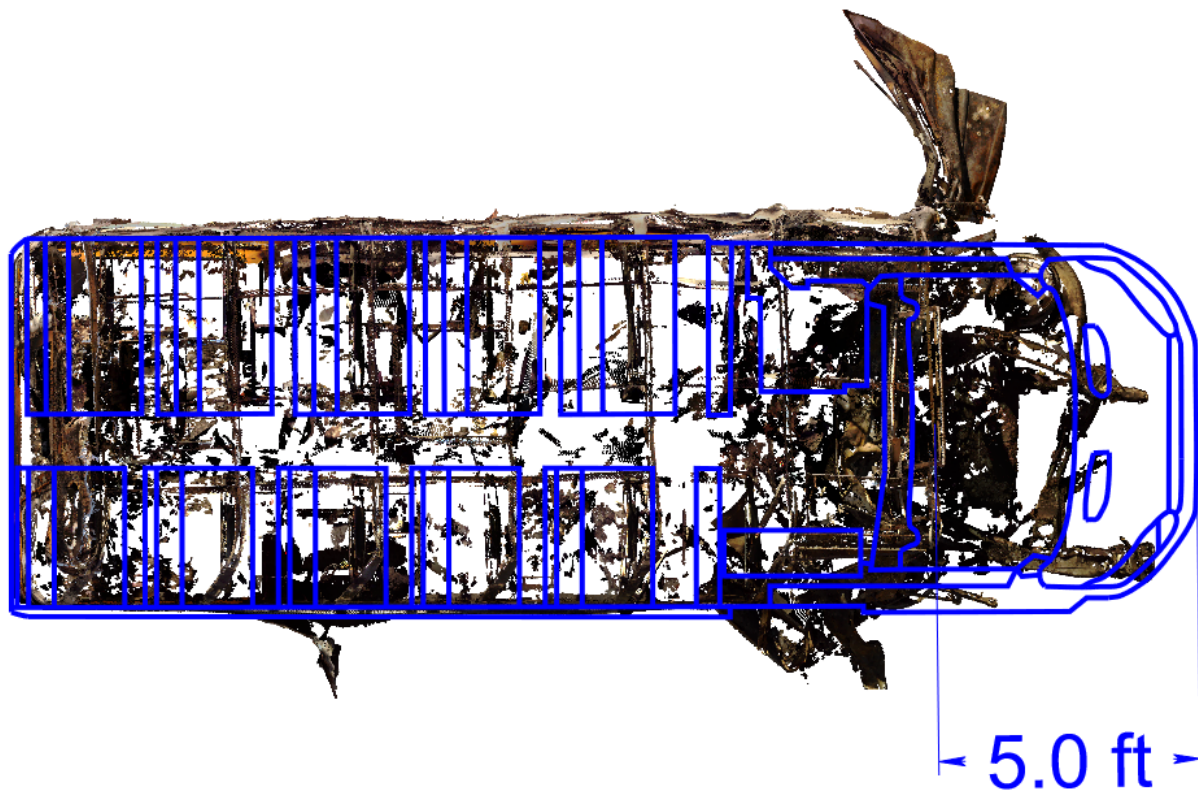
Figure 7 below is a graphic of the damaged bus captured from the three-dimensional scan, overlaid with an outline of the undamaged exemplar bus. The graphic is depicting the approximate distance, five feet, the front of the engine was displaced rearward as measured from the front bumper.

Figure 7. Graphic of the damaged bus overlaid with an outline of an undamaged bus.

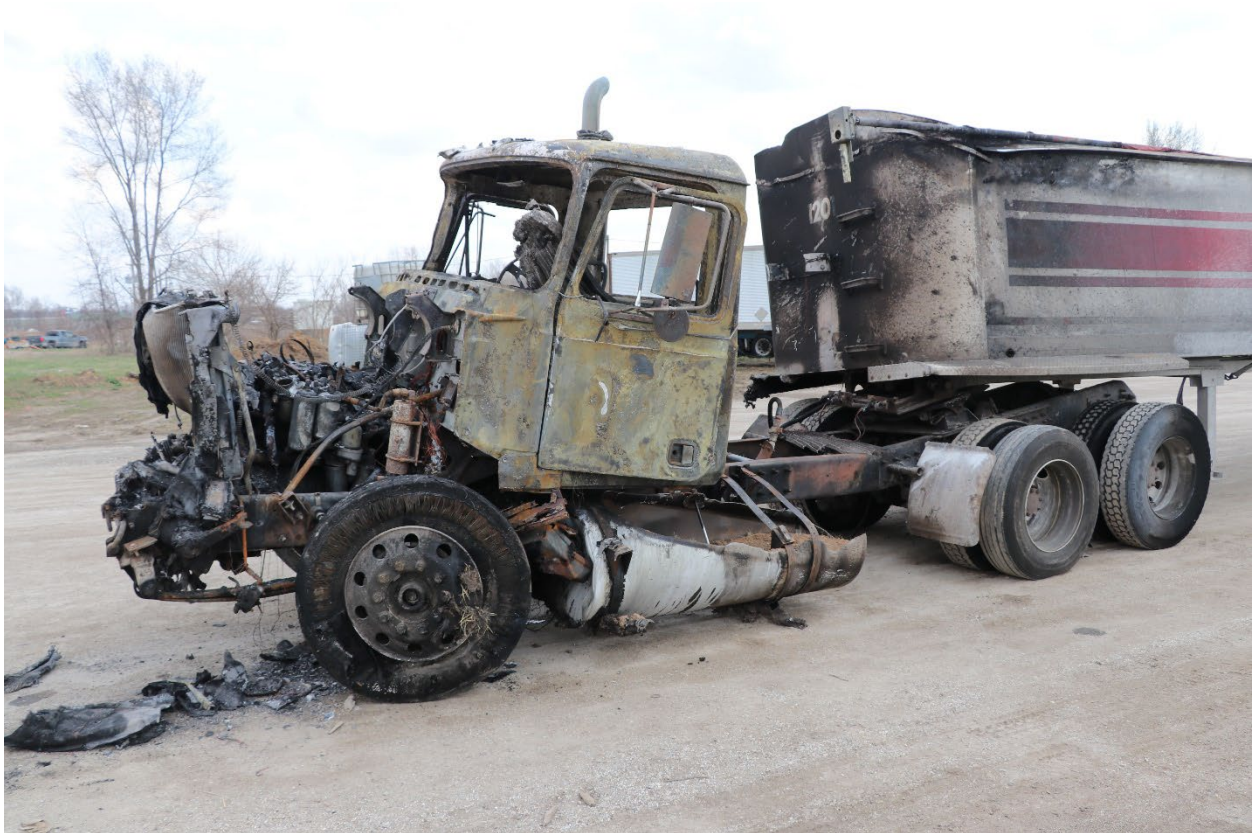
Due to extensive thermal damage, the front of the Mack exhibited direct contact damage across the full width. The front bumper cover, hood, and fenders were all missing, exposing the engine, frame rails, steering, and suspension components. The bumper and radiator were displaced rearward. The bumper and lower portion of the radiator, between the frame rails, were curved inward. The frame was buckled causing the top of the cab to lean rearward. The left-front wheel was displaced rearward into the small storage box forward of the saddle, which was subsequently pushed rearward into the front of the saddle tank damaging it. Additionally, the saddle tank received thermal damage. The left side frame rail forward of the second axle and fifth wheel was bent downward. The trailer was still coupled to the tractor via the fifth wheel coupler

and evidence of thermal damage was noted to the front and along the right side. Figure 8 is a photograph showing the damage to the truck tractor and front of the dump trailer.

Figure 8. Photograph depicting damage to the truck tractor.

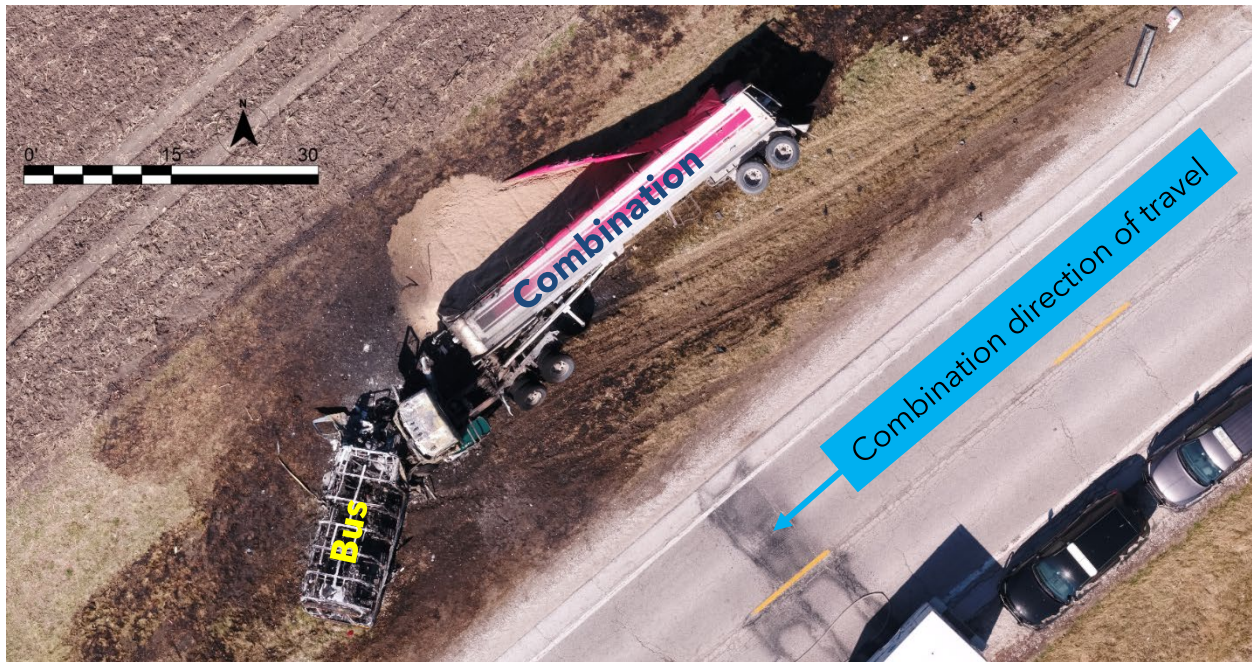
At final rest, the combination was in the drainage channel, approximately 25 feet north of the westbound lane, parallel with the roadway. The front of the combination was in contact with the front of the bus. The dump trailer had rolled over onto its right side resting along the backslope of the drainage channel. The combination and bus together were approximately 157 feet west of the AOI. The combination weighed approximately 79,680 pounds. Figure 9 is an image taken from the generated orthomosaic depicting the positions of final rest for the bus and combination vehicle.

Figure 9. Image from the two-dimensional orthomosaic depicting the vehicles final rest.

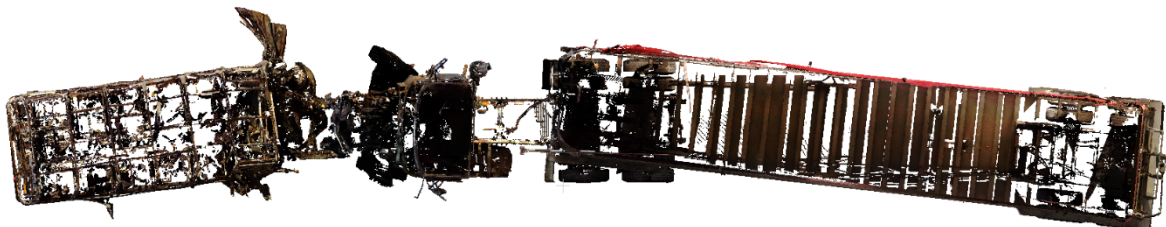
Alignment of the combination and bus point clouds corroborated an approximate 3-degree angled impact orientation as can be seen in Figure 10.

Figure 10. Screen capture of the vehicle's alignment at impact.

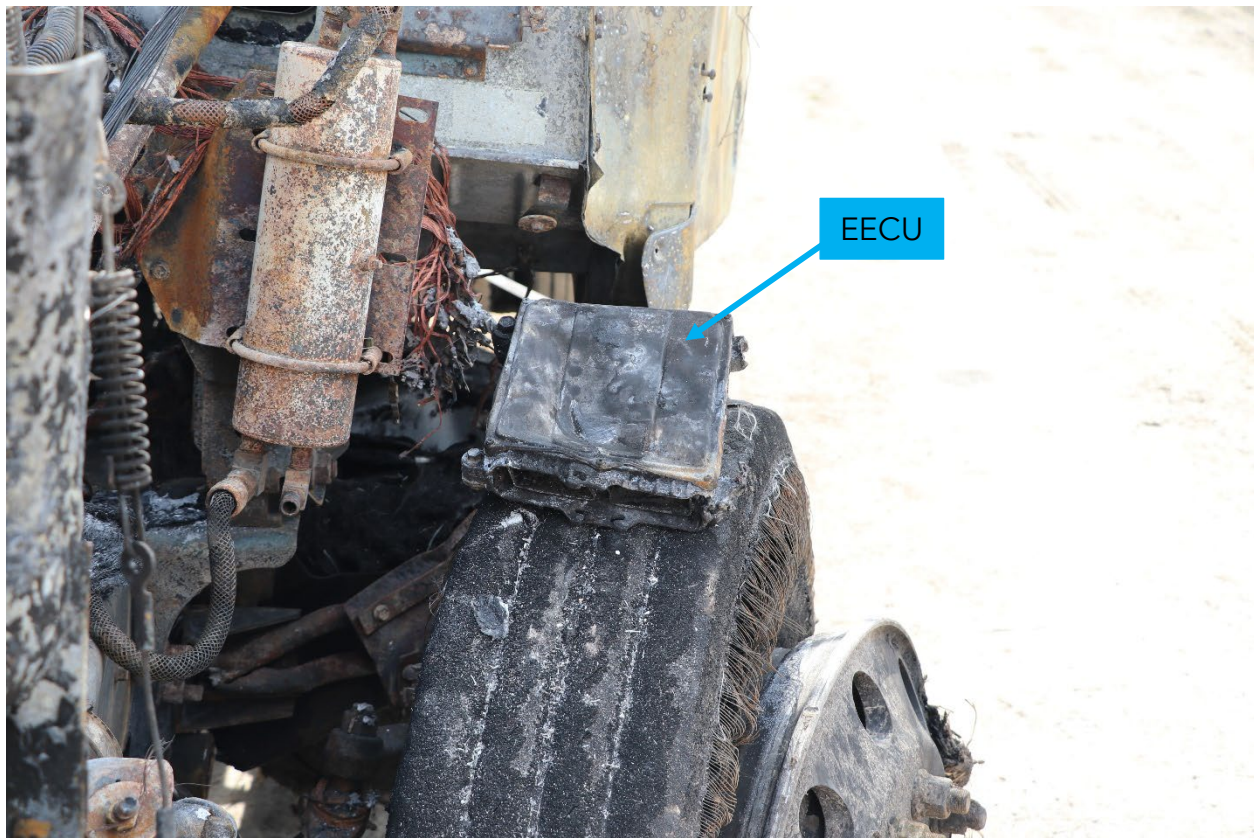
During the examination of the Mack truck tractor NTSB investigators located the EECU at the bottom of the engine next to the left frame rail. The EECU had broken from the mounting screws and was hanging by its wiring harness. The EECU was recovered and disconnected from the wiring harness. Closer examination found thermal damage to the metal case, and pin connectors as well as contact damage to the outer casing causing a large indentation. Figure 11 is a photograph of the EECU depicting the damage sustained in the collision. NTSB investigators located the VECU behind the kick plate and observed that it received extensive thermal damage. Figure 12 is a photograph of the VECU depicting the damage observed by investigators.

Due to the damage sustained by both modules, data was not able to be extracted.

Figure 11. Photograph of the Mack truck EECU.

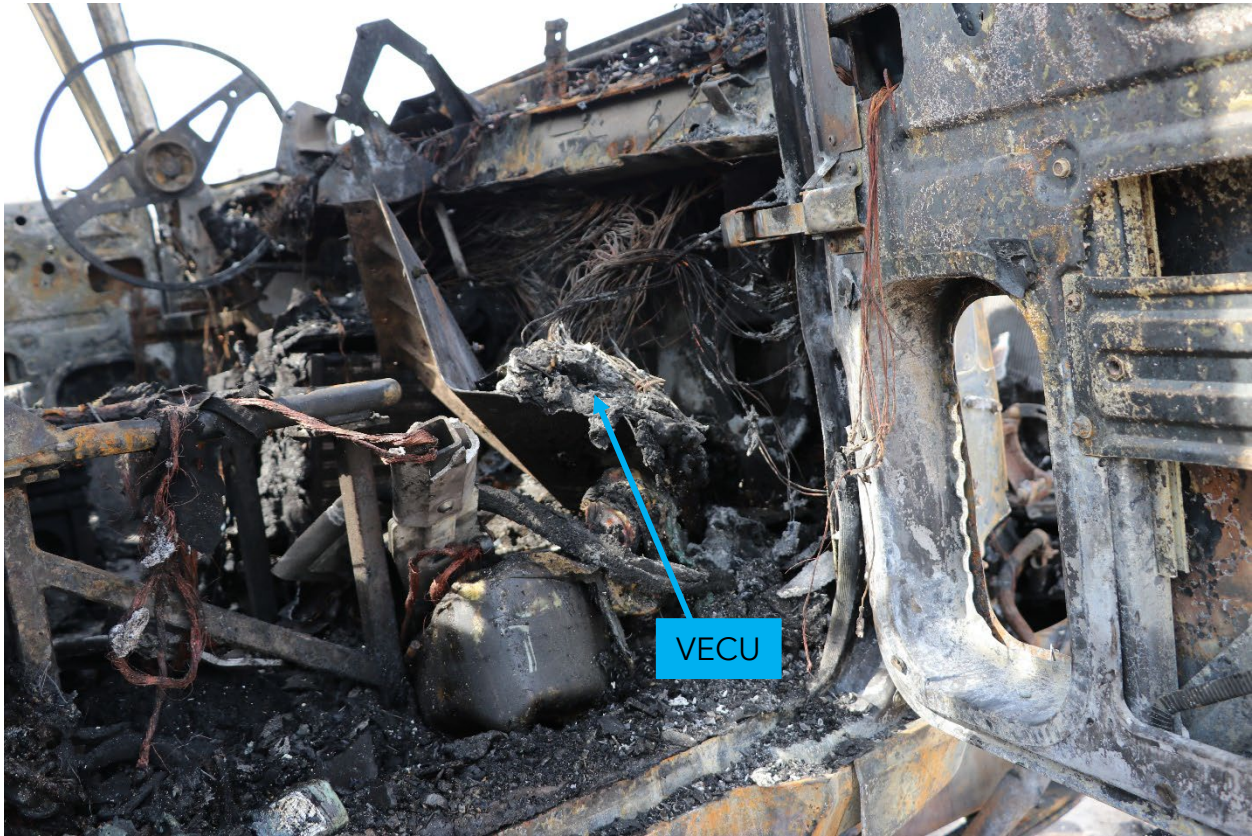
Figure 12. Photograph showing the VECU.

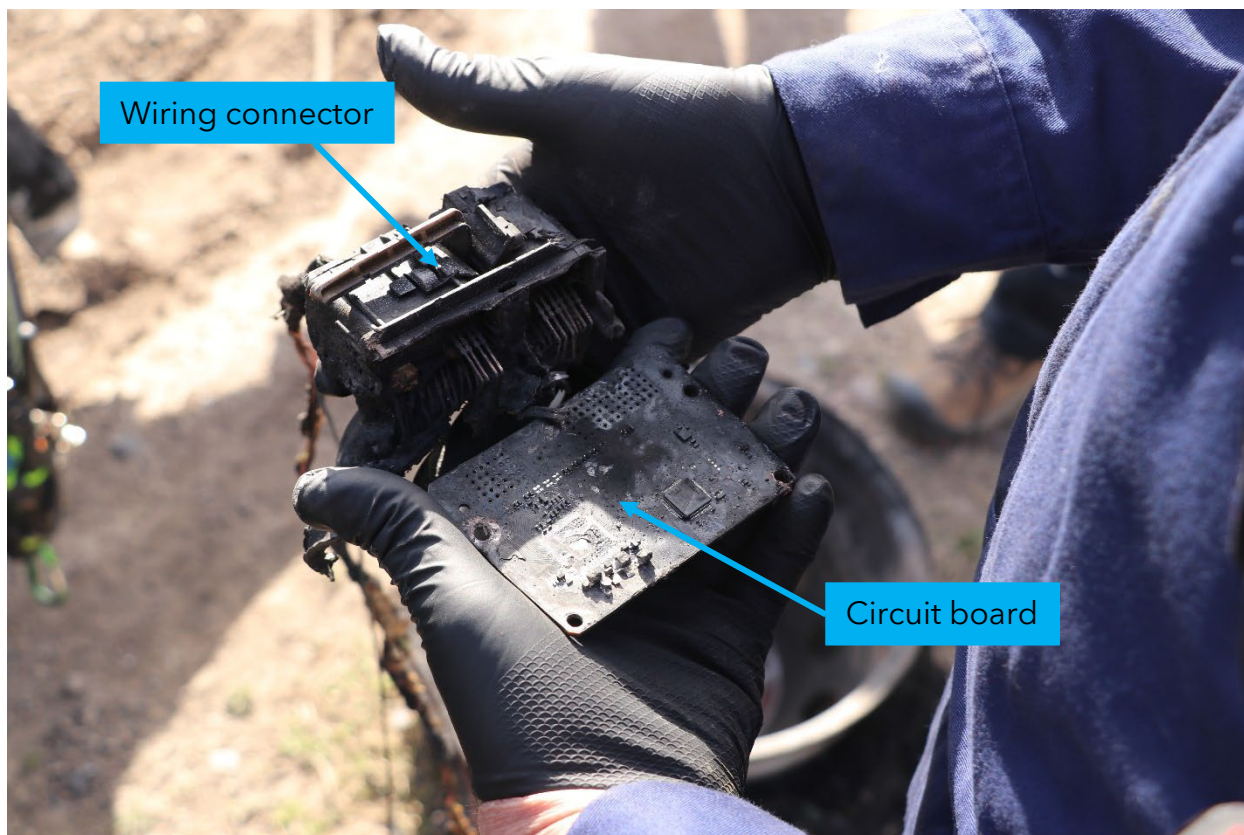
The bus body and seating were built atop the chassis of a 2020 Ford Transit 350 which was equipped with an airbag control module (ACM) with event data recorder (EDR) capability. During the examination of the bus, NTSB investigators were able to locate the ACM. The casing had broken apart revealing the circuit board inside. The circuit board and wiring harness were removed from the vehicle and photographed. Figure 13 shows the wiring connector and circuit board that was recovered from the bus. Along with the physical damage the components also sustained thermal damage. The circuit board was transported to NTSB headquarters by NTSB investigators.⁸ NTSB investigators examined the components for damage and completed the chip-level forensic examination on August 14, 2024. Data was not able to be recovered from the EDR.⁹

Figure 13. Photograph showing the wiring connector and circuit board.

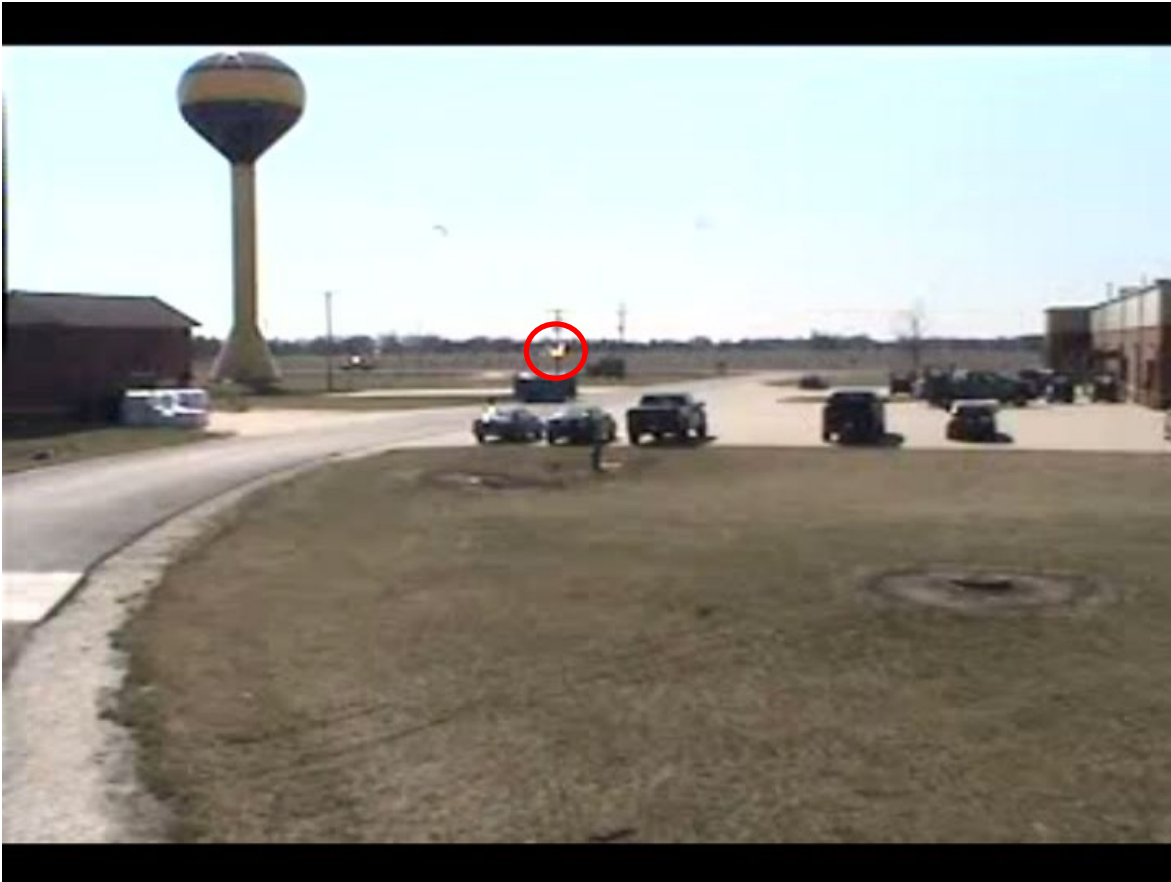
The combination appeared in the video traveling westbound. The bus was not visible in the video. The combination continued westbound until impact with the bus, white smoke and fire were all visible in the video. As the combination and bus moved west post-collision, the fire expanded westward. Figure 19 below shows the post-impact fire.

Figure 19. A screen capture from the Department of Justice Services video.
