Simon Forensic, LLC

Re: Moorage System Failure
Barge SM3
Your File No. DV 3148
S.F. Report No. 4132

2. Visual Examination

3. Fractographic Examination

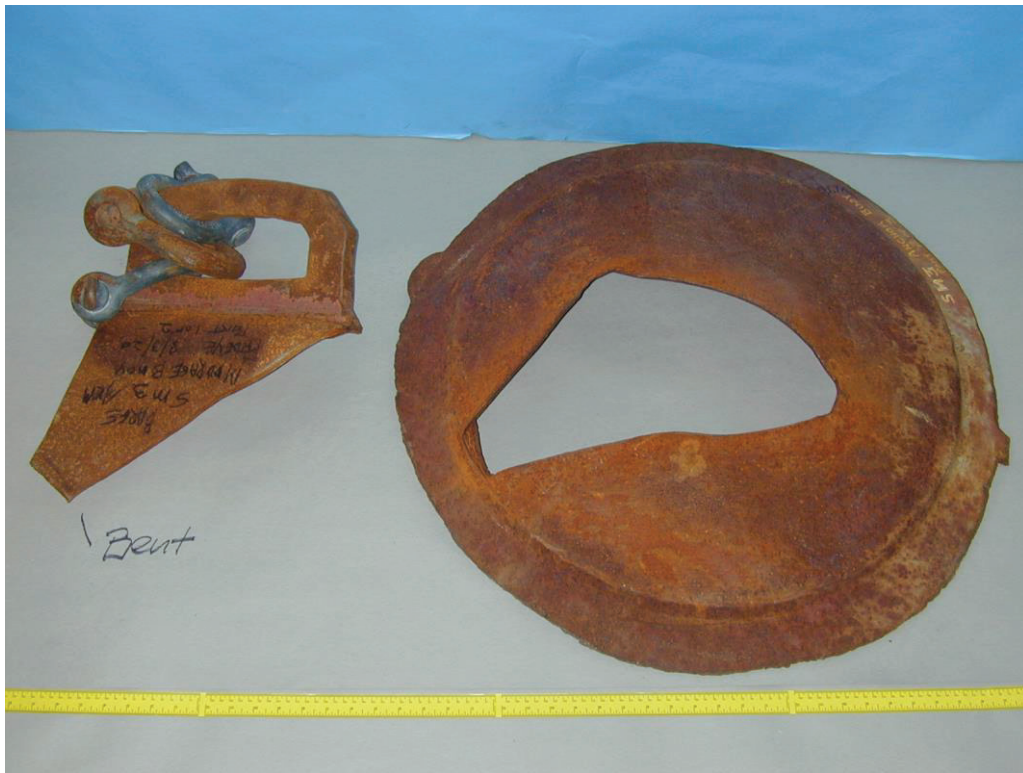
- The topside of the buoy consists of a padeye (1¼” thick plate) that had been fillet welded to the shell (5/16” thick curved sheet metal) of the buoy.
- The **buoy has functionally failed**, i.e. a **separating crack** had formed at the **fillet weld** of the **topside padeye** thus **allowing the uncontrolled separation of the padeye**, see Fig. 1-4.
- Three (3) shackles used in the mooring operation were found to be marked as follows:
 - 1) **Campbell 1 WLL 8’/2T**, measurements confirmed a shackle diameter of 1” (25mm), see Fig. 4-6 and 8.
 - 2) **Campbell 1 WLL 8’/2T**, measurements confirmed a shackle diameter of 1” (25mm), see Fig. 4-6 and 8.
 - 3) **Crosby WLL 1.5T**, 1 1/8 1251, Fig. 4-7.

Fig. 1: Overall view of the submitted failed section that had reportedly been removed from the buoy (see Attachment 2-3) utilized in the moorage arrangement of barge SM3.

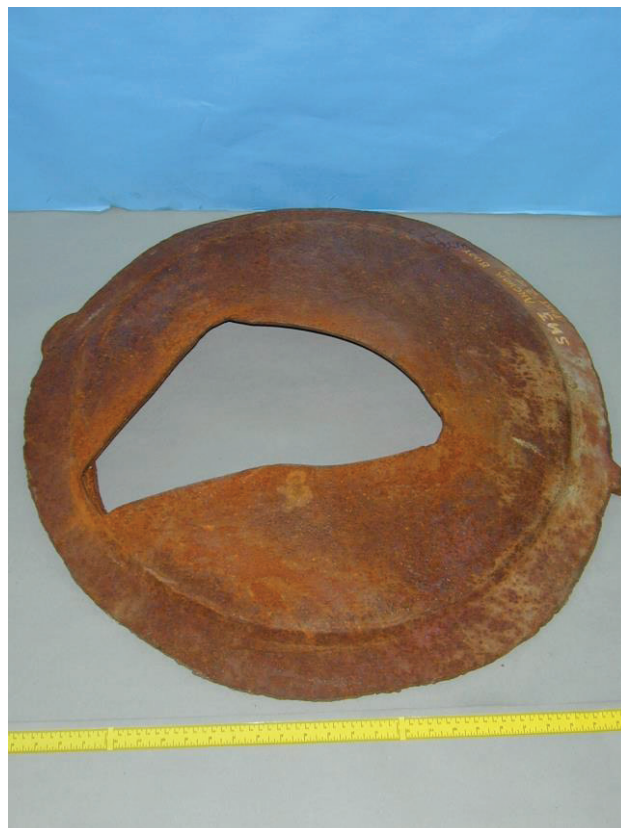
Fig. 2: Close up view of Fig. 1. Shell side of the failure.

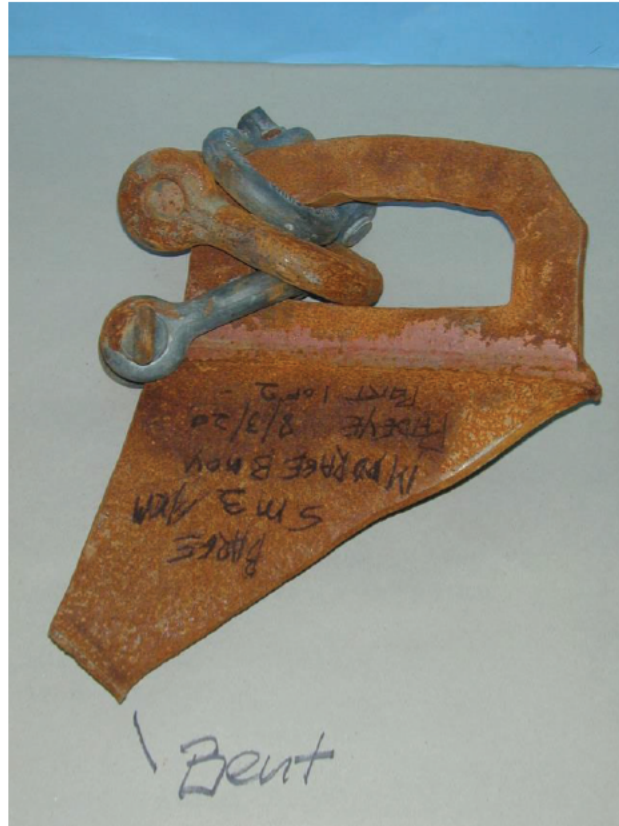
Fig. 3: Same as Fig. 2, but the liberated padeye with shackles is shown.

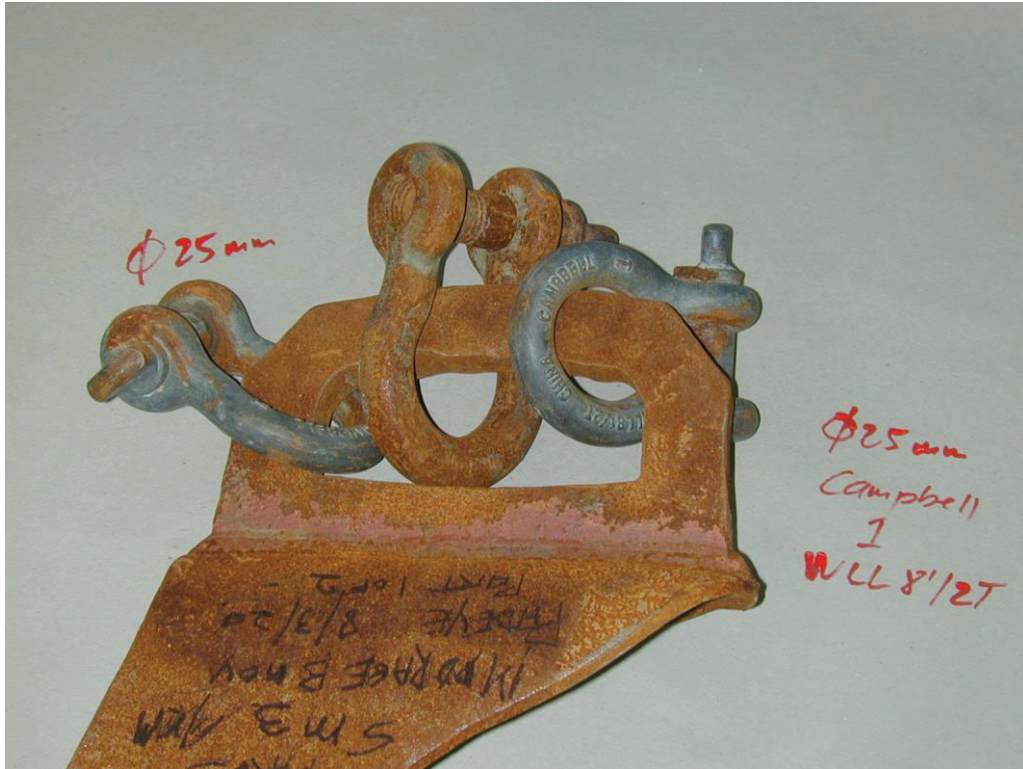
None of the shackles had failed, i.e. **no plastic deformation or cracking** was observed.

Fig. 5: Close up view of the 3x shackles.

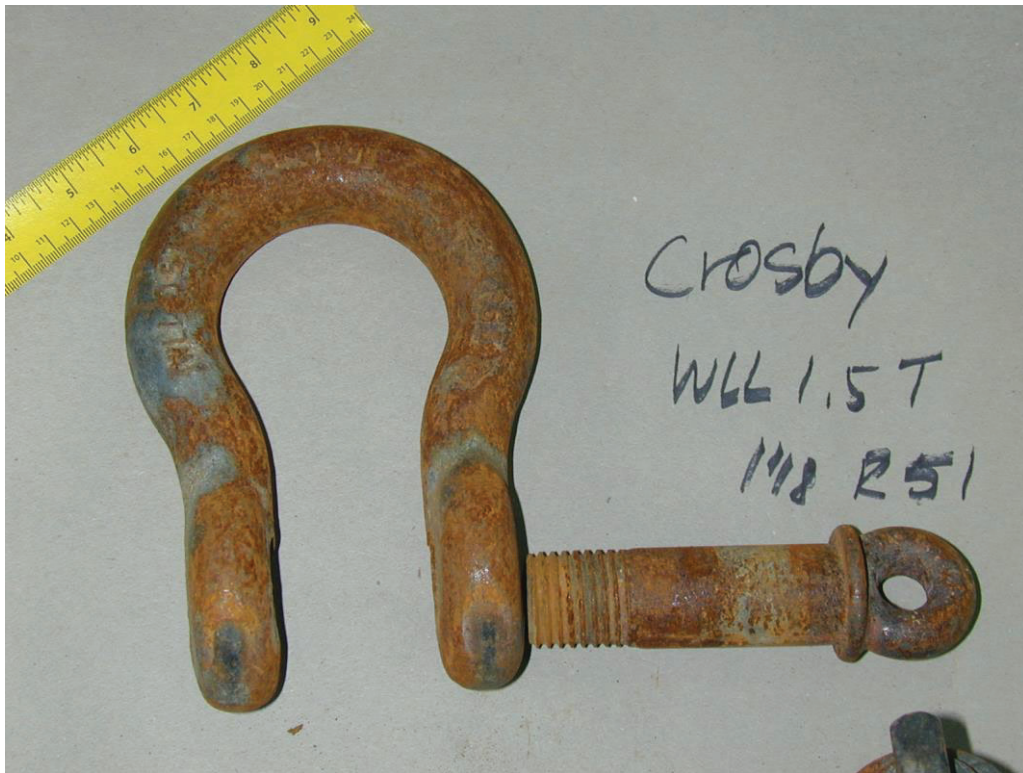
Fig. 7: Close up view of the Crosby shackle.

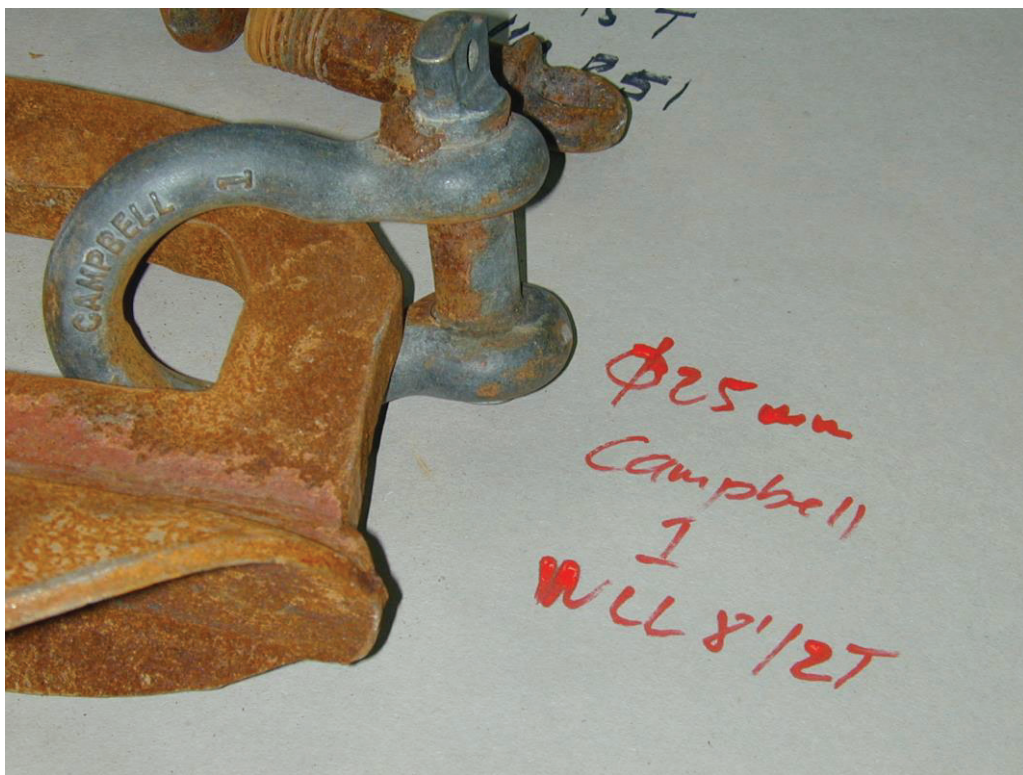
Fig. 8: Close up view of the Campbell shackle (#1).

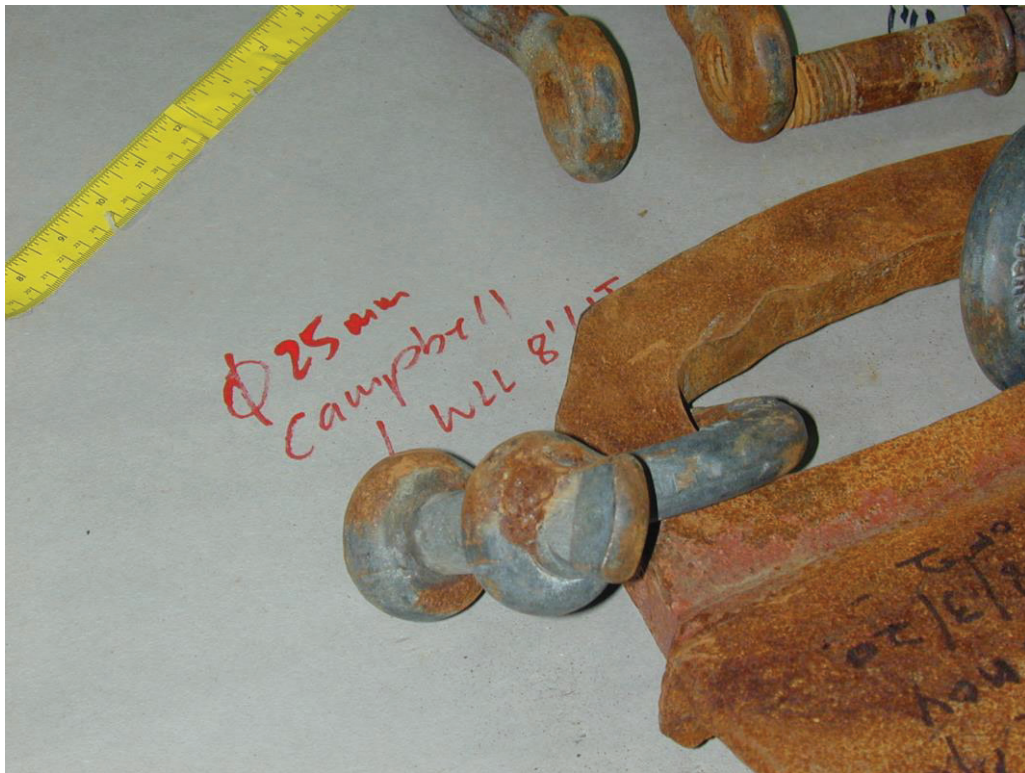
Fig. 9: Same as Fig. 8, but the other **Campbell shackle (#2)** is shown.

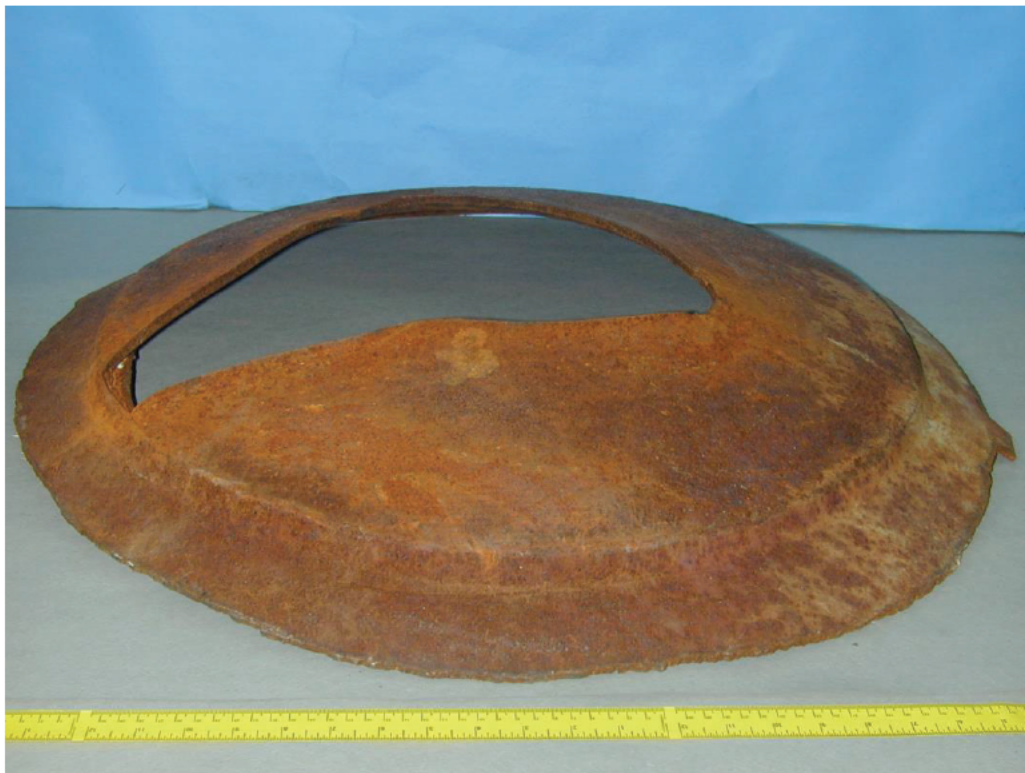
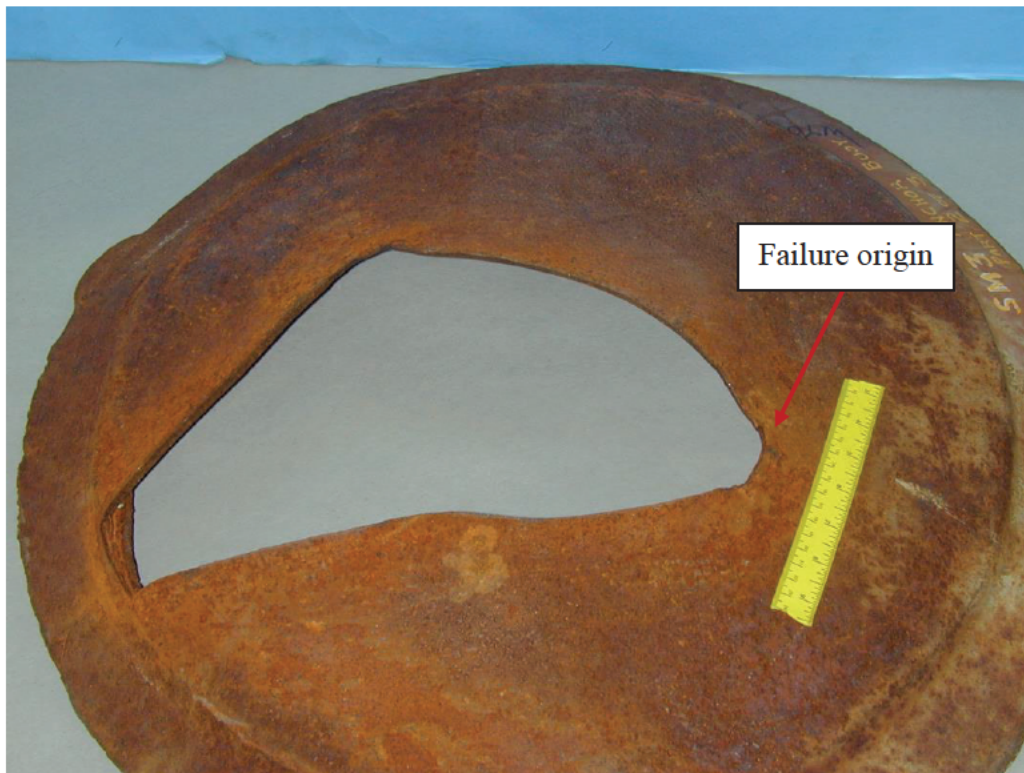
- A light layer of corrosion products was found to cover the fracture face thus masking the finer fractographic details, see Fig. 12-13.
- The **fracture initiated at the fillet weld** (plate side) at the **end face of the padeye**, see Fig. 17-18.
- A section containing the crack origin was removed (see Fig. 19-23) and ultrasonically cleaned, see Fig. 30.

Fig. 12: Same as Fig. 2, but the shell is shown from a different angle.

Fig. 13: Close up view of Fig. 12.

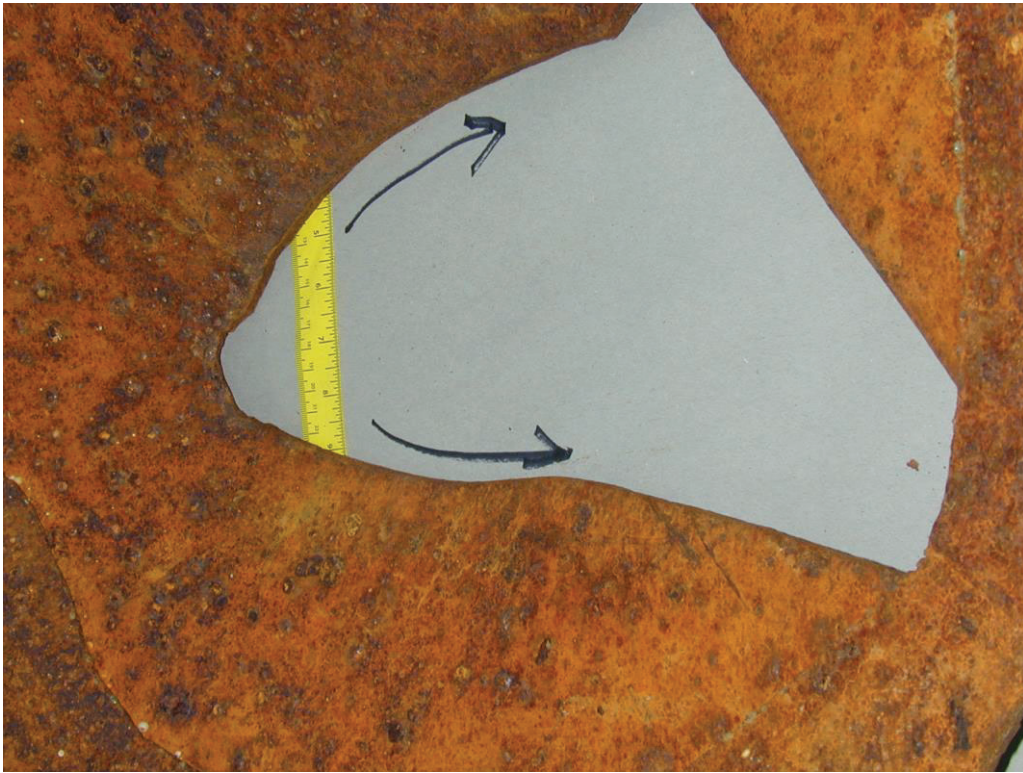
Fig. 15: Close up view of Fig. 14. Black arrows indicate the direction of crack advancement.

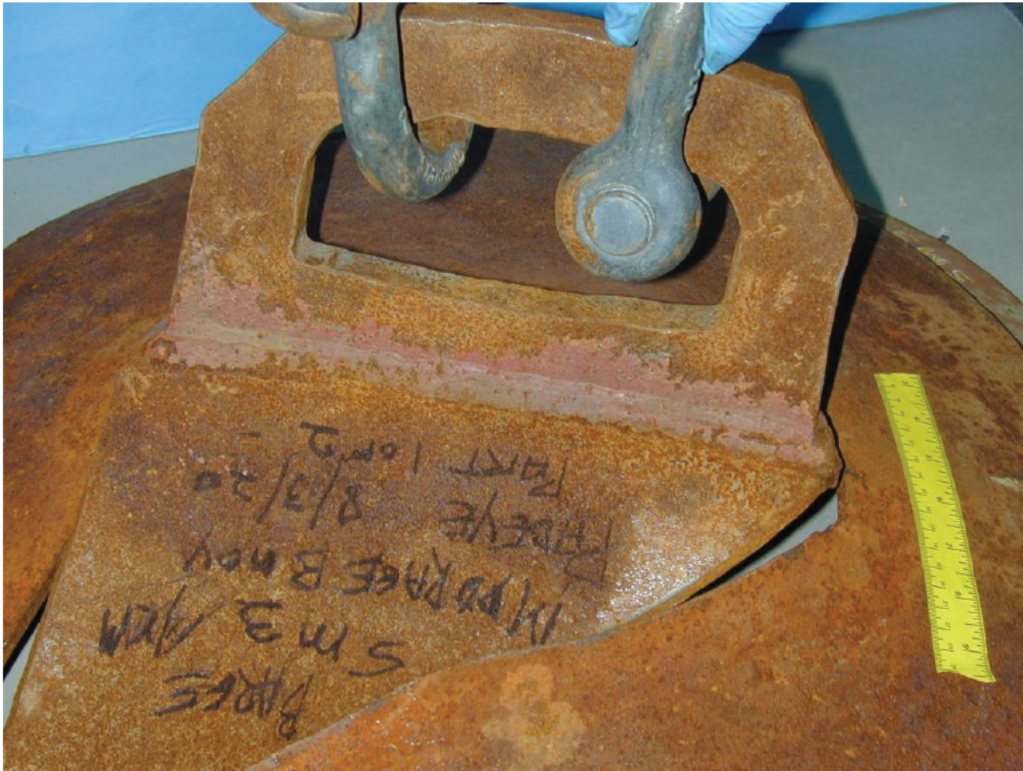
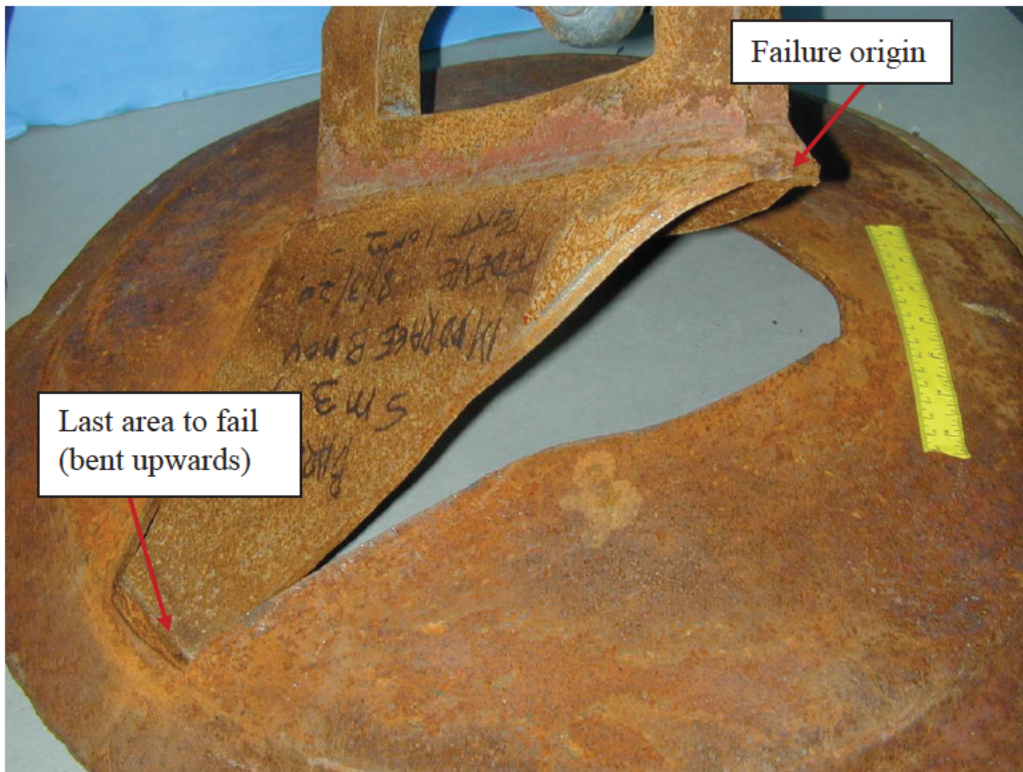
Fig. 17: Same as Fig. 13, but the liberated section has been superimposed for demonstrational purposes.

Fig. 18: Same as Fig. 17, but the direction of failure is been simulated.

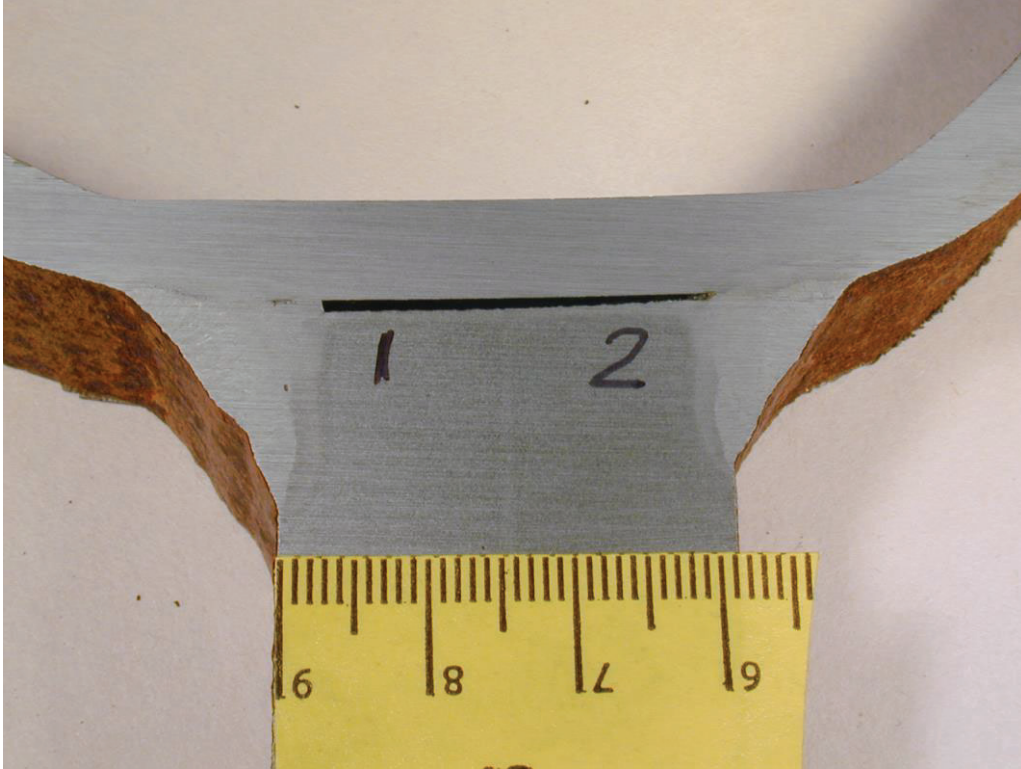
The subsequent visual examination revealed an **adequate weld quality**, i.e. a proper weld fusion/penetration and throat profile were observed, see Fig. 27-29.

Fig. 27: Close up view of the etched weld x-section. Note, **no defects were observed.**

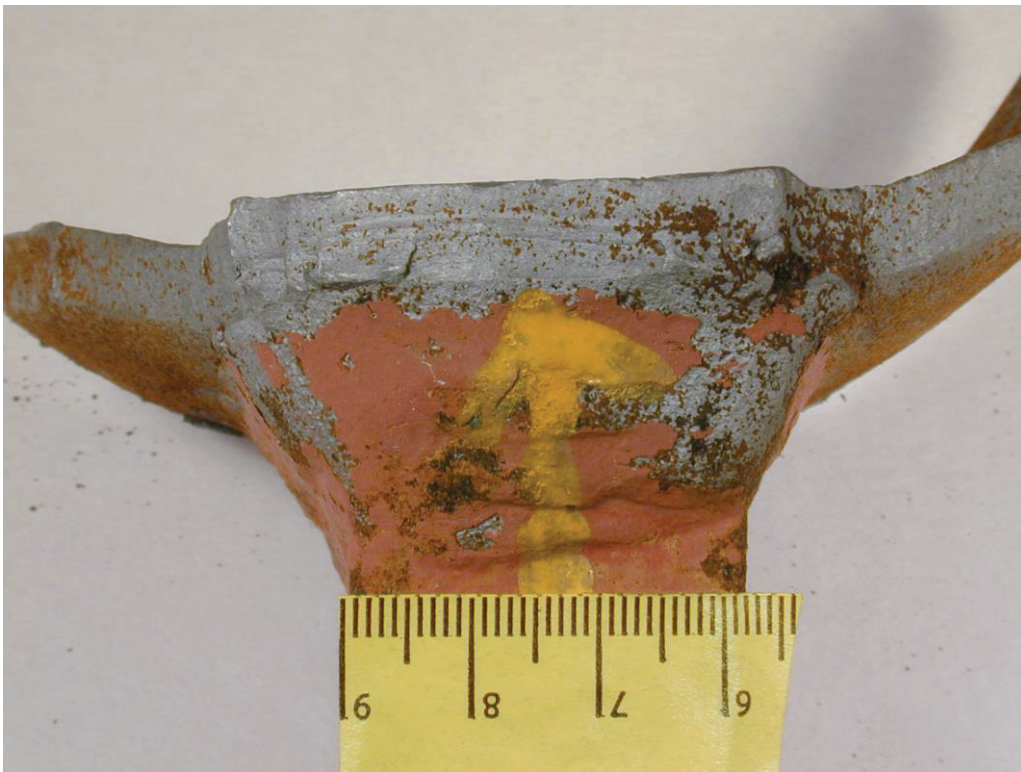
A closer examination revealed a **small fatigue zone** (approximately 5mm deep and extending over the width of the padeye), i.e. beach marks (witness marks of stage II fatigue) were observed, see Fig. 30-37.

Fig. 30: Close up view of the cleaned failed origin.

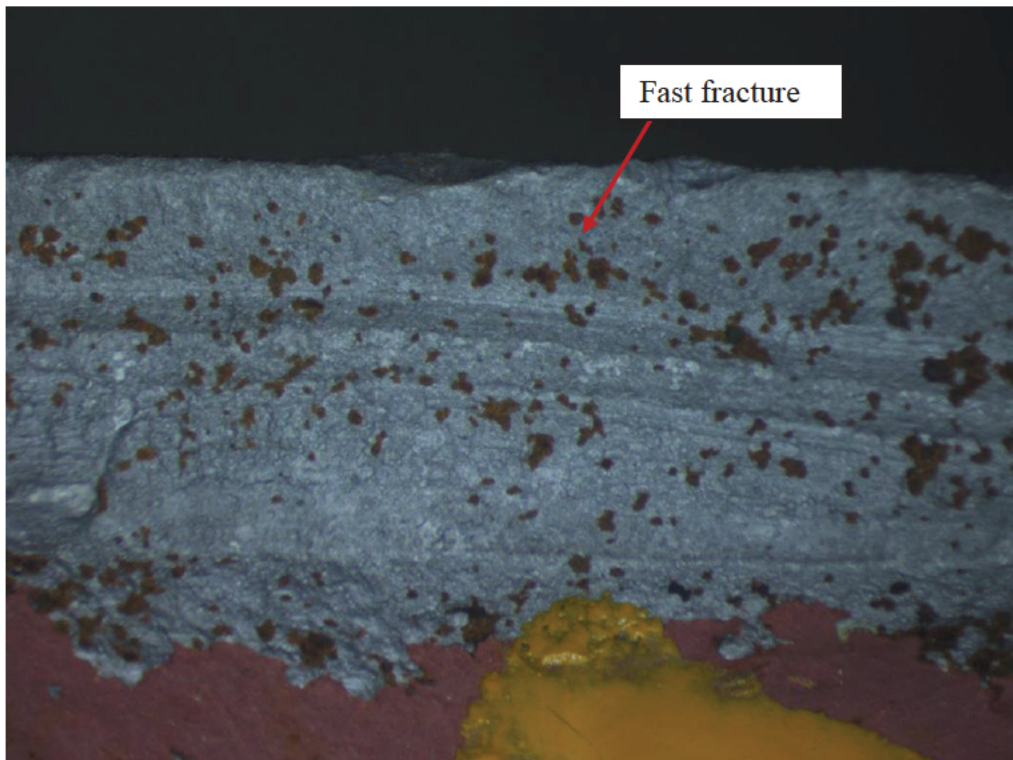
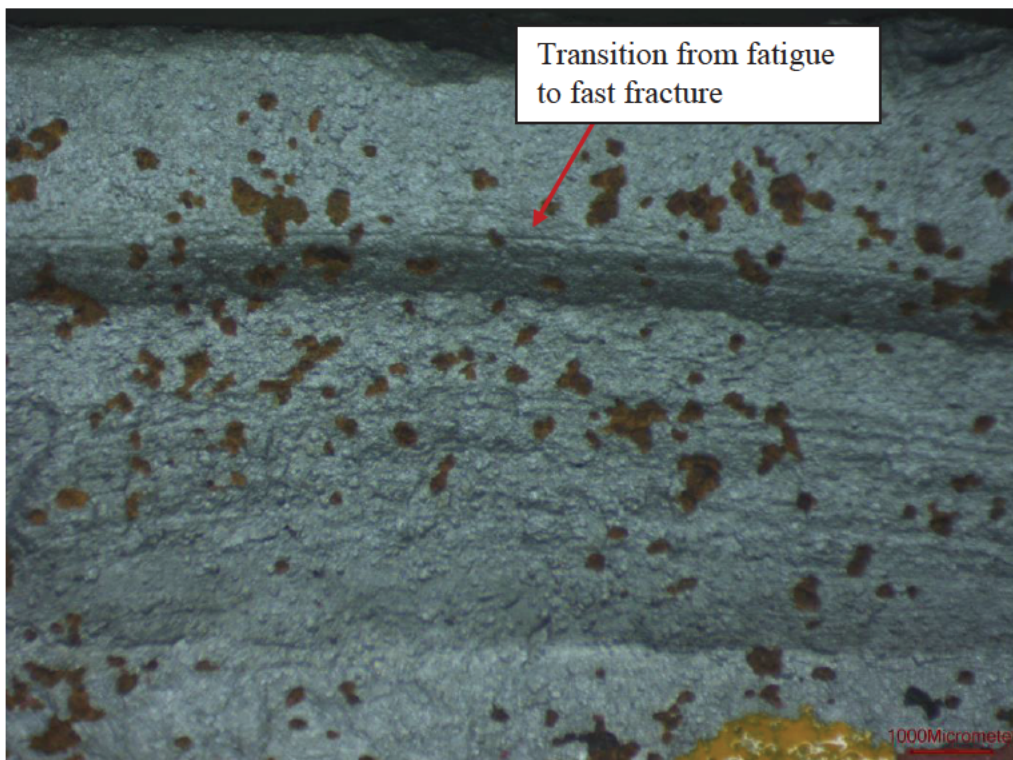
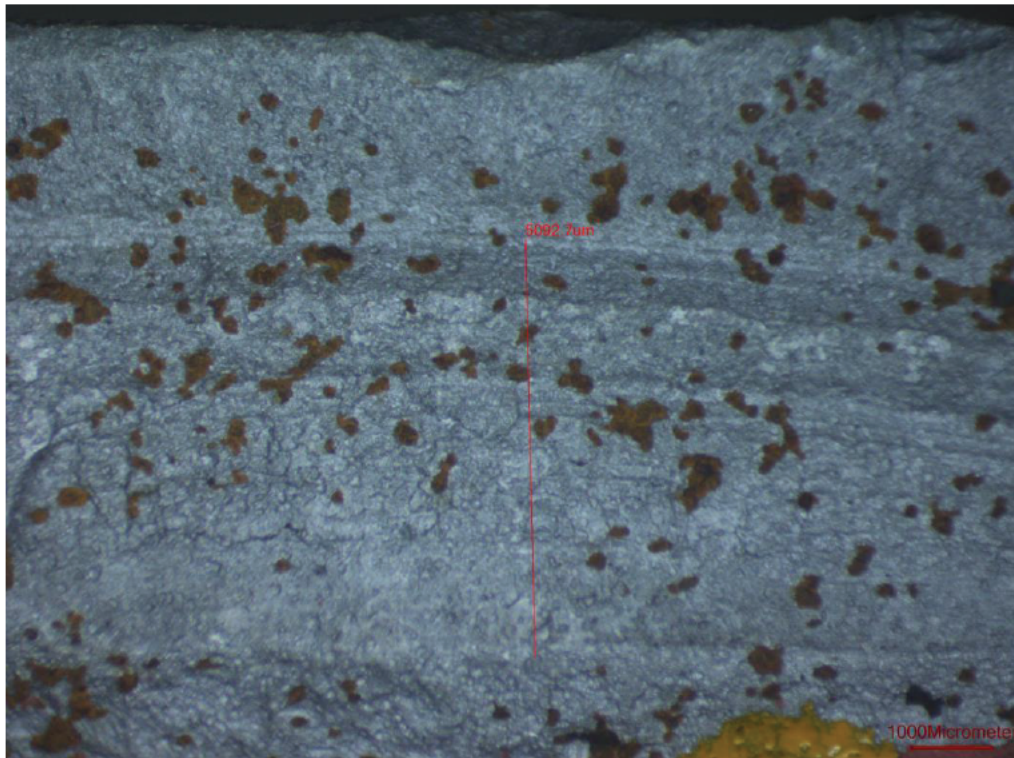
- Multiple fatigue crack origins were observed (separated by ratchet marks), see Fig. 38.
- No gross metallurgical (non-metallic inclusions) or weld related (lack of weld fusion for example) defects were observed at the crack origins, see Fig. 35-37.

Fig. 35: Close up view of Fig. 34 at 10x.

Fig. 36: Same as Fig. 35, but differently illuminated.

Fig. 37: Same as Fig. 36, but the depth of the fatigue zone has been measured, see annotations,

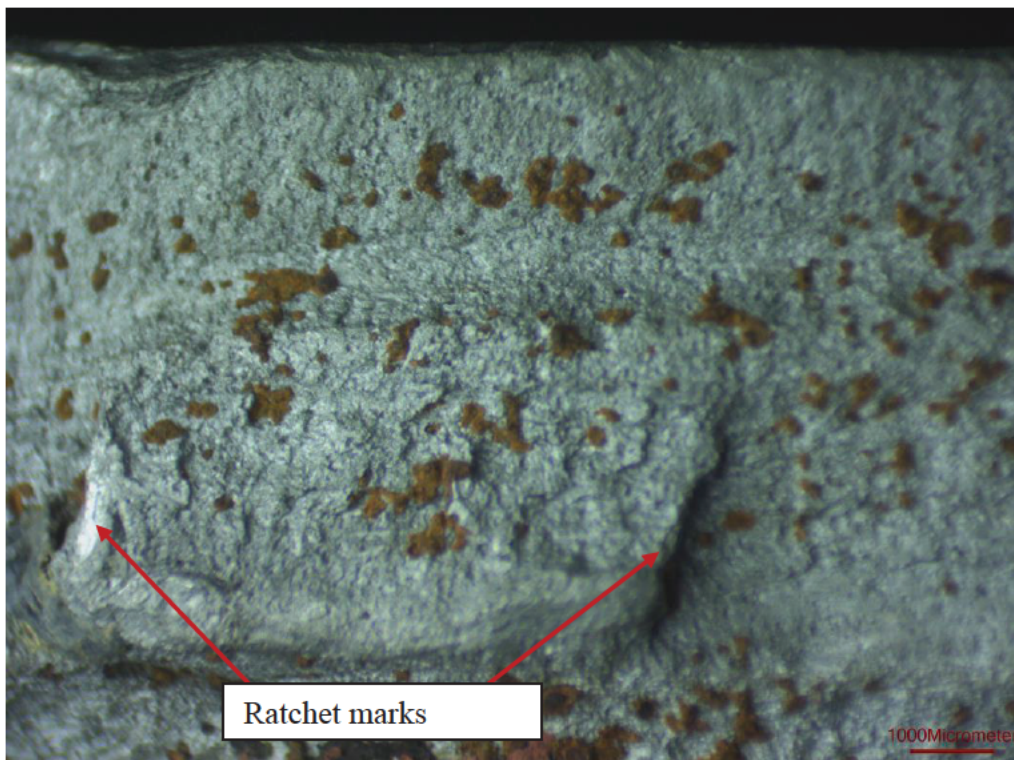
Fig. 38: Same as Fig. 37, but the area to the left is shown.

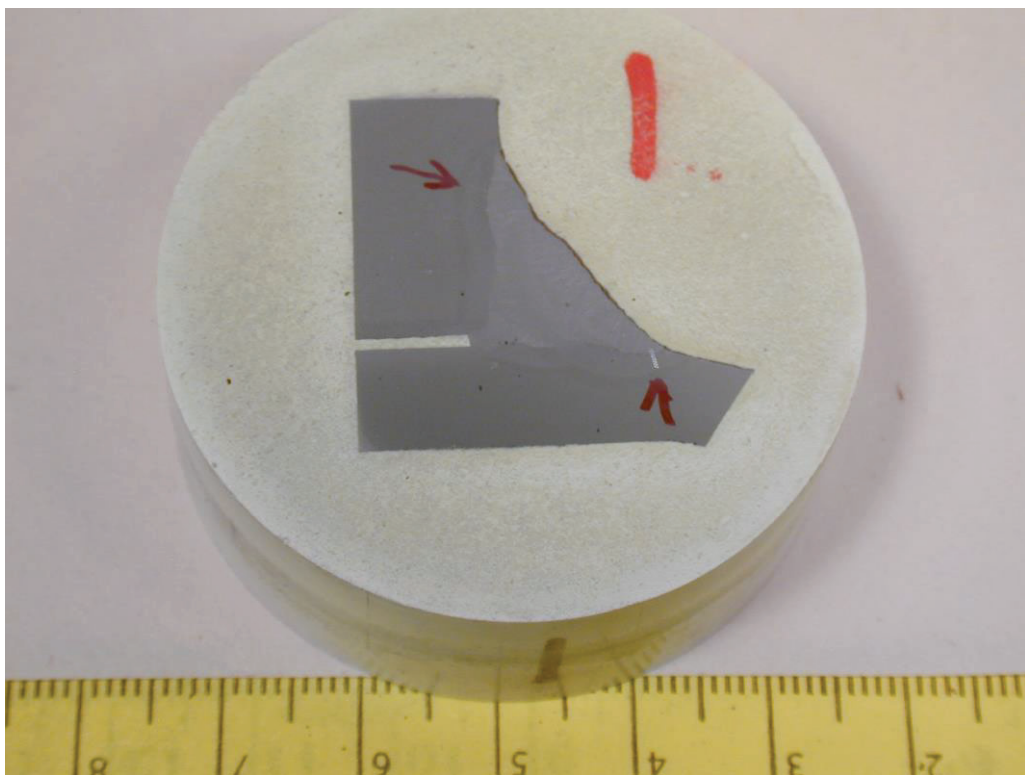
A microhardness survey across the HAZ of both legs revealed the following values:

Fig. 42: Close up view of Fig. 41 (weld #1). Red arrows indicate the locations of microhardness survey.

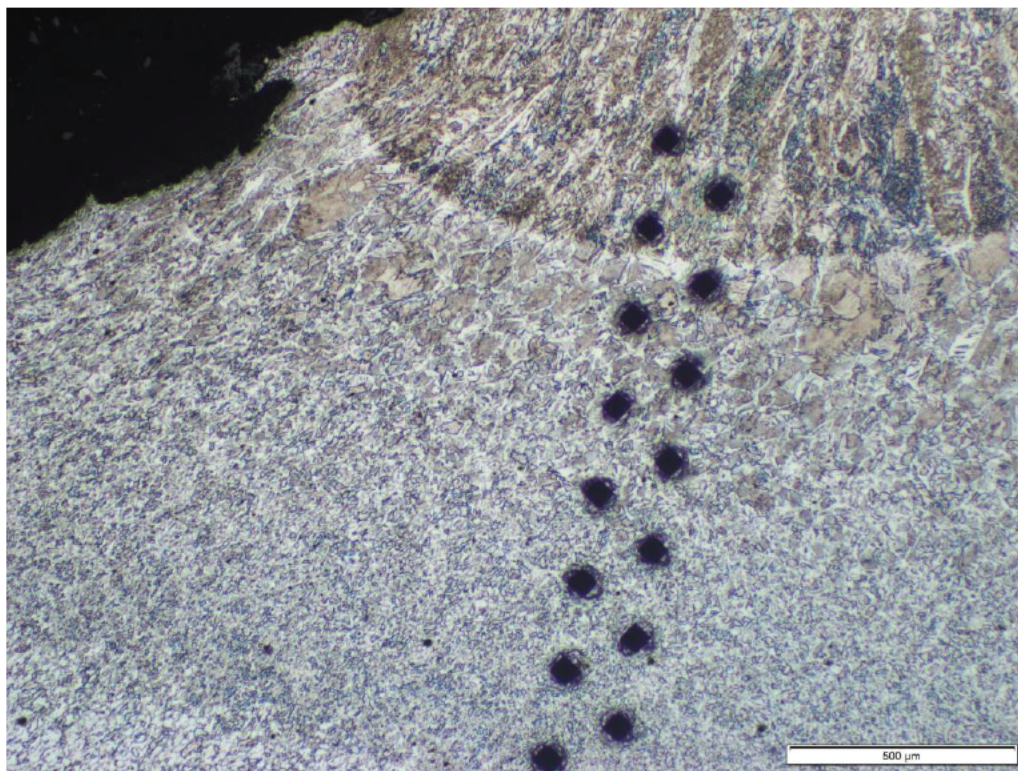
- The padeye is made from a mild carbon steel, i.e. a ferritic/pearlitic microstructure was observed, see Fig. 47.
- The buoy shell is made from a low carbon steel, i.e. a primarily ferritic microstructure was observed, see Fig. 45.
- No undesirable phase transformation products were observed in any of the examined HAZ’s suggesting that a proper temperature control had been maintained at the time of welding, see Fig. 44, 46 and 50-53.
- **No weld defects were found to have encouraged the failure.**

Fig. 44: Close up view of Fig. 43 at 50x. Note, no undesirable phase transformation products were observed.

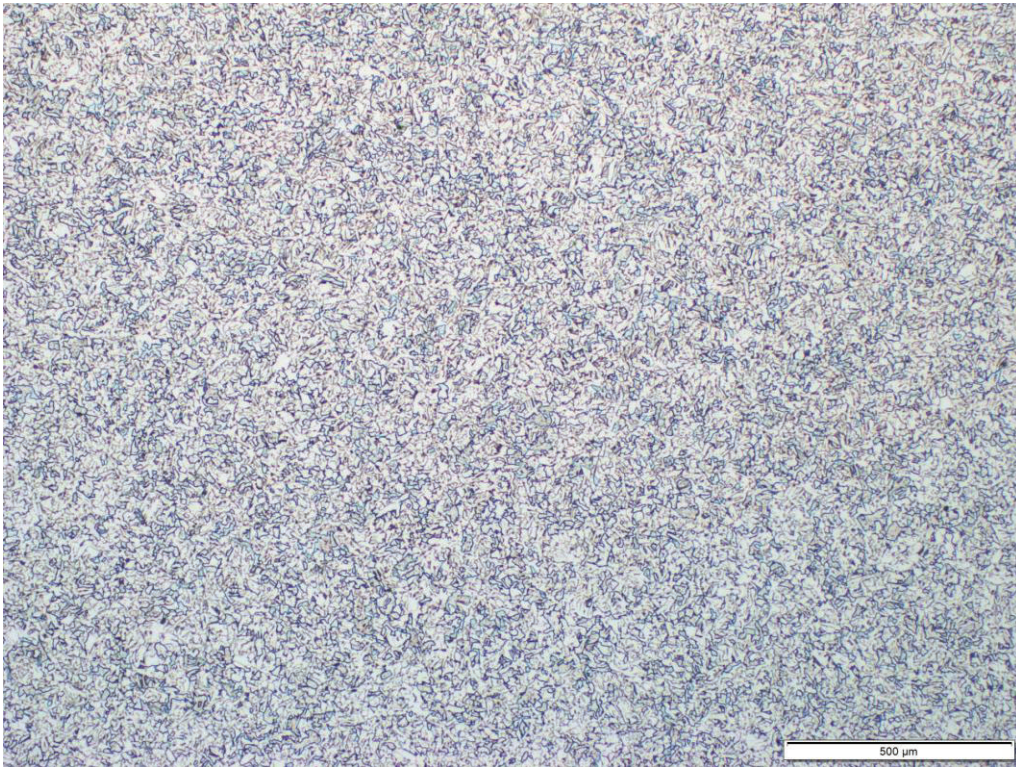
Fig. 45: Same as Fig. 44, but the base metal (buoy shell) is shown.

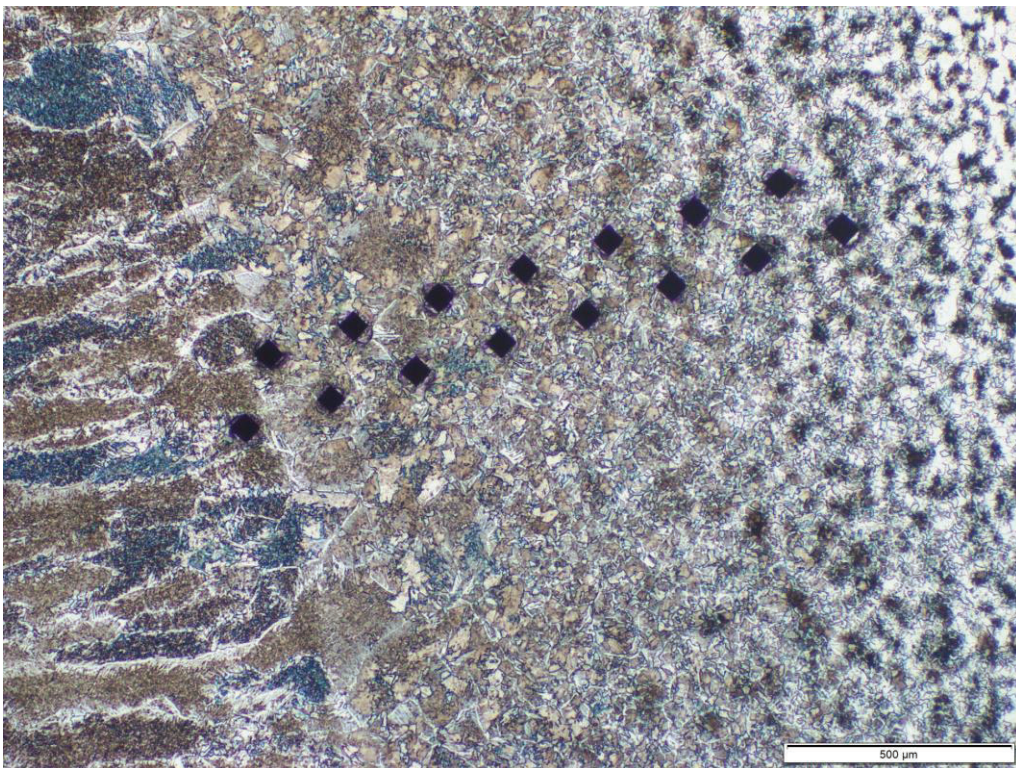
Fig. 46: Same as Fig. 44, but the other weld (see Fig. 43) is shown. Note, no undesirable phase transformation products were observed.

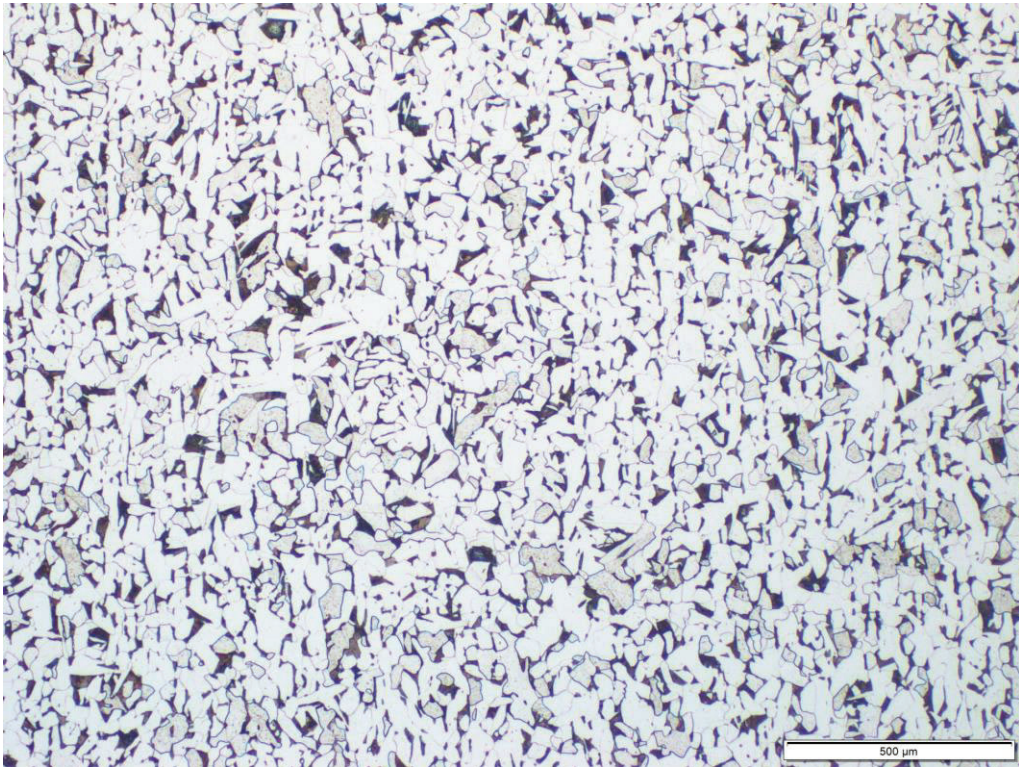
Fig. 47: Same as Fig. 46, but the base metal (padeye) is shown.

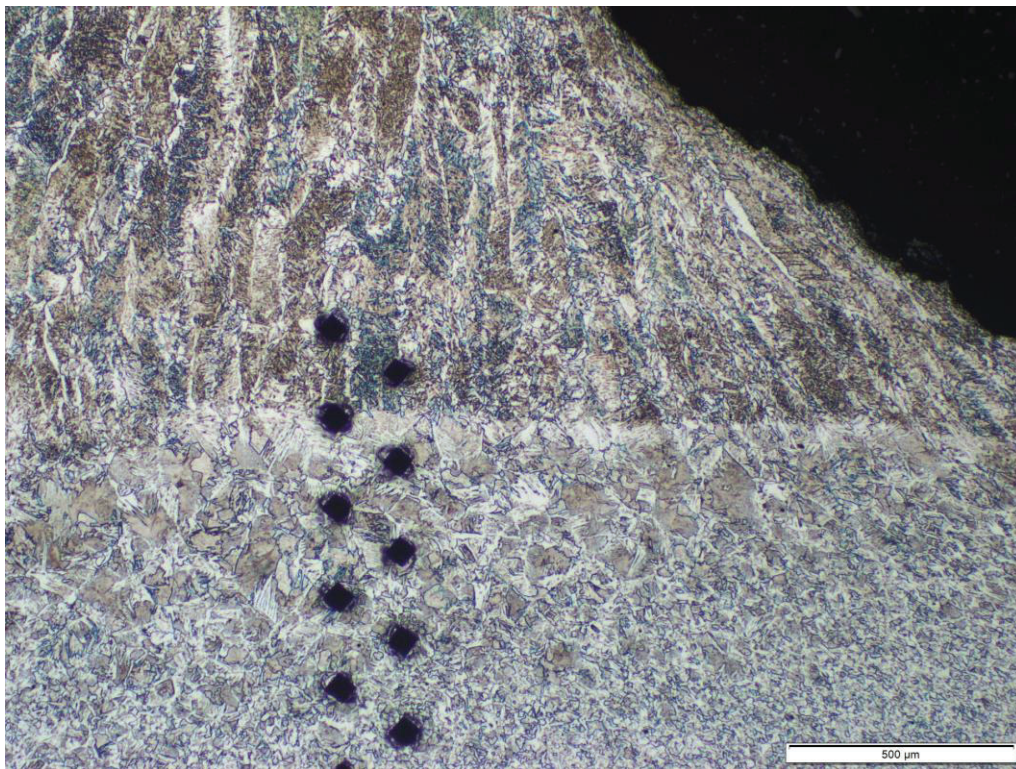
Fig. 50: Close up view of Fig. 51 at 50x. Note, no undesirable phase transformation products were observed.

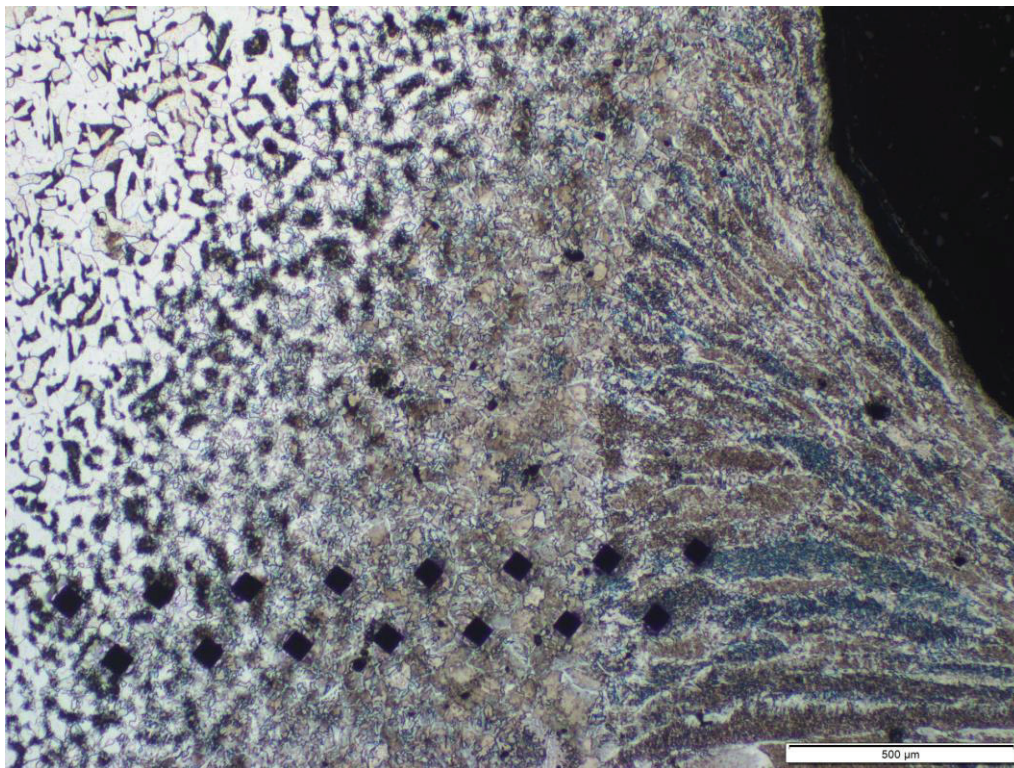
Fig. 52: Same as Fig. 50, but the other weld is shown. Note, no undesirable phase transformation products were observed.

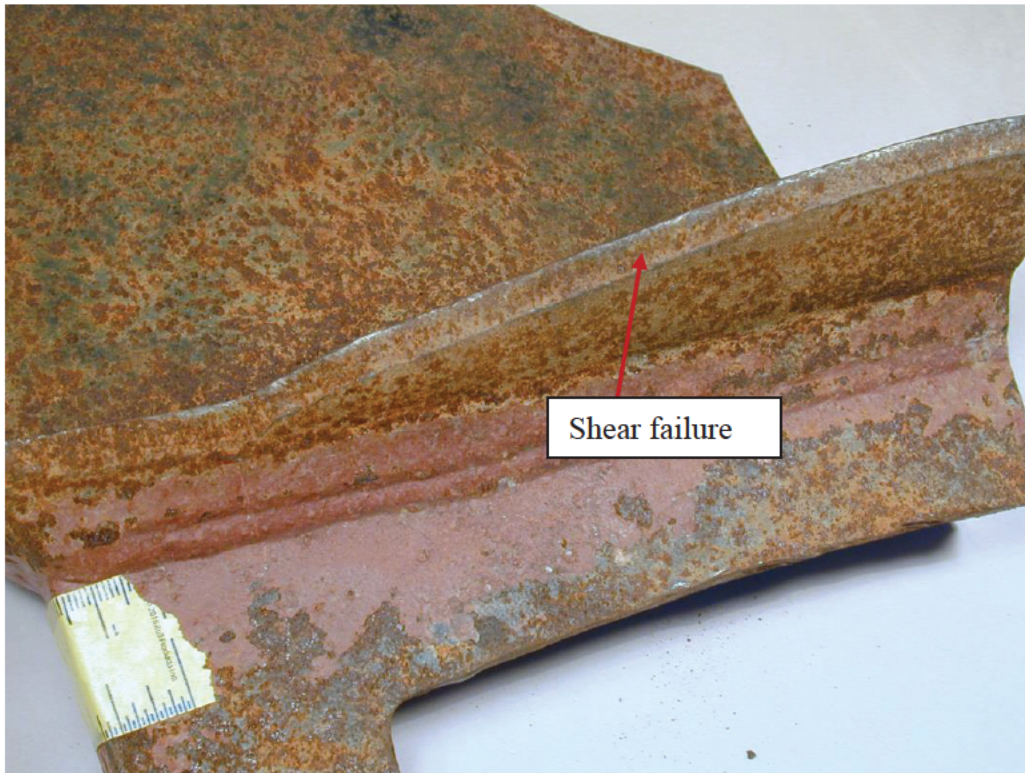
- **The buoy has functionally failed, i.e. a separating crack had formed at the fillet weld of the topside padeye thus allowing the separation (liberation) of the padeye from the buoy.**

- **The topside padeye (buoy) was structurally compromised at the time of the incident, i.e. a small fatigue crack had been present thus providing a mechanical stress riser.**

Fig. 57: View of the buoy shell failure.

1. Examine (visually and mag. particle or dye-penetrant) the bottom side padeye for evidence of cracking.

2. Conduct wall thickness measurements (UT) of the buoy shell (including top/bottom shell at the location of the pad eye).
 3. Open buoy to determine if an internal stiffener (center rod) has been present.
 4. Review the design of the buoy.
 5. Review the operation history of the buoy to determine if the buoy has been subjected to undue loads in the past.
8. For further details, please see Fig. 1-57 and Attachments 1-3.
