NATIONAL TRANSPORTATION SAFETY BOARD
Vehicle Recorder Division
Washington, DC 20594
July 17, 2015

Specialist's Factual Report
By George Haralampopoulos

Location: Reno, Nevada
Date: September 8, 2014
Aircraft: Backovich GP-5
Registration: N501GP
Operator: Private
NTSB Number: WPR14FA369

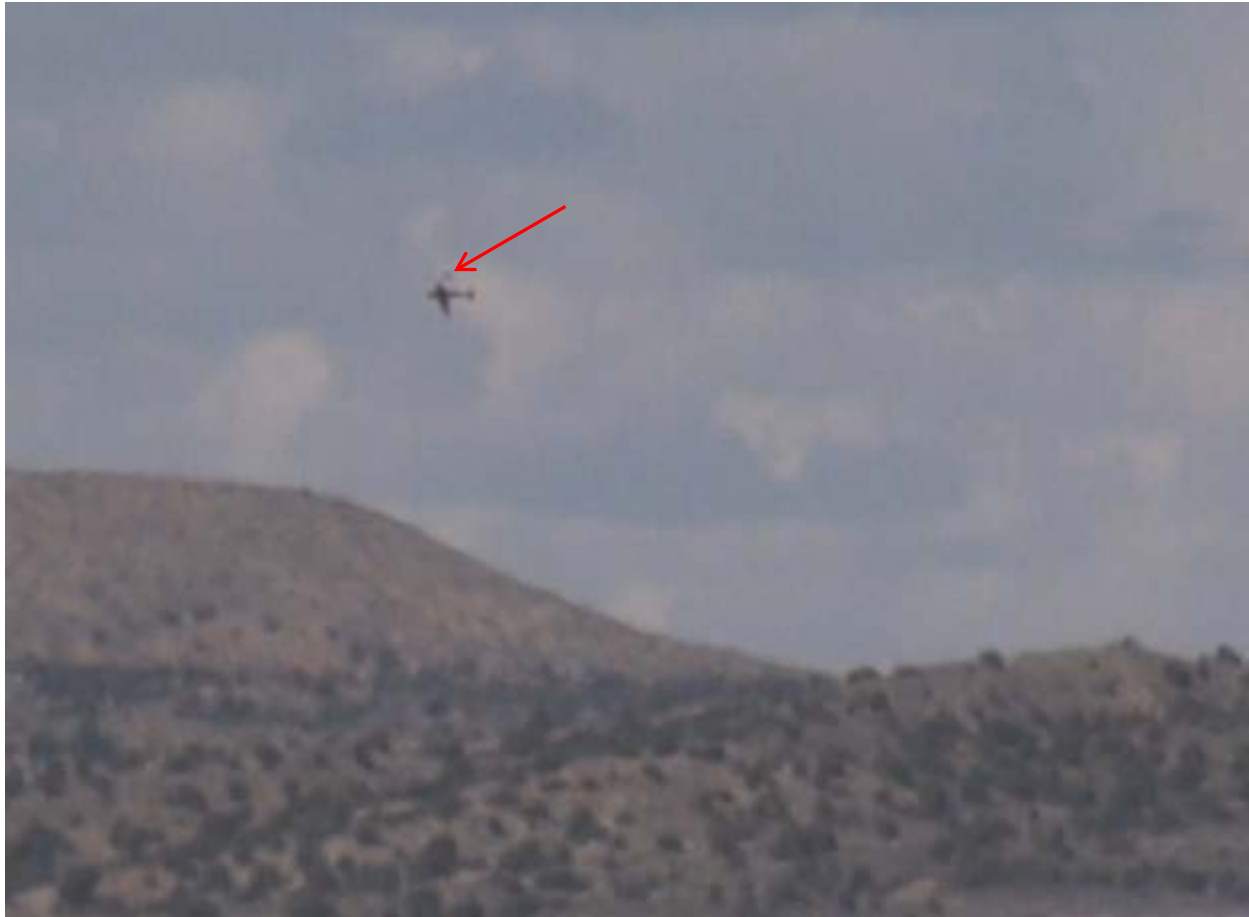
The aircraft reappeared at 0518:52 PDT, and maintained altitude while in a left wing down bank angle. The aircraft continued through its turn until 0519:04 PDT, when a piece of the right wing broke off from the aircraft (figure 1).

Figure 1.Extracted video still highlighting inflight breakup.
