Here is the damage survey for the barge.

**From:** Eric Sharp [REDACTED]@riverservicescompany.com>  
**Date:** Thu, Apr 25, 2019 at 4:28 PM  
**Subject:** Re: New Budwine Job / Terral River / M/V "Edna T Gattle" - Krotz Springs Railroad Bridge Allision / Preliminary Damage Survey / Krotz Spring, LA / 4.25.19 / RP: Josh Easterling - Surveyor: Eric Sharp & Ty Rattcliff  
**To:** [REDACTED]@terralriverservice.com>, <[dispatchbud@budwineassociates.com](mailto:dispatchbud@budwineassociates.com)>  
<[dispatchbud@budwineassociates.com](mailto:dispatchbud@budwineassociates.com)>  
**Cc:** TY Rattcliff [REDACTED]@riverservicescompany.com>, Brian Goldman [REDACTED]@riverservicescompany.com>, [REDACTED]@terralriverservice.com>, Allen Hartshorn [REDACTED]@terralriverservice.com>

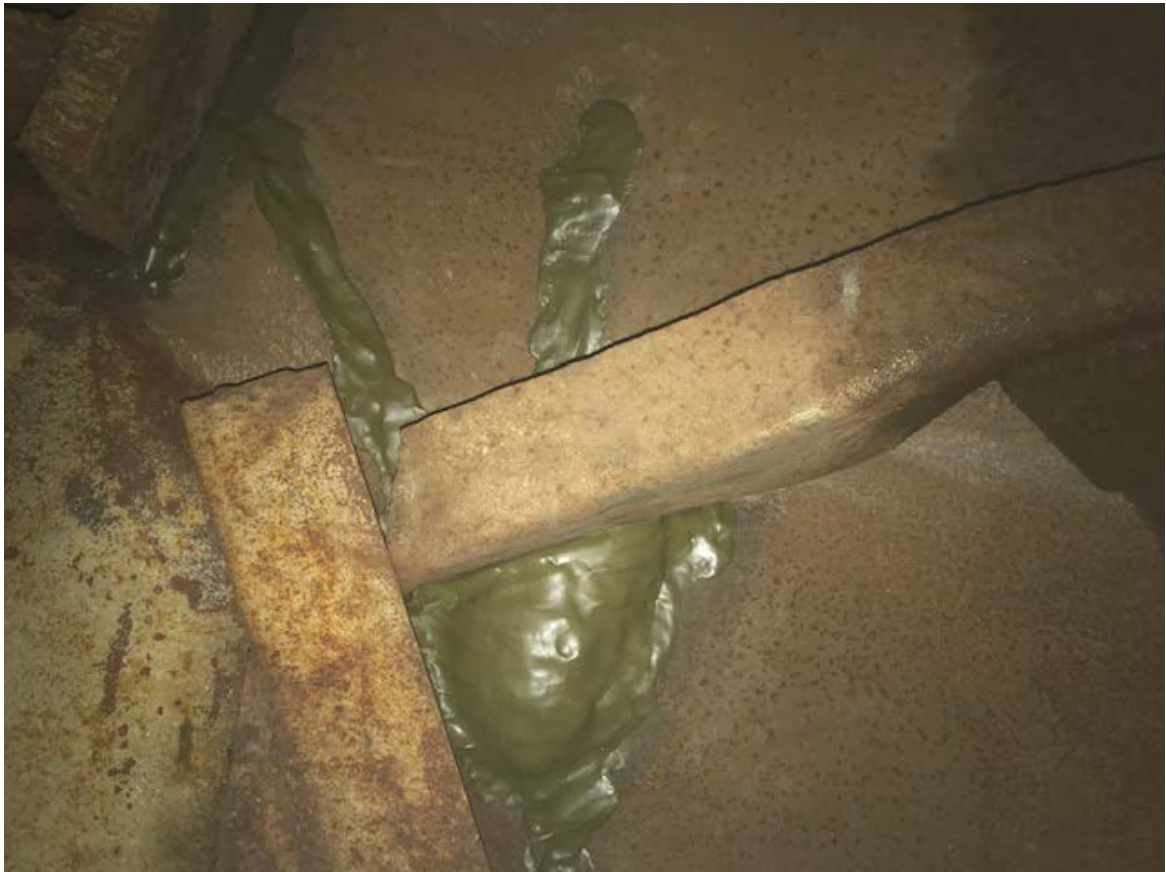
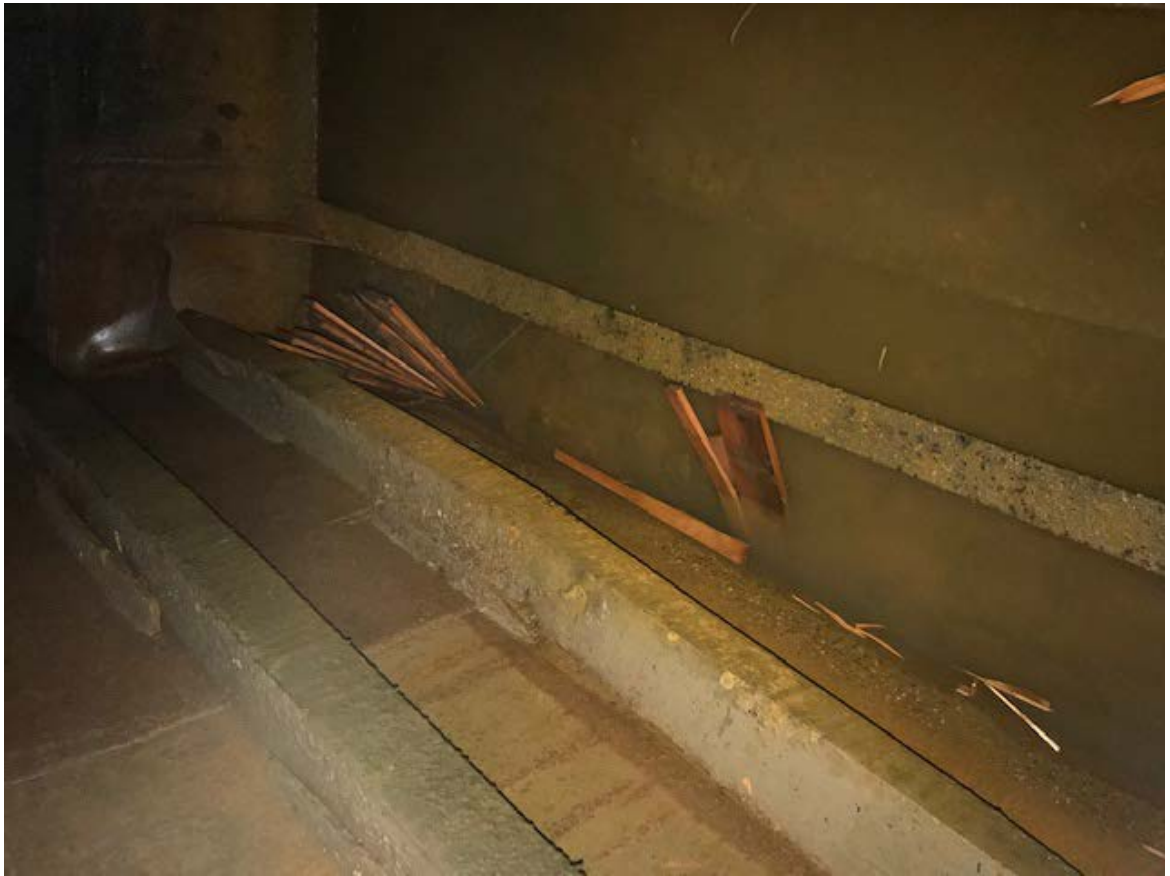
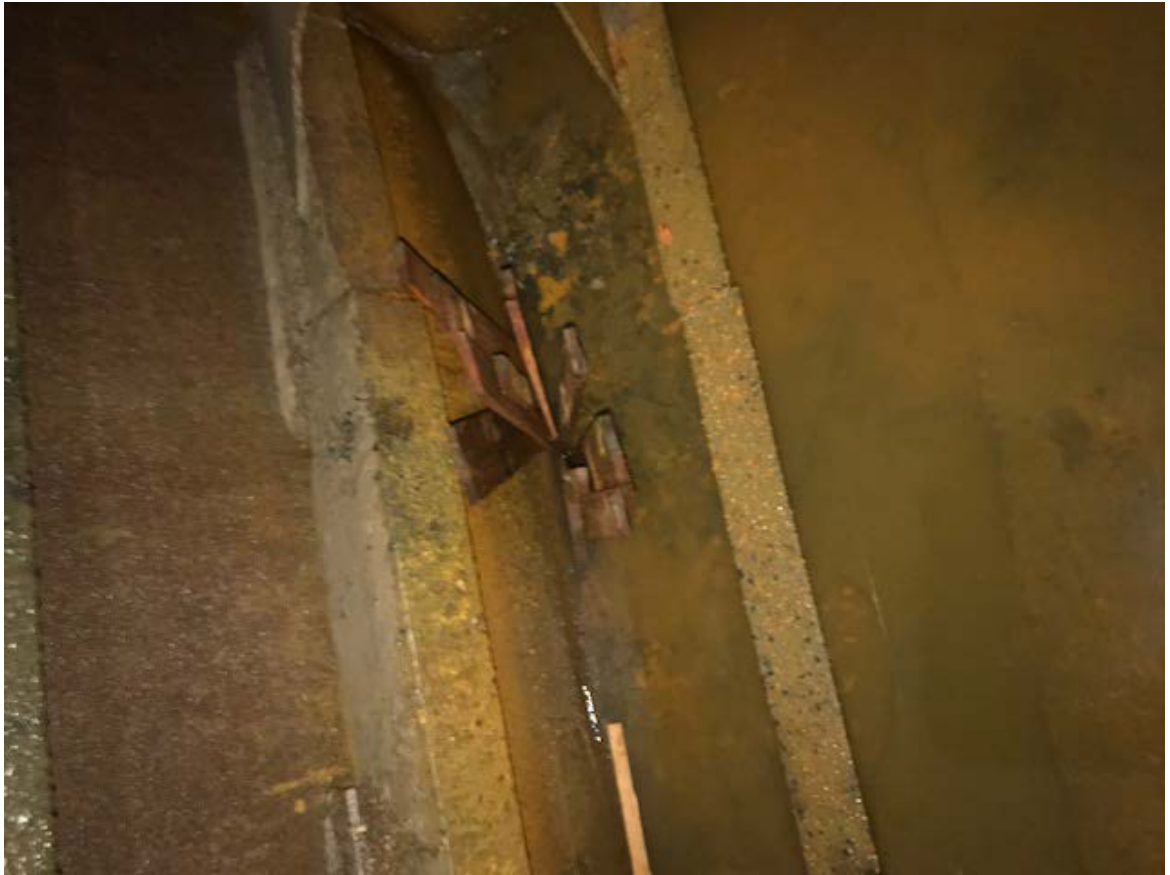
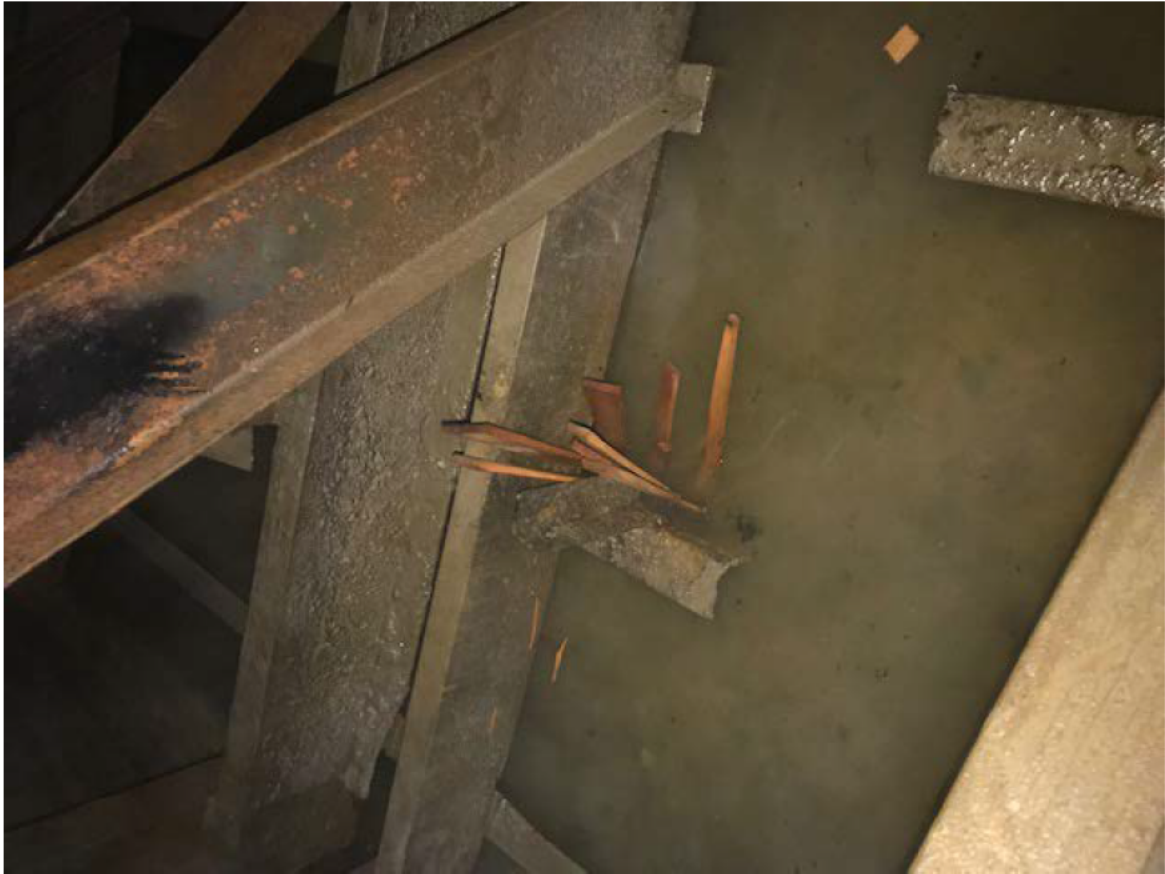
All voids in way of vessel have been stripped out and inspected internally and shingled where necessary:

- the port bow corner and knuckle is set in 0 - 4" with multiple holes and fractures in way over the forward 4', upper 5', noted to be of an older vintage; divers ragged and splashed large hole to minimize any water ingress during transit; located 2 - 3' above water line

- located 4' forward of the starboard number two aft bulkhead, the knuckle radius is fractured approximately 1/8" x 5"; fractures have been shingled to mitigate water ingress 100%

- located 14' aft of the starboard number three forward bulkhead, 3' 6" inboard of the

starboard side, hull bottom is fractured over an area of 1/8" x 4"; fracture has been shingled to mitigate water ingress 100%

- located 2' forward and 5' forward of the starboard number four aft bulkhead, two (2) knuckle radius fractures estimated 1/8" x 5"; fractures have been shingled to mitigate water ingress 100%

Vessel is currently in stable condition with no excess water in the void compartments. Survey/Dive Crews are standing by now awaiting details regarding transit plan before submitting to USCG for approval. If approved, divers will splash around shingled areas to minimize shingles being pushed out during transit
