National Transportation Safety Board

HWY24MH005

VEHICLE FACTORS

Group Chair's Factual Report

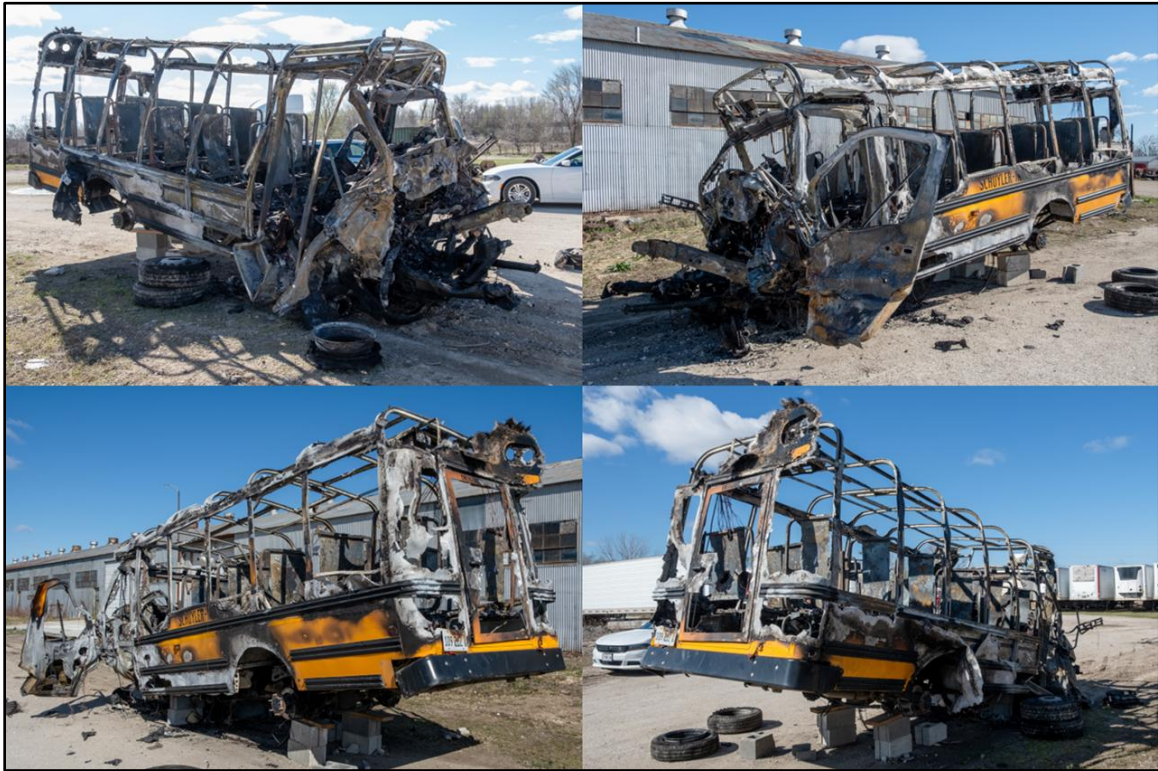
The Micro Bird sustained contact damage to the front, which resulted in crumpling, tearing, and rearward displacement of all components above the front sub frame. The engine was displaced into the occupant compartment. As a result of the post-crash fire, most of the remaining vehicle sustained thermal damage (Figure 2). Refer to the docket for additional damage description and vehicle damage profile.

Figure 2. The condition of the Micro Bird at the time of post-crash inspection on March 17, 2024.

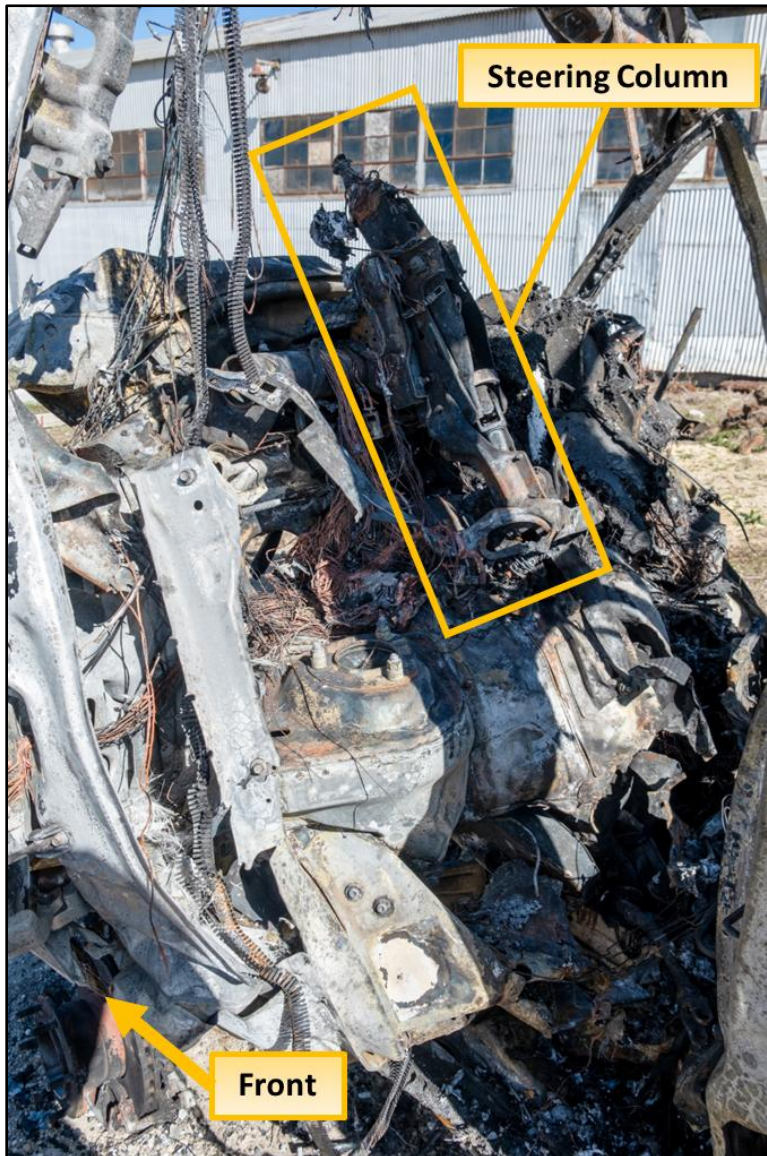
The Micro Bird was equipped with a tilt and telescoping steering column. The steering wheel was detached from the upper steering shaft and was not found during the inspection. Due to rearward displacement of the bulkhead and thermal damage sustained by the interior of the Micro Bird during the crash and post-crash fire, the position of the steering column was not determined (Figure 4). All gauges and switches were destroyed during the post-crash fire; therefore, driver control conditions (Figure 5) were not determined.

Figure 4. The condition of driver controls at inspection of the Micro Bird.

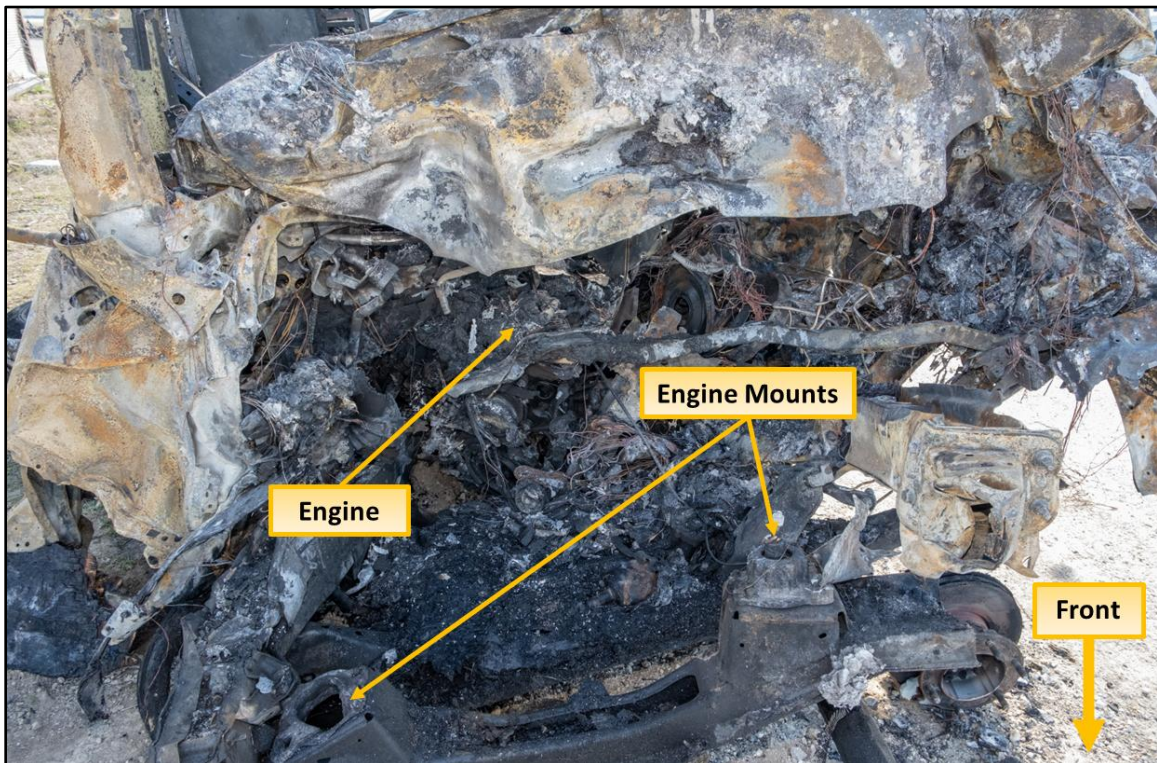
The powertrain consisted of a six-cylinder (V configuration) gasoline engine, 10-speed automatic transmission, a multi-piece propeller shaft,⁶ and one rear drive axle assembly (axle 2) with 3.73:1 gear ratio. The engine was mounted longitudinally at the front of the vehicle. The engine and all associated accessories had been displaced rearward, into the occupant space during the crash, and had sustained thermal damage during the post-crash fire (Figure 6). Engine fluids were not inspected. The accelerator pedal assembly, which would have been mounted to the interior side of the bulkhead, was destroyed during the crash and post-crash fire and was not available for inspection. The transmission gear lever, which would have been mounted to the dash (Figure 5), to the right of the steering column, was destroyed during the crash and post-crash fire.

Figure 6. Condition of the engine compartment at inspection of the Micro Bird.

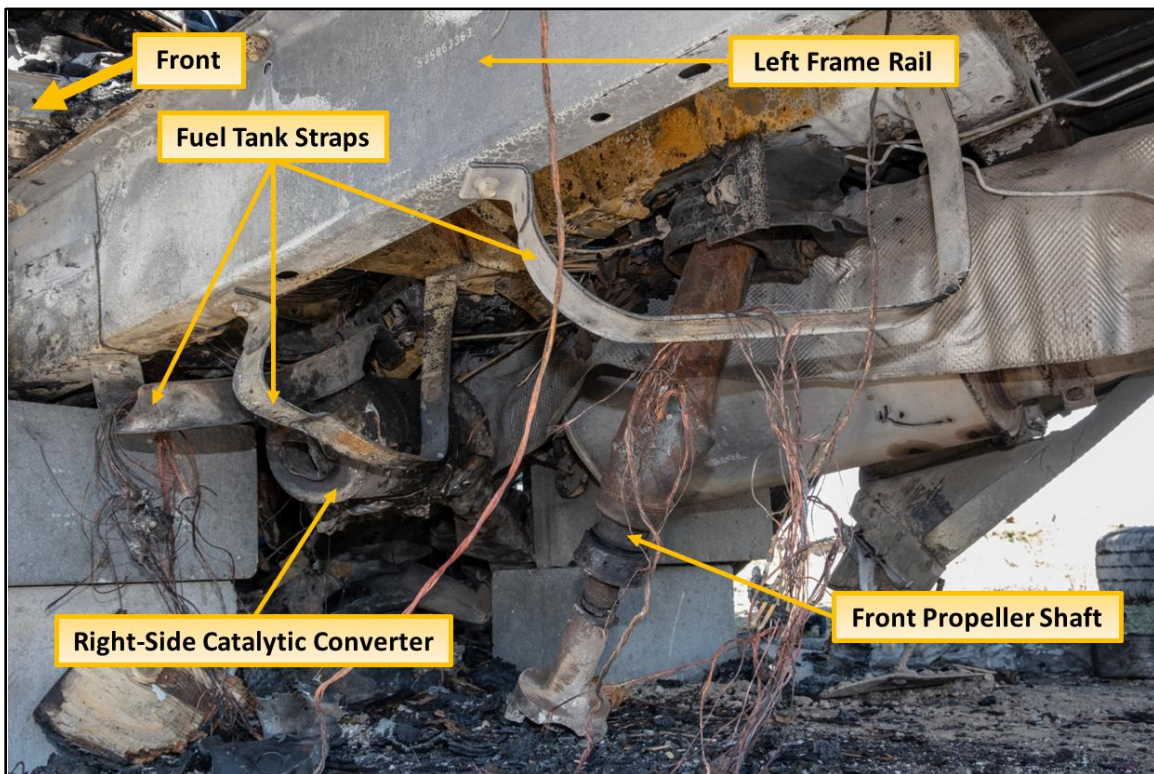
Engine exhaust was routed from each side of the engine, through left- and right-side catalytic converters into a single muffler and resonator before exiting below the right side of the rear bumper. Due to rearward displacement of the engine, the catalytic converters were disconnected from the muffler and the right-side catalytic converter was displaced to the left into the area previously occupied by the front of the High-density polyethylene (HDPE) fuel tank, which was normally suspended by straps between the left frame rail and propeller shaft (Figure 7).

Figure 7. Detached and displaced section of propeller shaft and exhaust components.

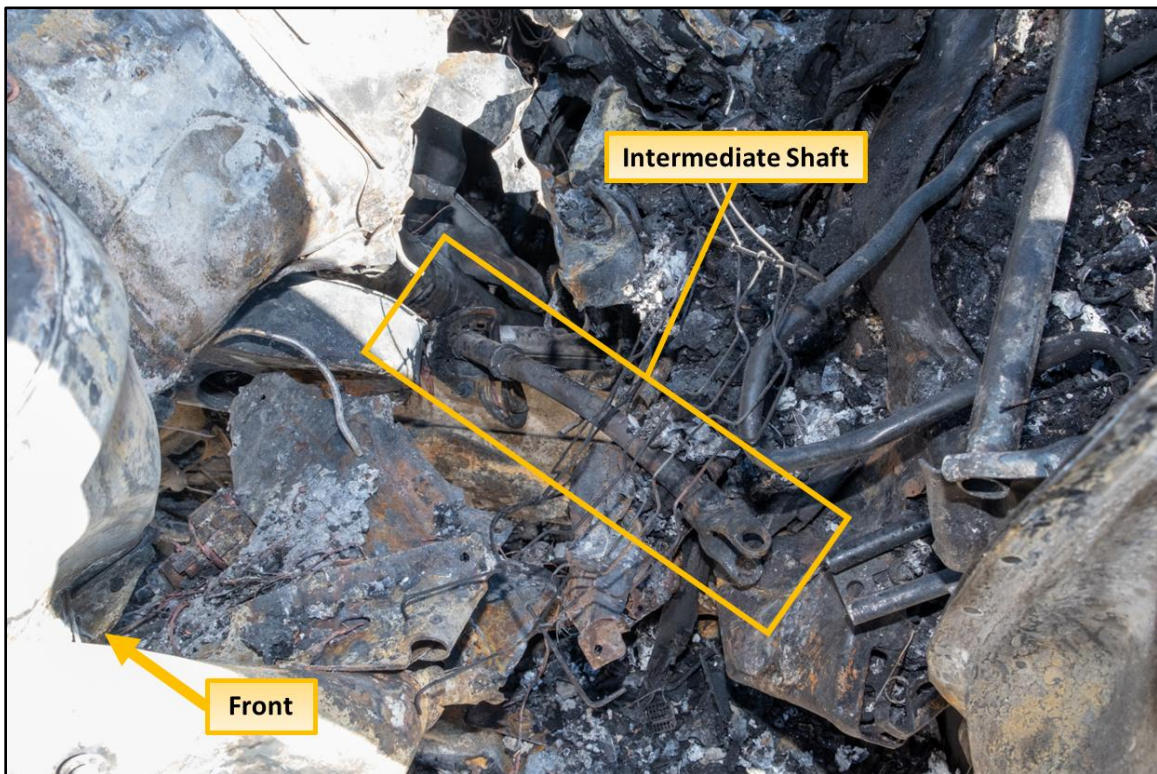
The Micro Bird was equipped with an electric rack-and-pinion steering system. The steering wheel was not found during inspection by NTSB Investigators. The tilt/telescoping steering column was in an undetermined adjusted position and had been displaced rearward and upward due to damage sustained by the bulkhead and dash (Figure 4). A section of the multi-piece intermediate shaft, which was normally connected with u-joints, was detached and found within the vehicle debris in the driver's area of the vehicle (Figure 8). The steering gear was intact and securely mounted near the front of the sub frame (Figure 9). The steering gear was normally connected to the left and right spindles through tie rods, which were bent and had sustained thermal damage as a result of the impact and the post-crash fire (Figure 10 and Figure 11). The right spindle was fractured at the tie rod end. The steering gear was removed and stored as evidence by ISP investigators.

Figure 8. The intermediate steering shaft on the floor of the Micro Bird, forward of the driver seat.

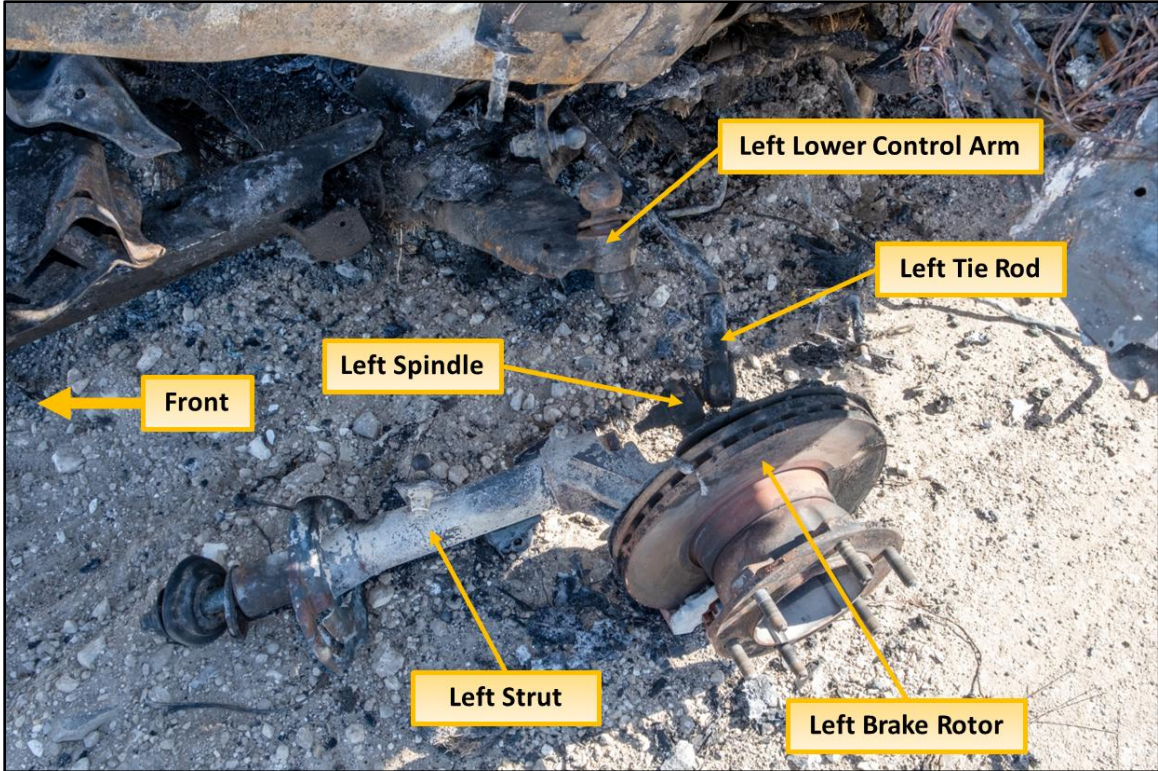
Figure 10. The left-side steering, axle 1 suspension, and brake components of the Micro Bird.

The left strut was detached from its upper mount and the coil spring was missing. The left spindle was detached from the ball joint on the lower control arm and the end link was detached from the stabilizer bar and strut (Figure 10). The top of the right strut remained attached to its upper mount, which was displaced rearward from its pre-crash location. The right spindle was detached from the ball joint on the lower control arm and the end link was detached from the stabilizer bar and strut. The right-side lower control arm was bent and displaced rearward (Figure 11). Combustible components of the axle 1 suspension, such as rubber bushings, were destroyed during the post-cash fire.

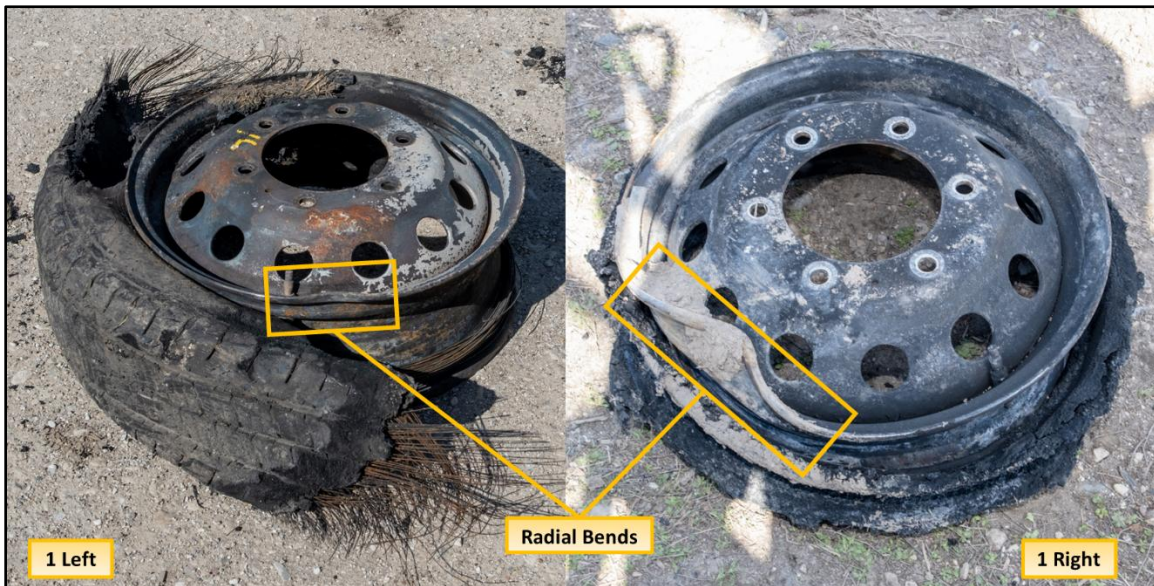
Figure 12. Wheels and remaining tires from axle 1.

Although limited information was available for documentation on the axle 1 tires due to thermal damage, remaining tread patterns and conditions were consistent with tires on axle 2. Tires mounted on axle 2 were the same size and load rating as recommended by Ford (Ford Motor Company, 2024).⁷

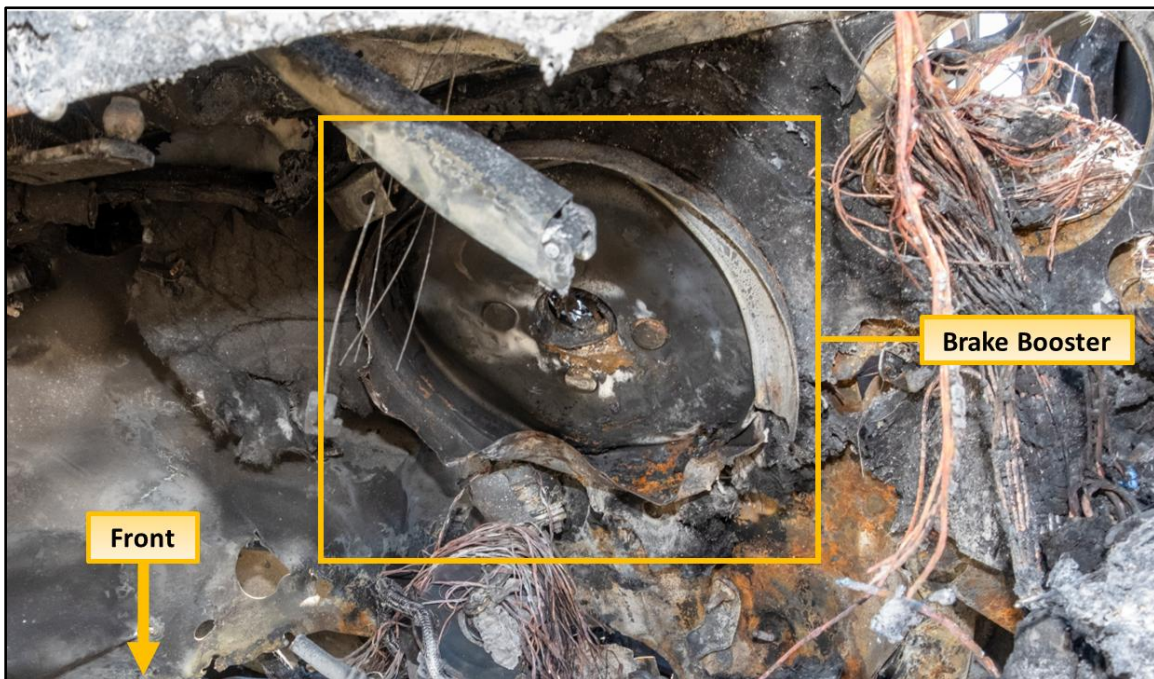
The Micro Bird was equipped with vacuum-assisted hydraulic disk brakes at both axles. Engine vacuum was normally supplied to a brake booster mounted between the bulkhead and a master cylinder and attached brake fluid reservoir. Only the rear of the booster remained mounted on the left side of the bulkhead (Figure 13).

Figure 13. Rear plate of the brake booster.

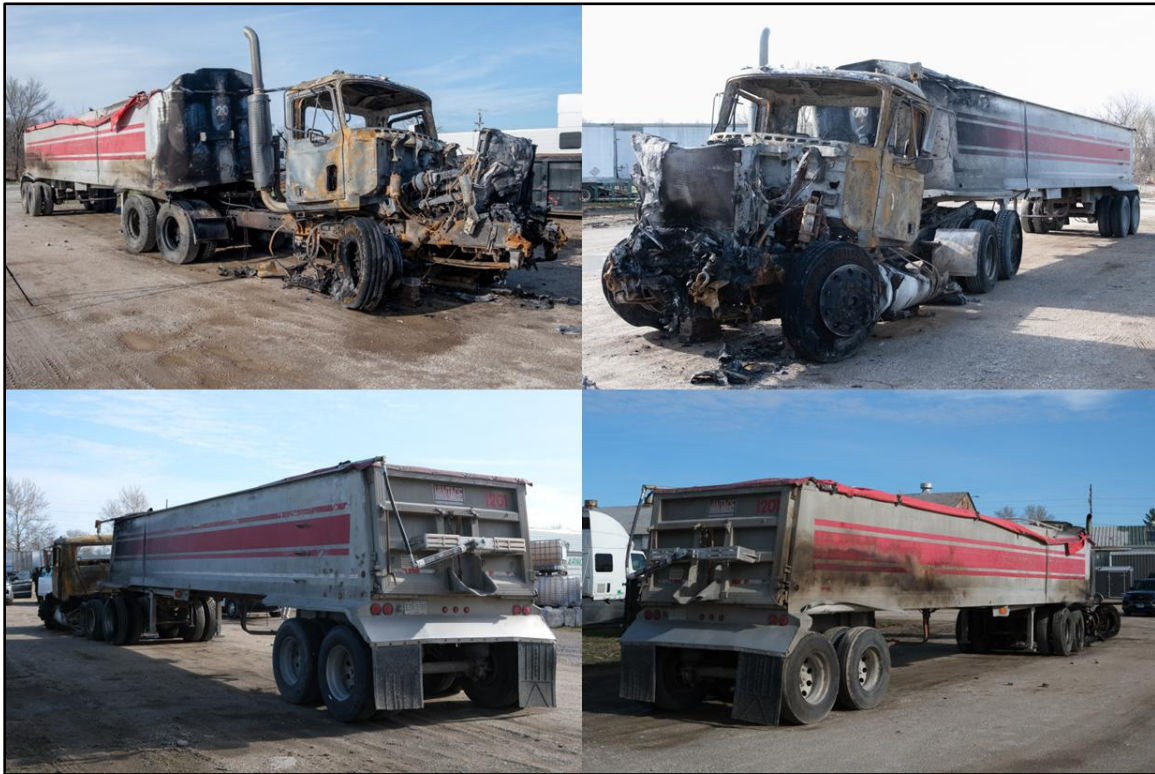
The Mack sustained complete thermal damage that extended from the front to axle 2 and partial thermal damage from axle 2 rearward. Observable contact damage to remaining components was limited to crumpling, tearing, and rearward displacement of the front crossmember and the radiator, with attached components, to the engine. Observable induced damage included buckling and twisting of the frame rails in multiple locations (Figure 16). Refer to the docket for additional damage description and vehicle damage profile.

Figure 16. The condition of the Mack at the time of post-crash inspection on March 15, 2024.

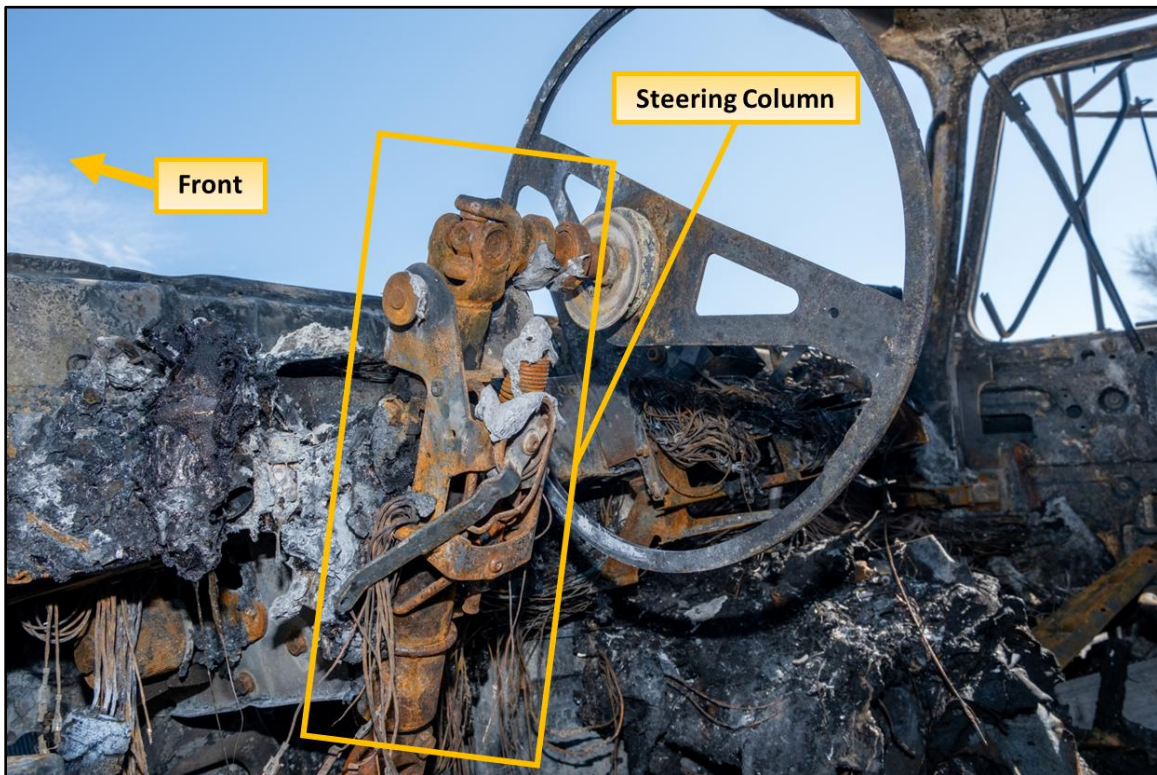
The Mack was equipped with a telescoping steering column with an 18-inch-diameter steering wheel. Due to thermal damage sustained by the interior of the Mack during the post-crash fire, the position of the steering column was not determined. All gauges and switches were destroyed during the post-crash fire; therefore, driver control conditions were not determined.

Figure 18. The condition of driver controls at inspection of the Mack.

At the scene, the steering wheel was observed tilted forward on the steering column (Figure 18). The 18-inch steering wheel had sustained thermal damage but appeared to be otherwise undamaged. The telescoping steering column was displaced forward, and its adjusted position was undetermined. The upper steering shaft was connected, via a u-joint, to an intermediate shaft, which passed through the bulkhead into the engine compartment. The intermediate shaft was bent upward near its midpoint and the forward end, a u-joint, was disconnected from the steering gearbox.

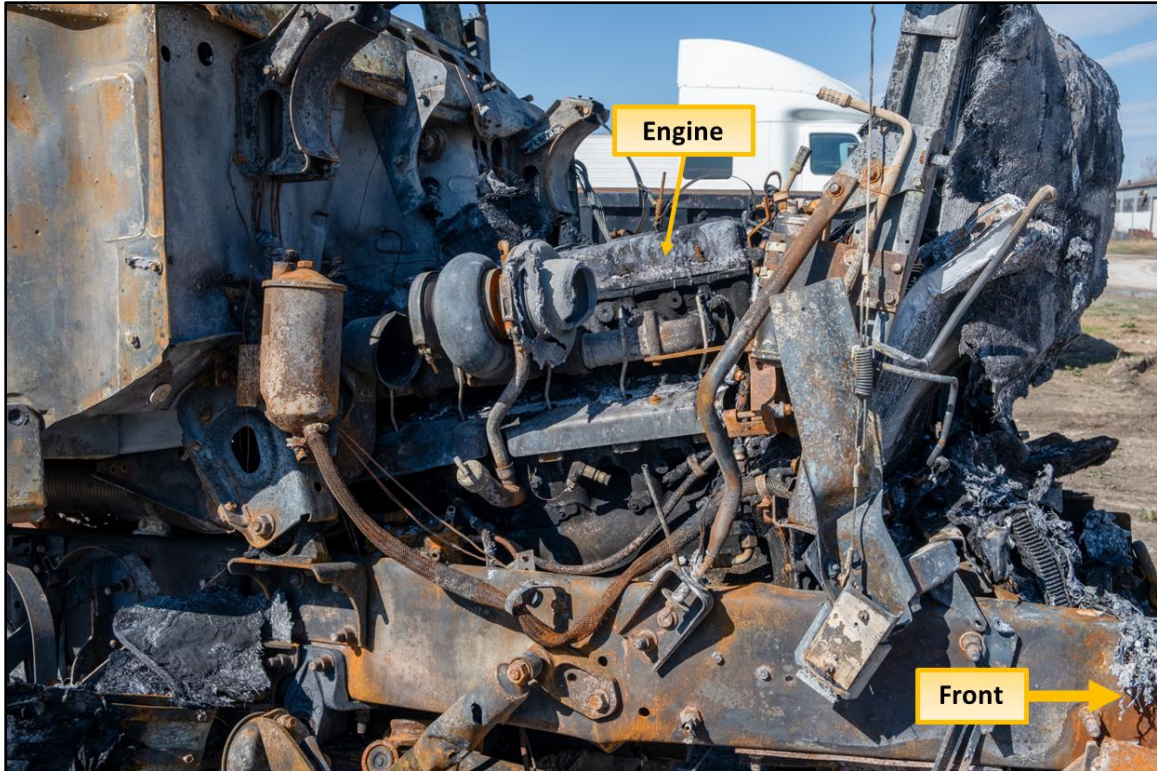
Figure 20. Condition of the engine compartment at inspection of the Mack.

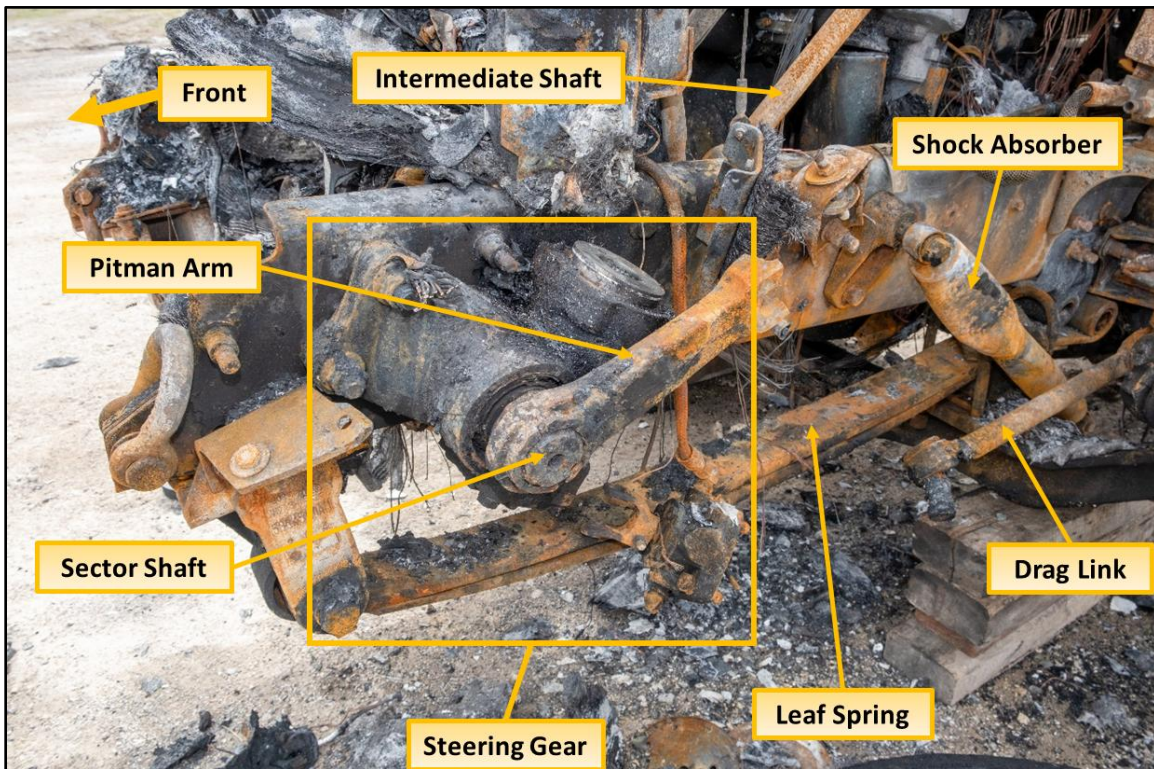
An RH Sheppard M100 steering gearbox was securely mounted to the outboard side of the left frame rail (Figure 21). The top of the steering gearbox, with the input yoke for the intermediate shaft u-joint, was broken from the body and hanging from one of the steel braided hydraulic fluid lines. One of the ears for the u-joint yoke at the input shaft to the steering gearbox was bent outward. The pitman arm was securely attached to the sector shaft of the steering gearbox. The end of the pitman arm, which would normally be connected to the drag link with a ball joint, was broken. A ball joint connected the drag link to the left steering knuckle. A tie rod was connected by ball joints at both ends to the bottom of each steering knuckle. The tie rod was bowed near its midpoint. All ball joints utilized castellated nuts and cotter pins, which were securely fastened.

Figure 21. Steering and axle 1 suspension components on the left side of the Mack.

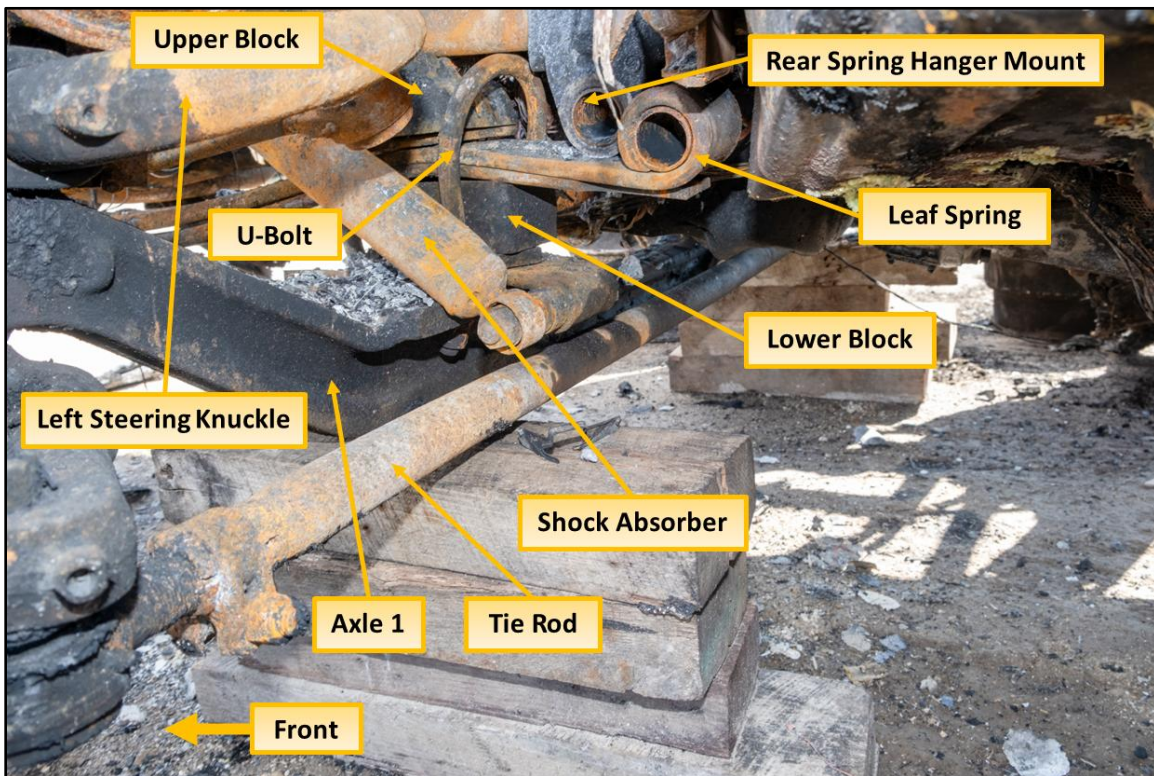
The steer axle (axle 1) was suspended at each end by a full taper spring pack consisting of two leaves (Figure 22). The leaf springs were connected to the axle with u-bolts and blocks. The axle was displaced rearward on both springs and the springs were bent upward above the axle. The u-bolts were loose, and upper blocks, which would hold the tops of the u-bolts in place above the springs, moved freely on the springs. The springs were free of visible cracks. Spring hangers at the trailing ends of the springs were broken. The left-side spring hanger was missing, but the mount was secured to the left frame rail. The right-side spring hanger was attached to the trailing eye of spring pack via a spring eye bushing, but detached from the mount, which was secured to the right frame rail. The fractured ends of the broken pin used to attach the spring hanger to the frame mount was visible within the mount. The leaf springs at axle 1 were supplemented by shock absorbers mounted to the outboard side of each frame rail and the rear of axle 1 at each u-bolt. Both shock absorbers were bent, and the body of the right shock had holes torn in the body. All non-metal components of the axle 1 suspension had melted during the post-crash fire.

Figure 22. Axle 1 steering and suspension components on the left side of the Mack.

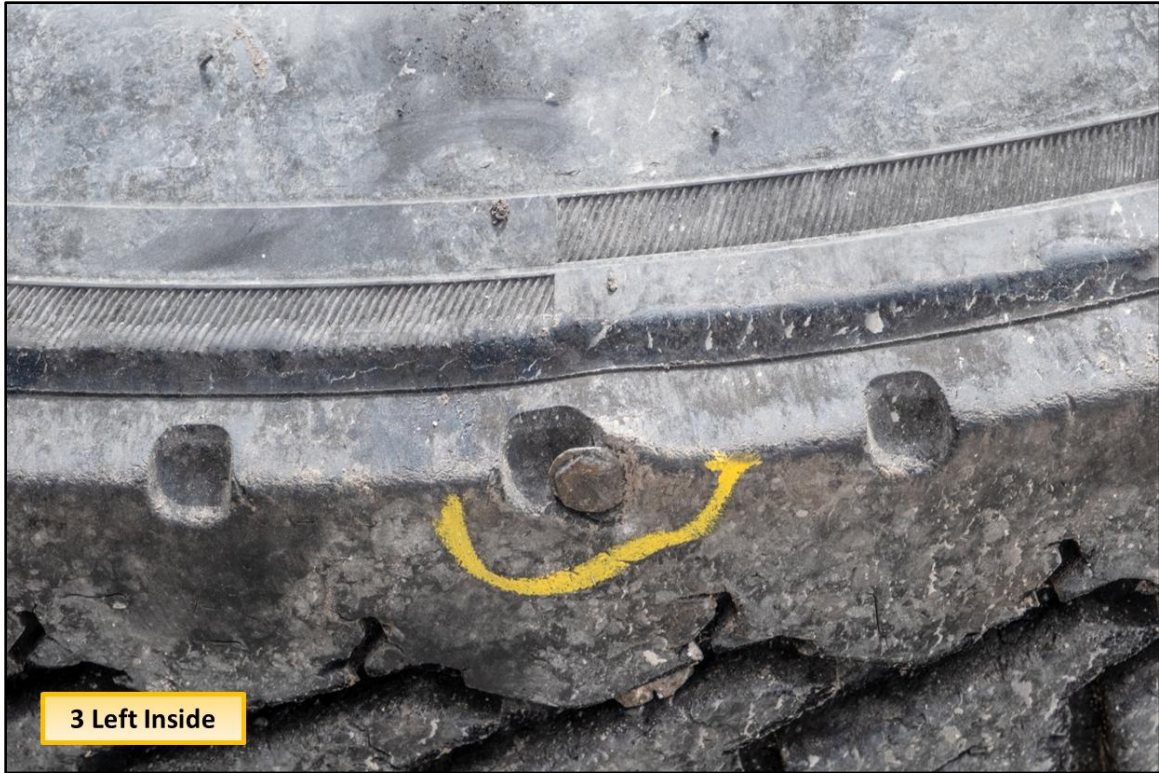
Tires at all positions except the right side of axle 3 had sustained varying degrees of thermal damage due to the post-crash fire. Balance rings²⁵ were in place between the wheels and drums on axle 1. An object was stuck in an inboard tread block of the left inside tire on axle 3 (Figure 23). The tire was not unmounted from the wheel to determine if the object penetrated the inner liner.

Figure 23. Object stuck in the tread of the left inside tire on axle 3.

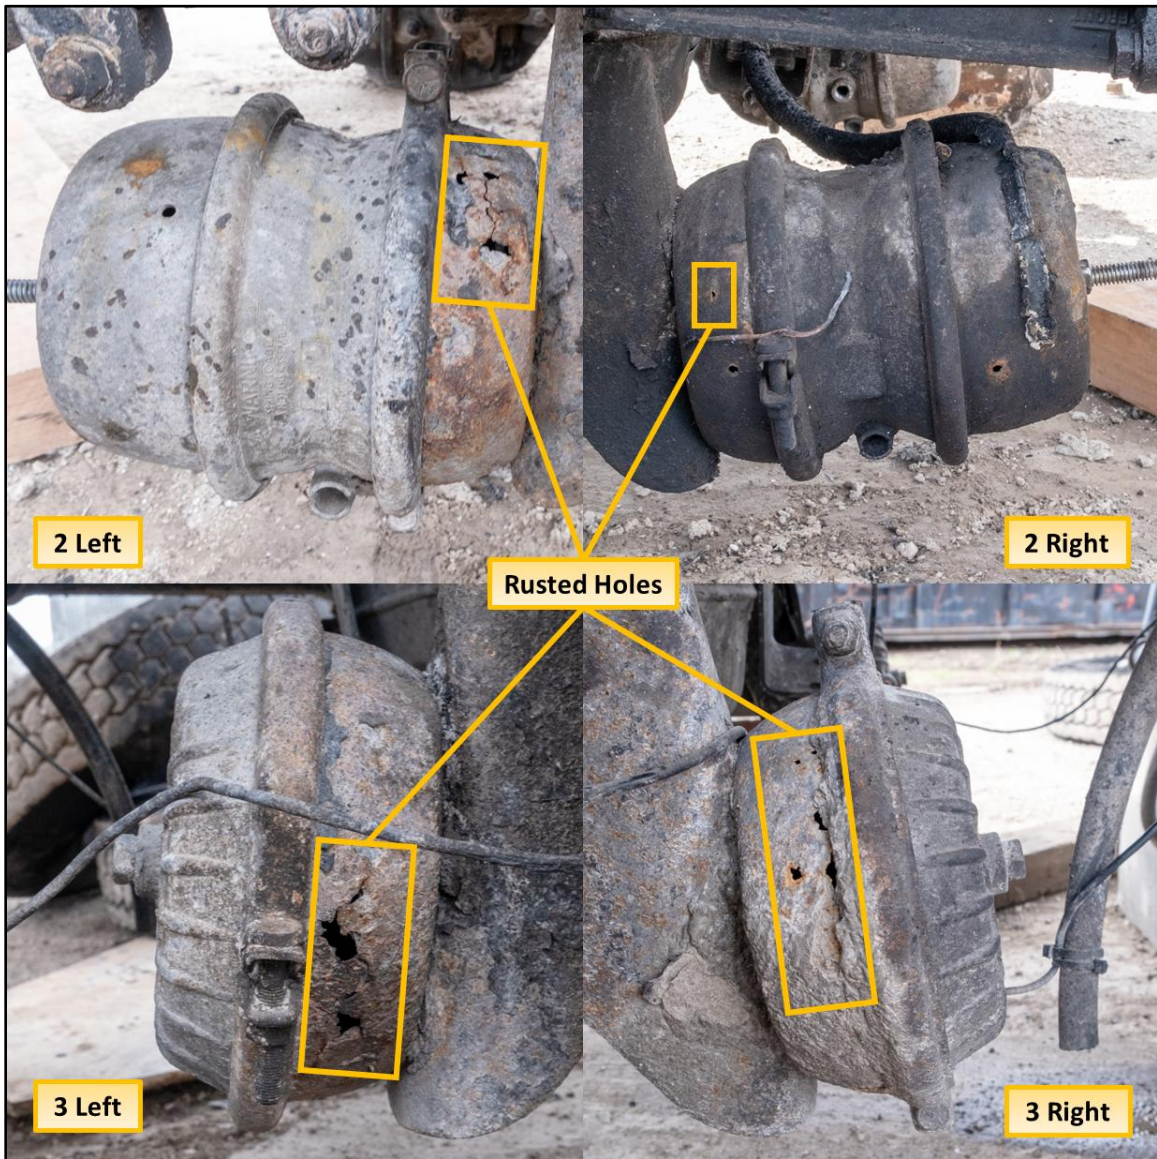
Wheels and brake drums were removed at each position to inspect brake shoes and drum friction surfaces. Cam rollers were in contact with brake cams, and return springs were in place at all positions. Holes rusted through the return-spring sides of the brake chambers on the brake chambers on axle 2 and axle 3 were observed (Figure 24). The holes would eventually lead to failure of the brake chambers and were a violation of the 49 CFR Part 396.3 (a). The condition did not otherwise affect the function of the brakes.

Figure 24. Rusted holes in brake chambers at axle 2 and axle 3.

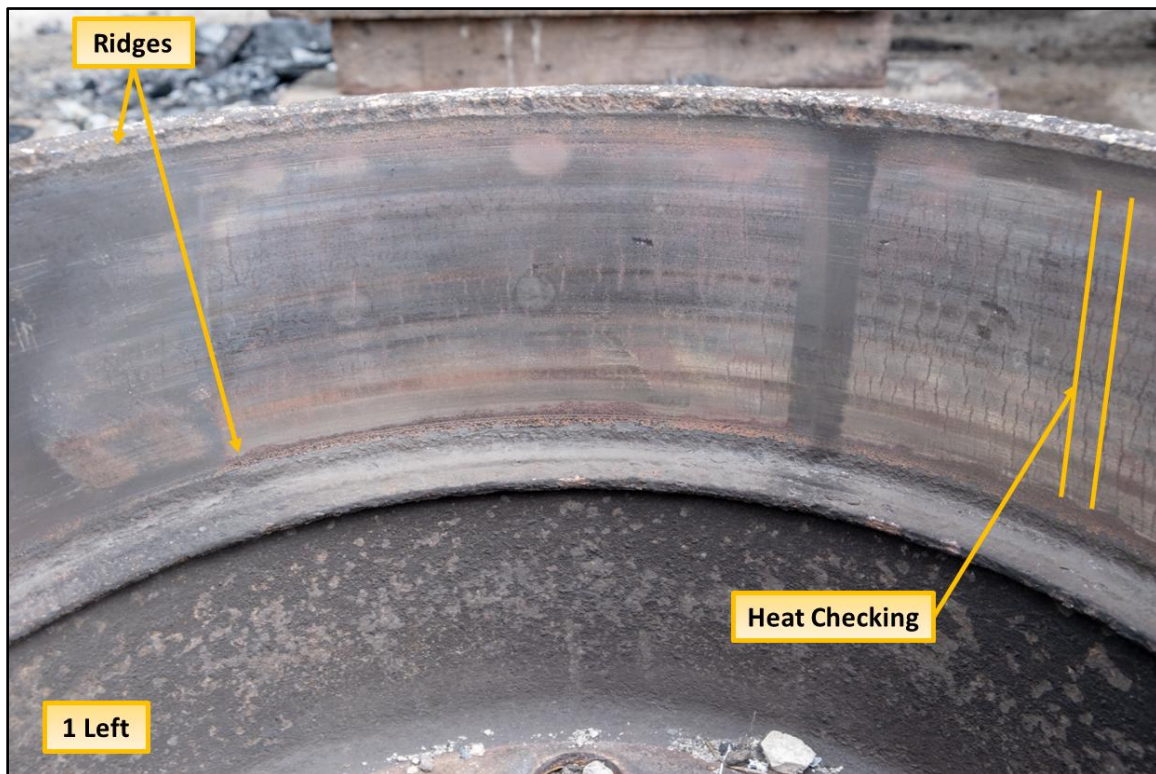
There were discernable ridges and heat checking on the friction surfaces of all drums (Figure 25). Measured drum diameters were less than the maximum diameter identified by markings embossed on the external surfaces of the drums. The right brake drum on axle 3 was cracked due to impact with a tool used by a service technician during removal for the post-crash inspection.

Figure 25. Inspected condition of the left friction surface of the brake drum on axle 1.

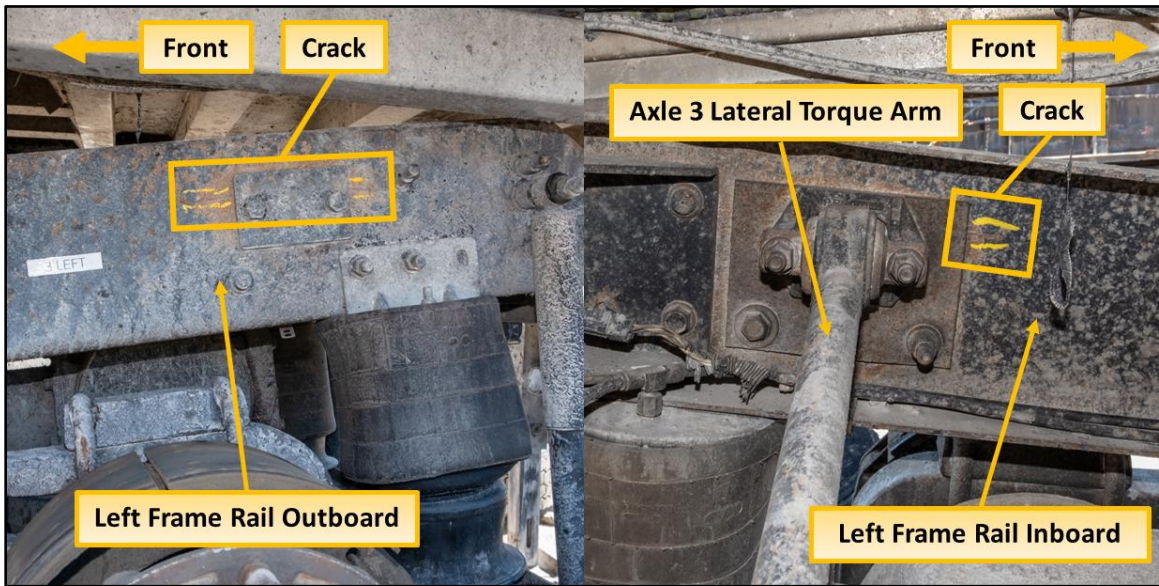
An eight-inch-long longitudinally aligned crack was observed on the left frame rail at the mount for the axle 3 lateral torque arm (Figure 26). There was a crack that extended from the web, through the radius, and into the bottom flange of the right frame rail, below the cab, in an area that would normally be obscured by the right-side fuel tank (Figure 27). Rust was observed on the edges of the crack. The right frame rail had buckled at the upper flange, above the crack. Located at a mounting point for the lateral torque arm, the pre-existing crack on the left frame rail adversely affected the support of functional suspension components; an out-of-service violation of 49 *CFR* Part 393.201 (a). The crack in the right frame rail, if pre-existing, would also be an out-of-service violation of 49 *CFR* Part 393.201 (a).

Figure 26. Crack in the left frame rail of the Mack.

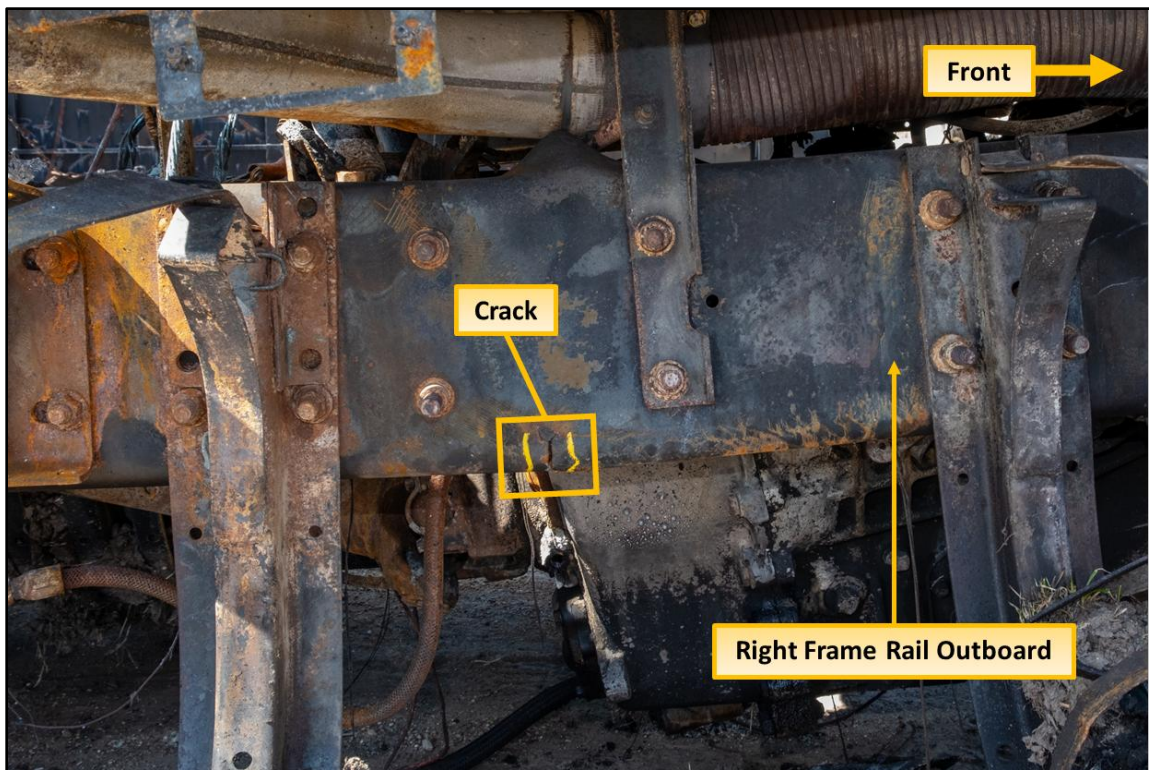
Figure 27. Crack in the right frame rail of the Mack.

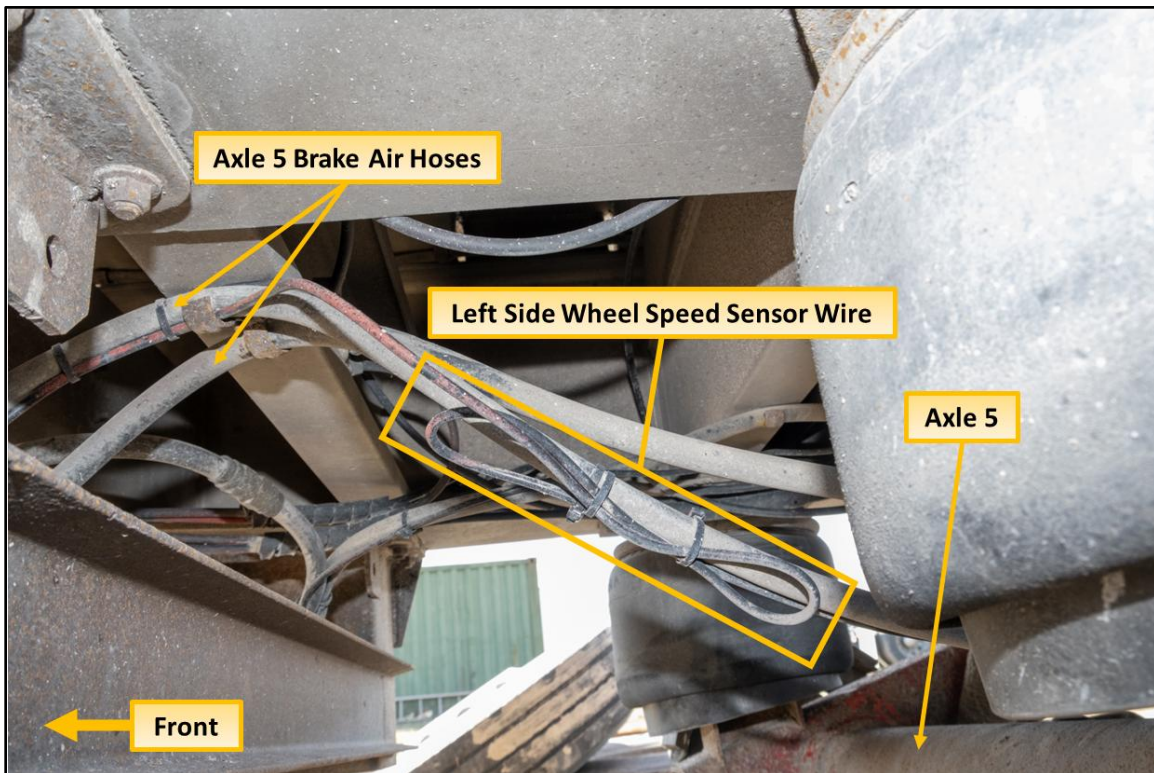
Figure 30. Left side wheel speed sensor wire cut and secured to an axle 5 brake air hose.

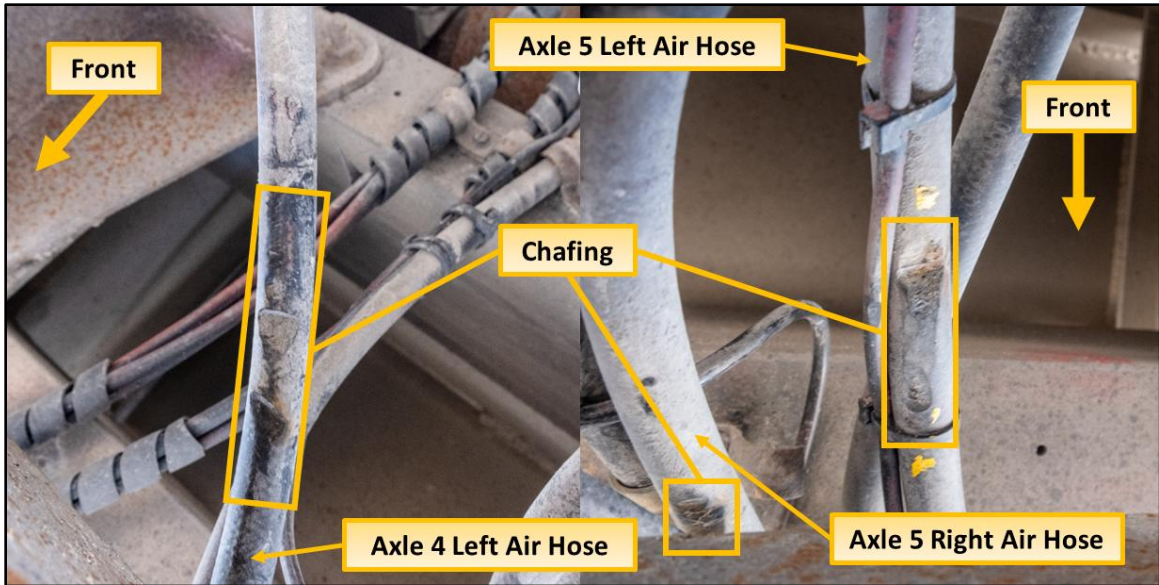
Chafing, which caused fraying of the reinforcing ply and a reduction of hose diameter was identified where air hoses contacted other vehicle components. Locations of the observed abrasions included a) a hose to the right brake chamber on axle 5 at the crossmember for axle 4, b) a hose to the right brake on axle 4 at the crossmember for axle 4, and c) a hose to the left brake on axle 4 at the crossmember for axle 4 (Figure 31). In addition to the chafing, there was a cut in the hose to the right brake on axle 5 that affected the reinforcing ply (Figure 32). The pre-existing conditions were out-of-service violations of 49 *CFR* Part 393.45 (b) (Commercial Vehicle Safety Alliance, 2023).

Figure 31. Chafing of air hoses to air hoses to axle 4 and axle 5.

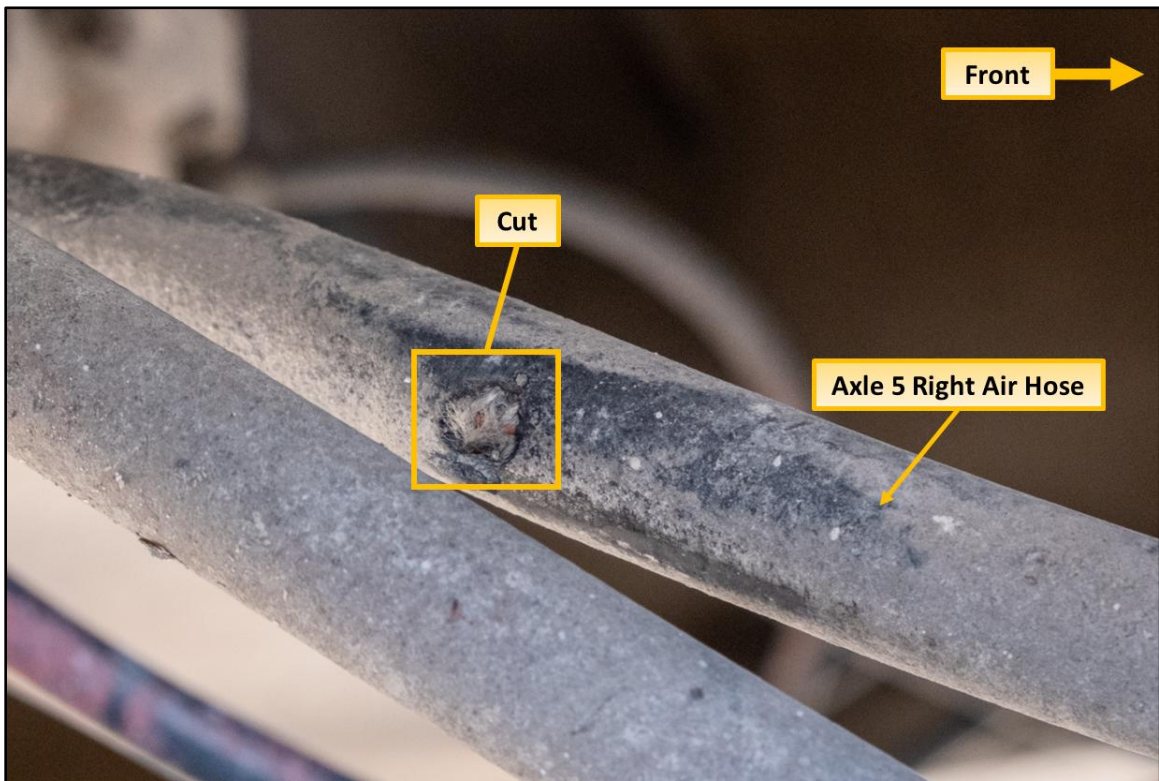
Figure 32. Cut into the reinforcing ply in the air hose to the right brake chamber on axle 5.

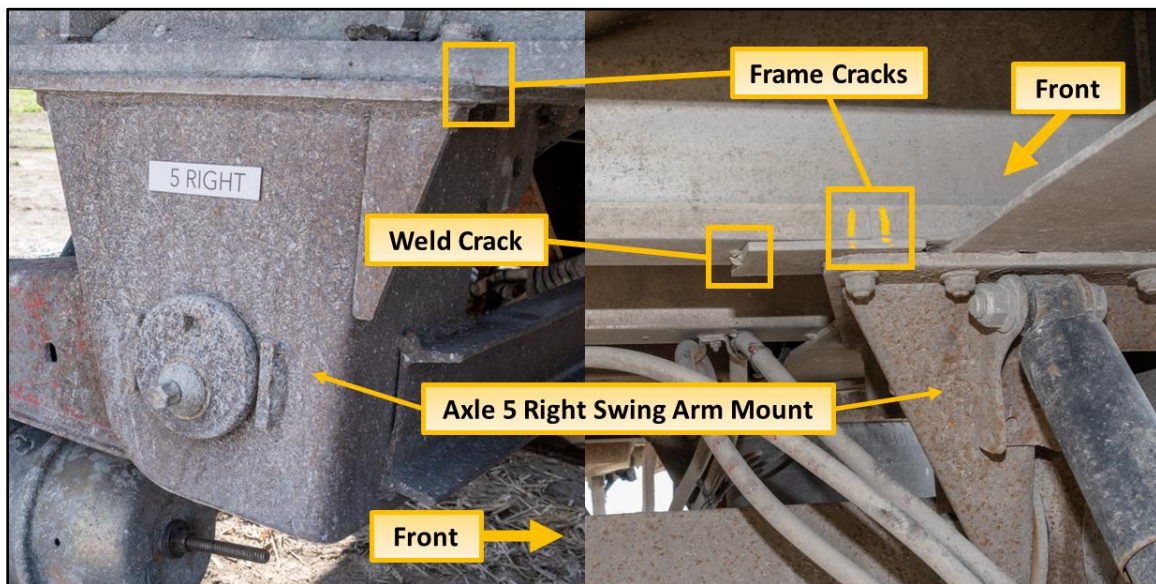
At the right swing arm mount for axle 5, vertically aligned cracks were observed in the bottom flanges of the outboard side of the frame rail and rear of the crossmember (Figure 33). There were also cracks through welds at metal shims between the axle 5 right-side swing arm mount and above the axle 5 right-side air bag mount (Figure 33 and Figure 34). The pre-existing cracks on the frame rail and crossmember at the right-side axle 5 swing arm adversely affected the support of functional suspension components; an out-of-service violation of 49 CFR Part 393.201 (a).

Figure 33. Cracks in the right frame rail and crossmember at the axle 5 swing arm mount.
