National Transportation Safety Board

HWY24MH005

VEHICLE FACTORS

Group Chair's Factual Report

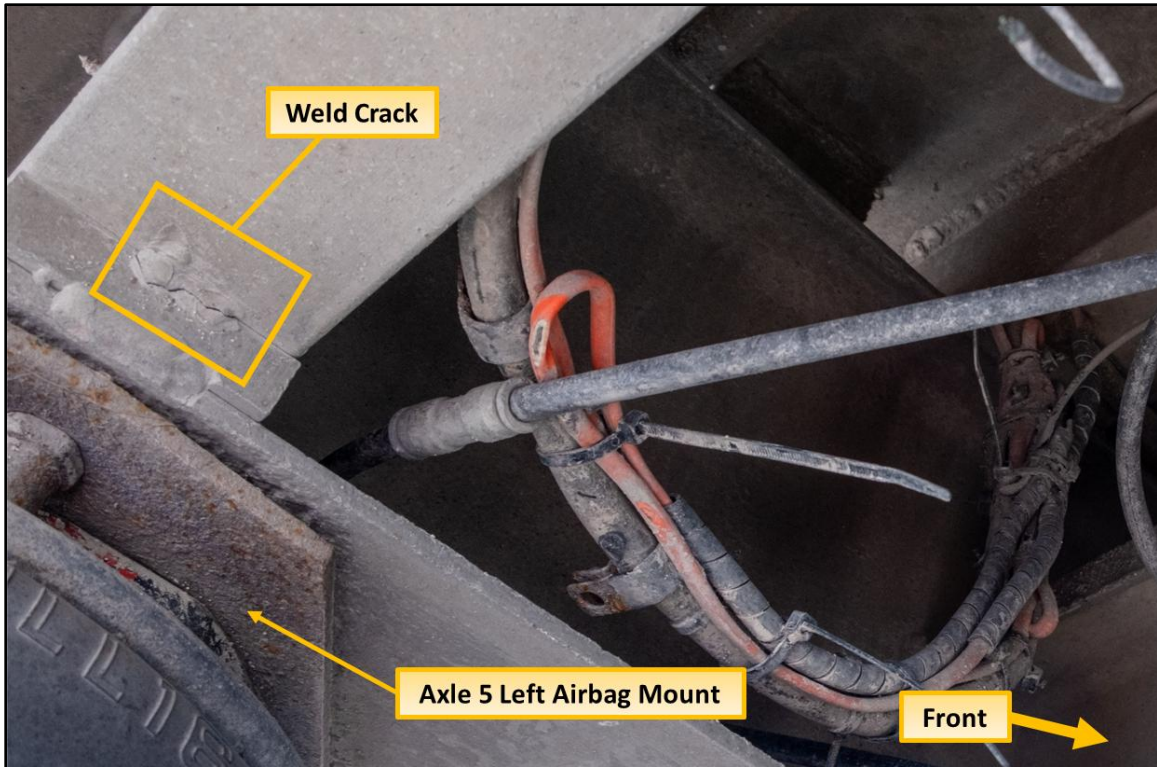
Figure 34. Weld crack at the left-side axle 5 airbag mount.
