National Transportation Safety Board

HWY23MH017

TECHNICAL RECONSTRUCTION

Group Chair's Factual Report

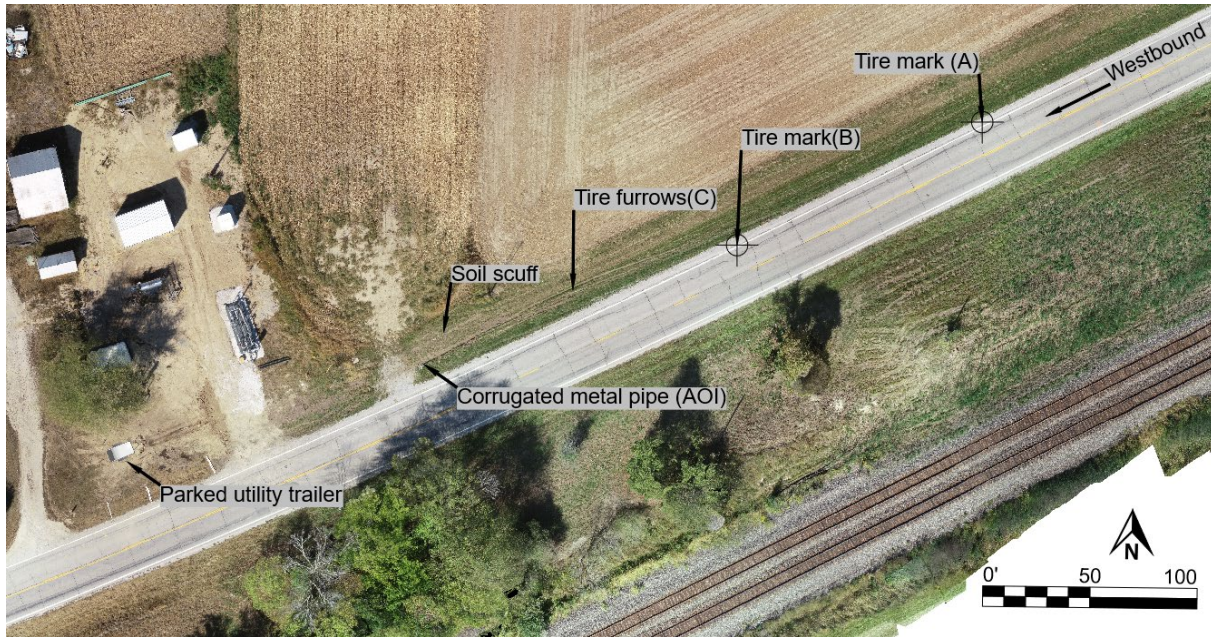
Figure 3. Cropped image of the two-dimensional orthomosaic identifying the areas of evidence discussed above.

NTSB investigators identified a tire mark (A) on the westbound shoulder consistent with the direction of travel of the combination's front axle. The single tire mark was approximately 283 feet east of the impact with the corrugated metal pipe and transverse slope, area of impact (AOI). The mark began at the pavement edge and continued for approximately 45 feet at an angle of about 2.0° relative to the roadway. The tire mark continued along the gravel shoulder increasing to an angle of approximately 3.0° for approximately 85 feet where it then transitioned to the grass. Here the combination vehicle experienced a change in topography. The combination vehicle transitioned from the relatively level shoulder to the approximate 11° foreslope of the drainage channel.

As the right side of the combination vehicle entered the grass, two additional tire imprints (B) were identified in the grass, consistent with the right side of axles two and three. The imprints continued, together, northwestward traversing the foreslope of the drainage channel. As the combination vehicle continued traveling northwestward an additional tire mark (C) was identified being consistent with the left side of the front axle; the tire mark appeared on the westbound gravel shoulder about 156 feet east of the AOI and approximately 145 feet west of the onset of the right-side tire mark. As the right-side of the combination vehicle entered the bottom of the drainage channel it turned left, traveling west parallel to the roadway. The imprints, which were approximately 12 feet north of the westbound travel lane, continued westward along the bottom of the drainage channel, transitioning to furrows, for about 130 feet until terminating at the transverse slope on the eastern side of the non-commercial driveway.⁵ The 12-inch diameter metal corrugated pipe extruded out into the drainage channel exposing approximately 3 feet of pipe. The entire right side of the exposed pipe was collapsed inward with a puncture about midway down the exposed pipe. A soil scuff mark was identified beginning approximately 38 feet northeast of the AOI along the back slope of the drainage channel. The disturbed area measured approximately 40 feet in length by 2.5 feet wide and extended westward parallel with the drainage channel and furrows. The mark was consistent with being created by the side of the cargo tank semitrailer. Figure 3 is an image of the two-dimensional orthomosaic depicting the evidence described above.

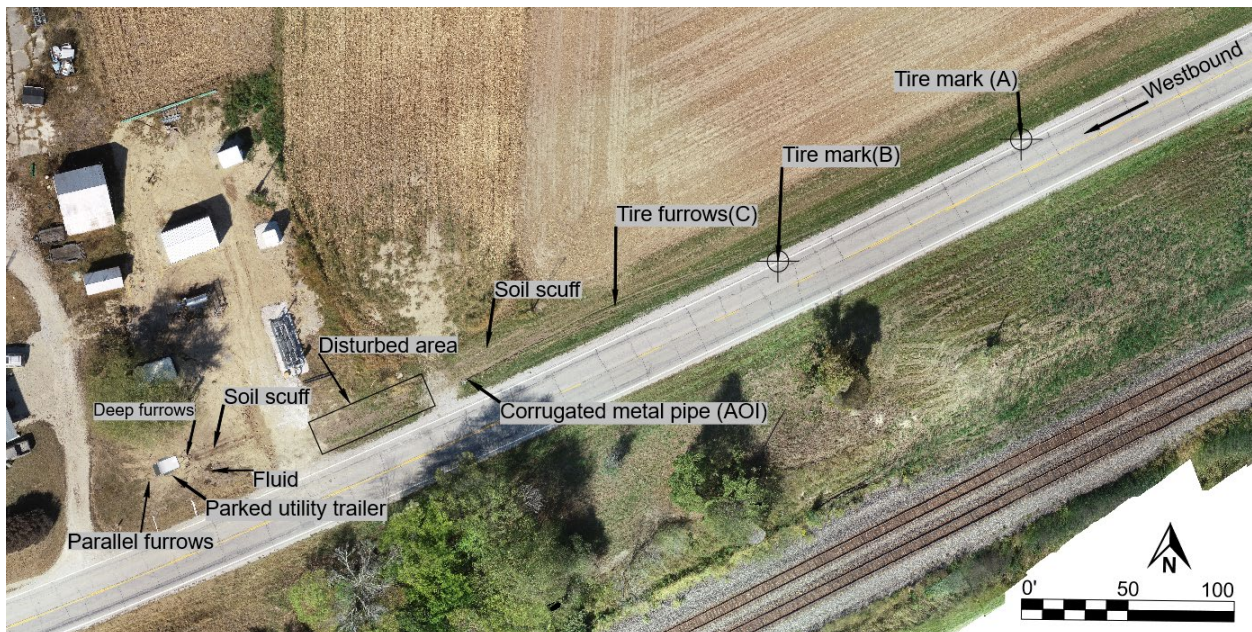
Figure 5. Cropped image from the two-dimensional orthomosaic depicting all described evidence.

commercial and non-commercial driveways was furrowed with areas of grass displaced westward. The surface evidence continued west across the commercial driveway transitioning into the dirt area west of the commercial driveway. There was a furrow in the dirt beginning at the west edge of the driveway extending westward, approximately 99 feet west of the AOI, measuring about 37 feet in length by 2.5 feet in width. The end of the furrow was cylindrical and consistent with the shape of the cargo tank semitrailer. At the end of the furrow was an area approximately 29 sq-ft consisting of deep furrows and disturbed dirt. Another area approximately 167 sq-ft was just south of the furrow and consisted of disturbed dirt with four separate smaller areas of fluid-soaked dirt.

Continuing westward, three parallel furrows were identified. The middle of the three furrows began approximately 8 feet west of the smaller area of disturbed dirt and measured about 19 feet in length. The outer two furrows began about 6-feet west of the middle furrow and measured approximately 17 feet in length. The distance between the two outer marks was about 8 feet which was consistent with the width of the utility trailer. Figure 5 below is an overhead view of the crash scene. Labeled on the image are the identified areas of evidence described above.

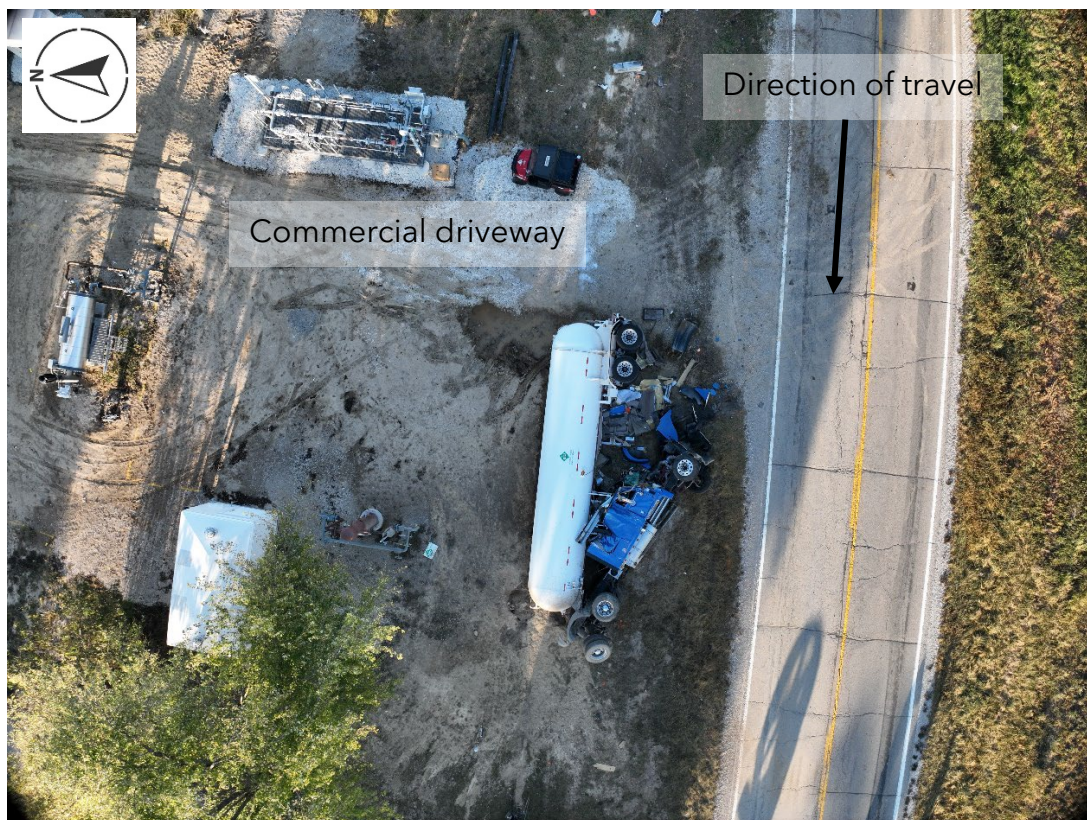
Figure 6. Overhead image of the combination vehicle at final rest. (Source: ISP edited by NTSB)

At final rest, the International combination was off the roadway in the dirt area between the residential driveway and commercial driveway approximately 22 feet north of US Route 40. The cargo tank semitrailer was aligned with the roadway and lying on its right side. The truck tractor remained coupled with the cargo tank semitrailer. The truck tractor had rotated approximately 155-degrees and was facing southeast relative to the cargo tank and was on its left side. The combination vehicle traveled approximately 422 feet after leaving the westbound travel lane. Figure 6 depicts the combination vehicle in its position of rest.

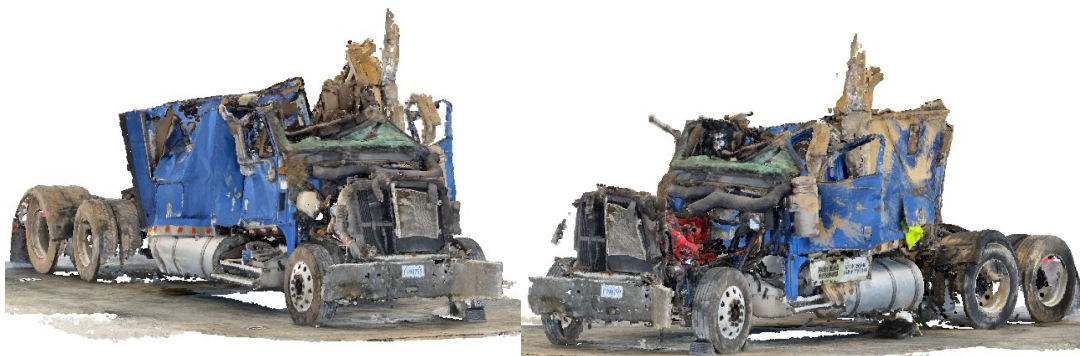
Figure 7. Three-dimensional point cloud images of the of the International truck tractor depicting the damage sustained from the crash.

The truck tractor exhibited contact damage around the entirety of the vehicle. The hood with integrated fenders and roof had been torn from the vehicle. The cab portion was broken from the frame and displaced rearward. The windshield was shattered with the top of both "A" pillars pushed inward. Along the left side (driver's side) the corner of the front bumper was bent and displaced outward from the wheel. There was dirt in the air cleaner, "A" pillar, driver's door, exhaust stack and along the left side of the sleeper berth coupled with linear scrapes/scratches. The rear wall of the sleeper cab was separated from the sides of the sleeper cab with the top displaced rearward.

The right-side (passenger side) dual tire set on axle two and axle three were displaced rearward. Continuing forward along the right-side, the side of the sleeper cab separated from the rear wall and the top was displaced inward and downward. Longitudinal scrape and scratch marks were observed along the length of the saddle tank and the cover for the storage box above the side-step was missing. The right-side air cleaner had been torn from the "A" pillar and dirt had accumulated in the front cowl. The bottom of the front bumper was displaced rearward. Figure 7 are two images of the generated three-dimensional point cloud of the International truck tractor. The images depict the damage sustained during the crash event.

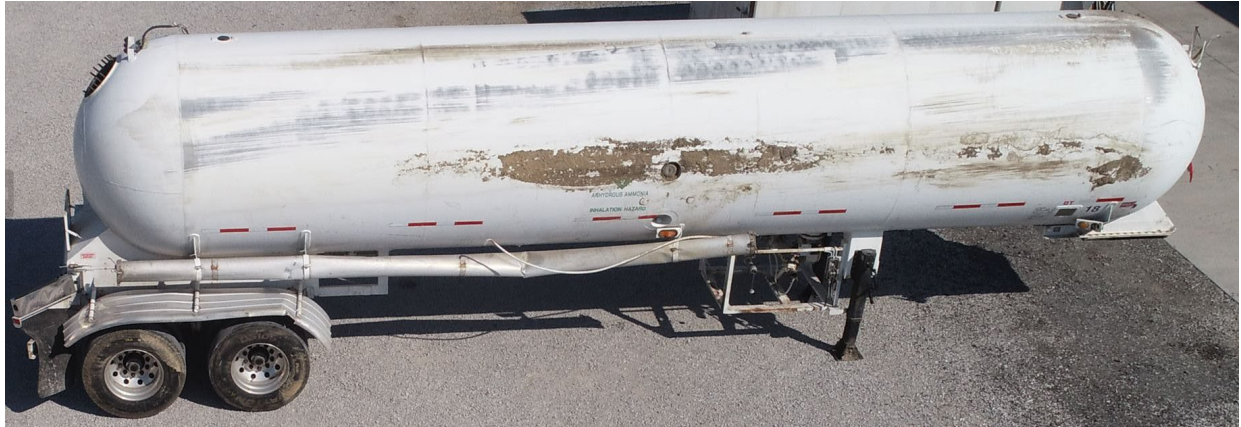
Figure 8. Image of the right-side of the cargo tank semitrailer.

The damage to the cargo tank was concentrated to the front and right-side. Beginning just aft of the tank head, longitudinally along the center line of the cargo tank, were scrape/scratch marks coupled with soil that had accumulated along the side. The scratch marks and accumulation of soil extended rearward for approximately 24 feet. An additional scrape/scratch mark was identified that extended from the top of the cargo tank rearward terminating just above the centerline. The scrape mark measured about 32 feet long and was at an approximate 3.4-degree angle in relation to the center line of the cargo tank. The hose tube, along the right side, was displaced down and inward. The front of the fender was displaced rearward, and the rear of the fender was displaced upward. The right-side of the bumper was bent and displaced

rearward. The damage was characteristic of a ½ turn rollover event. Figure 8 is an image of the right-side of the cargo tank depicting the scrape/scratch marks, soil accumulation, and damage sustained.

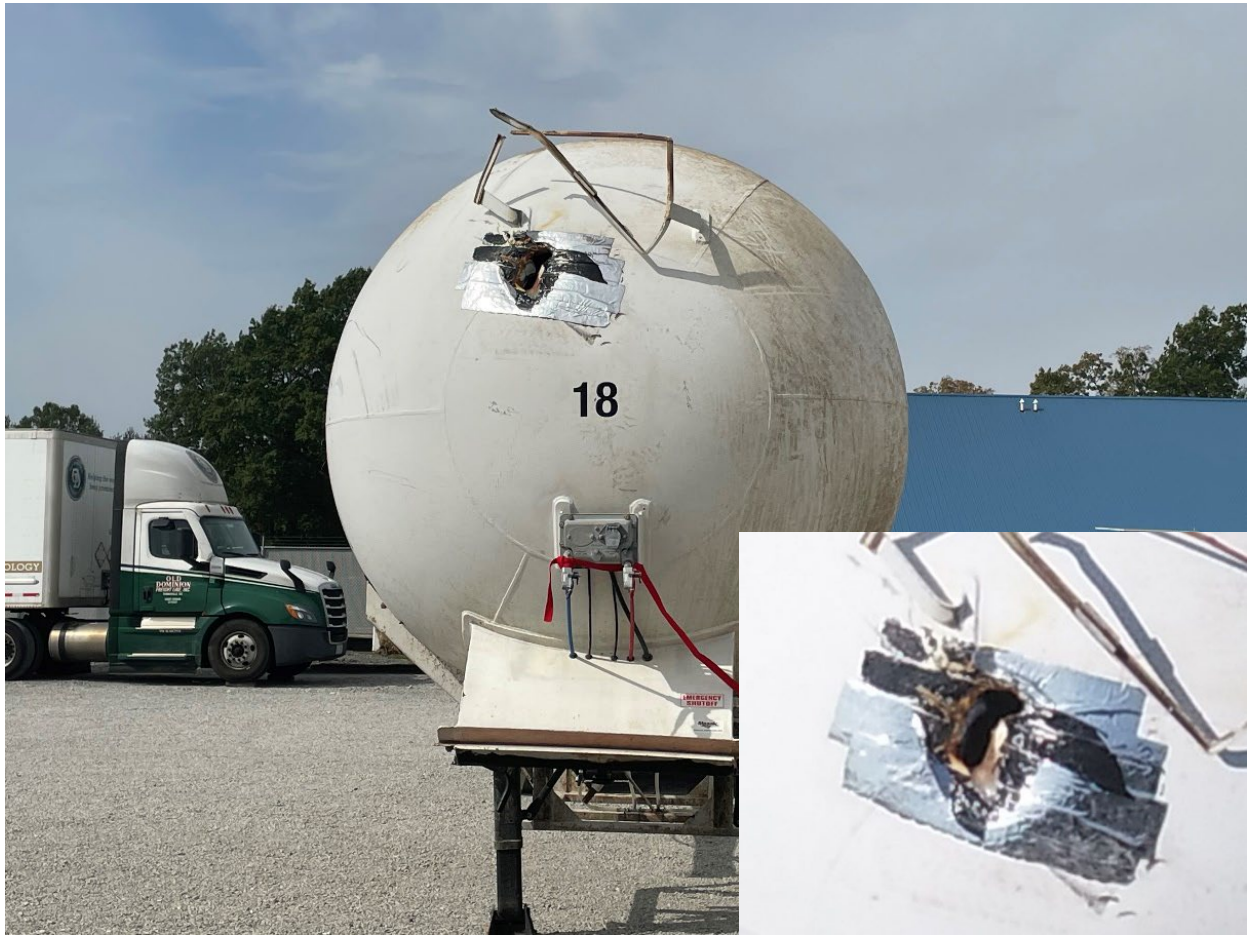
Figure 9. Image of the cargo tank semitrailer head depicting puncture.

A puncture was identified on the tank head located at approximately 11 o'clock, when looking directly at the front of the tank. The puncture measured approximately 7-inches in length and 4-inches wide. A metal frame located above the puncture was broken and displaced upward.

Figure 9 above is a photograph of the front of the cargo tank semitrailer depicting the puncture and damage to the metal frame. The inset image in the lower right corner is a close-up of the puncture.

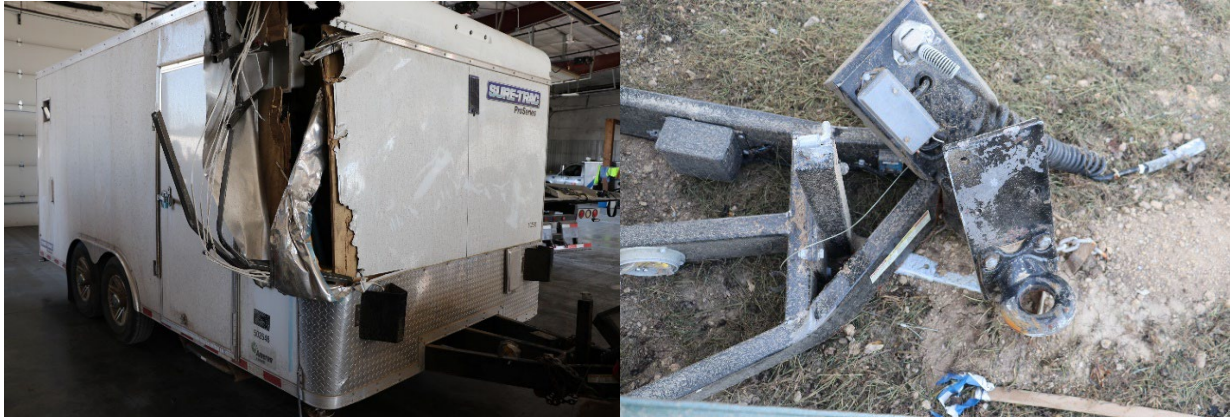
Figure 10. Photograph depicting the damage to the right front corner of the trailer. Right photograph shows damage to the tongue and lunette ring (Source: ISP).

The second vehicle involved in the collision was identified as a 2021 Sure-Trac Utility Trailer that was 16-feet long and 8-feet wide. The utility trailer was positioned in the dirt area between the commercial and residential driveways. At its position of final rest, the trailer was approximately 33 feet west of and in line with the combination vehicle. The right-side trailer tongue support rail was displaced inward while the lunette ring and plate was displaced to the right. The trailer jack was collapsed with the foot bent to the right. The right front corner sustained damage to the sheet metal, internal wooden structure, and frame rails exposing the interior of the trailer. Figure 10, below are two images of the utility trailer showing the damage to the right front corner and the trailer tongue and lunette ring.

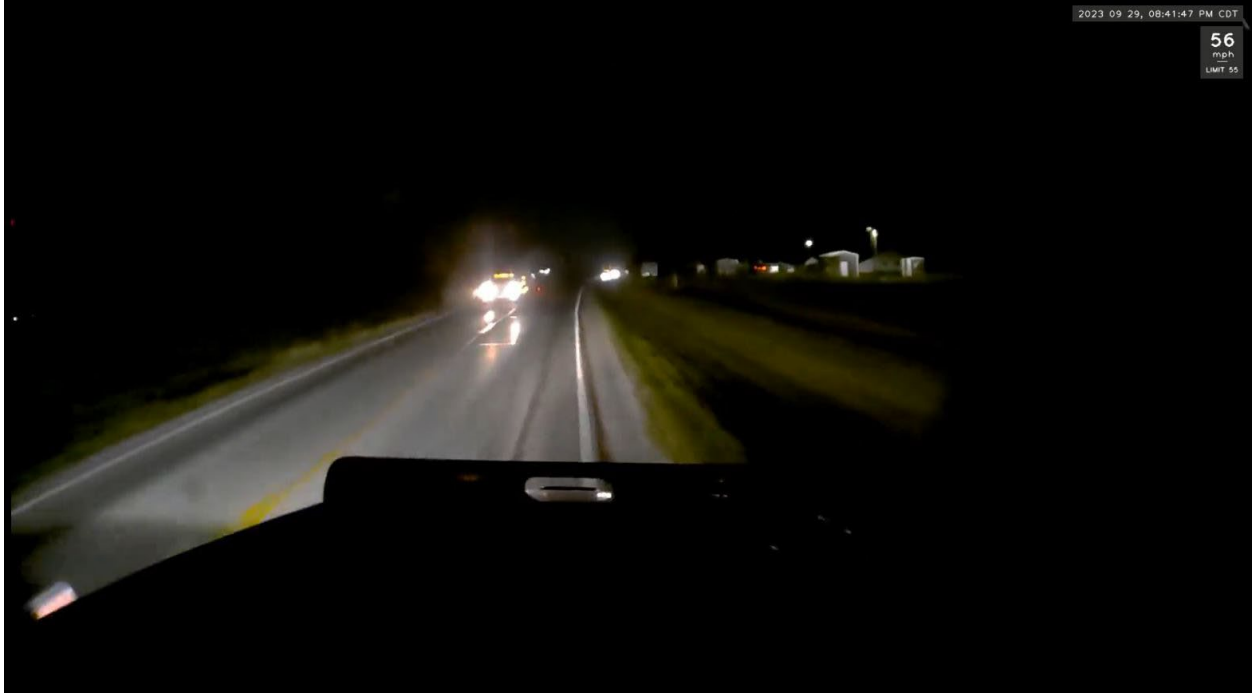
Figure 14. A screen capture of time stamp 08:41:47.

Prior to 08:41:45 the combination was observed to be travelling within the westbound travel lane. At this time the combination began a rightward movement toward westbound shoulder and had slowed to approximately 59 mph. Approximately two seconds later at 08:41:47 the right front of the combination crossed the shoulder and entered the grass slowing to approximately 56 mph; at the same time the right front headlight of another westbound vehicle is visible to the left of the combination. The vehicle was overtaking the combination with a vehicle traveling within the eastbound lane. Figure 14 is a screen capture taken at 08:41:47.

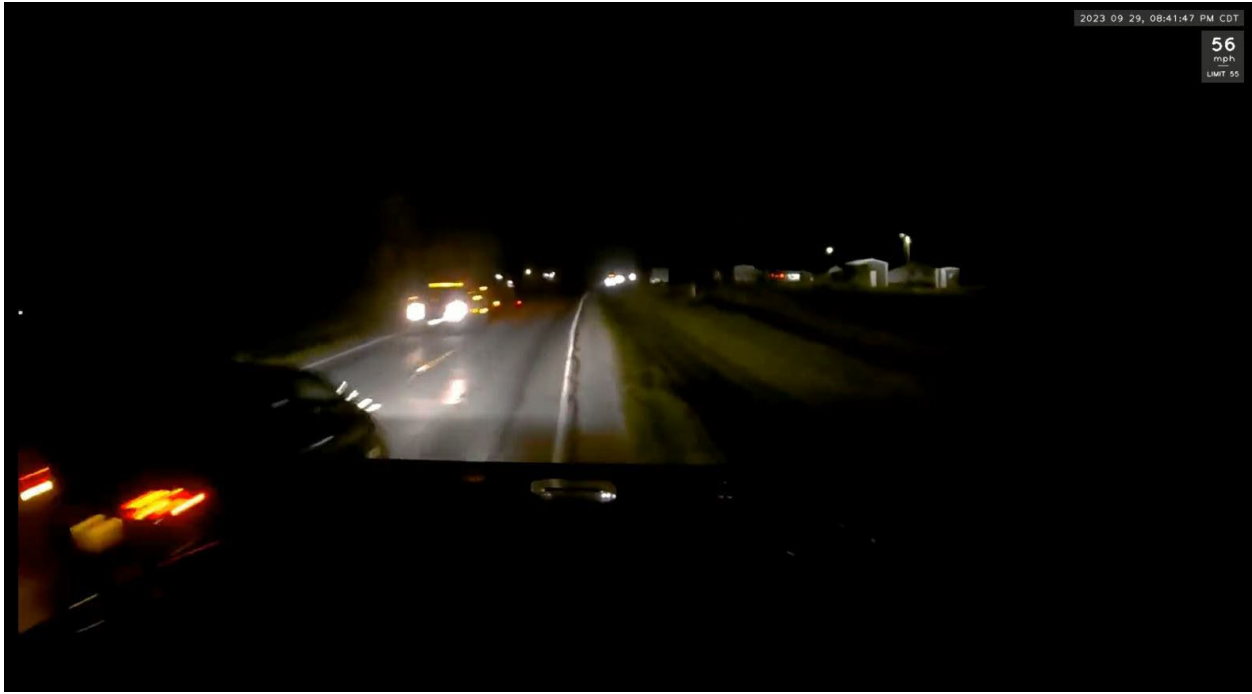
Figure 15. A second screen capture at time 08:41:47.

The combination continued rightward off the roadway, as the taillights of the overtaking vehicle, occupying both the east and westbound lanes, became visible. The eastbound vehicle is clearly visible as depicted in Figure 15 below.

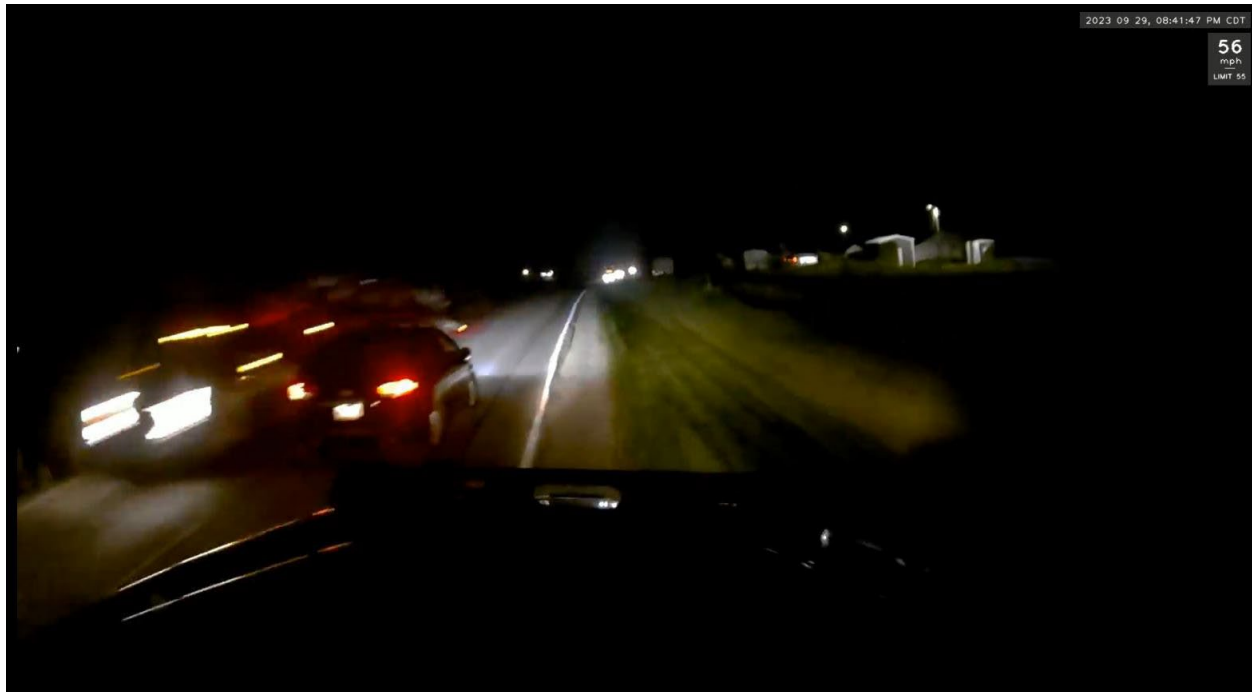
Figure 16. Additional screen capture from time 08:41:47.

Figure 16 below is an additional screen capture from 08:41:47. It shows the overtaking vehicle in the westbound lane narrowly avoiding a collision with the eastbound vehicle.

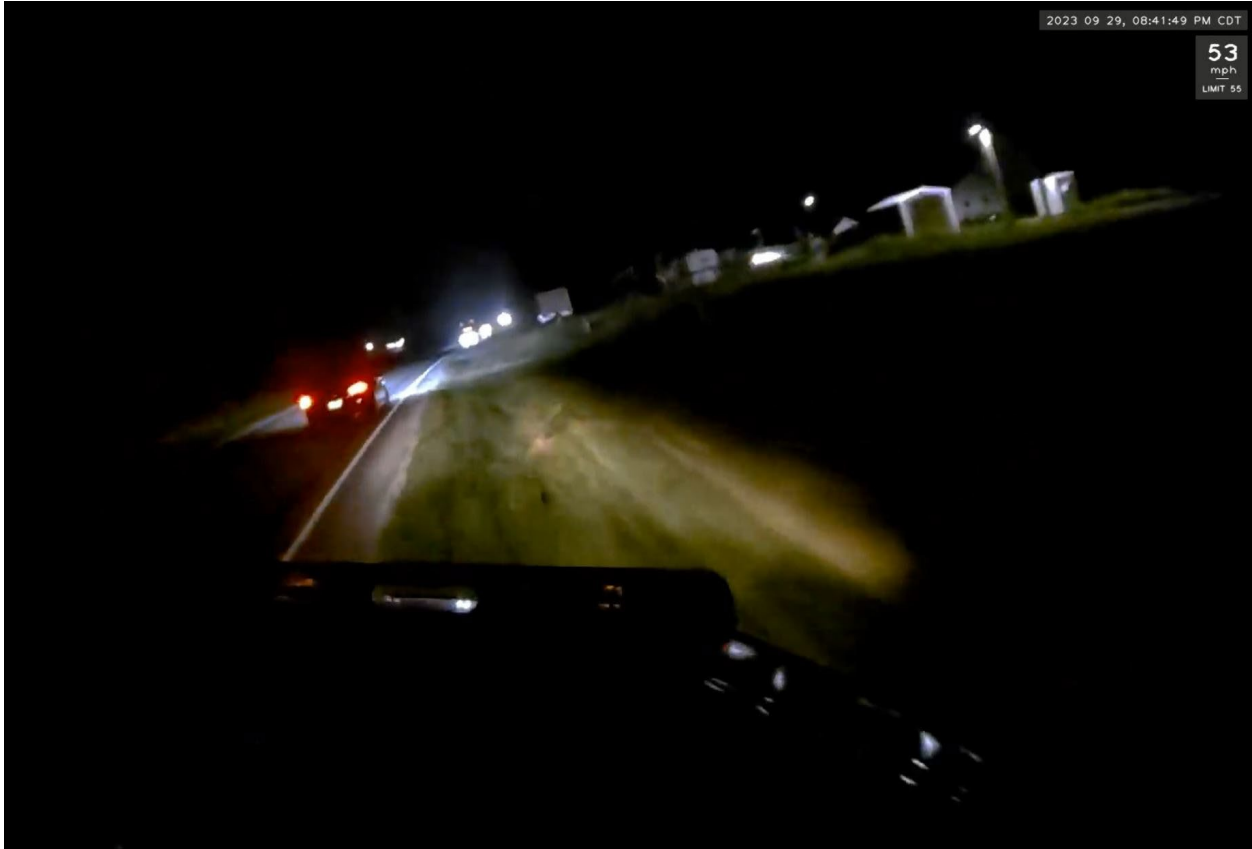
Figure 17. Screen capture from time stamp 08:41:49.

As seen in Figure 17 below at the time of 08:41:49 the overtaking vehicle has reestablished their position within the right lane and the right side of the combination is in the drainage channel. The combination continued westward in the drainage channel and had slowed to approximately 53 mph.

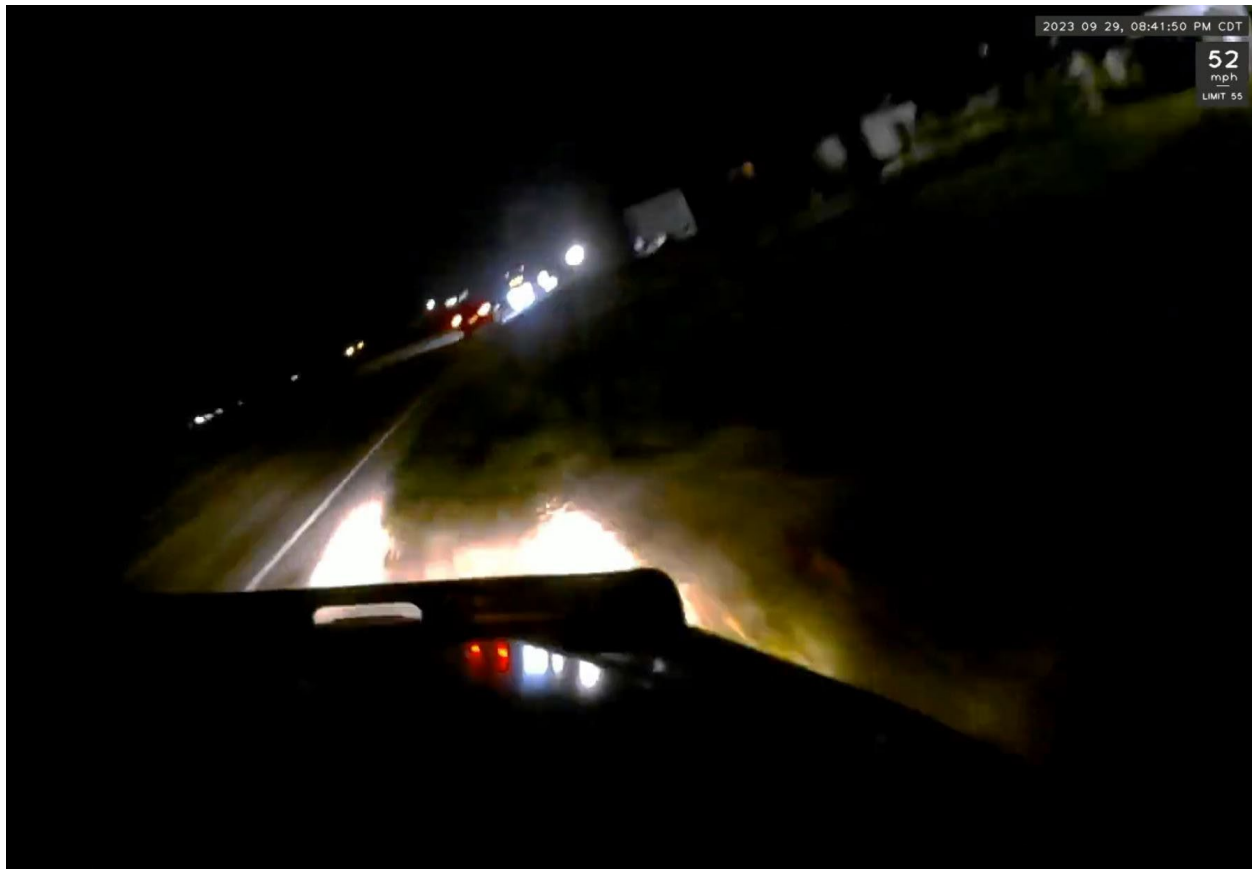
Figure 18. A screen capture from time stamp 08:41:50.

Figure 18 below is a screen capture from one second later at 08:41:50. The combination had fully entered the drainage channel, began to overturn, and impacted the transverse slope of the drainage channel. Also visible in the is the parked utility trailer that was impacted by the cargo tank trailer.
