## Jacqueline A - Additional Photos

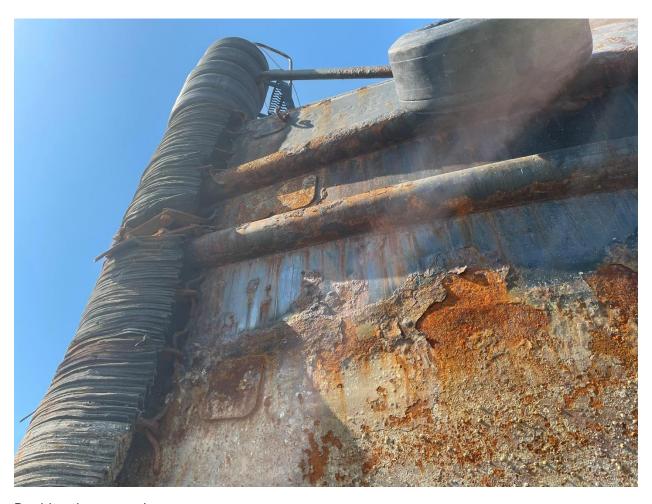
Doubler plates, port bow

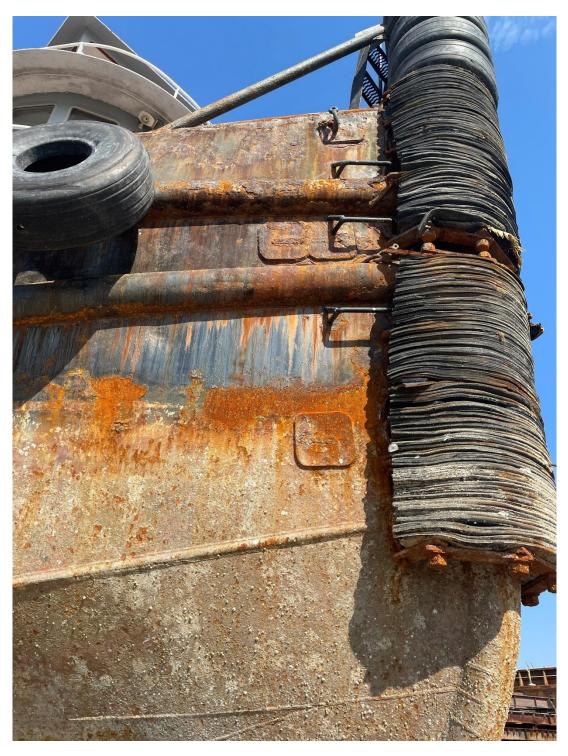
Doubler plates, starboard bow

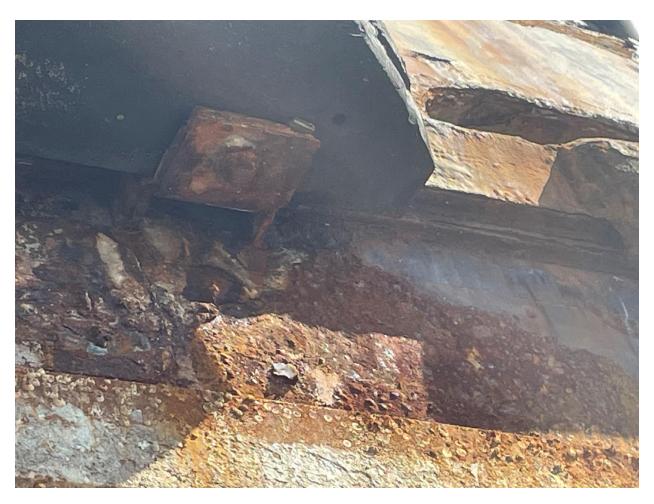
Doubler plate, starboard aft

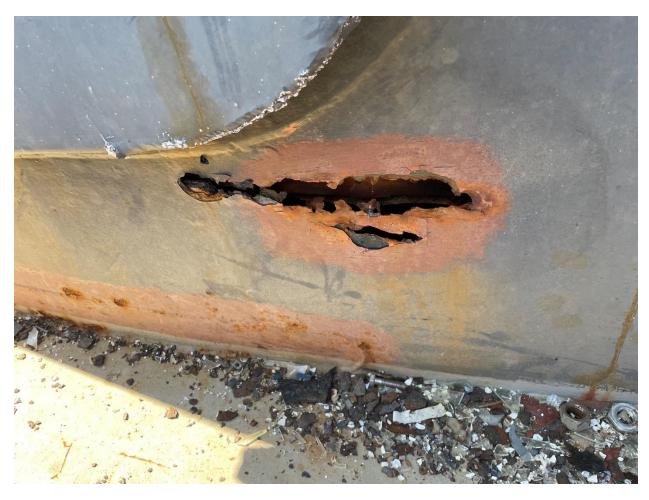
Wastage, port deckhouse

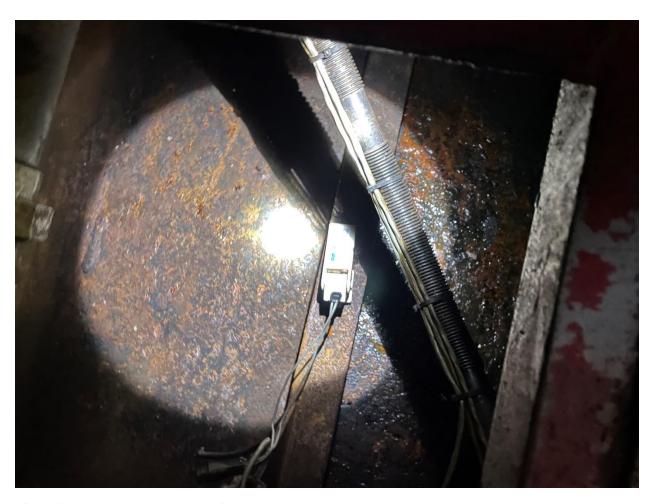
Bilge high water float sensor, engine room forward

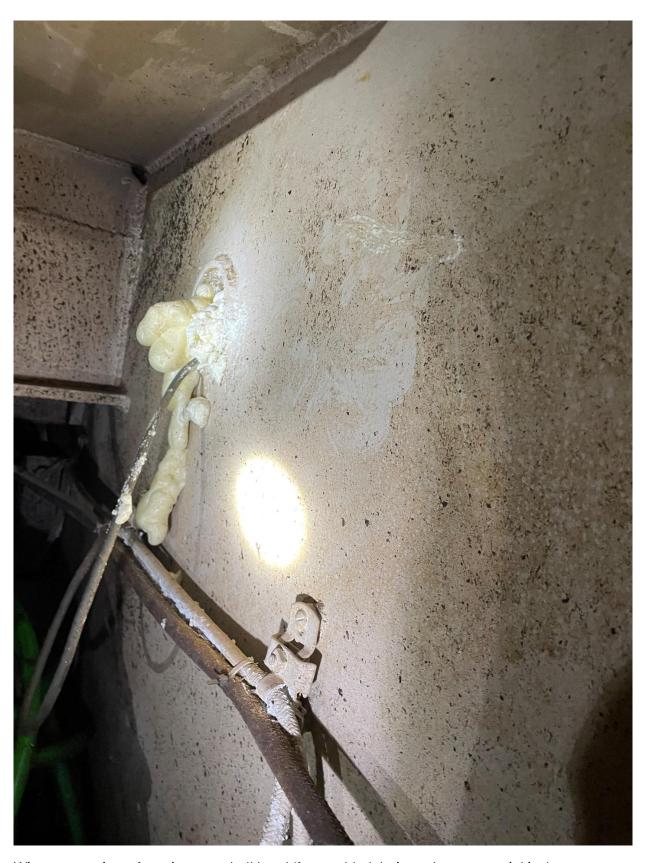
Wire run opening, aft engine room bulkhead (foam added during salvage post-sinking)

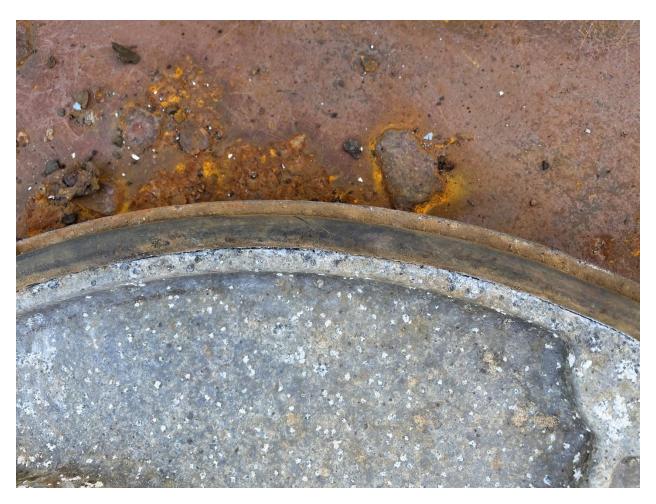
Gasked, port lazarette hatch
