National Transportation Safety Board
Office of Aviation Safety
Washington, DC 20594

WPR23FA110

AIRFRAME AND ENGINE EXAMINATION REPORT

Location: Grass Valley, California
Date: February 19, 2023
Time: 1335
Airplane: Lockwood AirCam / N420PF

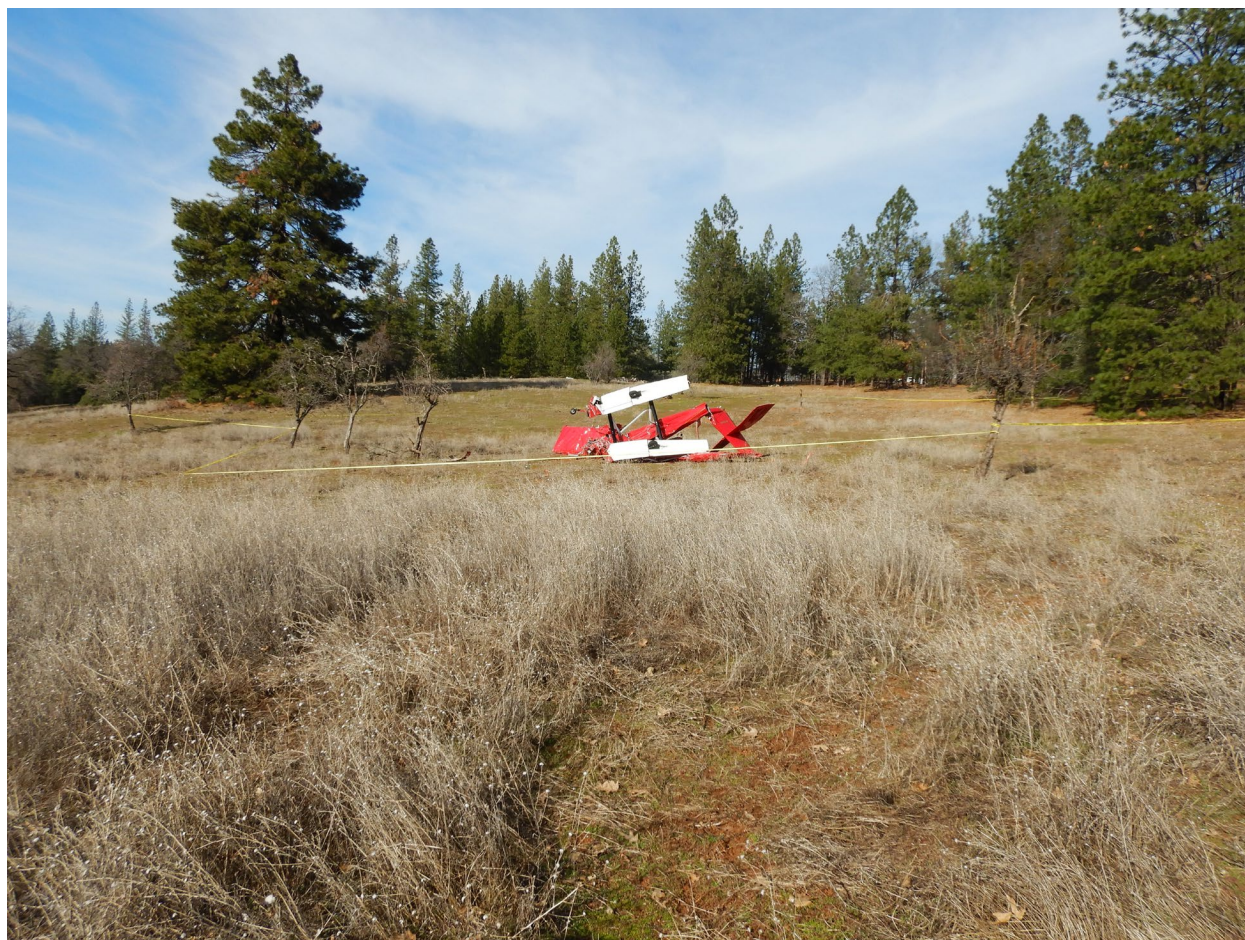
The airplane impacted terrain in an open field surrounded by pine trees of about 70 to 80 feet tall. The first point of probable impact were three gouges in the terrain about ten feet west of the main wreckage. The gouges were consistent with contact made by the nose of the airplane, and the tips of the two floats. All major components of the airplane remained secured to the airframe. The debris field was contained to an area of no more than 50 feet around the wreckage, with one separated propeller blade outside of that area. The floats remained attached to the undercarriage and the retractable wheels were extended.

Figure 1. Accident site in Grass Valley, California, looking north.

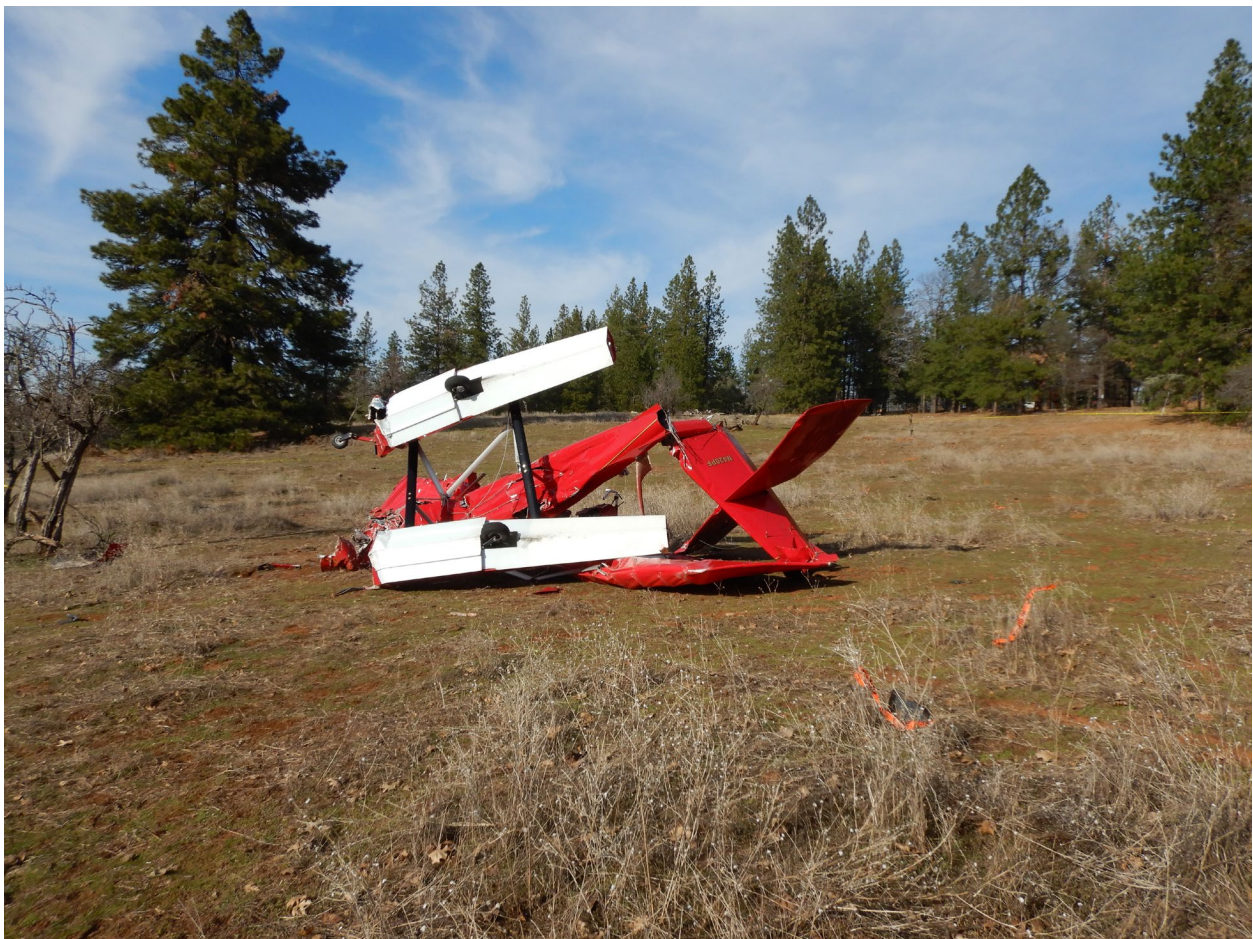
The airplane came to rest on its right side. The fuselage was substantially damaged beginning at the nose to about mid-section. The metal was crumpled in an accordion fashion aft past the rear seating area. The forward-right side exhibited more impact damage than the forward-left side. The front cockpit area was heavily crushed and fragmented. The front windscreen was fragmented and separated from the fuselage. There were two near vertical slash cuts into the aluminum skin located on the left side of the fuselage. One of the slash cuts penetrated the inner wall of the cockpit area.

Crushing and bending was observed throughout the fuselage, the degree of damage lessened as it neared the empennage.

Figure 2. Close up view looking north.

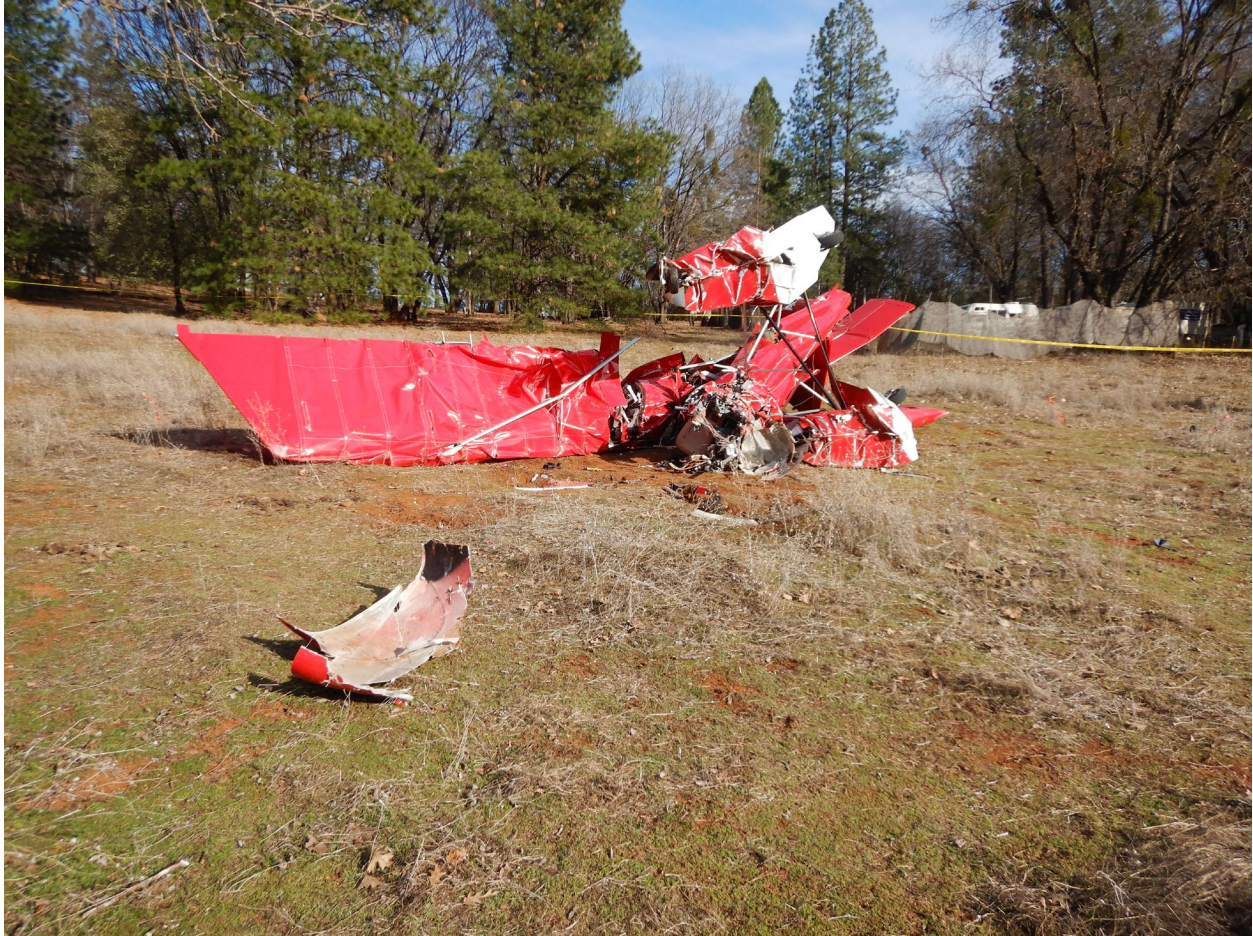
Figure 3. View of the front of the airplane.

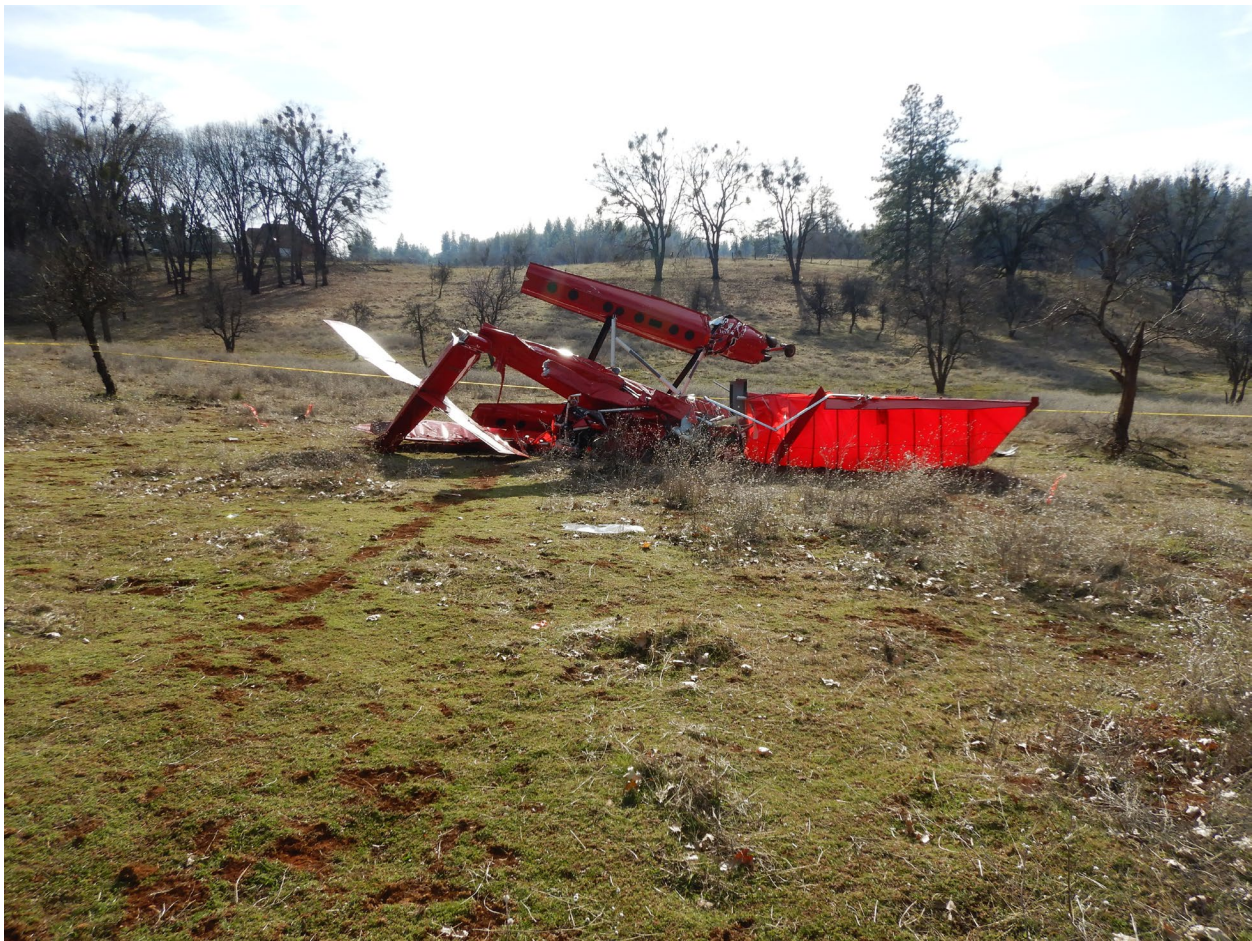
Figure 4. Left rear view.

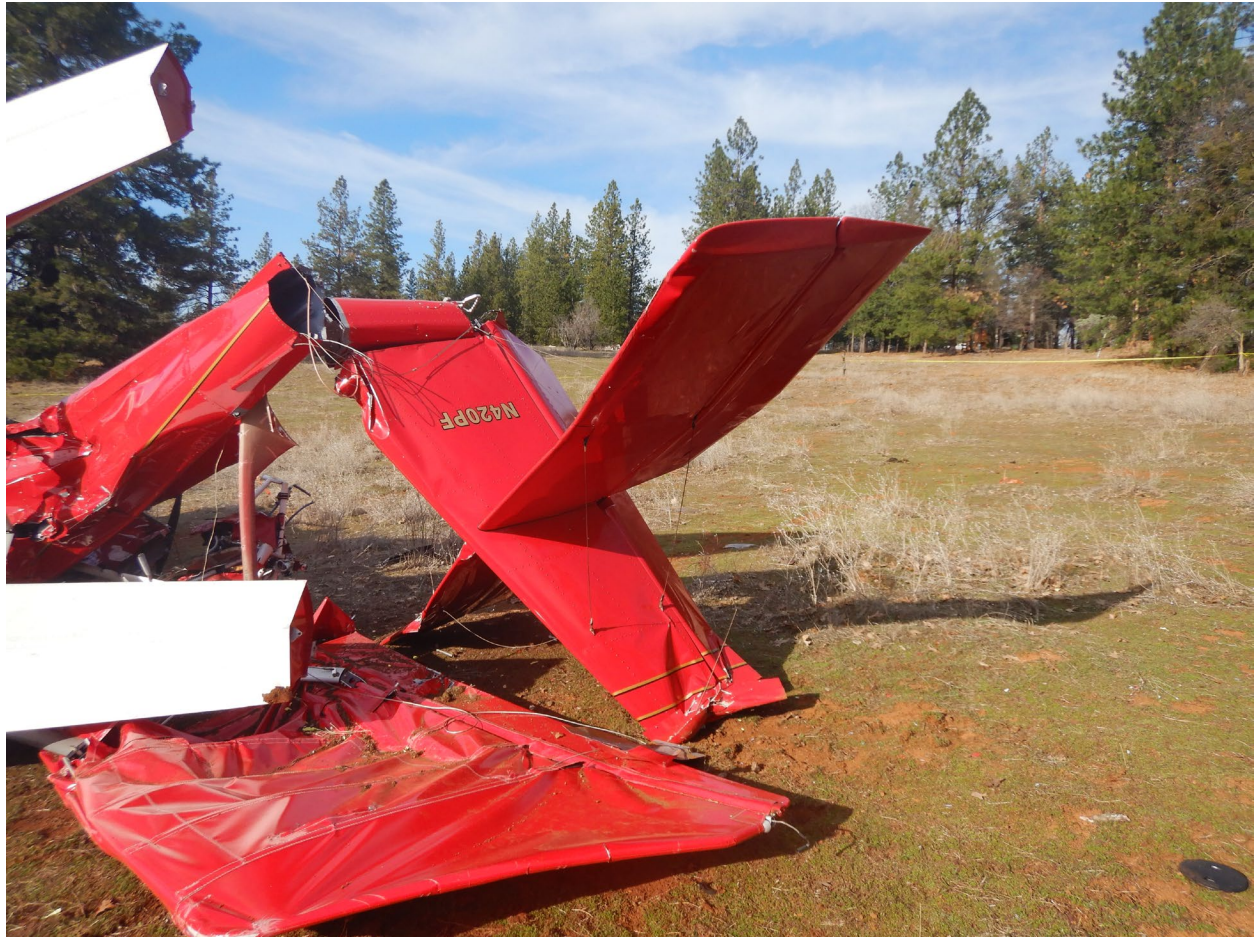
Figure 5. Empennage

The empennage separated from the aft fuselage but remained partially attached by the control cables. At the area of the separation was a circular row of rivets that had separated from the two halves (empennage and aft fuselage). The horizontal stabilizers and elevators remained installed to the empennage and exhibited bends to the metal structure, and wrinkles to the fabric skin. The elevator trim remained installed on the left elevator and exhibited minor damage. The vertical stabilizer and rudder remained installed on the empennage and exhibited downward crush damage that began at the top of the vertical stabilizer and rudder. All rudder and elevator control cables remained installed on their respective control surfaces and ran through the aft fuselage to their respective flight controls in the cockpit. The flap actuator separated from the airplane and was among the debris.

The elevators remained attached to the horizontal stabilizers. The right-side horizontal stabilizer and elevator exhibited a chordwise downward bend about mid-span. The left

side horizontal stabilizer and elevator exhibited structural bending and wrinkles in the fabric.

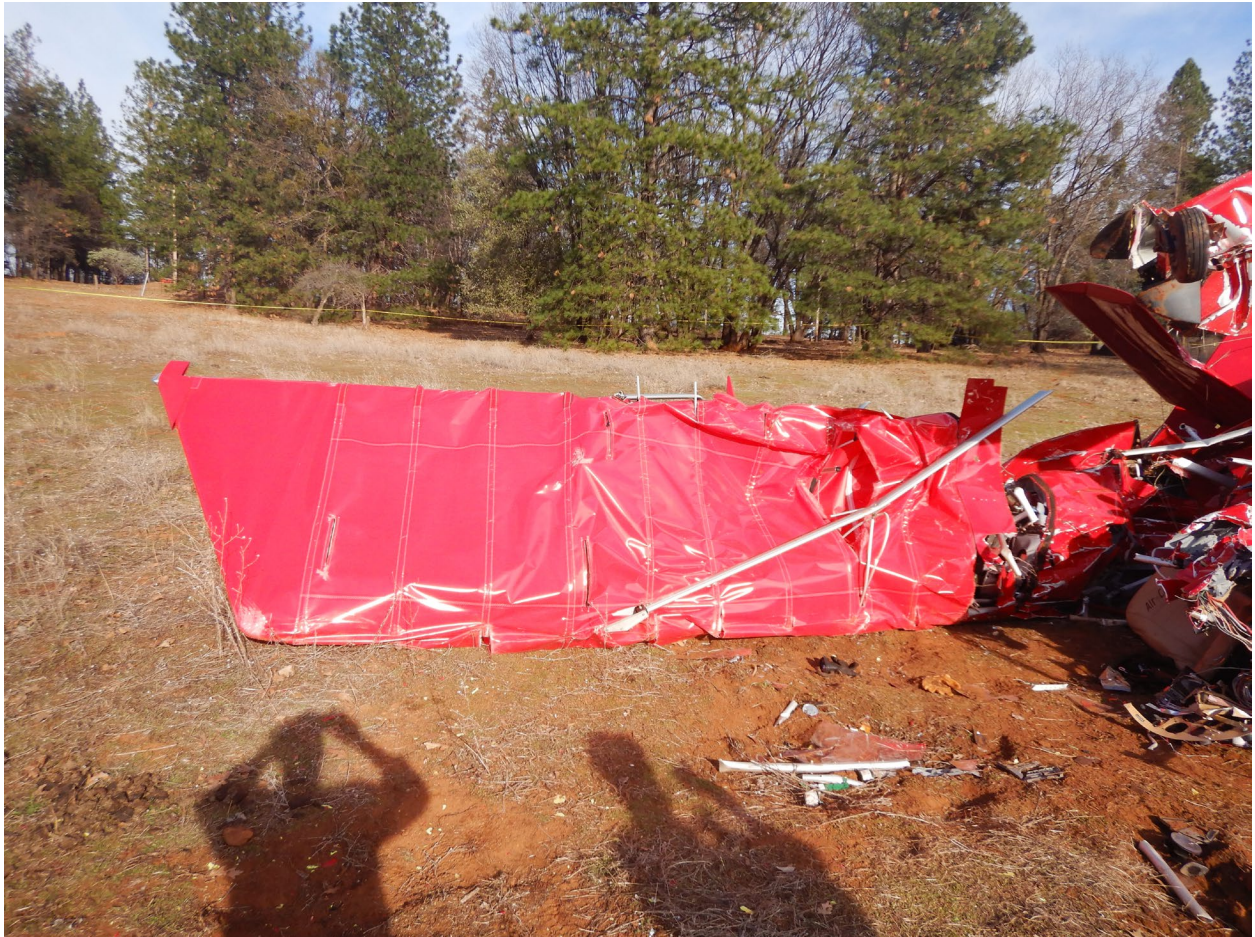
Figure 6, Left Wing

The left wing exhibited substantial damage with bent metal framework, The left aileron remained installed on the left wing. The aileron control cable from the aileron to the bellcrank and from the bellcrank to the center/common bellcrank remained installed. The aileron control cable from the center/common bellcrank to the front and back flight

controls remained installed. The left flap remained installed on the left wing but was separated at the root end nearest the fuselage.

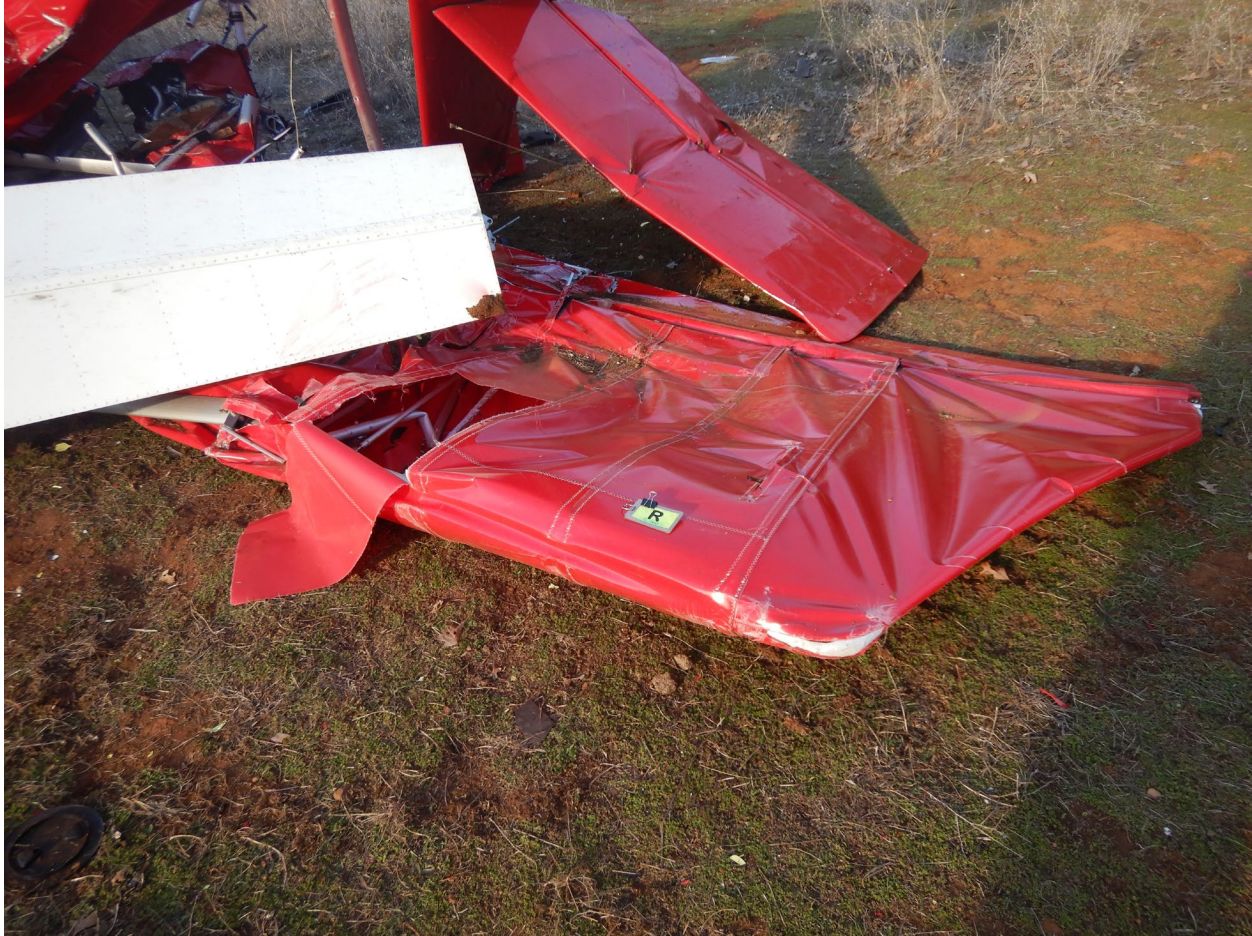
Figure 7. Right wing

The wings and engines separated from the fuselage as a single unit but remained partially attached by various cables and some attachment brackets. The right wing exhibited substantial damage with bent metal framework. The right aileron remained installed on the right wing. The control tube from the aileron to the bellcrank remained installed and was bent. The spanwise control tube fractured at the bellcrank, mid-wing, but remained installed at the center/common bellcrank. The right aileron control cable remained installed from the center/common bellcrank to the front and rear control stick. The right flap remained installed on the right wing and was damage.

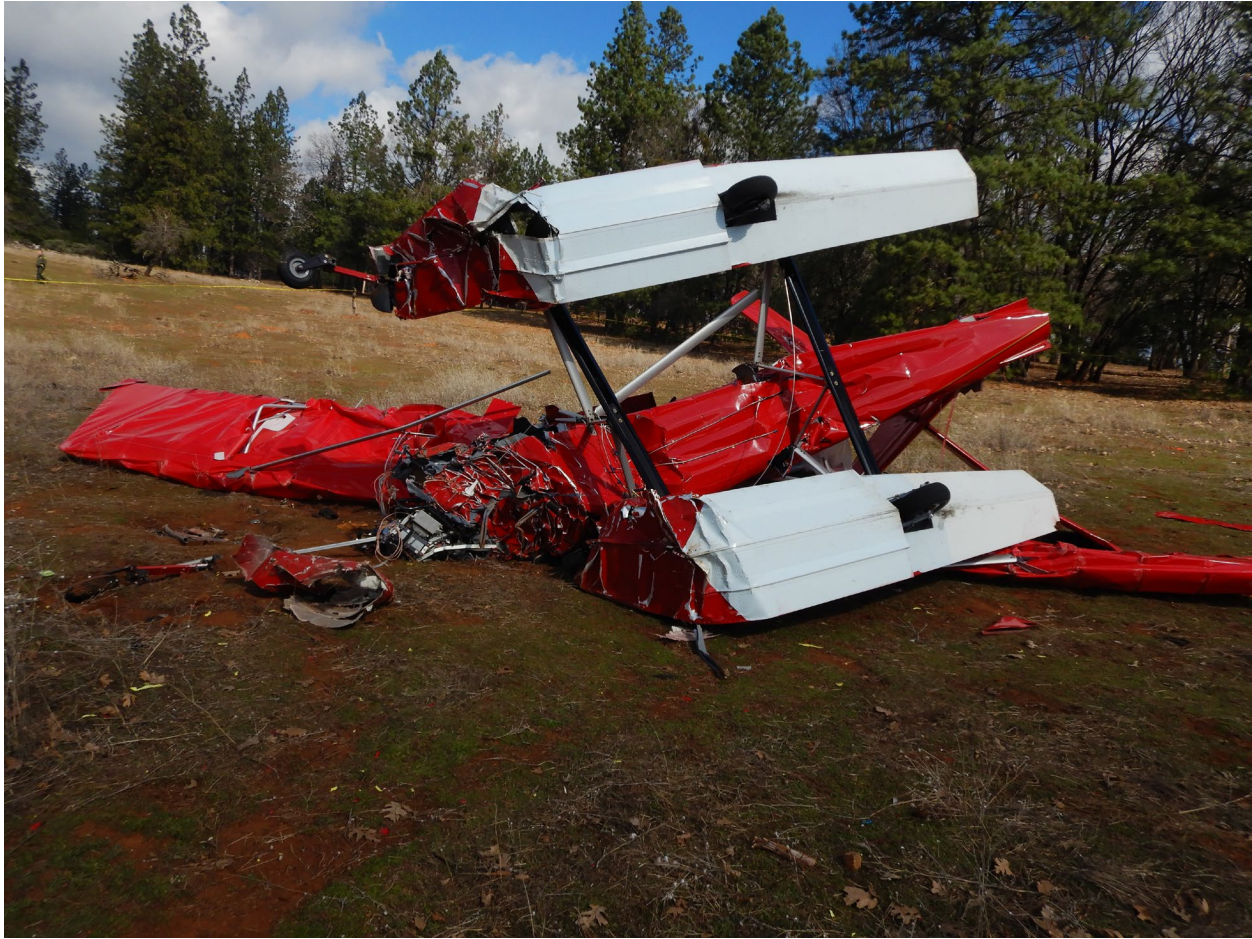
Figure 8. Landing gear, underside view

The right pontoon remained installed on the struts. The tip to the forward strut was crushed upward, aft and displaced to the left. The front right wheel separated from the pontoon mount and was found in a gouge in the ground. The rear wheel remained installed and was extended. The right float rudder was absent. According to the manufacturer, the float rudders were not necessary for this airplane due to the efficiency of the airplane's rudder.

The left float remained installed on the airplane. Both the front and rear wheel remained installed on the float and were extended. The tip of the float, aft to the front strut was heavily damaged, crushed upward, aft, and bent to the left. The left float rudder was absent. According to the manufacturer, the float rudders were not necessary for this airplane due to the efficiency of the airplane's rudder.

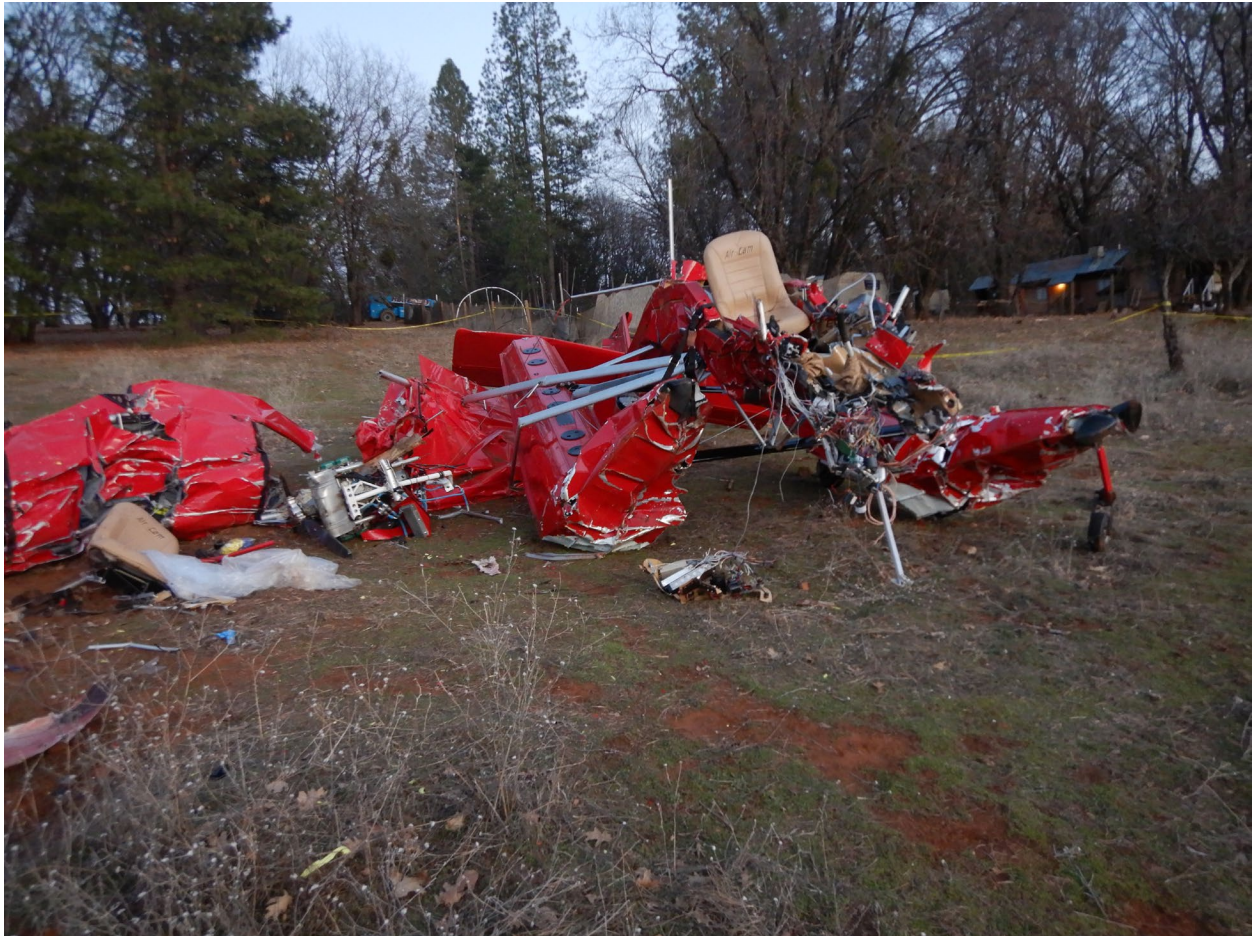
Figure 9. Cockpit view

The front seat area was destroyed. Most of the instruments were fracture separated from the fractured instrument panel. The front seat separated from the floor at the rivets. All flight controls remained installed in the front seat area. The rudder pedals fractured and partially separated front their mounts. The rudder control cables remained installed to the pedals. The front control stick remained installed to the floor. All control cables remained attached to the control stick. The throttle quadrant remained installed to the fuselage. The throttles were not evenly matched.

The rear seat area was substantially damaged but not to the extent of the front seat area damage. The rear seat remained installed. The flight controls remained installed. The control cables remained installed to the controls. The throttles remained installed and were evenly matched to the idle position.

The cockpit instruments were found strewn about the wreckage.
Airspeed indicator: 80 KIAS

Altimeter: 2,480 ft @ 30.09
Vertical Speed Indicator: lodged at -2,000 ft per minute
A Cylinder Head Temp: 100°F
B Cylinder Head Temp: 160°F
Volts: Damaged, unreadable
Oil Pressure: Damaged unreadable
Fuel Quantity, Left and Right: Less than ¼ tank
Flaps Switch: Toggle centered
Trim: Toggle centered
AUX Fuel Pumps: On
MAGS Left and Right: Undetermined
Starters: Left
ELT: Not armed
Both Tachometers: Damaged Undetermined

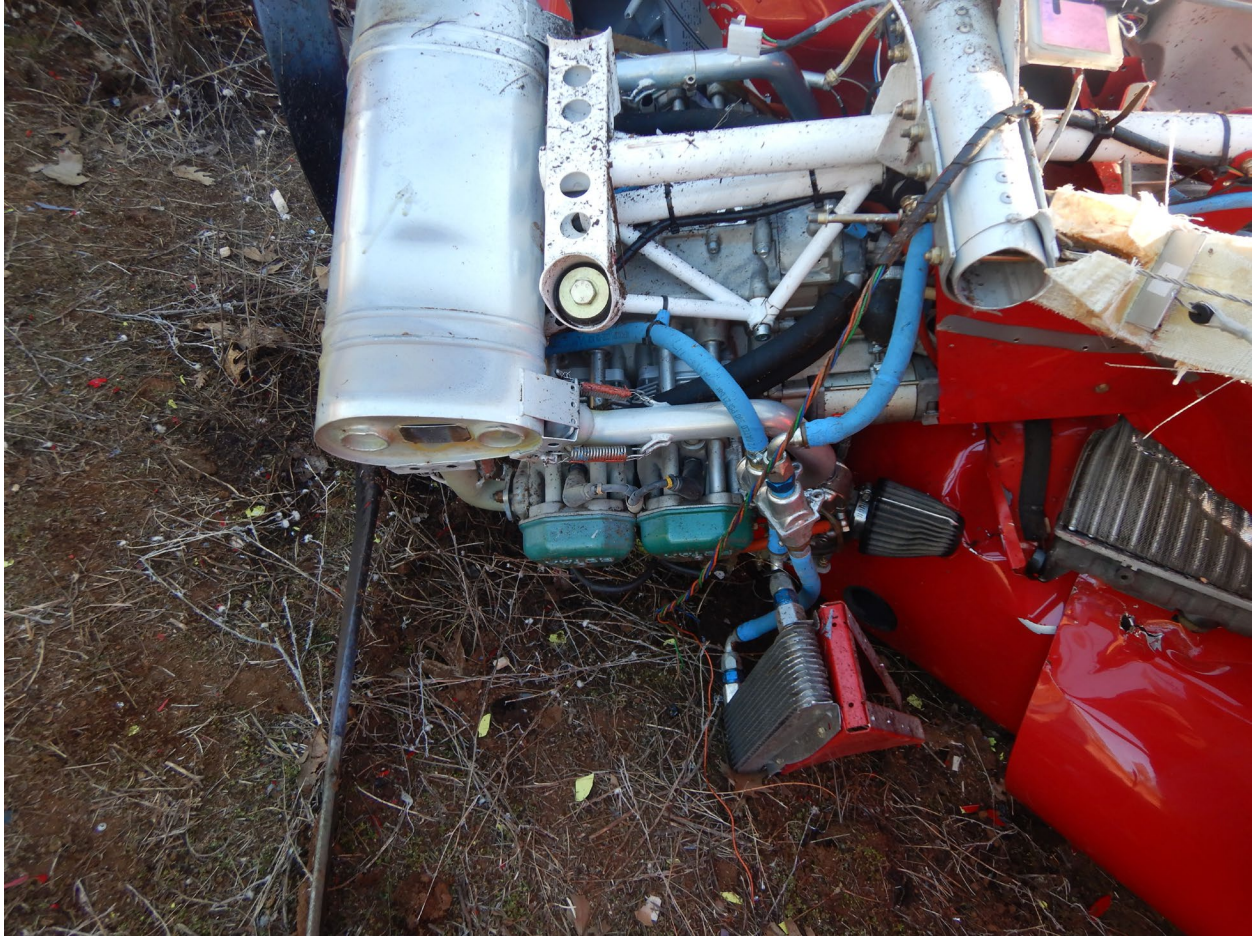
Figure 10. Left engine

The engine remained attached to the engine mount. The engine mount was cut and removed from the wing during recovery.

The top and bottom spark plugs were removed. The spark plugs appeared to be gapped in accordance with the manufacturer's recommendation and exhibited yellow staining on the electrodes.

The engine was set up for a test run. This included re-installing the carburetors, which had separated from the intake manifold due to the impact. The fuel line was cut and placed into a container of gasoline. The fuel return line was also placed into the container holding gas. One half quart of oil was placed into the oil tank. An electrical source was attached to the starter. The engine started easily and ran at idle without effort. The throttles were manually advanced, and the engine responded. There were no backfires or unusual engine noises. The engine was shut down after about two to three minutes run time.

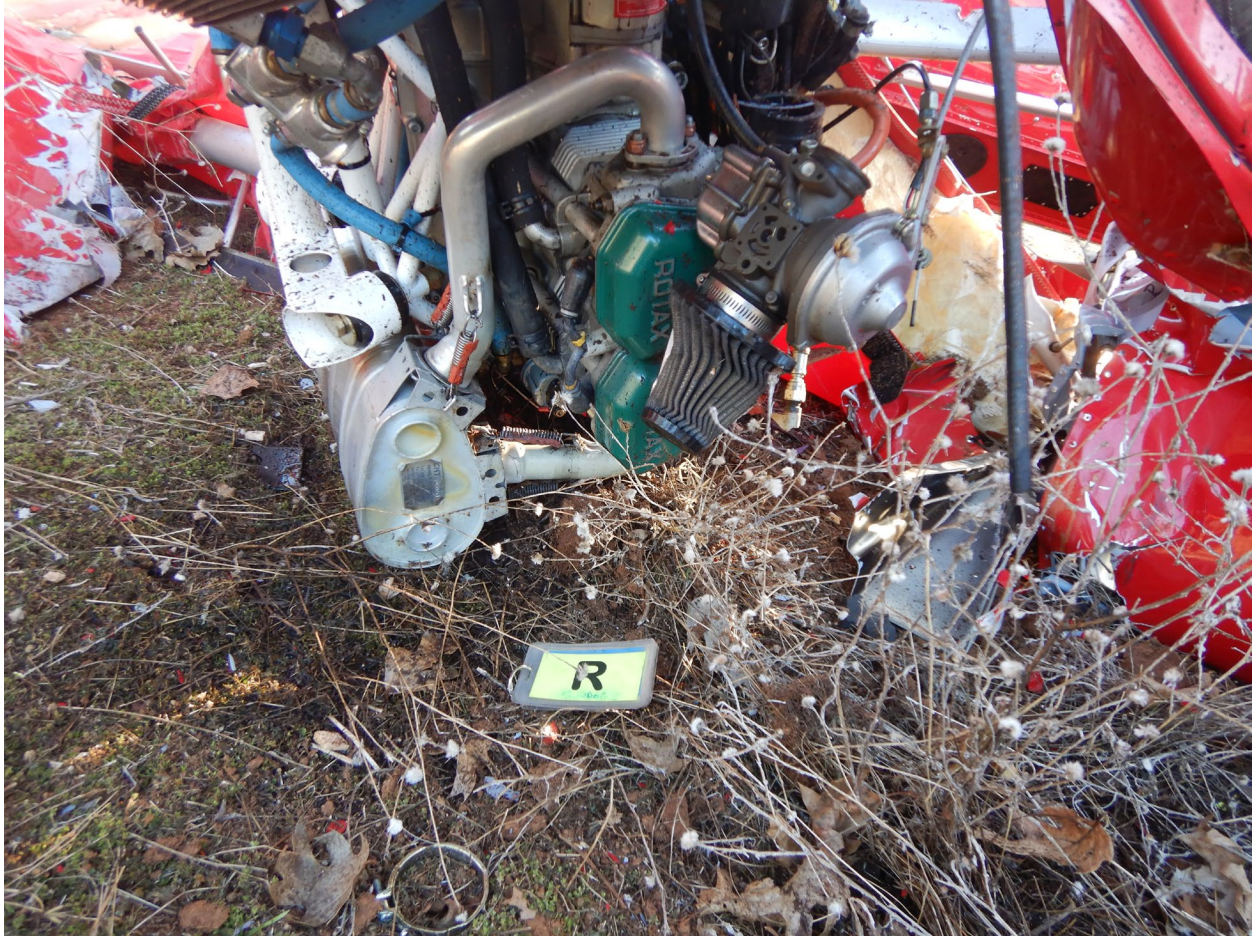
Figure 11. Right engine

The engine remained attached to the engine mount. The engine mount was cut and removed from the wing during the recovery. Upon examination the engine would not rotate. Upon removal of the number 1 cylinder head, there was an oil build up that prevented the engine from rotating. After the number one head was removed, the engine rotated with no resistance. The remaining heads and all cylinders were removed. The rocker boxes were all oil wetted and appeared normal. All cylinder walls were smooth with no signs of scoring. All pistons and wrist pins were smooth and appeared normal. The cylinder head inner chambers all exhibited a yellowish colored deposit, consistent with lead from low lead gasoline. The camshaft and lobes were normal with no wear on the cam lobes. Valve train continuity was confirmed normal.

There was evidence that the pickup trigger coils were impact damaged.

The engine driven fuel pump was removed. Examination of the pump revealed that the ports for the fuel lines were fractured. The diaphragm operated normally. All spark plugs exhibited a yellowish stain on the electrodes, consistent with lead deposits from low lead gasoline.

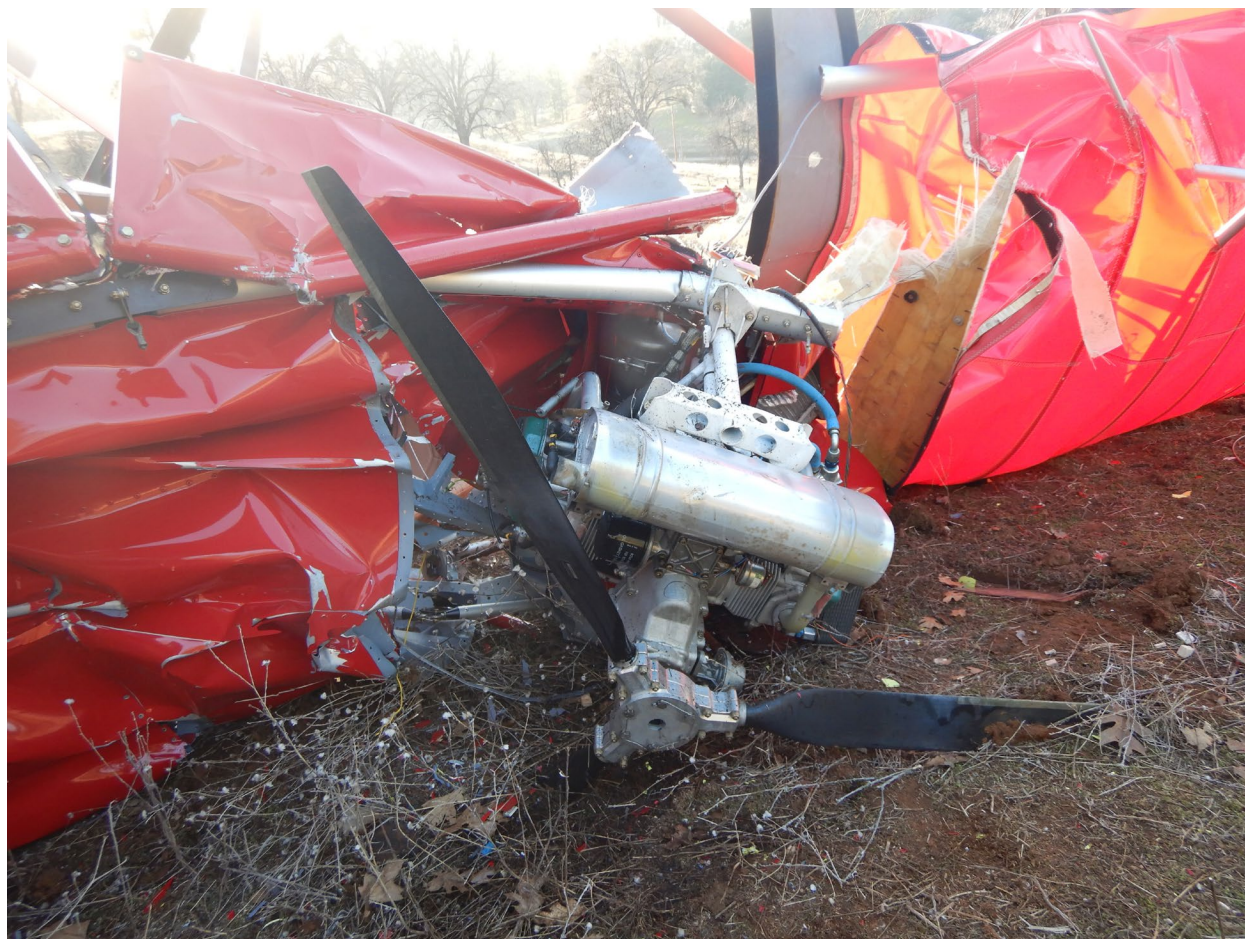
Figure 12. Left propeller

The left propeller exhibited fracture separation of one blade (L1) The blade fractured and separated about 7 inches from the root end. The L1 blade was located 120 feet east of the wreckage. The tip of the L1 blade exhibited red color transfer on the leading edge. The root of the blade remained installed on the hub and rotated about 80°. The next blade, L2, remained installed on the hub and exhibited no damage. The L2 blade

also exhibited red color transfer on the leading edge. The third blade, L3, remained installed on the hub and exhibited no damage. The red color transfer on the two left blades was consistent with the red paint of the fuselage.
