**NATIONAL TRANSPORTATION SAFETY BOARD**

WPR23LA307

**AIRFRAME AND ENGINE EXAMINATION REPORT**

Airplane: Stearman / N5697

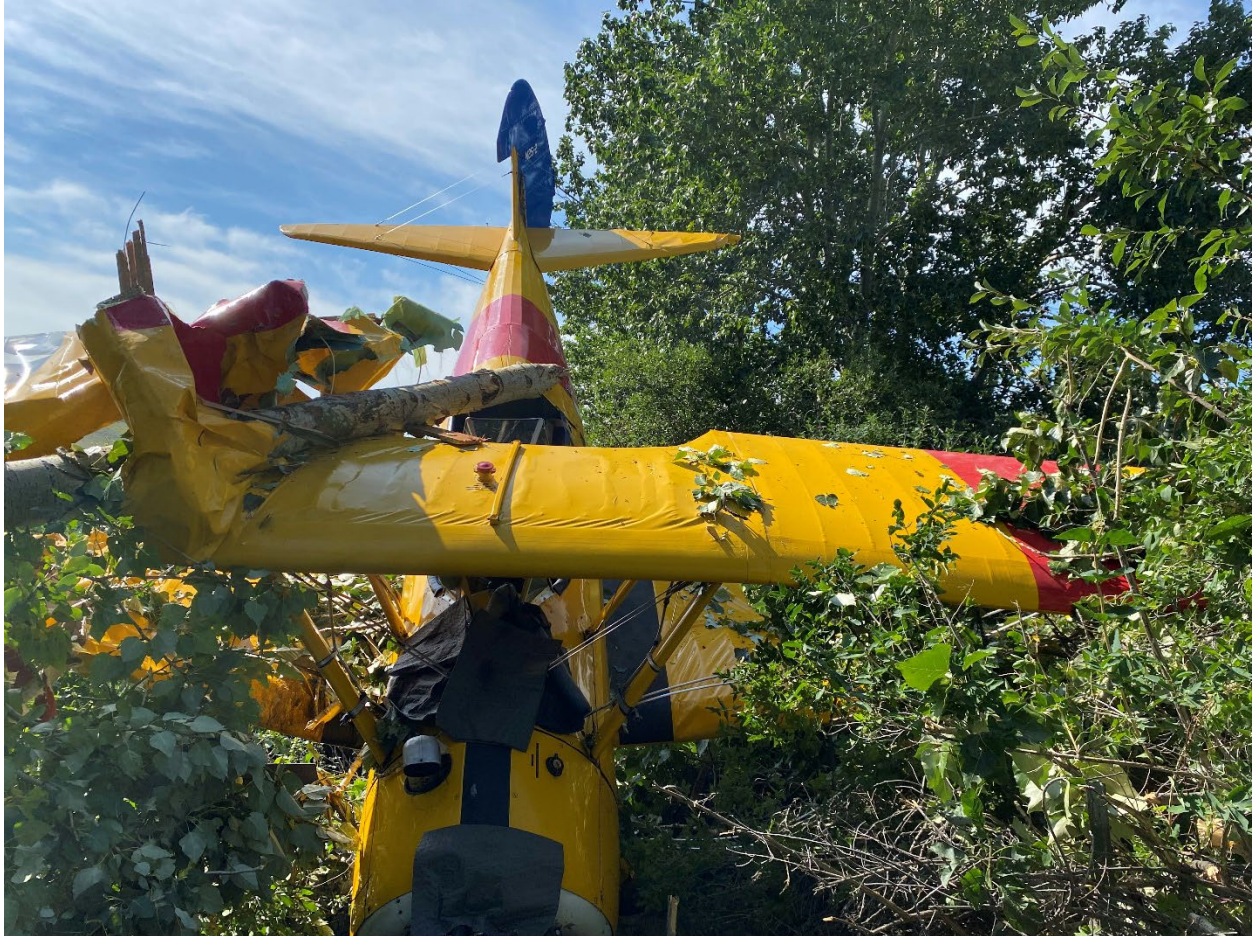
The airframe exhibited substantial damage to the upper and lower wings, near the left-side mid-fuselage, the left elevator, and near the tail wheel assembly. Figure 1.

Figure 1. N56907 at the accident site. Photo pilot.

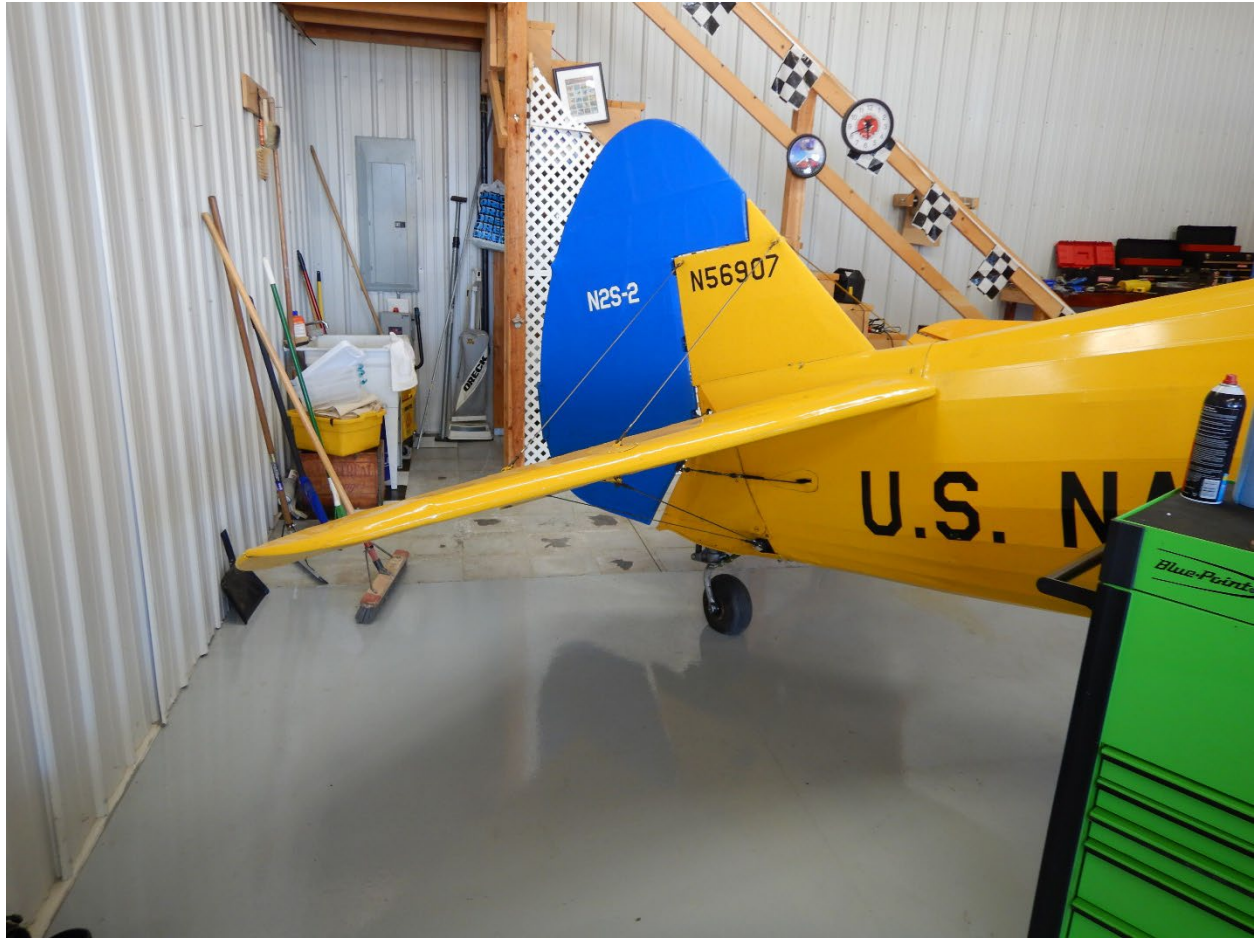
The left elevator and left horizontal stabilizer received substantial damage. The vertical stabilizer, rudder, right horizontal stabilizer, and elevator were not damaged. Flight control continuity was established from the control stick to the elevators, and from the rudder pedals to the rudder. Figure 2 and 3.

Figure 2. Empennage, right side.

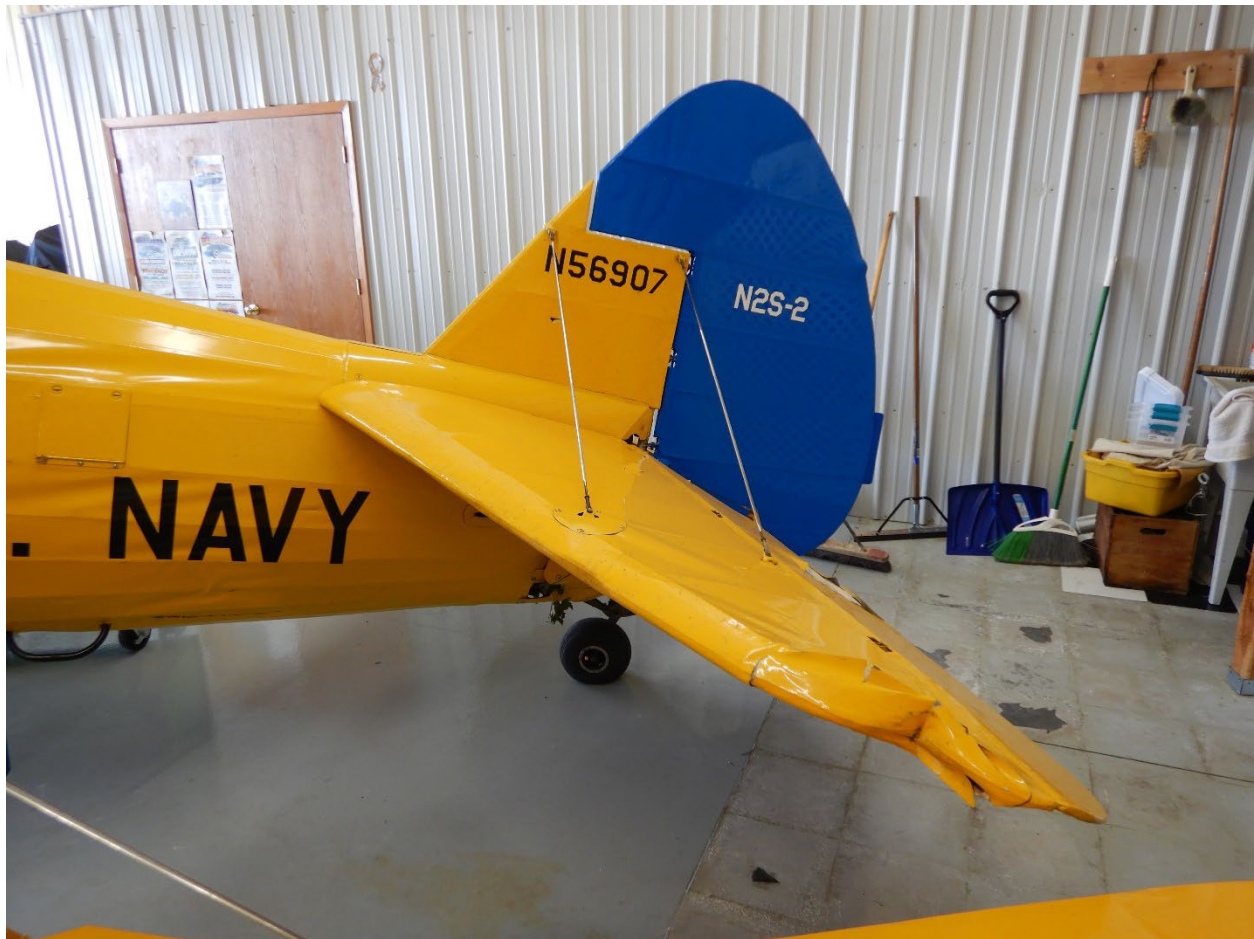
Figure 3. Empennage, left side, showing substantial damage to the horizontal stabilizer.

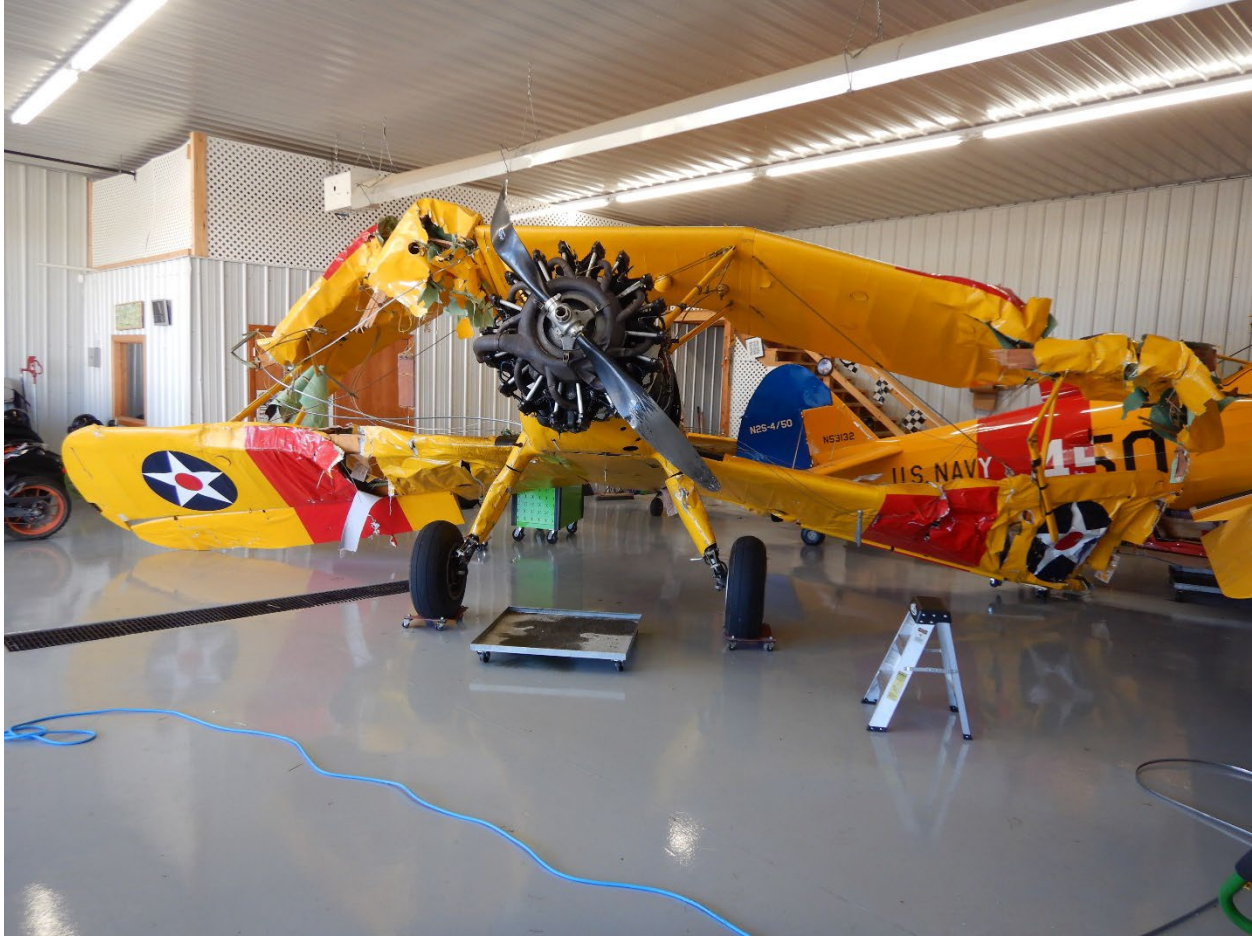
The airplane was equipped with upper and lower wings. The lower left and lower right wings were substantially damaged. The upper left and upper right wings, along with the left and right ailerons were substantially damaged. Flight control continuity could not be determined from the control stick to the ailerons; however, the pilot maintained full control of the airplane until contact with the trees. Figure 4.

Figure 4. Upper and lower wings, showing substantial damage.

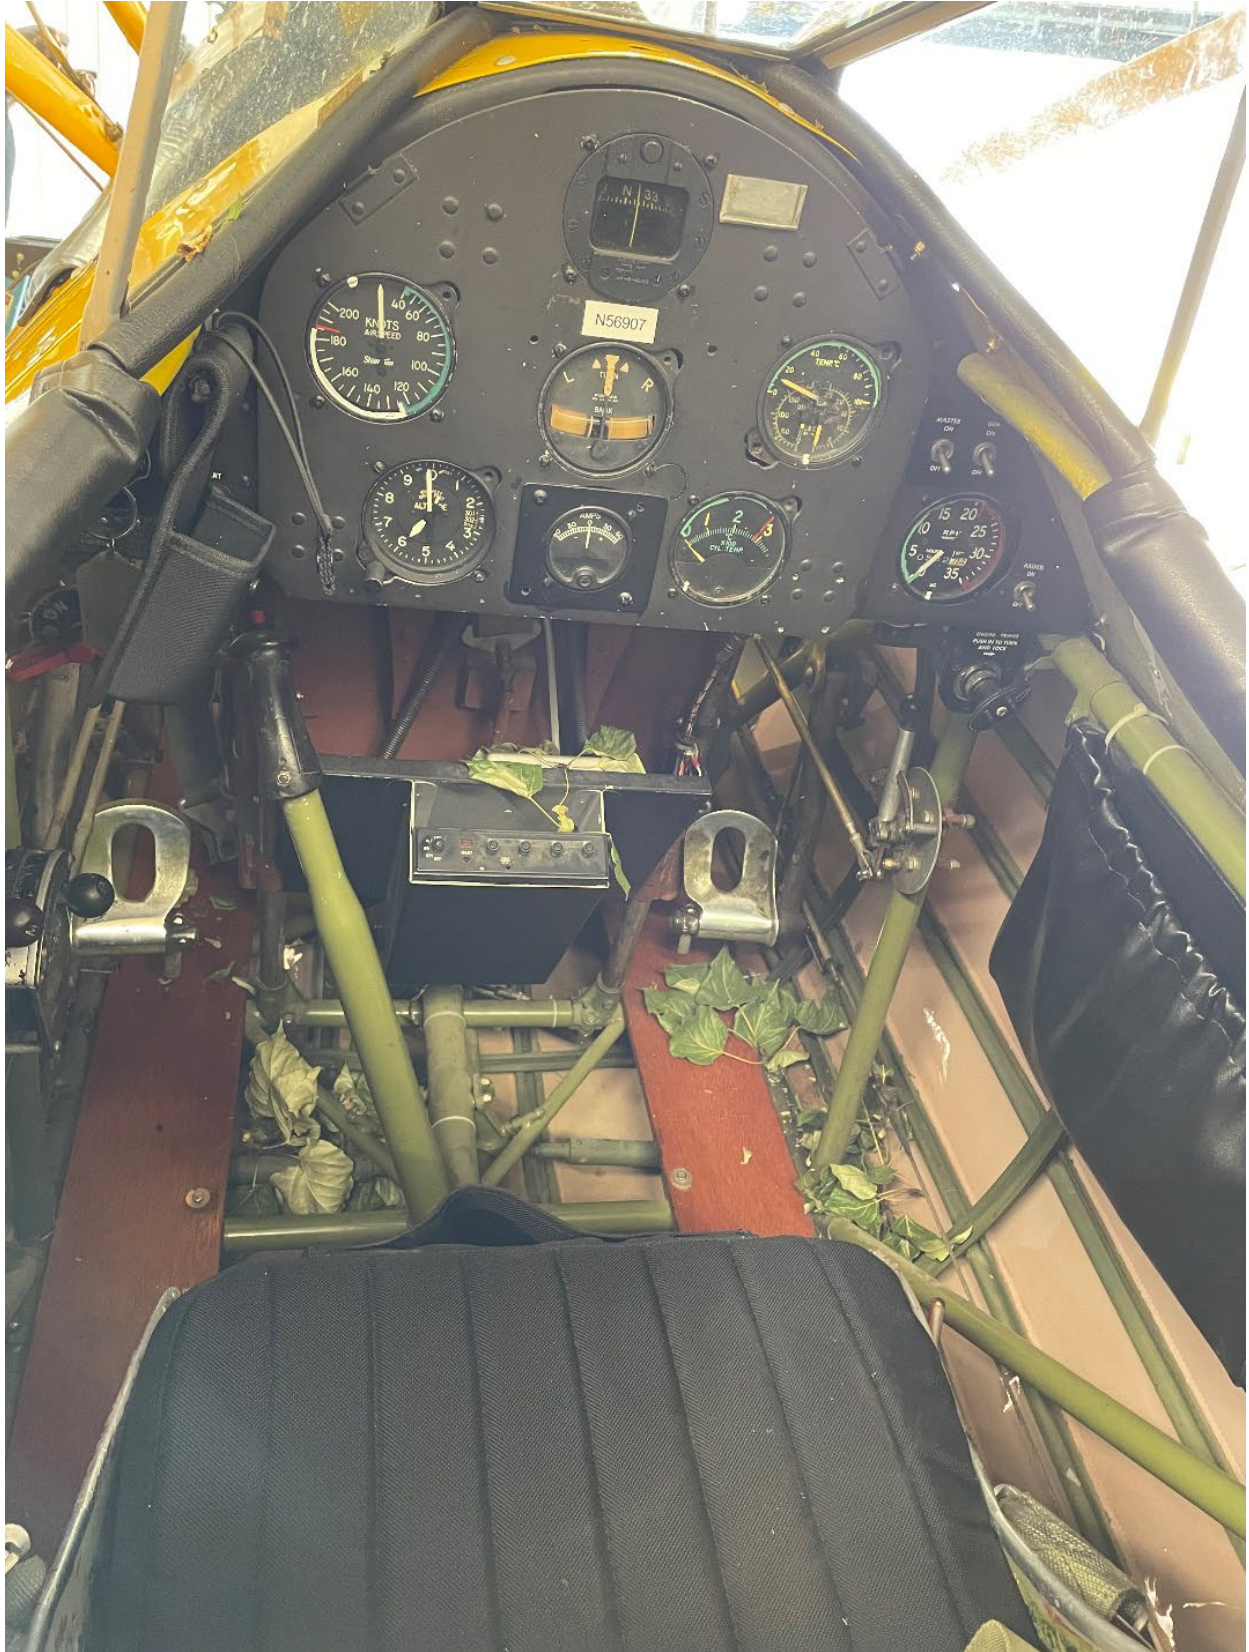
The cockpit was not damaged. All instruments remained installed. The flight controls were not damaged. The throttle and mixture were not damaged. Figure 5.

Figure 5. Cockpit view.

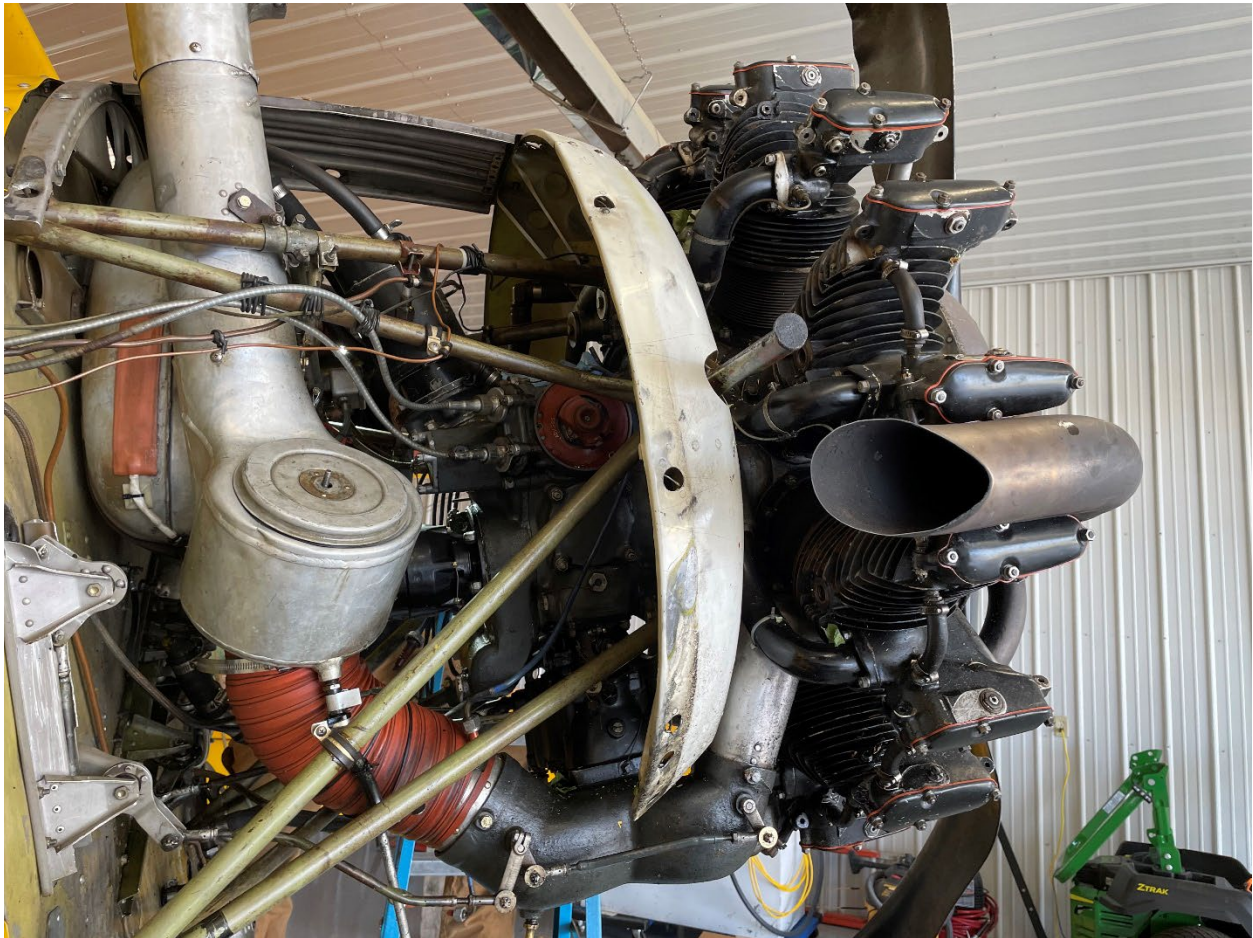
The engine was a Lycoming R-680-17 9-cylinder radial, serial number: L014804. The engine was in good condition with some minor damage from impacts from tree branches. Figure 6.

Figure 6. Engine, right side.

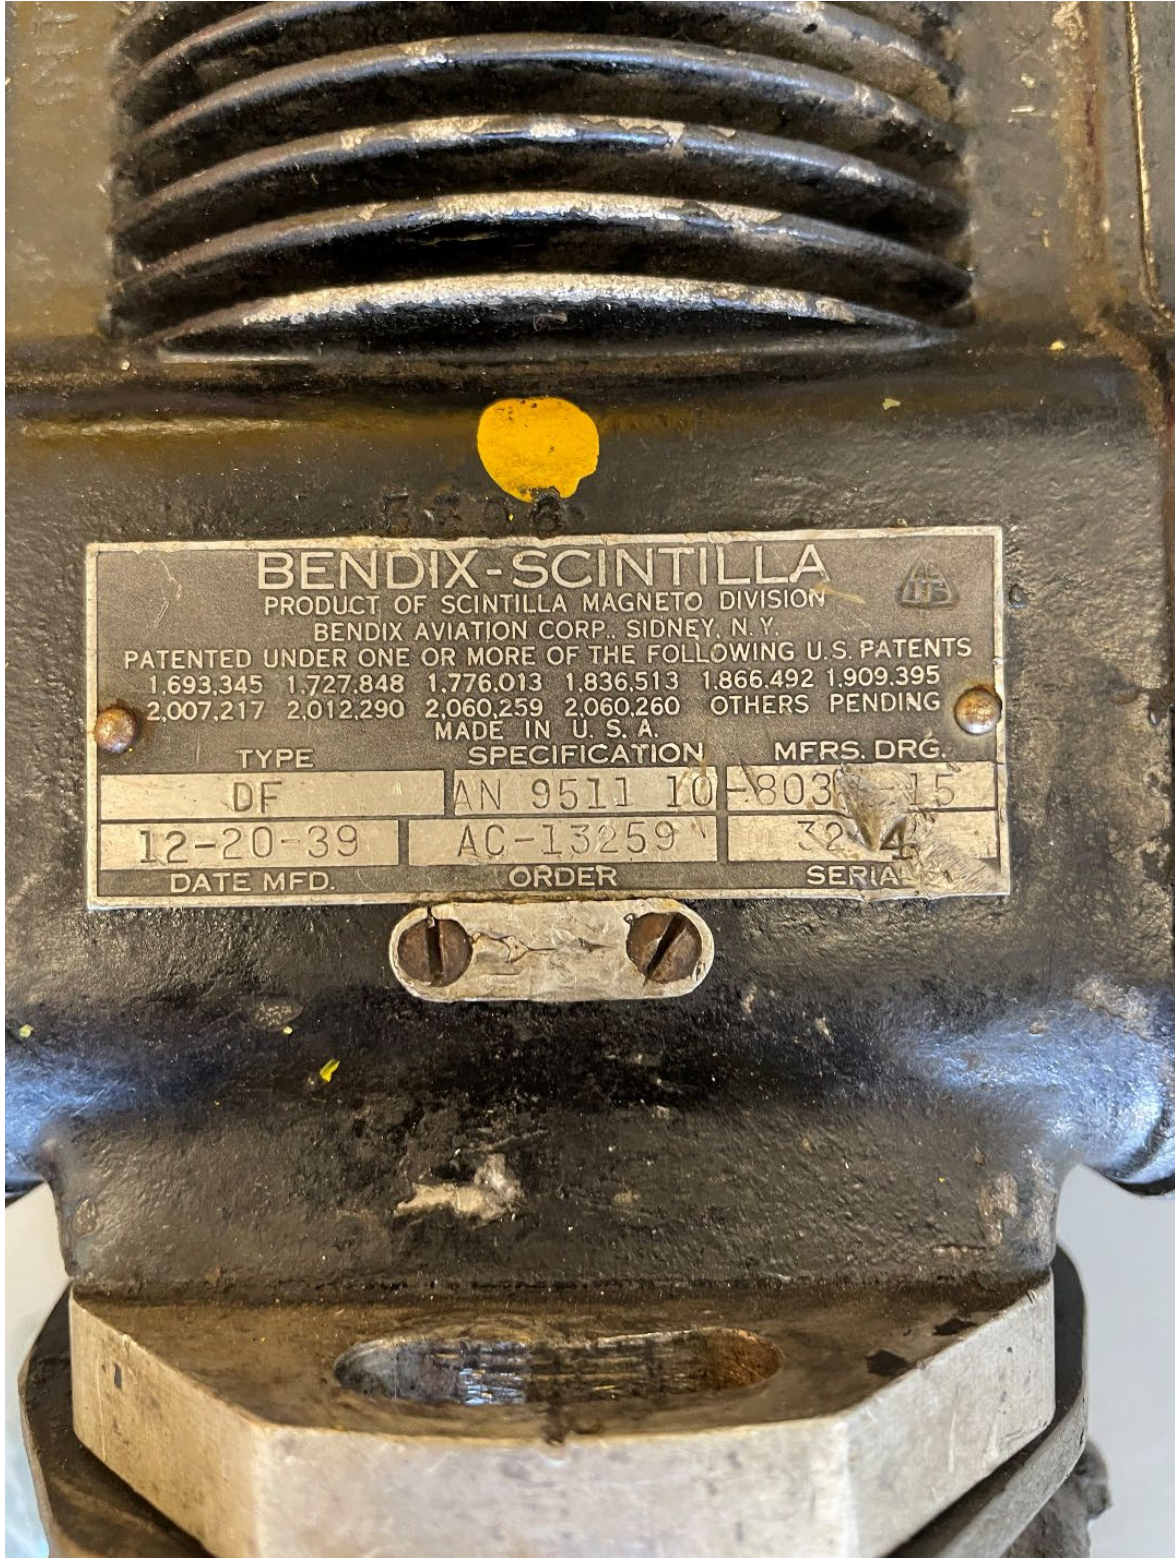
- Removed P-leads from the magneto.
- Rotated the engine by the starter and checked for spark on front and back leads. No spark observed.
- Checked the points of the magneto (Bendix-Scintilla, model DF) (Figure 7) that contained dual points. When rotated by hand, the 4 O'clock points did not open and remained closed. The 9 O'clock points opened and closed as the engine rotated. There was no spark observed when the 9 O'clock points opened. Both points were secured in their respective mounts, and the yellow torque-stripe material was solid with no fractures. All points retention screws were snug and did not lose torque. Figure 8.

Figure 7. Bendix-Scintilla Magneto.

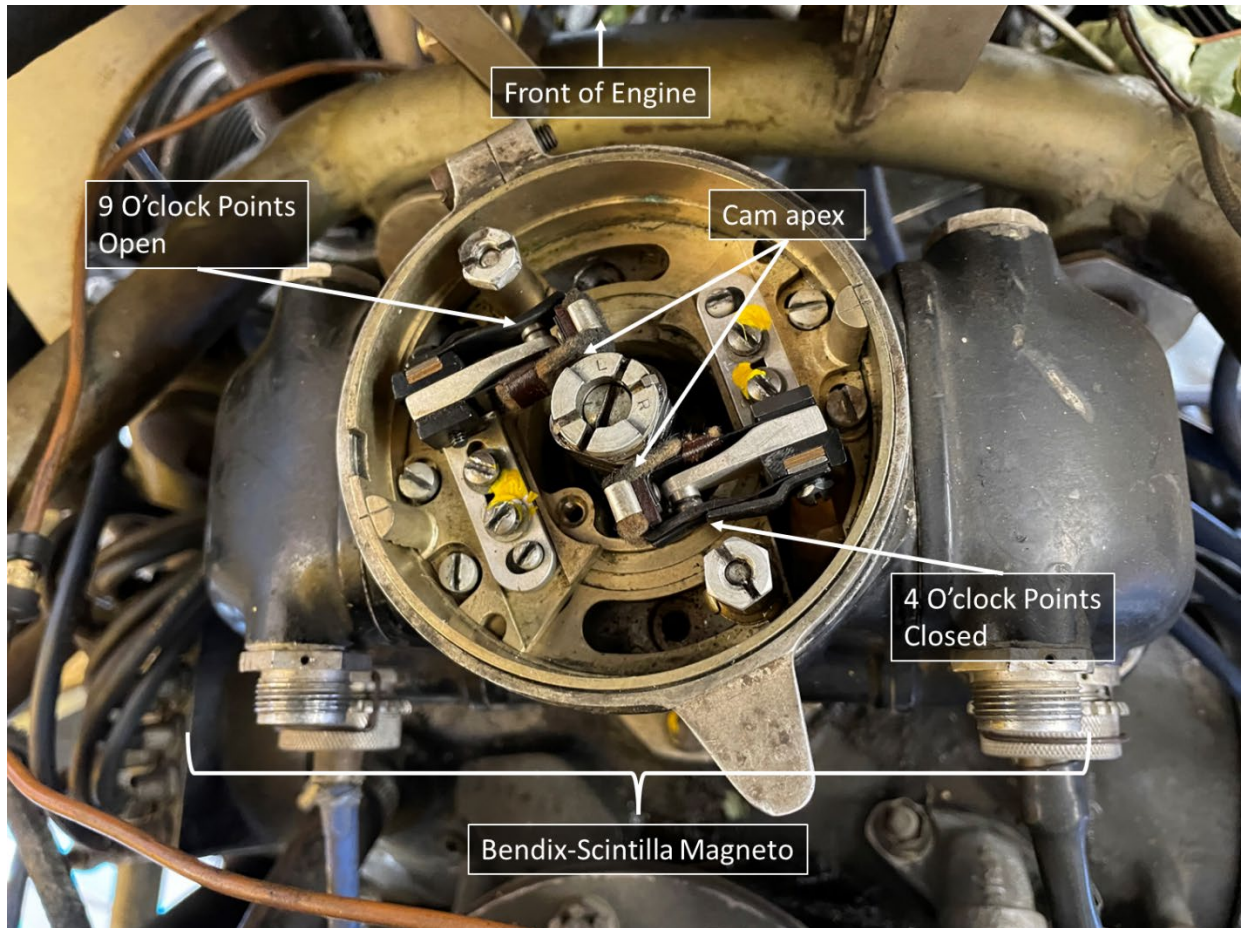
Figure 8. Top of magneto, showing the two sets of points.

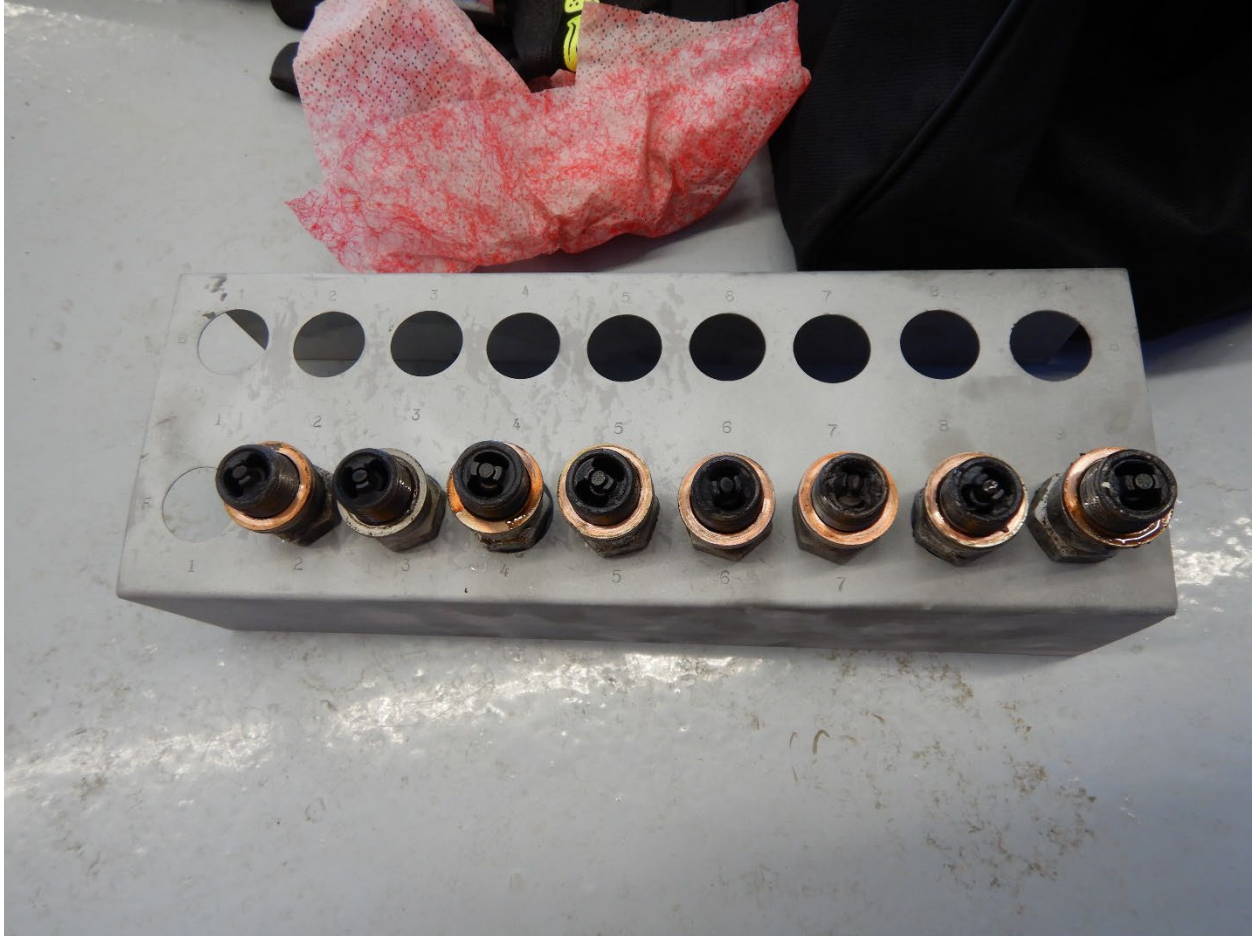
- Removed the front and back spark plugs. Some of the lower spark plugs had a wet oil-soaked appearance. All others looked normal.

Figure 9. Front spark plugs.

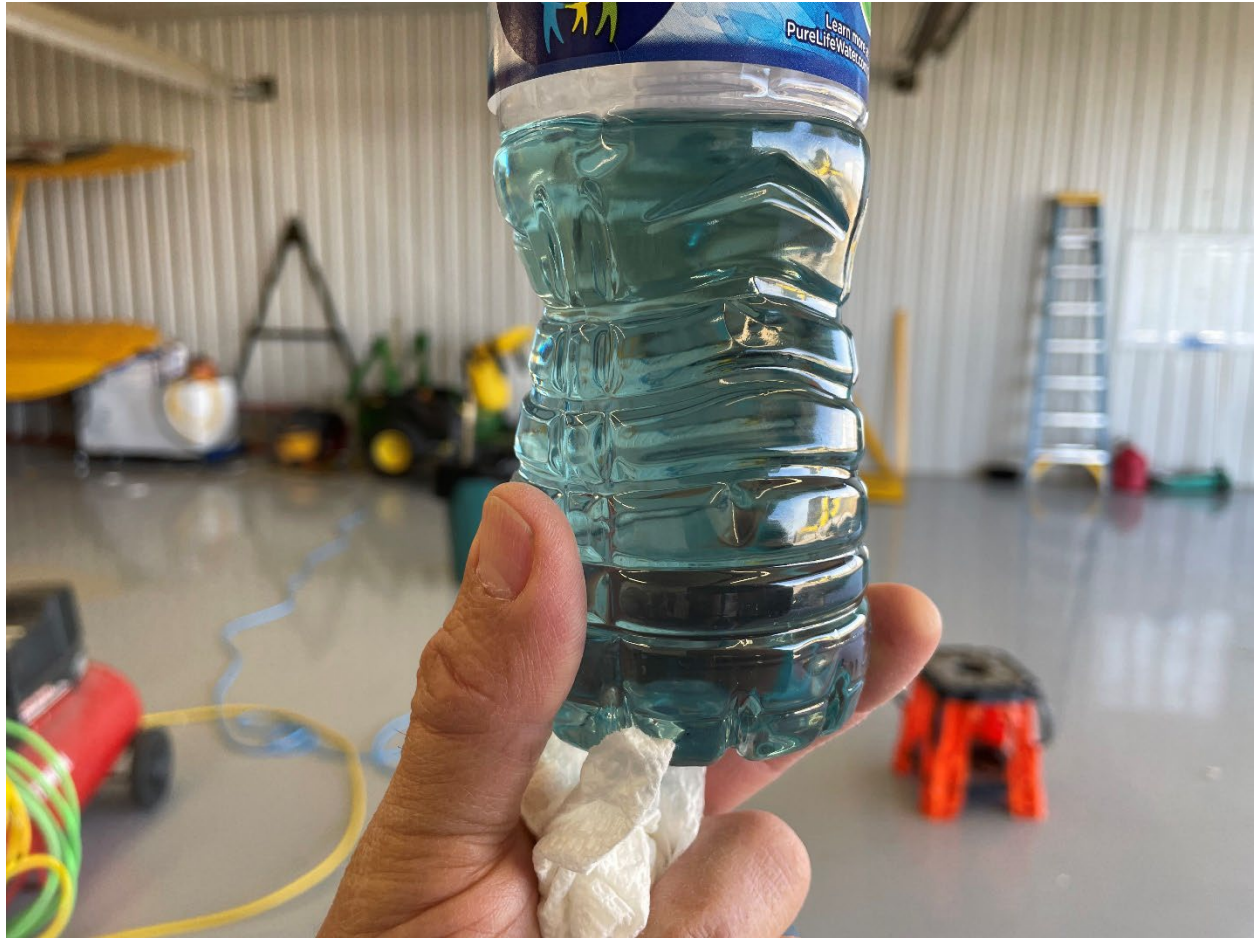
- Removed the air filter. Air filter was unobstructed.
- Drained about 1 pint of fuel from the gascolator. Fuel was clean, bright, and contained no contaminants.

Figure 10. Fuel sample taken from the gascolator.

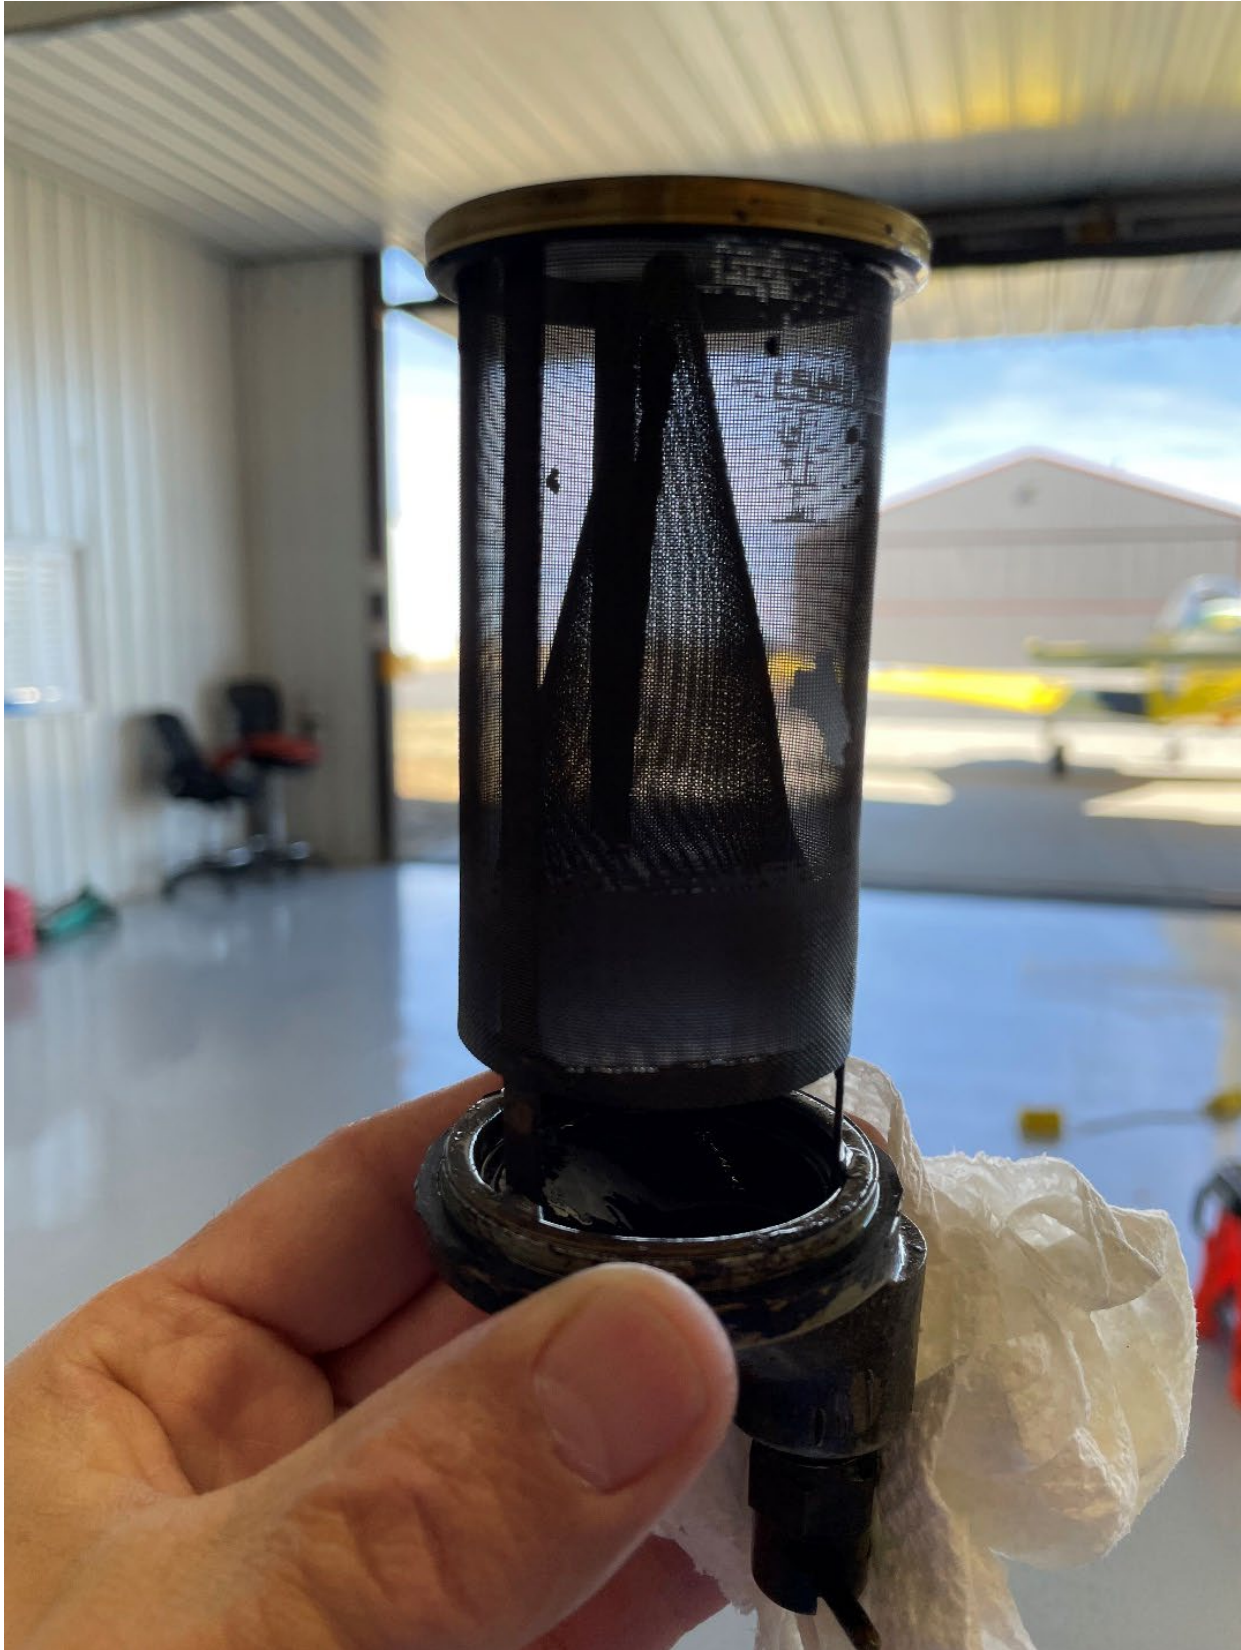
- Gas screen was clear and unobstructed.
- Rotated engine by the starter and checked for spark from front and back leads. No spark was observed on front and rear leads.

Figure 11. Gascolator fuel screen.

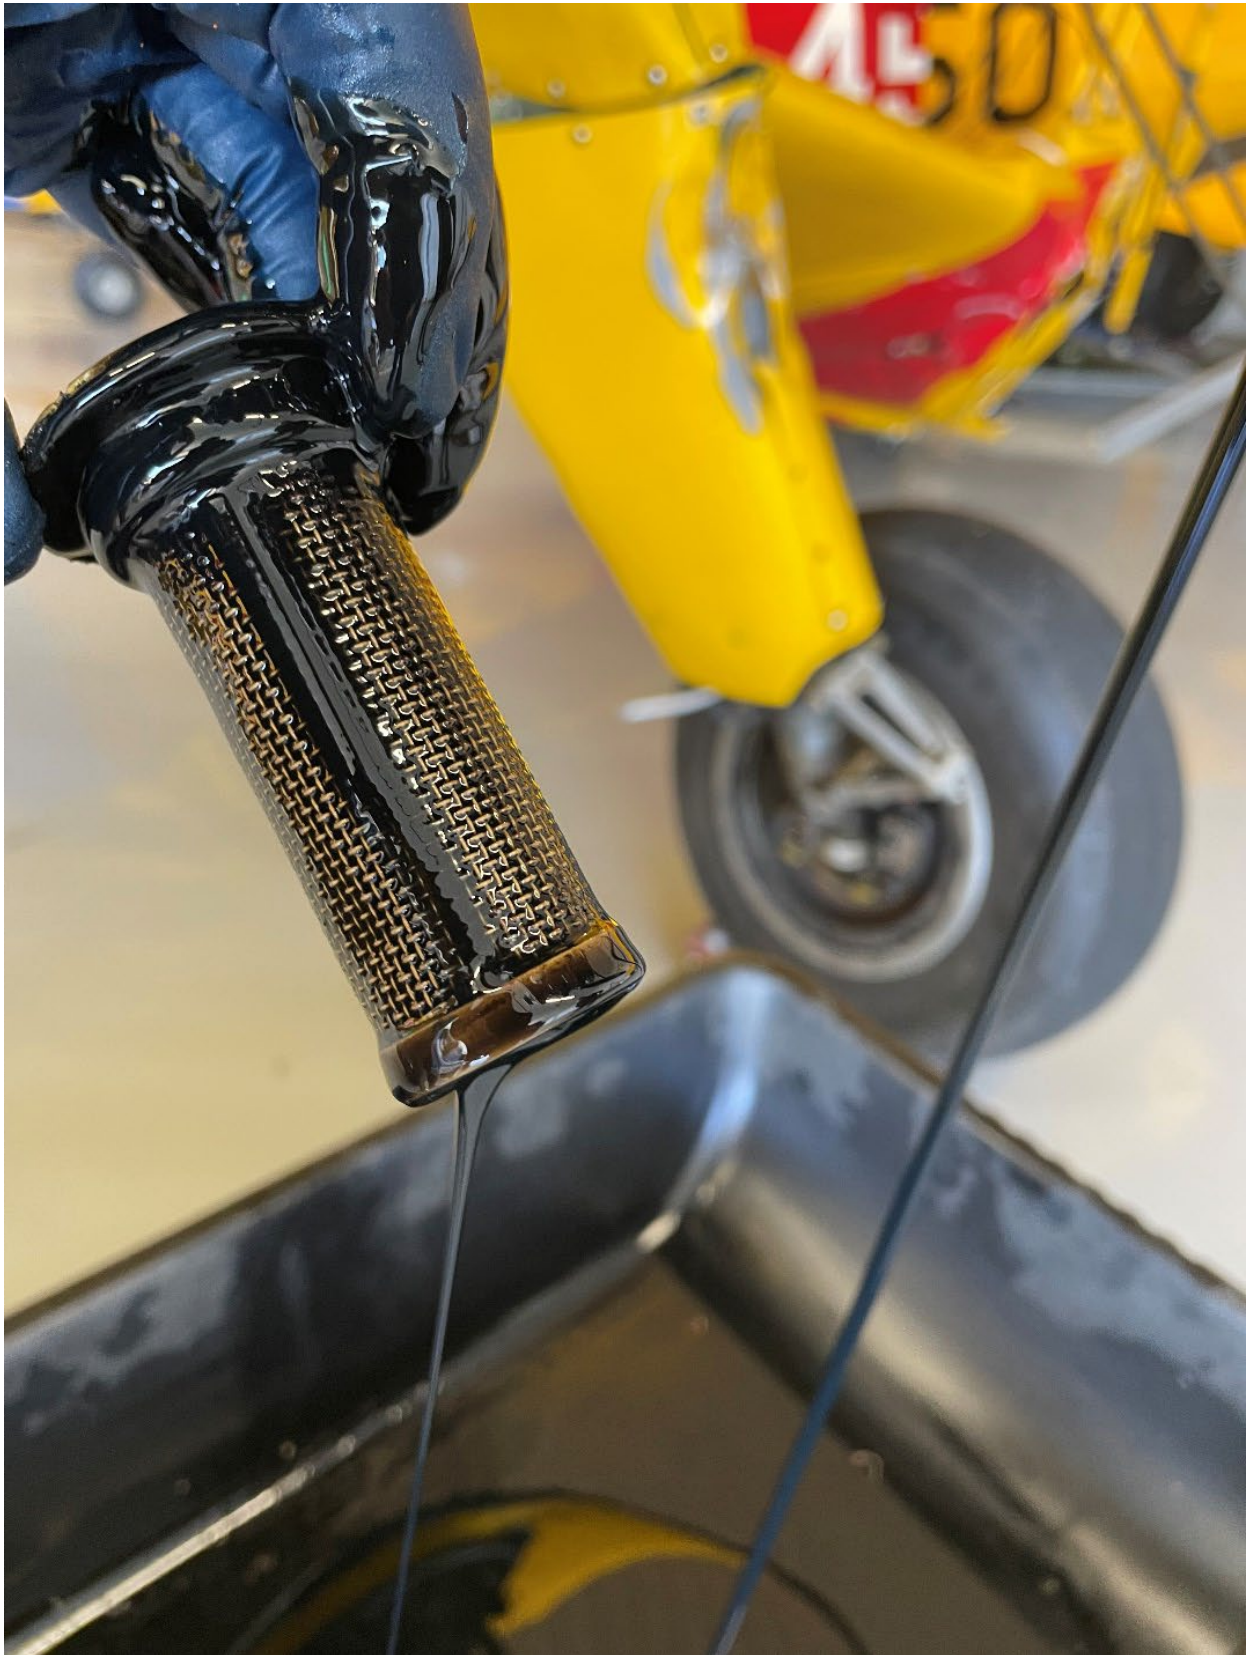
- Checked for thumb force compression on all cylinders. All cylinders had thumb force compression.
- Drained oil screen. Oil was dark but contained no metal or contaminants. Oil screen was clear and unobstructed.

Figure 12. Oil sump filter screen.

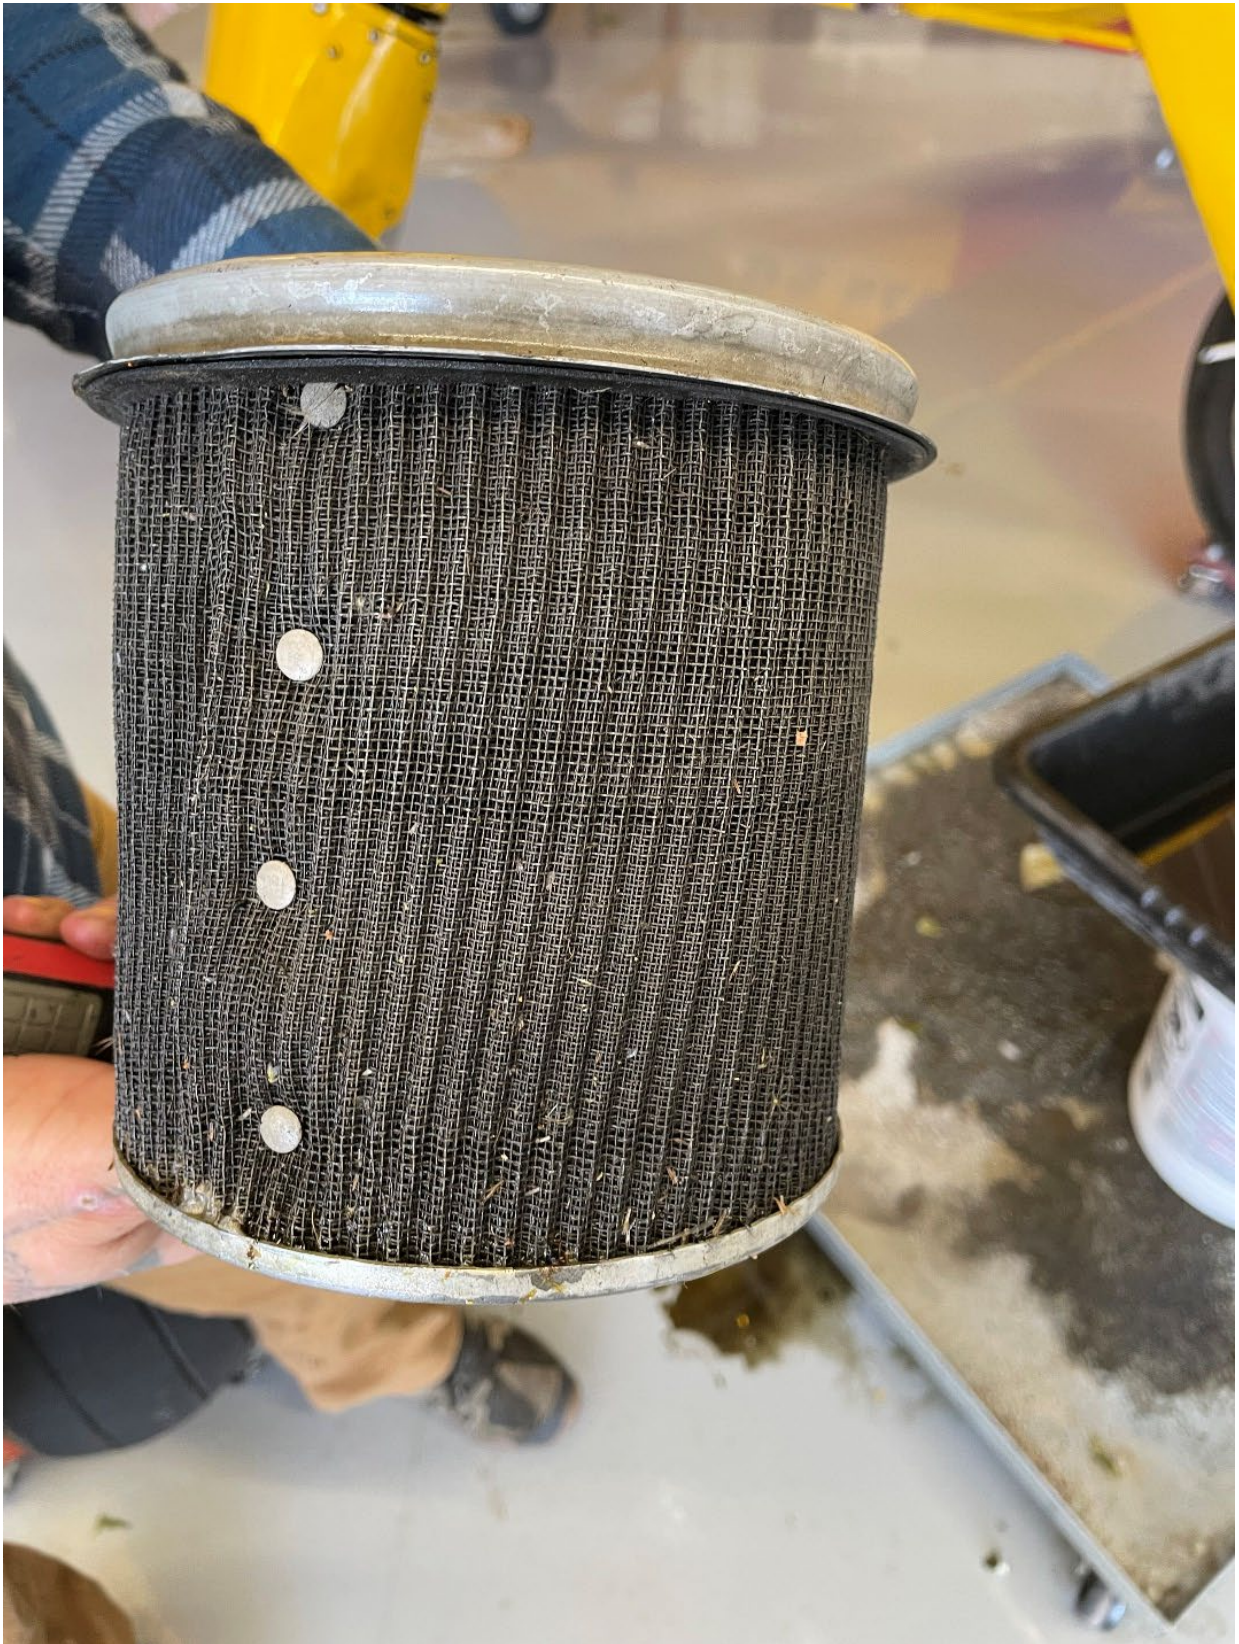
Figure 13. Air filter screen.

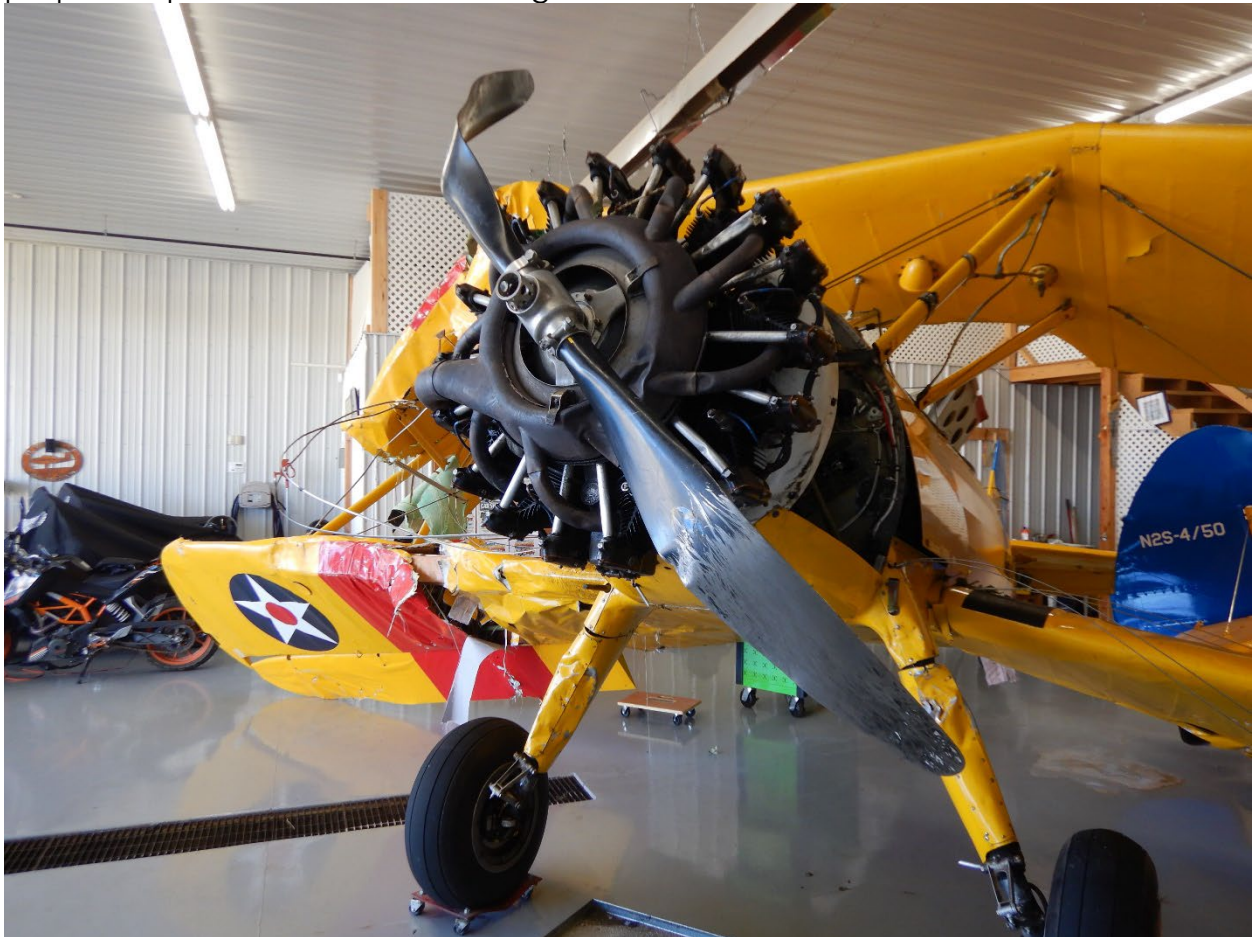
According to the pilot, most of the propeller damage was due to the recovery efforts. The two-blade aluminum propeller exhibited damage to both propeller blades. One blade exhibited spanwise striations and aft chord-wise bending about mid-span. The other blade exhibited aft, chord-wise bending and span-wise striations. Both propeller tips exhibited minor damage.

Figure 14. Propeller.
