HMD23LR001

HAZARDOUS MATERIALS GROUP ATTACHMENT

Lucid Motors Battery Examination Results

Lucid Battery Testing Protocol NTSB Investigation HMD23LR002

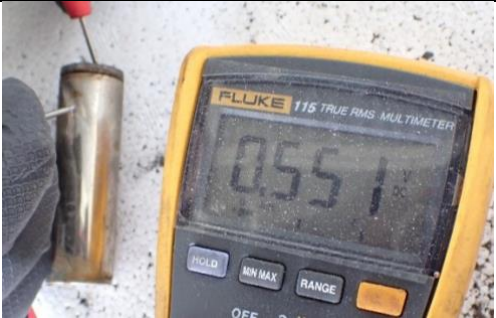
0	no damage – cell has voltage and no visible defects

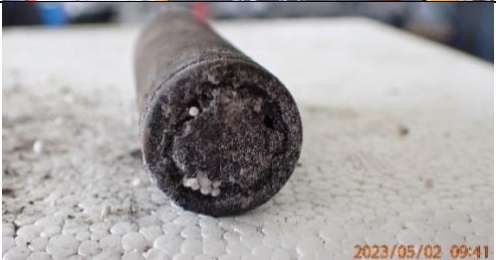
1	top cap intact – cell has no voltage and minor visible defects

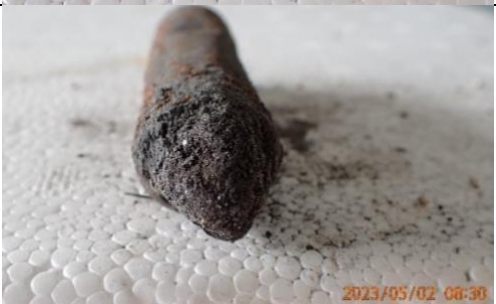
2	partial jellyroll ejection – cell has no voltage and jellyroll has partially ejected from one end of the cell

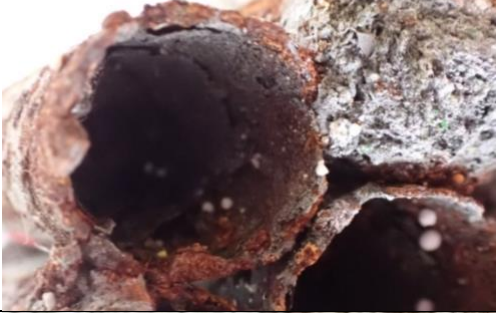
3	full jellyroll ejection – cell has no voltage as entire jellyroll has ejected outside the can

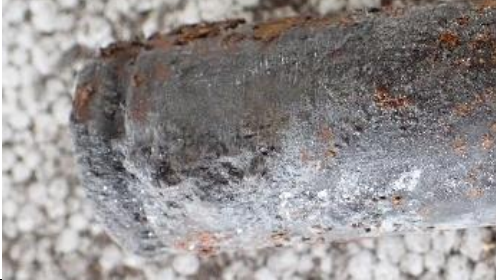
4	small side rupture – cell has no voltage, and the side of the battery cell can has ruptured. Identified with a small crack along the battery cell can.

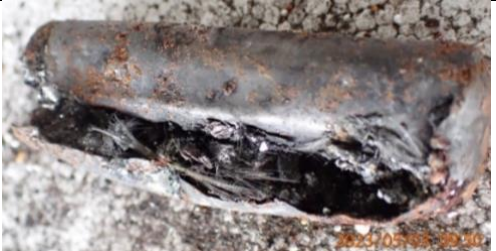
5	large side rupture - cell has no voltage, and the side of the battery cell can has ruptured. Identified with a large crack along the battery cell can.	Not seen during inspection
6	can open – cell has no voltage and entire side of battery cell has ruptured open. Jellyroll can be seen.

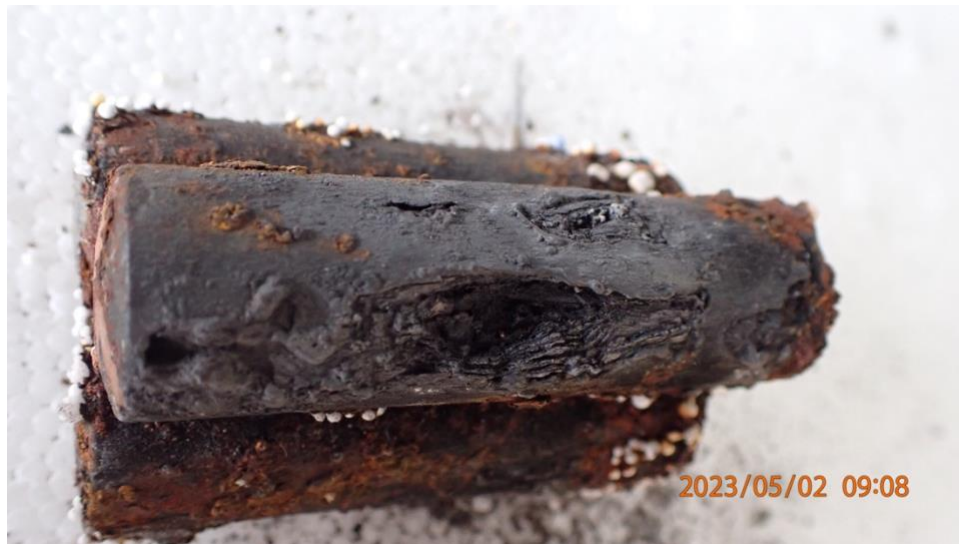
- Across all sampled cells, there were two cells with residual voltage left, both slightly $> 0.6V$; these cells had CID (Current Interrupt Device) activation.
- A metal ring, suspected to be foreign to the packs, was found in the barrels.
- There were fourteen unbreakable clusters among all sampled cells.
- One half-module was found with the module plastic, PCBA, and cells mostly intact.
- Two cells out of all sampled cells were potential candidates for evidence of high voltage arcing, based on the size of the holes on the cells. They were cell 35 (upper) and cell 270 (lower). Please see the pictures below.

Figure 1 – Sampled Cell #35 – Potential Candidate of High Voltage Arcing

Compared to cell 35 of the incident, this cell from the previous arc-initiated test had a less defined cell opening and more binding between the steel can body and the unburned jellyroll inside.

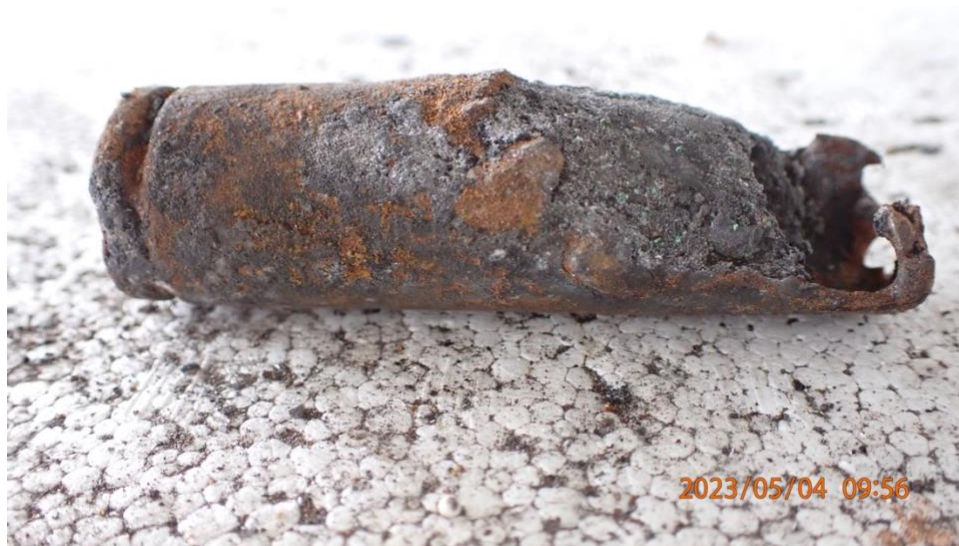
Figure 2 – Sampled Cell #270 – Potential Candidate of High Voltage Arcing

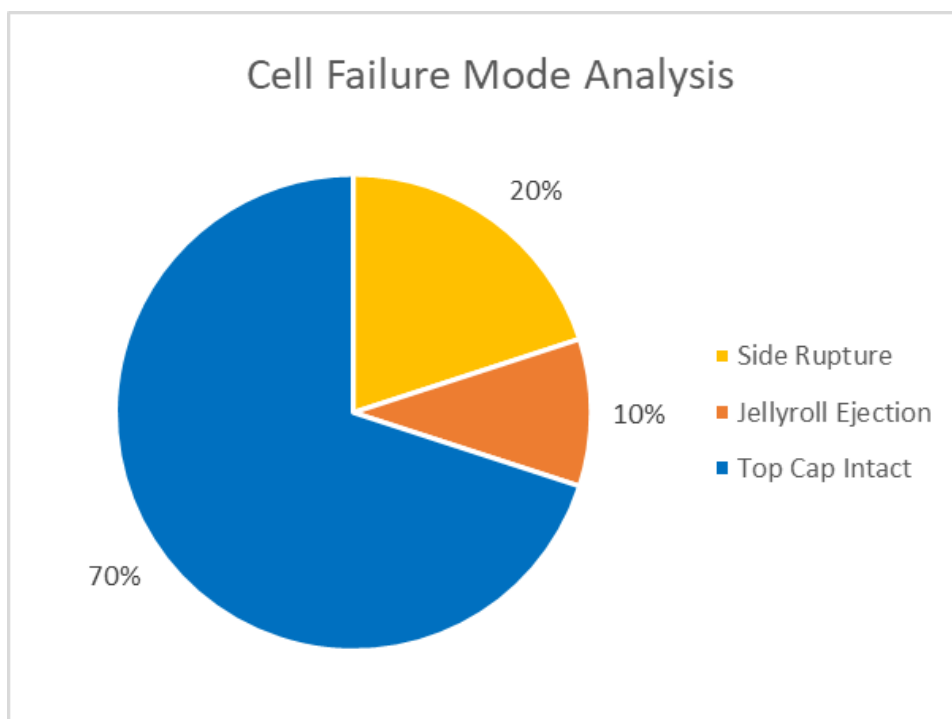
Table 3: Propagation Test Damage Intensity Distribution

Below is the module level test cell failure mode pie chart. The trial (sample size: one every three cells) that has the most “Top Cap Intact” failure mode was chosen to find similarity between the previous test and the incident. Comparison of Table 3, below, to Table 2, above, shows the test trial had a much higher percentage of side rupture cells (20%) than the incident (1.75%).

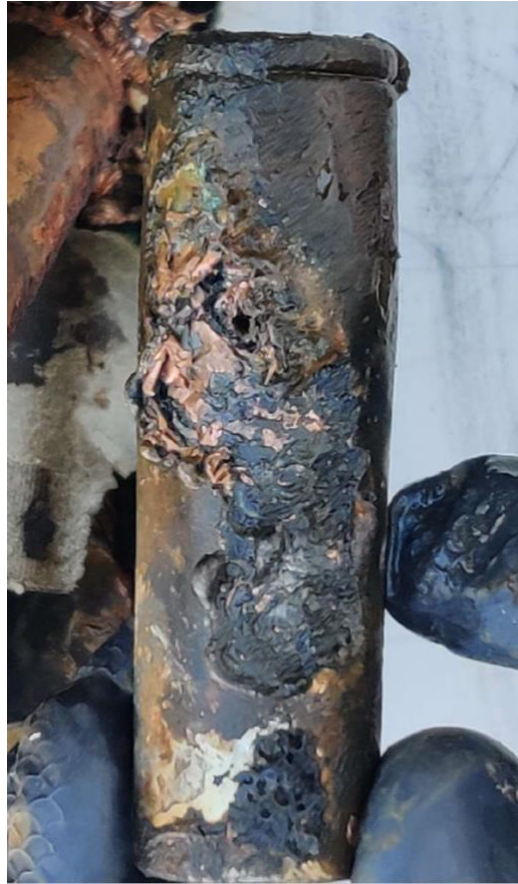
Lucid had also performed a pack level thermal runaway test initiated by high voltage arcing. Figure 3 below shows the picture of a cell impacted by high voltage arcing. There is clearly melted steel can material deposited on the cell can body.

Figure 3 - Arc-Initiated Test Cell - not seen in incident - shown for reference
