Basic Factual Information  
SPIRIT OF NORFOLK Fire and Subsequent Total Loss

*SPIRIT OF NORFOLK Fifth District Formal Investigation  
USCG Public Hearing*

CG 001

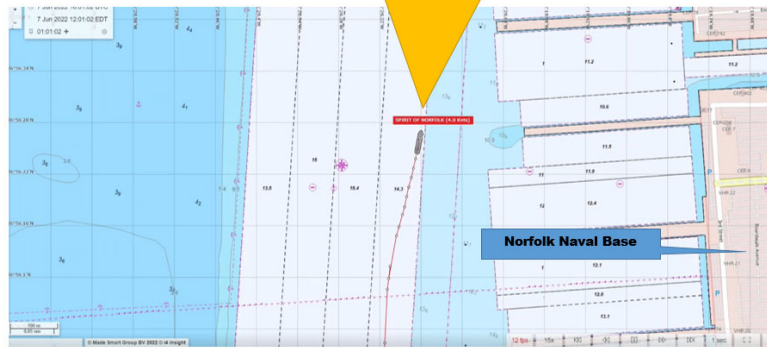
12:01 pm, June 7, 2022

When attempting to reengage the port main engine, the starboard engine was lost. Port engine and Starboard engine lost connection to the alarm panel and throttles became inoperable, vessel had lost propulsion control.

At approximately 12:01 pm, Eastern Standard Time the engine control module in the SPIRIT OF NORFOLK alarmed, indicating loss of communications with the port main engine. The Captain began to investigate the cause of the loss of engine control. These activities resulted in the detection of a fire in the engine room by crew who had to open the engine room watertight door to determine if there was a fire. The vessel was not required, by regulation, to be fitted with a fire detection or fixed fire suppression system in the engine room.

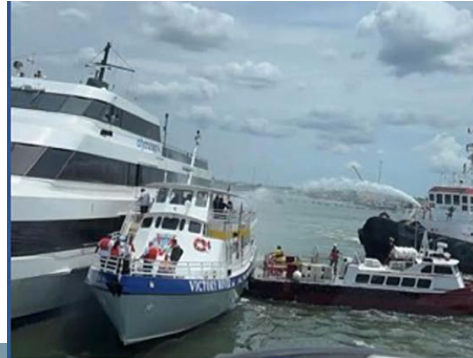
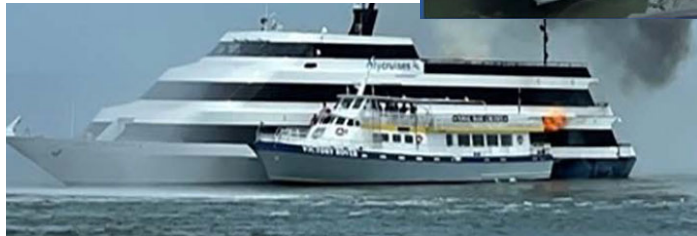
**VICTORY ROVER**  
Passenger  
Evacuation

The excursion vessel VICTORY ROVER was in the general vicinity of the emergency and immediately proceeded to the SPIRIT OF NORFOLK. The SPIRIT OF NORFOLK had a large boarding area on the main deck on the port side and the VICTORY ROVER maneuvered alongside to position the vessel to take the crew and passengers of the SPIRIT OF NORFOLK aboard. During the evacuation of passengers two vessels positioned themselves to make sure the two vessels stayed close together for the safety of the transfer of personnel.

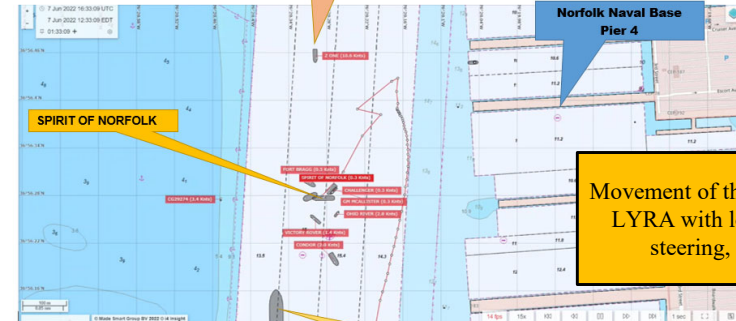
12:33 pm, June 7, 2022

MV SPAR LYRA approaching the area. Engine stopped, 20-degree starboard rudder ordered to swing stern clear of vessel activities and to pass clear of response activities.

About the time the fire event was unfolding the SPAR LYRA a loaded bulk carrier departed the International Terminal headed to sea. At 1233 the vessel was approaching the area of the response to the SPIRIT OF NORFOLK and when maneuvering the vessel lost electrical power, propulsion and steering. The vessel took immediate action to pass the response site and approximately 6 minutes later regained propulsion. Several of the tugs assisting with the response were dispatched to render assistance to the SPAR LYRA and two tugs actually made fast to control the ship's movements.

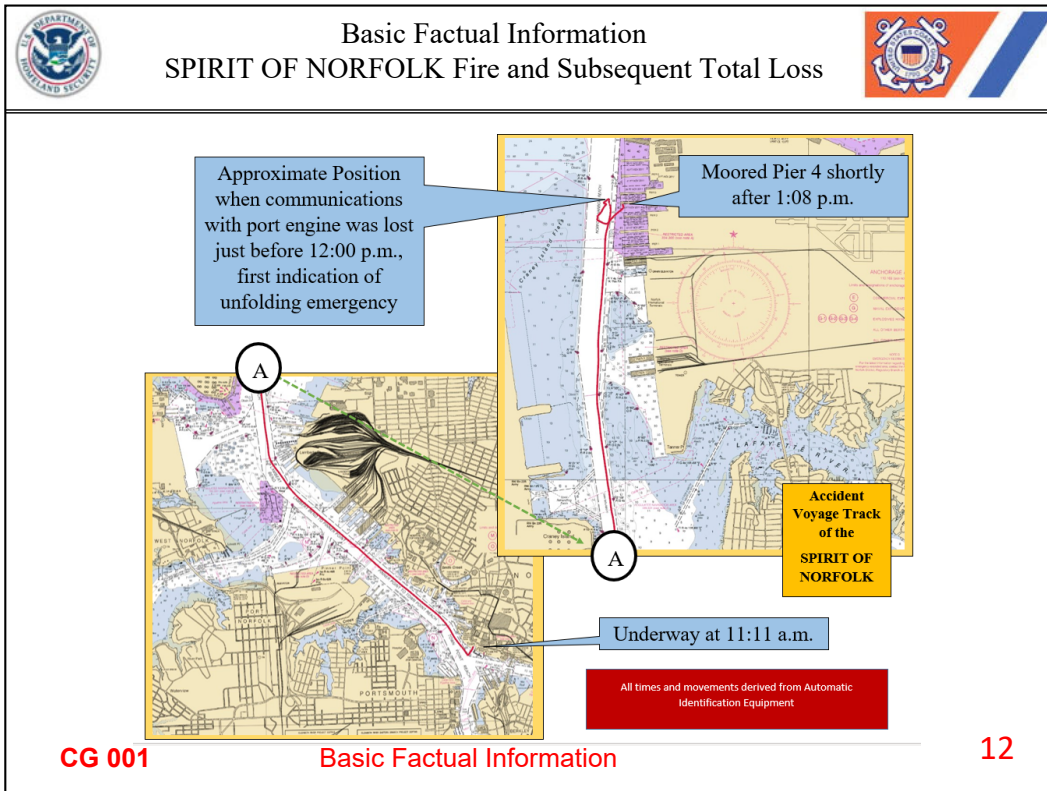
In this slide we see the voyage track of the SPIRIT OF NORFOLK on June 7, 2022. The vessel departs the Norfolk Virginia waterfront and proceeds north on the Elizabeth River towards the Norfolk Naval Base. The vessel then turns and begins the run back along the docks towards the planned destination at the Norfolk waterfront. Shortly after beginning the turn the Captain hears and alarm indicating a loss of communications to the port engine. Shortly after that the crew identifies a fire in the engine room and notifies the Coast Guard. Responding vessels evacuate the passengers and crew, fight the fire and maneuver the SPIRIT OF NORFOLK to Pier 4 at the Norfolk Naval Base.

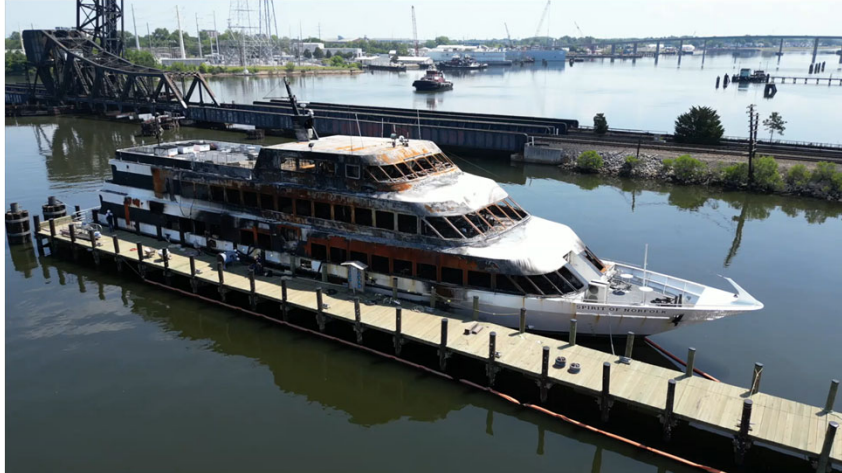
## Fire Damaged SPIRIT OF NORFOLK

In this slide, drone video footage created by the Coast Guard's Fifth District Public Affairs office, shows the overall extent of the fire damage to the exterior of the small passenger vessel SPIRIT OF NORFOLK.
