NATIONAL TRANSPORTATION SAFETY BOARD
Office of Aviation Safety
Washington, D.C. 20594

POWERPLANT GROUP CHAIRMAN'S FACTUAL REPORT

NTSB No: DCA17FA021

Aircraft: American Airlines, Boeing 767-323, registration number N345AN, flight number 383

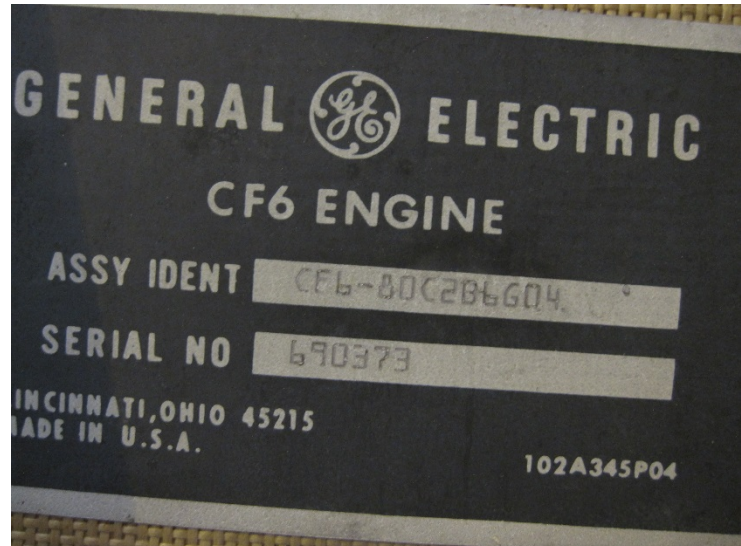
PHOTO 1: RIGHT ENGINE DATA PLATE

The right engine installed on the accident airplane was a General Electric (GE) CF6-80C2B6 turbofan engine, engine serial number (ESN) 690-373 (**PHOTO 1**). At the time of the accident, ESN 690-373 had accumulated 68,785 hours time since new (TSN), 10,984 cycles since new (CSN), 19,139 hours time since last shop visit (TSLSV), and 3,057 cycles since last shop visit (CSLSV). The last engine shop visit occurred in January 2011 at the AA engine maintenance facility in Tulsa, Oklahoma. With rare exception, all AA CF6-80C2 engine shop visits occurred at the Tulsa maintenance facility.

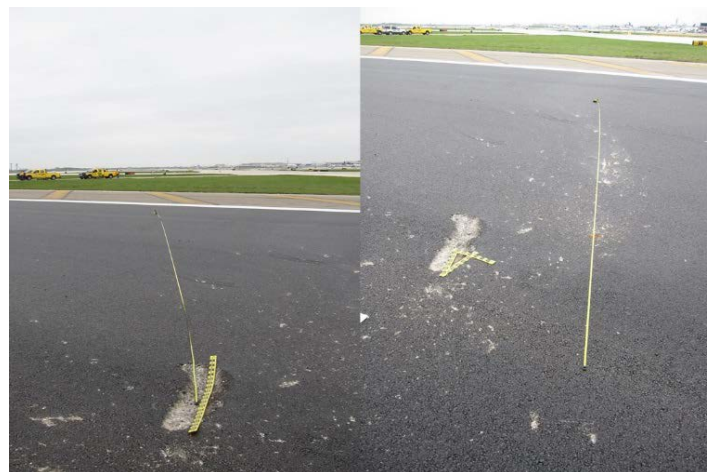
PHOTO 5: GENERAL DIRECTION OF GROUND IMPACT AND RECOVERED FRAGMENTS

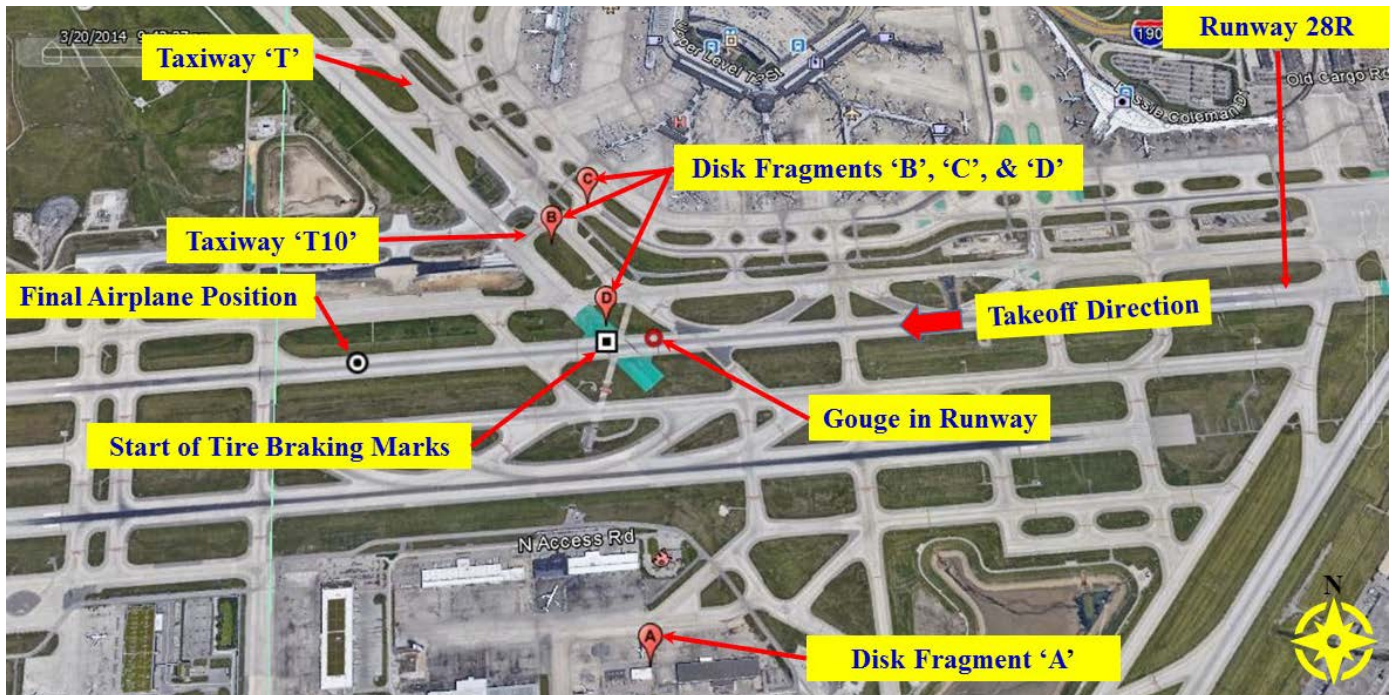
FIGURE 6: RECOVERED HIGH PRESSURE TURBINE STAGE 2 DISK FRAGMENT LOCATIONS

Three HPT stage 2 disk fragments (arbitrarily labeled as 'B' 'C' and 'D') were found during the search of the 28R runway and surrounding area. One HPT stage 2 disk fragment (arbitrarily labeled as 'A') penetrated through the roof of the UPS cargo facility south of runway 28R-10L (still on the airport property), about 2,935 feet (See **FIGURE 6**) from where the engine failure occurred (initial ground scar/gouge). AA personnel recovered fragment 'A' before the investigative group had arrived on scene. Fragment 'A' is thought to have penetrated through the inboard right wing and remained airborne until it struck and penetrated through the roof of the UPS building. Fragments 'B', 'C' and 'D' were recovered north of runway 28R at distance of 1,365-feet, 1,500-feet, and 475-feet from the initial ground scar/gouge respectively.

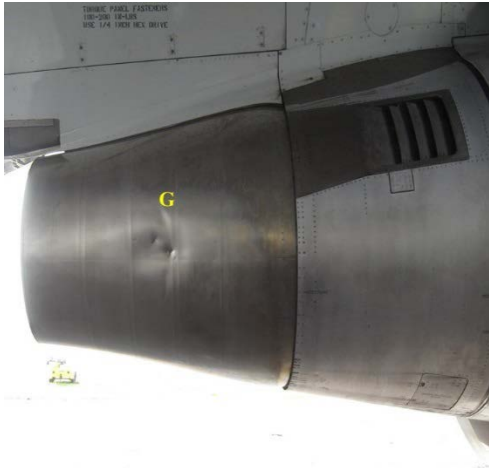
Examination of the left engine, No. 1, revealed small fragment impact marks along the inboard nacelle (**PHOTOS 6 and 7**); 2 impact marks in the fan cowl, 4 in the TR translating sleeve, 2 in the TR inner wall, and 1 in the core exhaust nozzle. The impact marks were arbitrarily labeled to facilitate documentation. **TABLE 2** provides the impact damage locations and descriptions; locations in red are those that were penetration thru-holes in the cowling structure.

PHOTO 6: EXHAUST NOZZLE DAMAGE

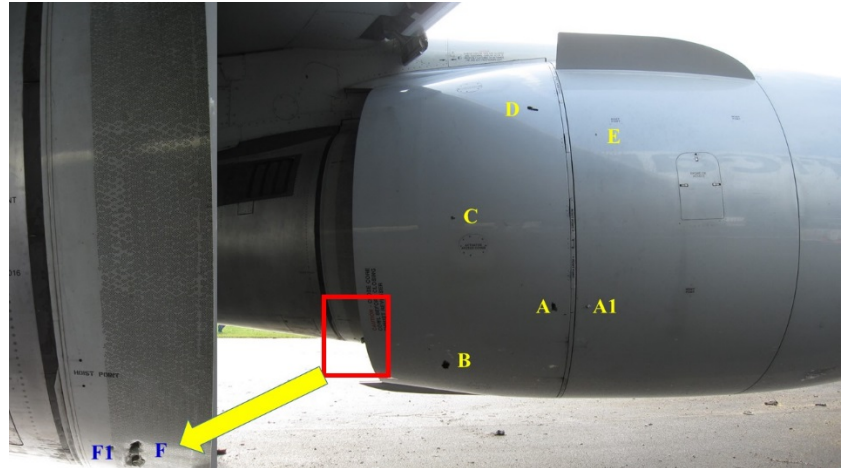
PHOTO 7: DAMAGE FAN COWL, TR, AND CORE COWL

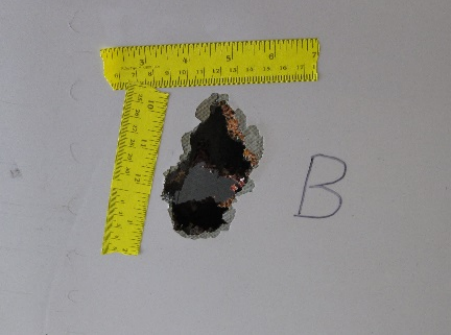
TABLE 2: LEFT ENGINE NACELLE DAMAGE DOCUMENTATION					PHOTOS
IDENTIFIER	COWL	LOCATION	IMPACT/HOLE DIMENSIONS	TYPE OF IMPACT	
B (PHOTO 9)	TR Transcowl	5:00 o'clock 31-inches aft of the transcowl LE and 42-inches circumferential from the TR split line at the 6:00 o'clock position	2.25-inches axial x 4.25-inches circumferential	A pass-thru penetration – in line with a blade fragment imbedded in the TR lower bifurcation side wall

<p>PHOTO 9: BLADE FRAGMENT THRU-HOLE 'B' (OUTBOARD)</p>
B (fan flow path side) (PHOTO 10)	TR Transcowl	5:00 o'clock 31-inches aft of the transcowl LE	2.25-inches axial x 1.00-inches circumferential	Puncture thru-hole

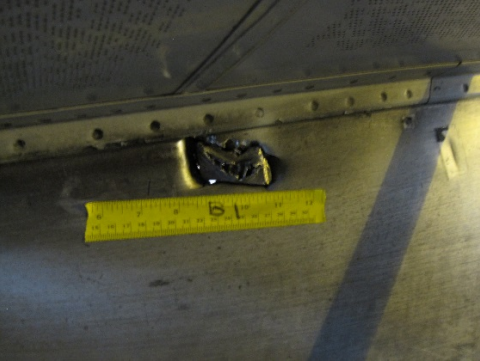
<p>PHOTO 10: BLADE FRAGMENT THRU-HOLE 'B'(INBOARD)</p>
B1 (PHOTOS 11 and 12)	TR Lower Bifurcation Side Wall	6:00 o'clock	3.0-inches axial x 1.25-inches radially Blade fragment weighed 5.455 ounces	HPT stage 2 blade fragment embedded in the structure

<p>PHOTO 11: HPT STAGE 2 BLADE FRAGMENT EMBEDDED IN BIFURCATION PANEL (OUTBOARD)</p>

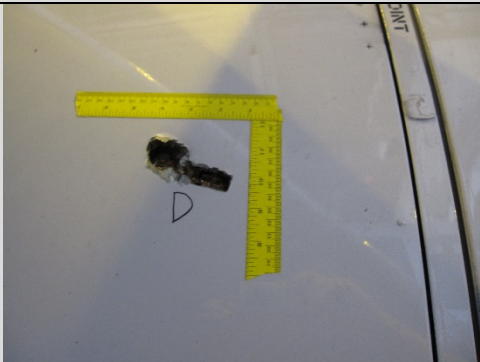
TABLE 2: LEFT ENGINE NACELLE DAMAGE DOCUMENTATION					PHOTOS
IDENTIFIER	COWL	LOCATION	IMPACT/HOLE DIMENSIONS	TYPE OF IMPACT	
D (PHOTO 15)	TR Transcowl	2:00 o'clock 5.75-inches aft of transcowl LE and 65-inches circumferential below the chine	3.0-inches axial x 1.75-inches circumferential	Puncture of outer panel but not through blocker door

<p style="text-align: center;">PHOTO 15: IMPACT DAMAGE 'D' (OUTBOARD)</p>
E (PHOTO 16)	Fan Cowl	2:30 o'clock 6.875-inches forward of fan cowl TE and 28- inches circumferential below the chine	0.5-inches axial x 0.75-inches circumferential	Puncture of outer skin but not a thru-hole

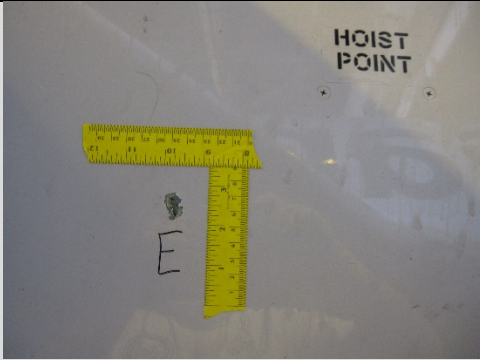
<p style="text-align: center;">PHOTO 16: IMPACT DAMAGE 'E' (OUTBOARD)</p>
F (PHOTO 17)	TR Inner Wall	5:30 o'clock 7.5-inches forward of TR inner wall TE and 13-inches to the bottom of the lower impact and 19- inches to the top of the upper impact circumferential from the TR lower centerline	2.5-inches axial x 7.25-inches circumferential	Puncture thru-hole

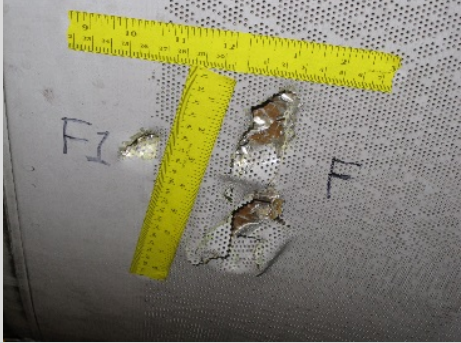
<p style="text-align: center;">PHOTO 17: IMPACTS 'F' AND 'F1' - 'F' THRU-HOLE (OUTBOARD)</p>

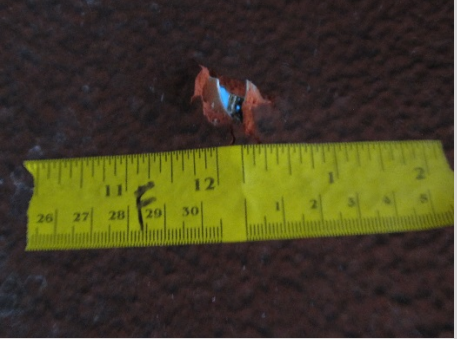
TABLE 2: LEFT ENGINE NACELLE DAMAGE DOCUMENTATION					PHOTOS
IDENTIFIER	COWL	LOCATION	IMPACT/HOLE DIMENSIONS	TYPE OF IMPACT	
F (core compartment side) (PHOTO 18)	TR Inner Wall	5:30 o'clock 7.5-inches forward of TR inner wall TE	0.75-inches axial x 0.75-inches circumferential	Puncture thru-hole

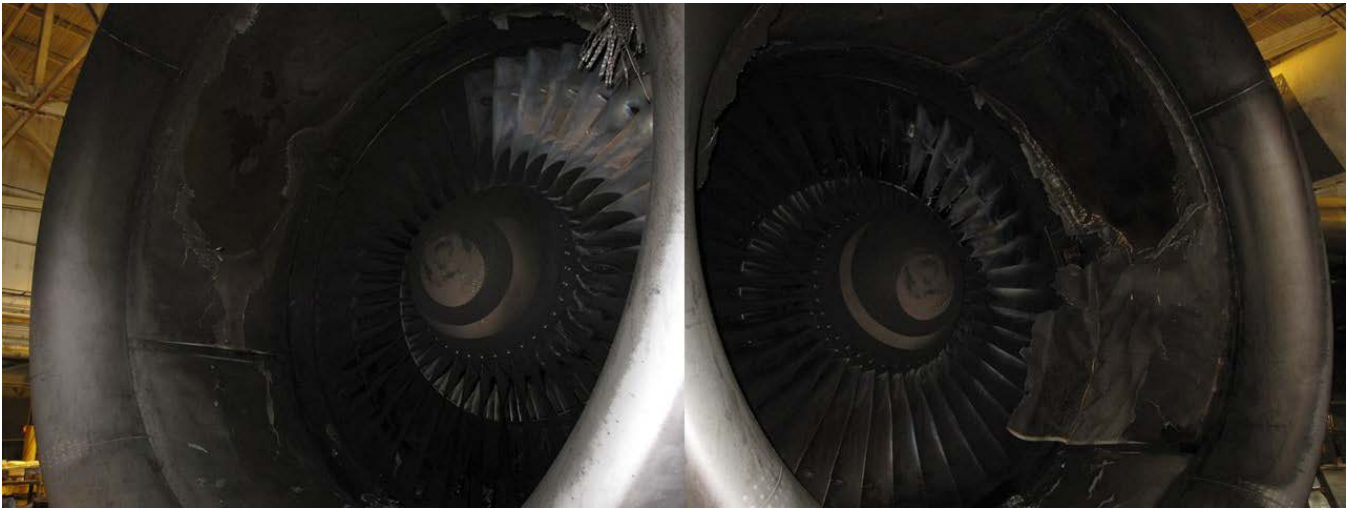
The inlet cowl inner barrel (airflow area) exhibited evidence of thermal distress and was blackened and sooted. The upper section of the inner barrel from 7:30 to 3:30 o'clock position exhibited missing outer perforated acoustic liner skin. The first layer of the honeycomb ply beneath the acoustic liner outer skin from the 9:00 to 3:00 o'clock (180° arc) was missing. In this same 180° arc, the second layer of honeycomb was cracked, buckled, and exhibited thermal distress. The lower section of the inner barrel from the 3:30 to 7:30 o'clock exhibited thermal distress, was blackened and sooted, but the perforated acoustic liner skin remained intact (**PHOTO 20**).

PHOTO 20: INLET COWL DAMAGE – MISSING ACOUSTIC LINER AND DAMAGED HONEYCOMB

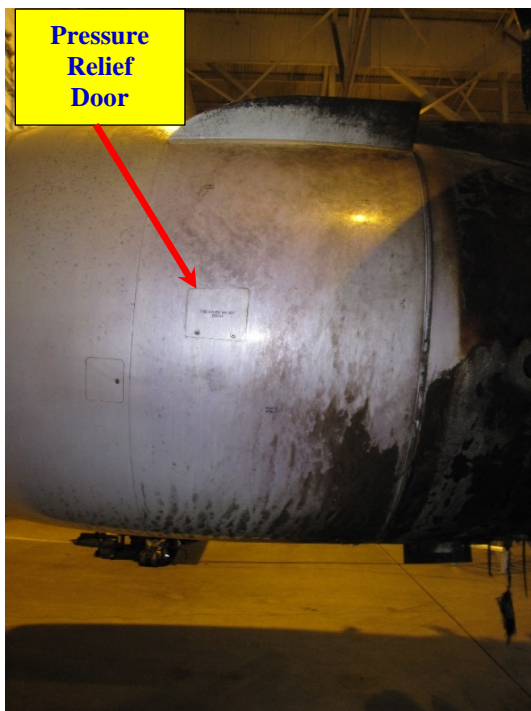
Both inboard (left side) and outboard (right side) fan cowls were intact and sooted on their external surfaces. The inboard fan cowl had significant thermal distress on the aft portion between the 6:00 to 7:30 clock position; the skin was charred, paint bubbled, and had lost its structural integrity. The pressure relief door, which is located on the inboard cowl, was secured and latched (**PHOTO 21**). The inboard chine was intact and sooted on most of its surface. The outboard fan cowl exhibited thermal distress centered on the aft area of the cowl between the 3:00 to 6:00 o'clock position; the skin was charred, the paint bubbled, and from the 4:00 to 5:00 o'clock position, the skin had delaminated and lost its structural integrity (**PHOTO 22**). The oil access door, which is located on the outboard cowl, was secured and latched. All three fan cowl latches were in the CLOSED and LOCKED (latched) position.

PHOTO 21: INBOARD FAN COWL

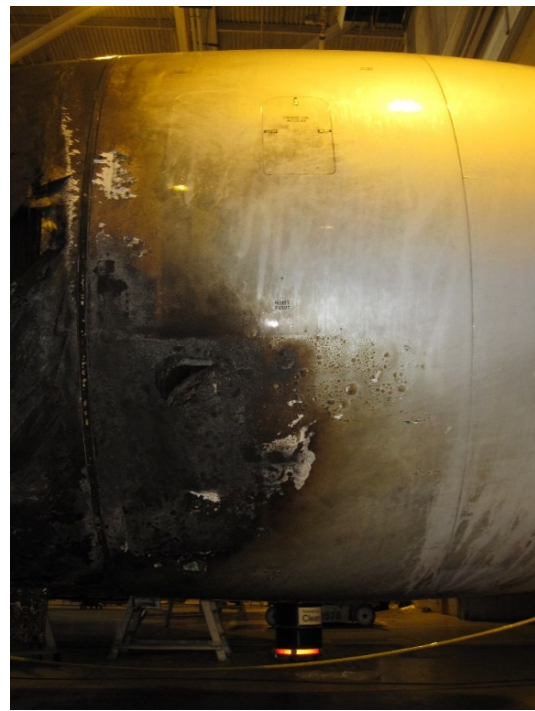
PHOTO 22: OUTBOARD FAN COWL

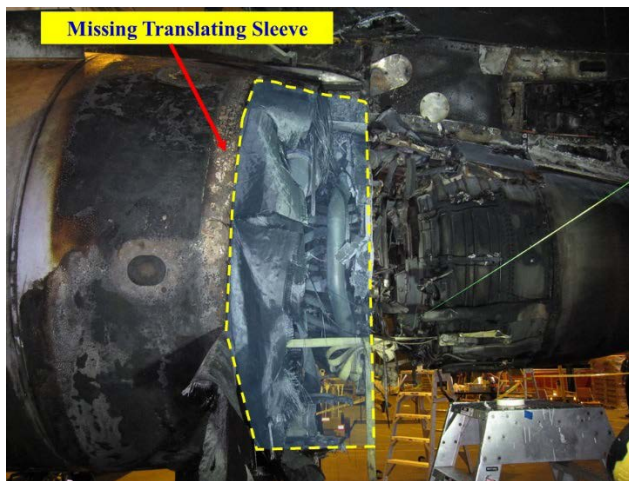
The TR translating sleeve was heavily sooted and exhibited significant thermal distress consisting of delamination to the extent that multiple graphite plies were exposed below the fiberglass nomex exterior. Approximately the aft 15-inches of both the inboard and outboard translating sleeves were missing/consumed from the pylon down to lower bifurcation panel. The TR inner wall was missing an approximately 16-inch axial section from the 3:00 o'clock position to the pylon. The remaining intact inner wall was significantly thermally distressed and delaminated (**PHOTOS 23** and **24**). All three TR latches were in the CLOSED and LOCKED (latched) position.

**PHOTO 23: INBOARD TRANSCOWL SLEEVE
DAMAGE**

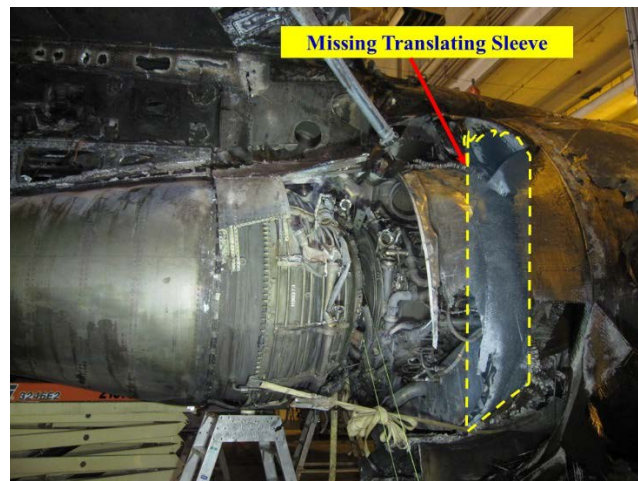
**PHOTO 24: OUTBOARD TRANSCOWL SLEEVE
DAMAGE**

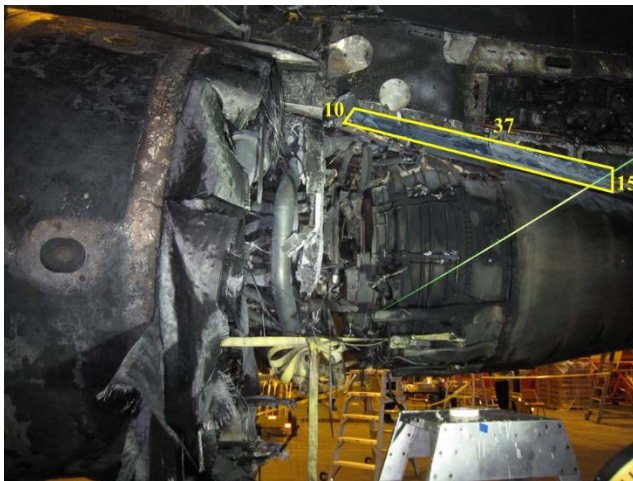
Much of the inboard core cowl was missing, with only a small portion of the cowl remaining intact and still attached to the upper hinge fittings. The remaining inboard core cowl was pie-shaped and measured 10-inches circumferentially at the forward end, 15-inches circumferentially at the rear end and the overall length was 37-inches (**PHOTO 25**).

PHOTO 25: INBOARD CORE COWL DAMAGE

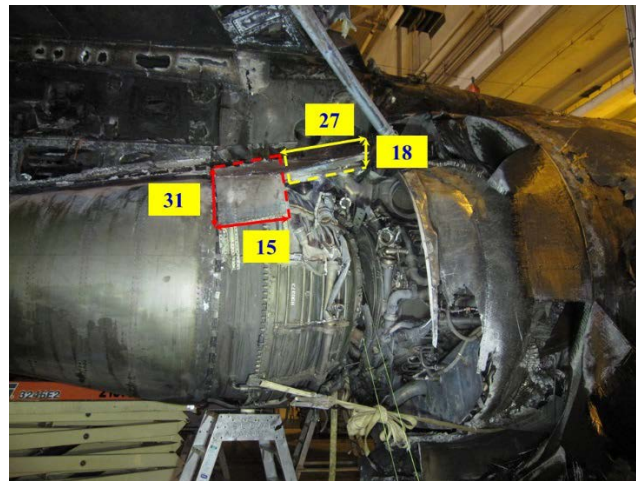
Much of the outboard cowling was also missing with only a small portion of the cowling remaining intact and attached to the upper hinge fittings; the remaining piece was 'L'-shaped and measured as follows: forward piece measured 18-inches circumferentially by 27-inches axial and the rear piece measured 31-inches circumferentially by 15-inches axially (**PHOTO 26**).

PHOTO 26: OUTBOARD CORE COWL DAMAGE

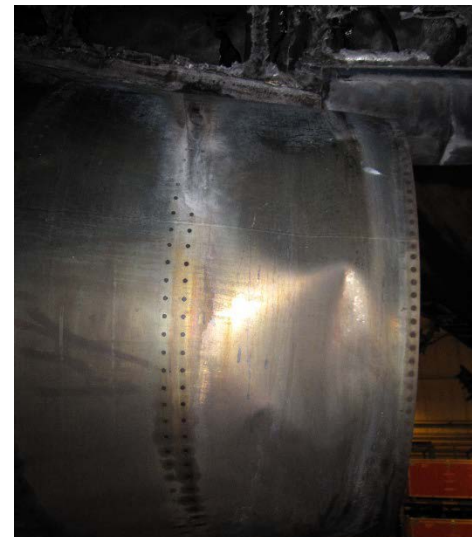
The core exhaust nozzle was intact; the aft part of the nozzle was buckled from about the 6:00 to 3:00 o'clock position (**PHOTO 27**) and impact damaged at about the 5:00 o'clock position near the forward edge. All the bolts that secure it to the TRF outer flange were in place, secured, and intact. The aft centerbody was intact, secure, and all the centerbody-to-TRF bolts were intact and in place.

PHOTO 27: BUCKLED CORE EXHAUST NOZZLE

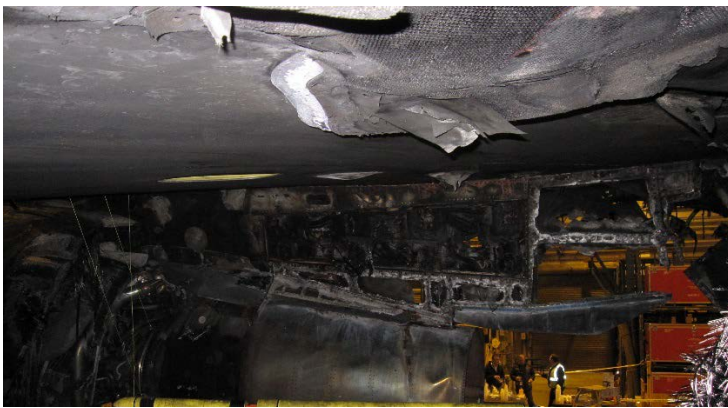
FIGURE 7 provides the nomenclature and location of strut/pylon components. This section documents the external damage found on the strut-to-wing interface fairings. All fairing panels, which include the forward, reverser, underwing, aft access panel, and trailing edge, had significant thermal distress, delamination, and missing material in most of the panel locations (**PHOTOS 28** and **29**). The aft strut fairing heat shield remained intact.

PHOTO 28: INBOARD PYLON/STRUT THERMAL DAMAGE

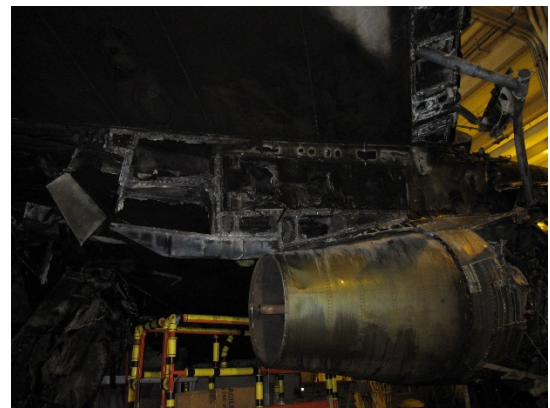
PHOTO 29: OUTBOARD PYLON/STRUT DAMAGE

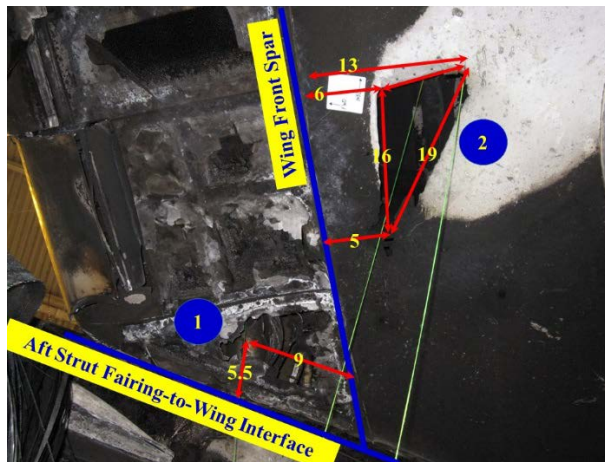
No airplane impact damage was observed outboard of the right engine pylon from exiting HPT stage 2 disk or engine debris; all impact damage was located inboard of the pylon. Examination of the bottom of the wing inboard of the right engine pylon revealed two thru-hole penetrations (**PHOTOS 30** and **31**, holes labeled **1** and **2**) through the lower and upper skins of the wing. Hole **1** was located forward of the front spar in the fixed-wing leading edge panel (**PHOTOS 32** and **33**). Hole **2** was located aft of the wing front spar between wing rib No. 6 and 9 (**PHOTOS 30, 32, and 33**).

**PHOTO 30: RIGHT WING INBOARD OF PYLON
LOWER WING SKIN THRU-HOLE PENETRATIONS
– ALL MEASUREMENTS ARE IN INCHES**

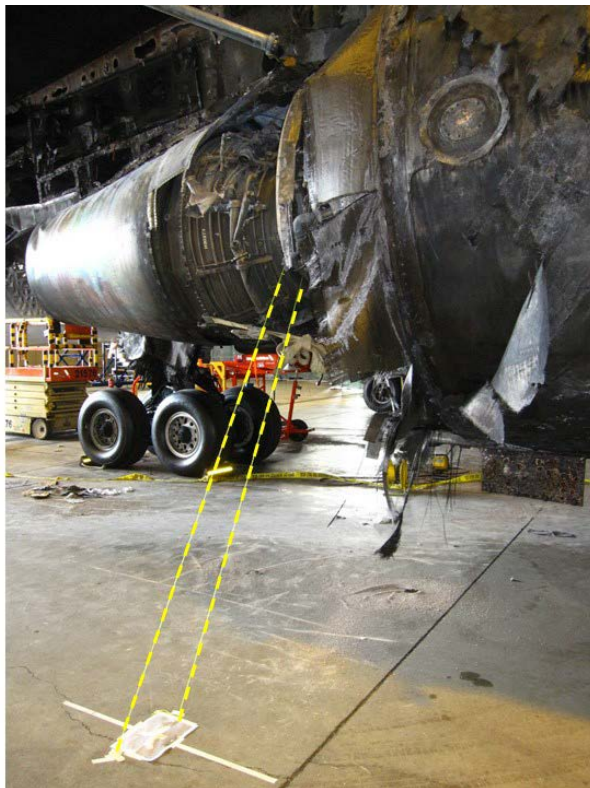
A mark was made on the hangar floor 31.5-feet from the centerline of the airplane and in-line with the rotational plane of the HPT stage 2 disk to represent the initial impact ground scar/gouge that was observed at runway 28R (**PHOTOS 36** and **37**).

**PHOTO 36: OUTBOARD TRAJECTORY –
LOOKING AFT**

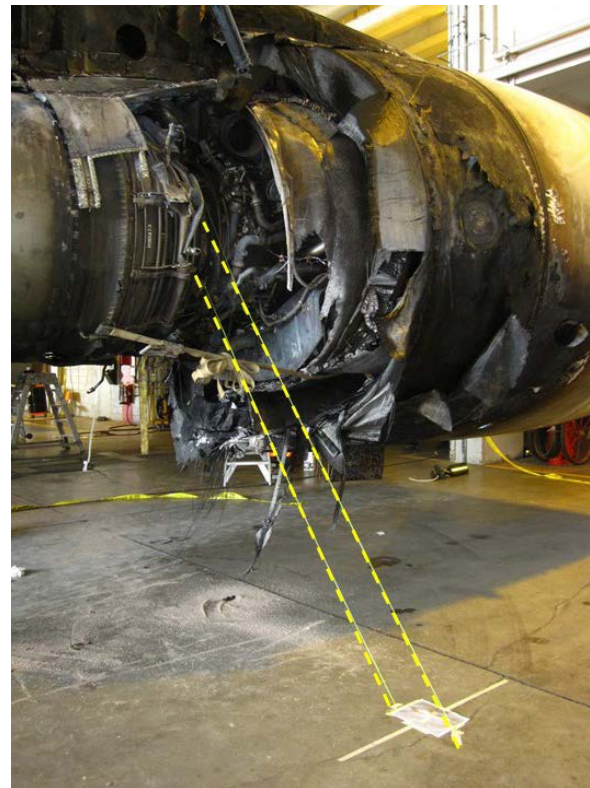
**PHOTO 37: OUTBOARD TRAJECTORY –
LOOKING FORWARD**

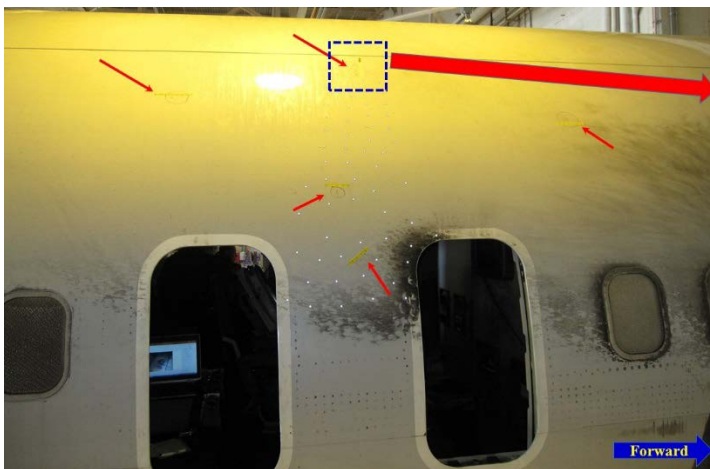
PHOTO 38: DEBRIS IMPACT MARK ON RIGHT SIDE OF FUSELAGE NEAR THE OVERWING DOORS

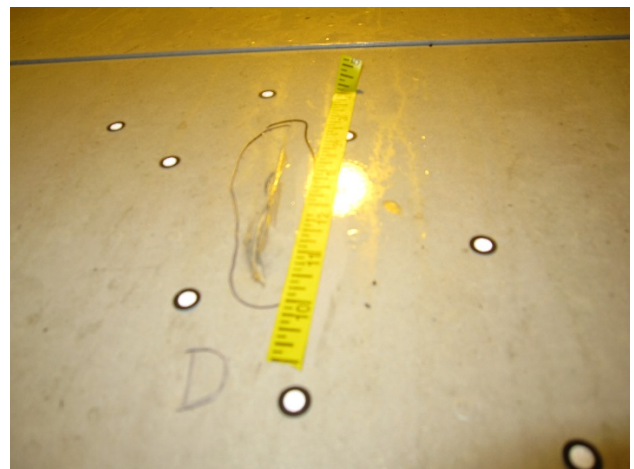
PHOTO 39: CLOSE-UP OF IMPACT MARK – SLIGHTLY WORSE THAN TYPICAL OBSERVED IMPACT

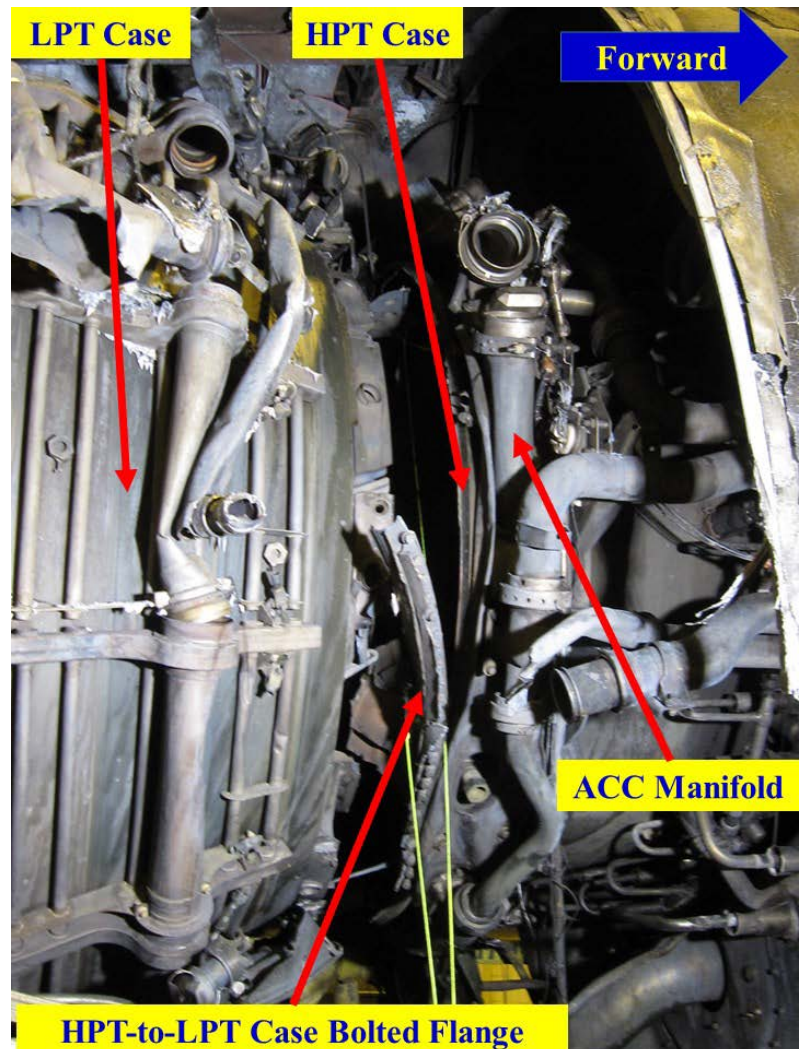
The LPT case exhibited a 360° circumferential breach in-plane with the HPT stage 2 hardware; all hardware in the radial plane of the breach was severed. The entire rear flange of the HPT case and the front flange of the LPT case were missing except for a joined/bolted HPT-LPT case flange segment located between the 3:00 and 6:00 o'clock position that was pushed outwards (PHOTO 40). The HPT case rear flange segment measured about 30-inches in length and the LPT case segment was shorter, about 22-inches in length. The breach in the LPT case was measured at several locations around the circumference and the gap measured between 3.0-inches and 7.5-inches wide. The remainder of the HPT case forward of the rear flange appeared to be intact underneath the HPT active clearance control (ACC) manifold. The HPT ACC manifold was intact, secure, and exhibited some impact damage and deformation.

PHOTO 40: BREACH IN LOW PRESSURE TURBINE CASE

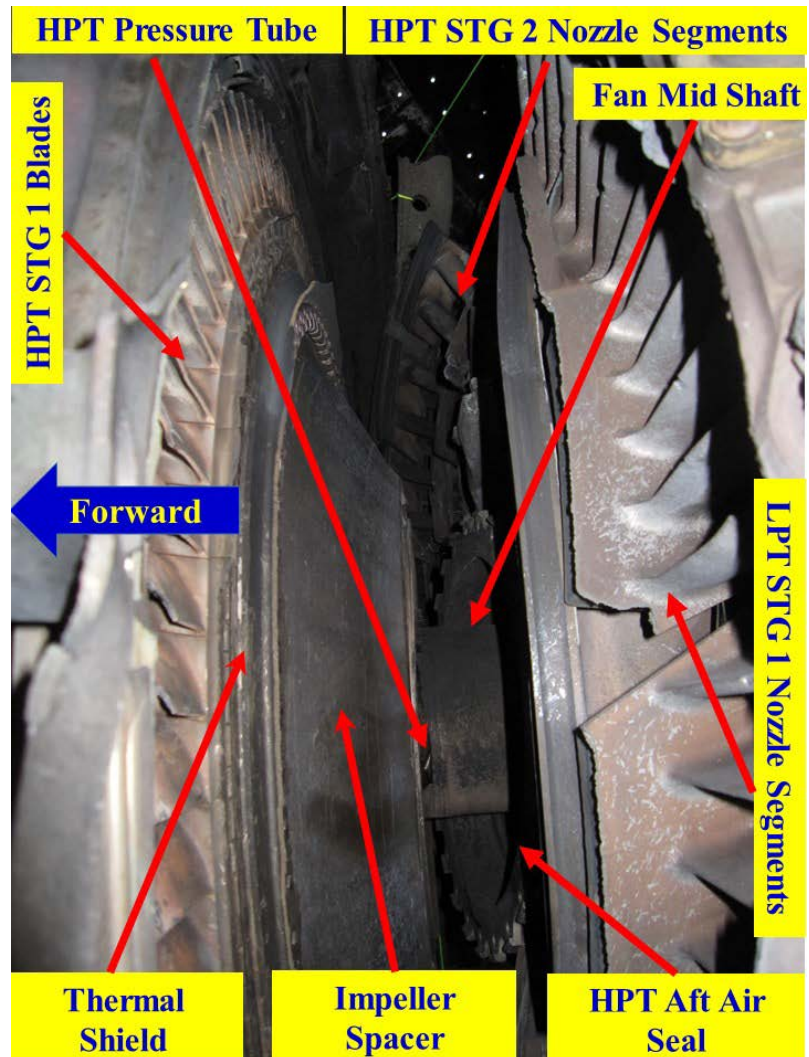
Looking through the breach in the LPT case, the hardware from the HPT stage 1 disk aft to the LPT stage 1 nozzle segments was visible. All eighty HPT stage 1 blades were present, full length, and exhibited TE airfoil damage. The thermal shield that attaches between the HPT stage 1 and 2 disks was missing except for the front flange that remained attached to the rear face of the HPT stage 1 disk; all the HPT stage 1 disk-to-thermal shield hook bolts were present and secured to the disk. The impeller spacer remained attached to the rear face of the HPT stage 1 disk and appeared to be intact except for the rear flange that attaches to the forward flange of the HPT stage 2 disk. All the HPT stage 1 disk-to-impeller spacer bolts were present and secure but none of the HPT stage 2 disk-to-impeller spacer bolts were present. During the collection of the debris from the runway, hardware consistent with the HPT stage 2 disk-to-impeller spacer bolts was recovered. The coupling nut and pressure tube (also referred to as the HPT pressure tube) was sheared in-line with the rear flange of the impeller spacer; the portion of the HPT pressure tube from the shear plane aft was missing. With the rear section of the HPT pressure tube missing, a portion of the fan mid shaft was visible. The fan mid shaft appeared intact with no significant distress or scoring (**PHOTO 41**).

PHOTO 41: HPT STAGE 1 DISK, THERMAL SHIELD, IMPELLER SPACER, AND HPT AFT AIR SEAL DAMAGE

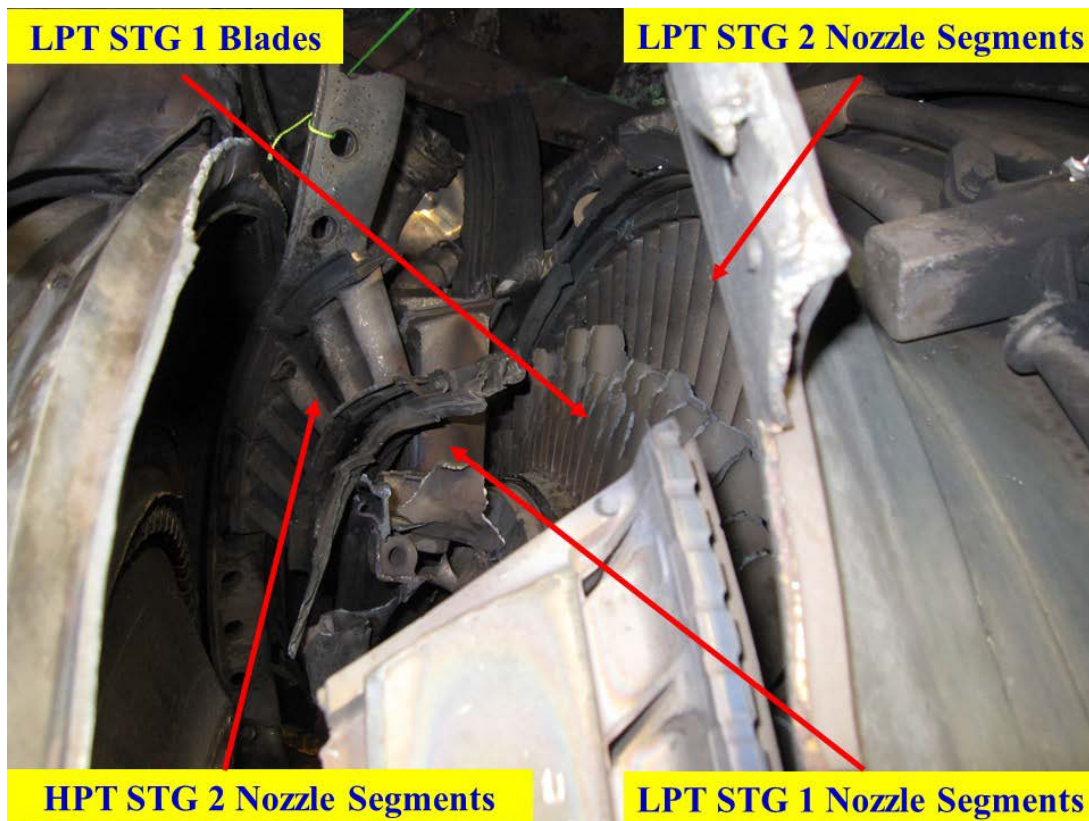
All the HPT stage 2 nozzle segments were missing (many of which were collected from the runway) except for five segments; two near the top at about the 11:00 o'clock position and three near the bottom at the 4:00 o'clock position. All the LPT stage 1 nozzle segments were present, except for 1 located at about the 10:00 o'clock position and 1 located at the 5:00 o'clock position; many of the airfoils exhibited leading edge impact damage. All the LPT stage 1 blades were present but were fractured transversely across the airfoil at different lengths. All the LPT stage 2 nozzle segments were present (**PHOTO 42**).

PHOTO 42: LPT STAGES 1 AND 2 HARDWARE DAMAGE

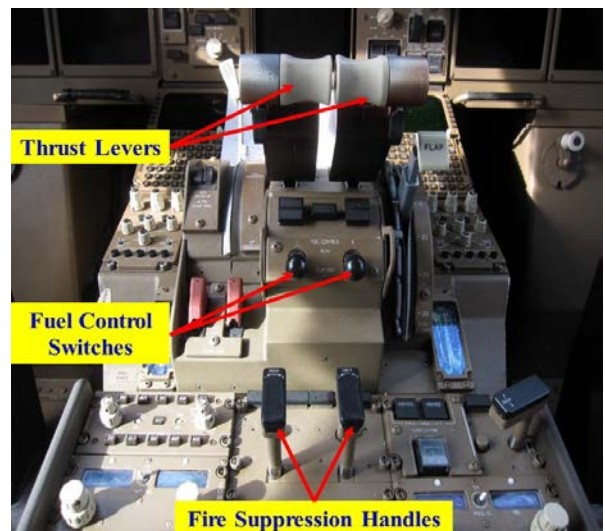
Examination of the flight deck revealed that both thrust levers (throttles) were against the aft stops, both fuel control⁹ switches were in the down and CUTOFF position (**PHOTO 43**), and the left and right engine fire suppression handles were pulled up but not rotated. The APU and cargo fire handle was found pulled up and rotated.

PHOTO 43: FLIGHT DECK THROTTLE AND FIRE SUPPRESSION HANDLE POSITIONS

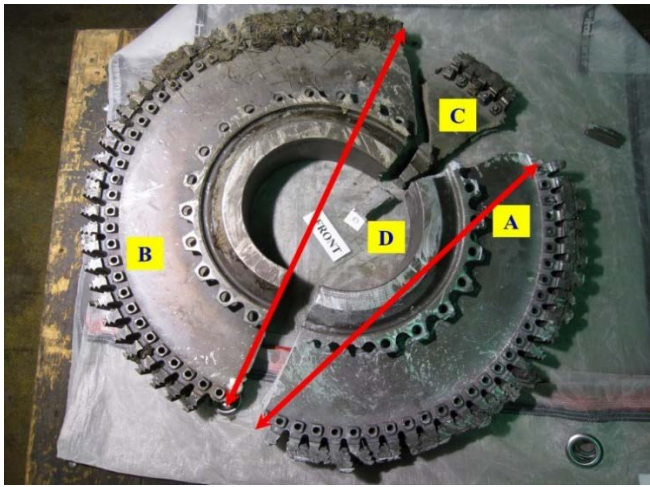
**PHOTO 46: RECOVERED PIECES OF THE EVENT
HPT STAGE 2 DISK – FORWARD SIDE**

Fragment ‘A’ was recovered from the UPS facility and consisted of 27 blade-retaining posts (approximately 36% of the entire rim). The maximum chordal length was approximately 21.5-inches (red arrows in **FIGURES 46** and **47**). All the blades were fractured transversely across the airfoil at the platform with most of the blade shanks still present in the disk. Ten impeller spacer-to-HPT stage 2 disk attachment bolt flange holes (approximately 42% of the total) were present with seven intact and three were fractured through. All the thermal shield-to-HPT stage 2 disk bolts were fractured and only three of the bolt shanks remained in their respective holes on the HPT stage 2 disk. None of the thermal shield remained attached to fragment ‘A’. Viewing the aft side of the disk, the entire spacer arm/air seal flange was fractured at the disk-to-flange radius.

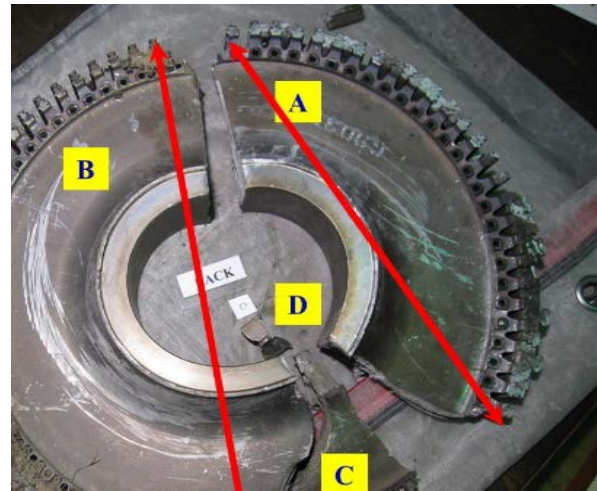
A general observation was that the aft side of the disk exhibited circumferential scoring along the web area while the forward side did not. The Powerplant team labeled the HPT stage 2 disk fracture faces on-site as follows: first letter specifies the fragment in which the face is located and the second letter specifies the fragment to which the fracture face mates. For example, fracture face labeled ‘A-B’ indicating the fracture face is located on fragment ‘A’ and matches with fragment ‘B’.

**PHOTO 47: RECOVERED PIECES OF THE EVENT
HPT STAGE 2 DISK – AFT SIDE**

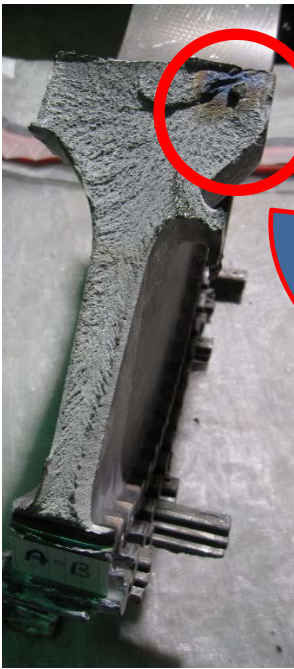
Fragment ‘A’ fracture surface ‘A-B’ exhibited a discolored region near the bore of the disk towards the forward face. The discolored area exhibited a dark bluish appearance surrounded by a dark brownish appearance; away from the discolored region, the fracture surface color was fairly uniform, greyish color, and had a waffle-like appearance. The corresponding region on fragment ‘B’ fracture face surface ‘B-A’ did not show the same type or intensity of discoloration as what was seen on fragment ‘A’; however, in the region that corresponded to discoloration on fragment ‘A’, fragment ‘B’ was slightly greyer than the surrounding fracture face (**PHOTOS 48 - 51**).

**PHOTO 48: HPT STAGE 2 DISK
FRACTURE SURFACE FOR
FRAGMENT 'A' THAT MATCHES
WITH FRAGMENT 'B'**

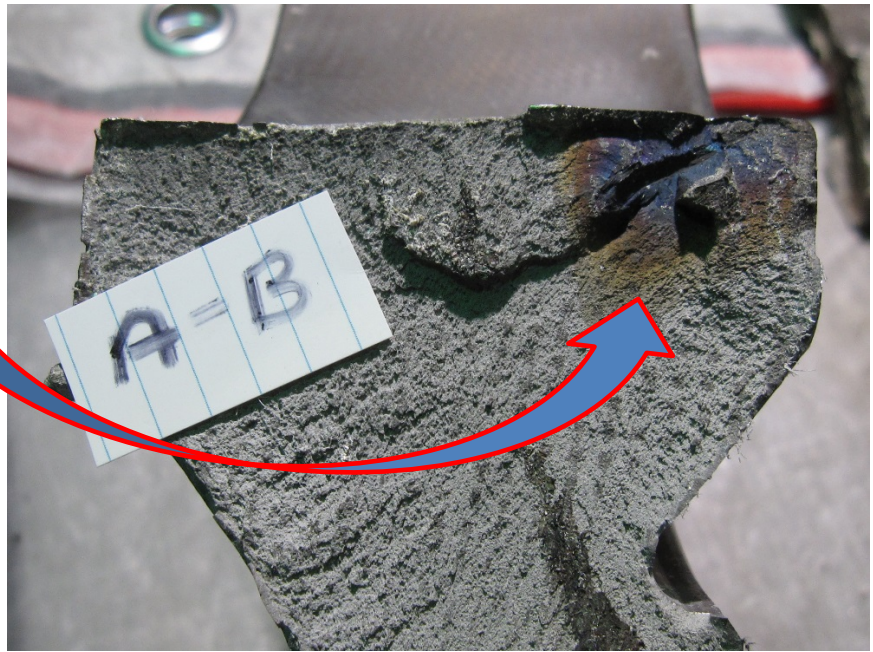
**PHOTO 49: CLOSE-UP OF DISCOLORED AREA NEAR BORE
TOWARDS FORWARD FACE ON FRAGMENT 'A'**

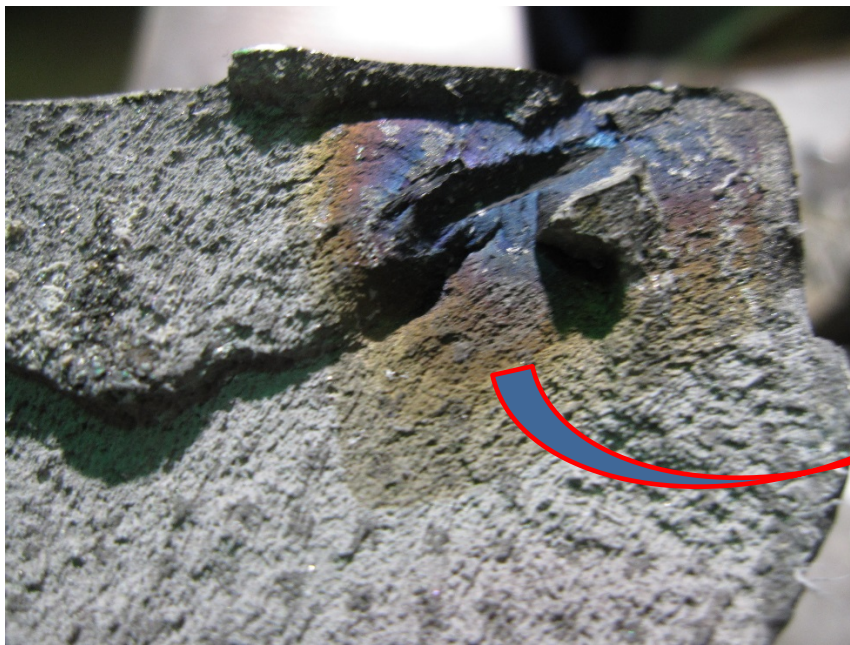
**PHOTO 50: CLOSE-UP OF DISCOLORED AREA NEAR BORE
TOWARDS FORWARD FACE ON FRAGMENT 'A'**

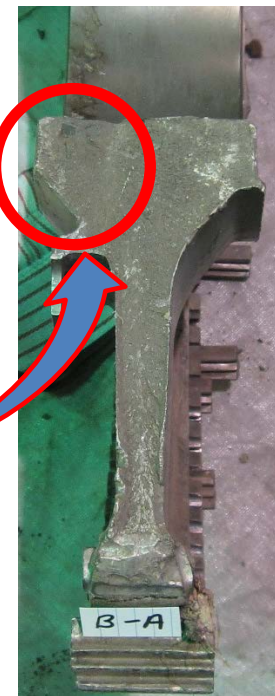
**PHOTO 51: CORRESPONDING
FRACTURE SURFACE ON
FRAGMENT 'B'**

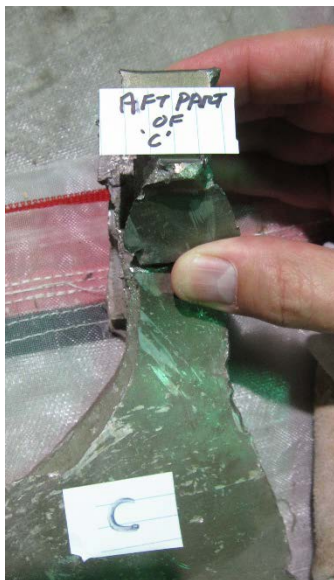
PHOTO 52: FRAGMENT 'D' MATCHED 'C'

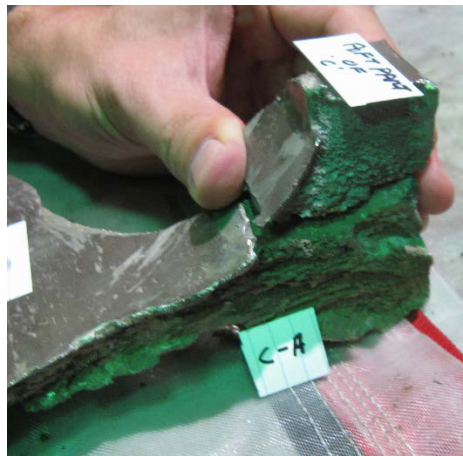
PHOTO 53: MATCHED FRACTURE SURFACES 'C'-TO-'A'

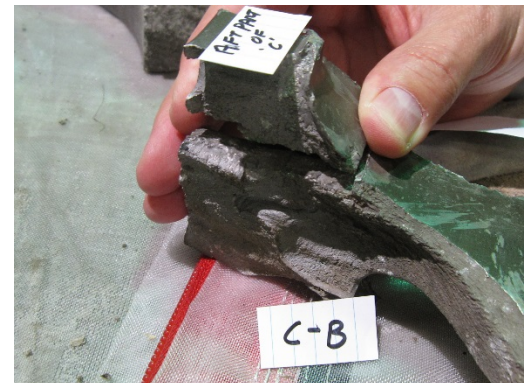
PHOTO 54: MATCHED FRACTURE SURFACES 'C'-TO-'B'

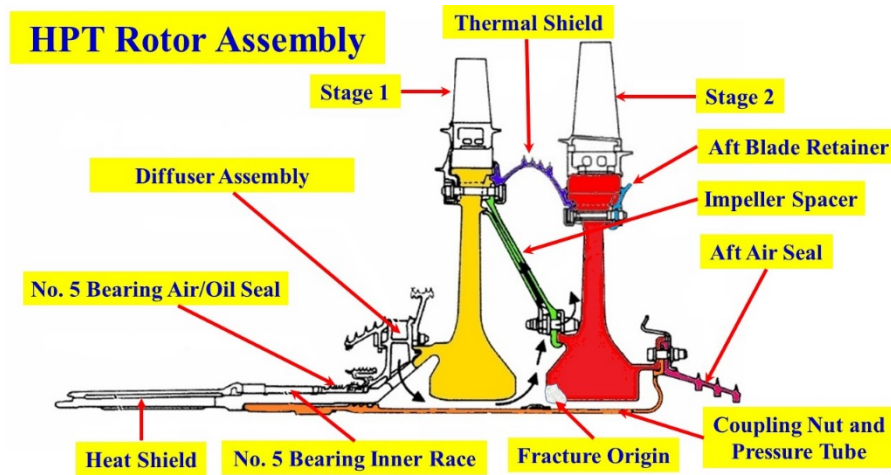
FIGURE 8: PRIMARY FRACTURE ORIGIN LOCATION ON THE EVENT HPT STAGE 2 DISK (GREYED AREA)

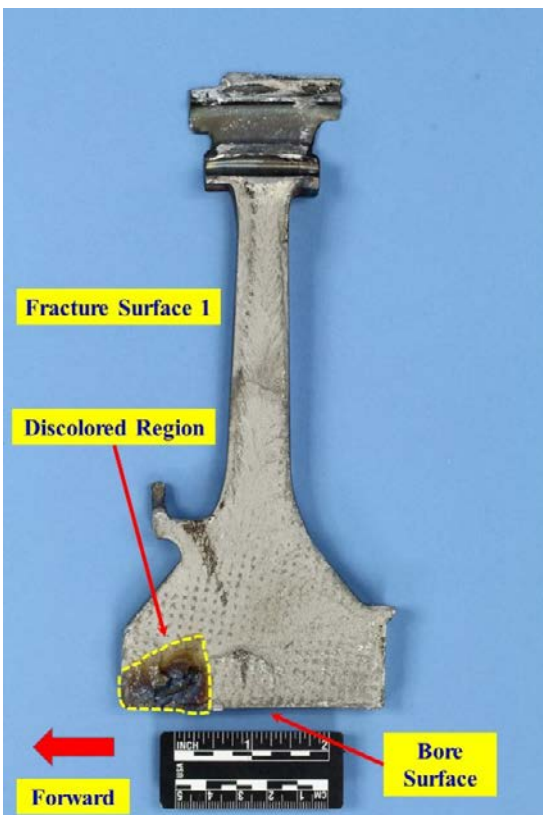
PHOTO 55: FRACTURE SURFACE 1 PRIOR TO CLEANING

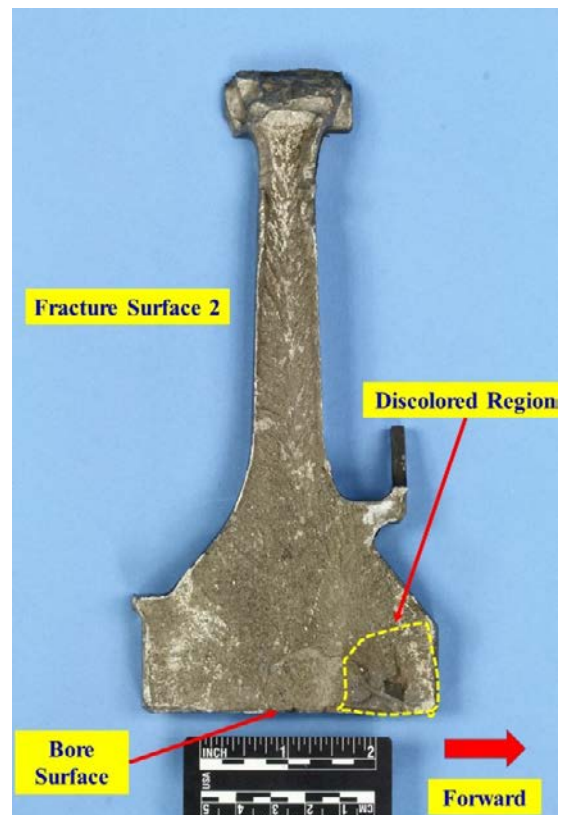
PHOTO 56: FRACTURE SURFACE 2 PRIOR TO CLEANING

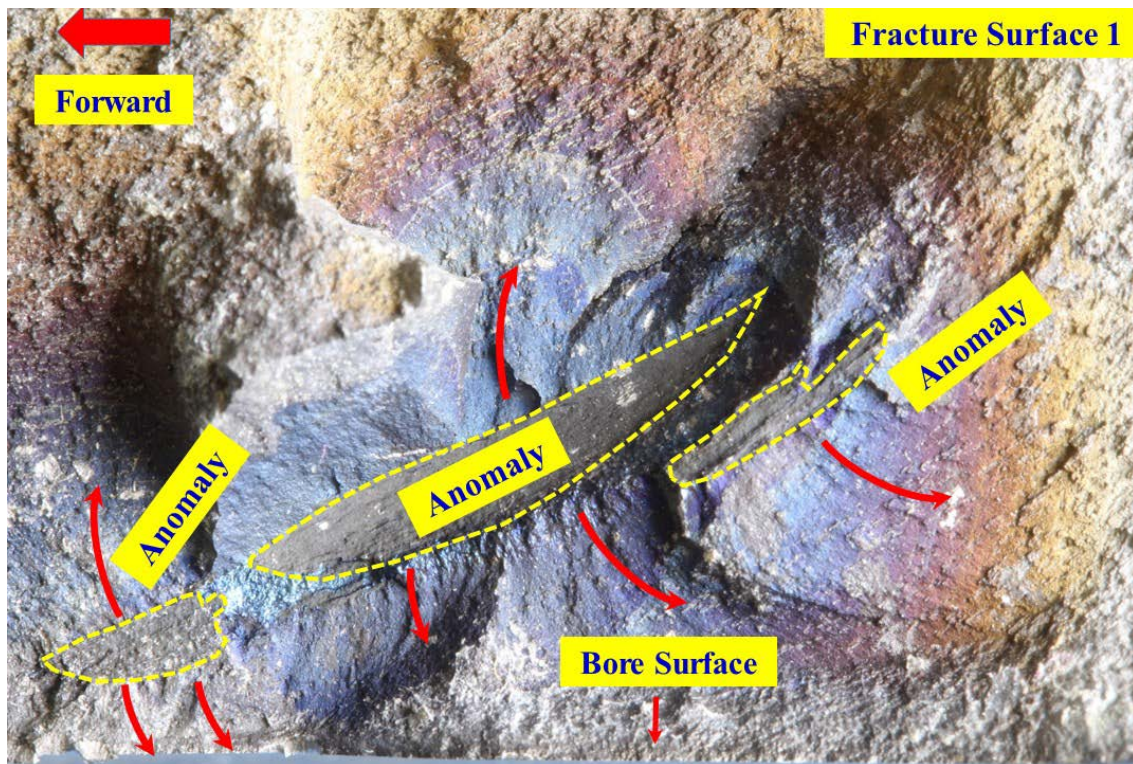
PHOTO 57: ELLIPTICAL MATERIAL ANOMALIES FOUND SUB-SURFACE NEAR BORE

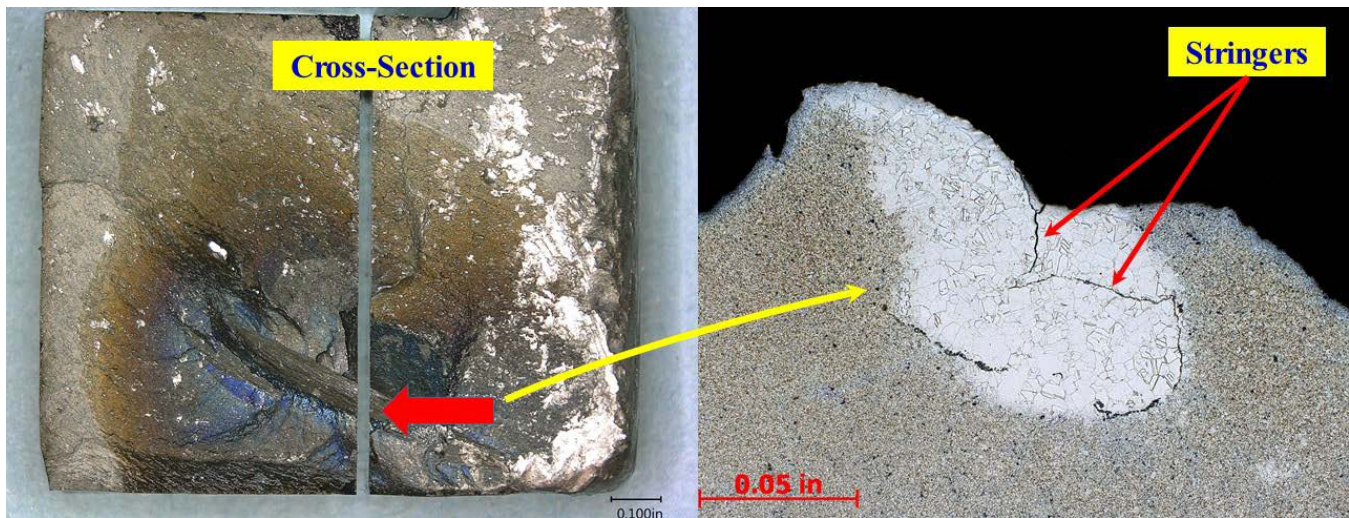
PHOTO 58: CROSS-SECTION VIEW OF ANOMALY IDENTIFIED AS A DISCRETE DIRTY WHITE SPOT
