Loss of Control While Maneuvering  
Pilatus PC-12/45, N128CM  
Butte, Montana  
March 22, 2009

NTSB/AAR-11/05  
PB2011-910405

**LOSS OF CONTROL WHILE MANEUVERING  
PILATUS PC-12/45, N128CM  
BUTTE, MONTANA  
MARCH 22, 2009**

**Abstract:** This accident report discusses the March 22, 2009, accident in which a Pilatus PC-12/45, N128CM, was diverting to Bert Mooney Airport (BTM), Butte, Montana, when it crashed about 2,100 feet west of runway 33 at BTM. The safety issues discussed in the report address fuel system limitations, requirements for fuel filler placards, and guidance on fuel system icing prevention. Safety recommendations concerning these issues are addressed to the Federal Aviation Administration (FAA) and the European Aviation Safety Agency. Previous safety recommendations concerning crash protection for airplane occupants and flight recorder systems were addressed to the FAA.

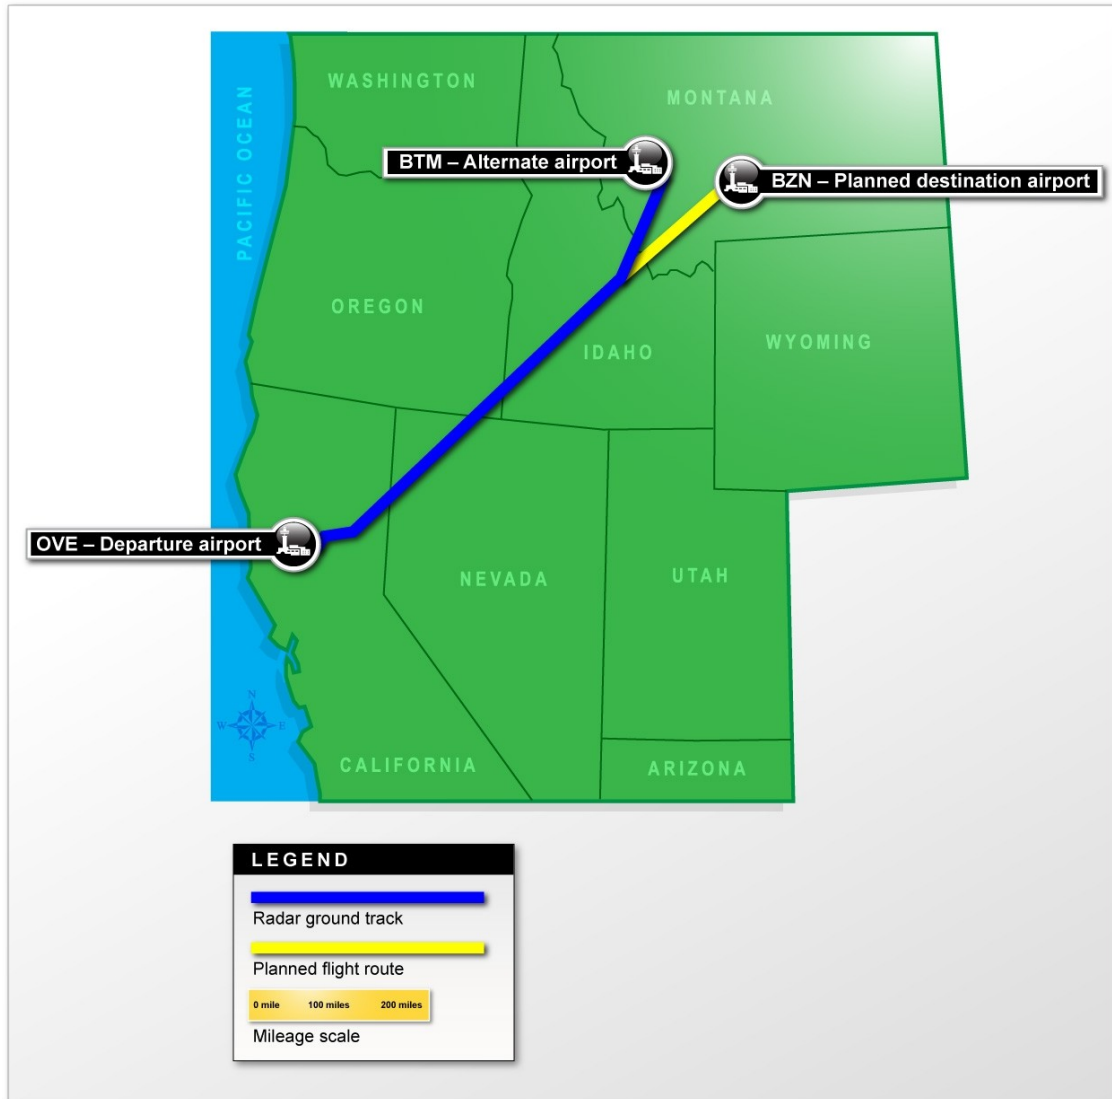
**Figure 1.** Radar ground track and planned flight route.

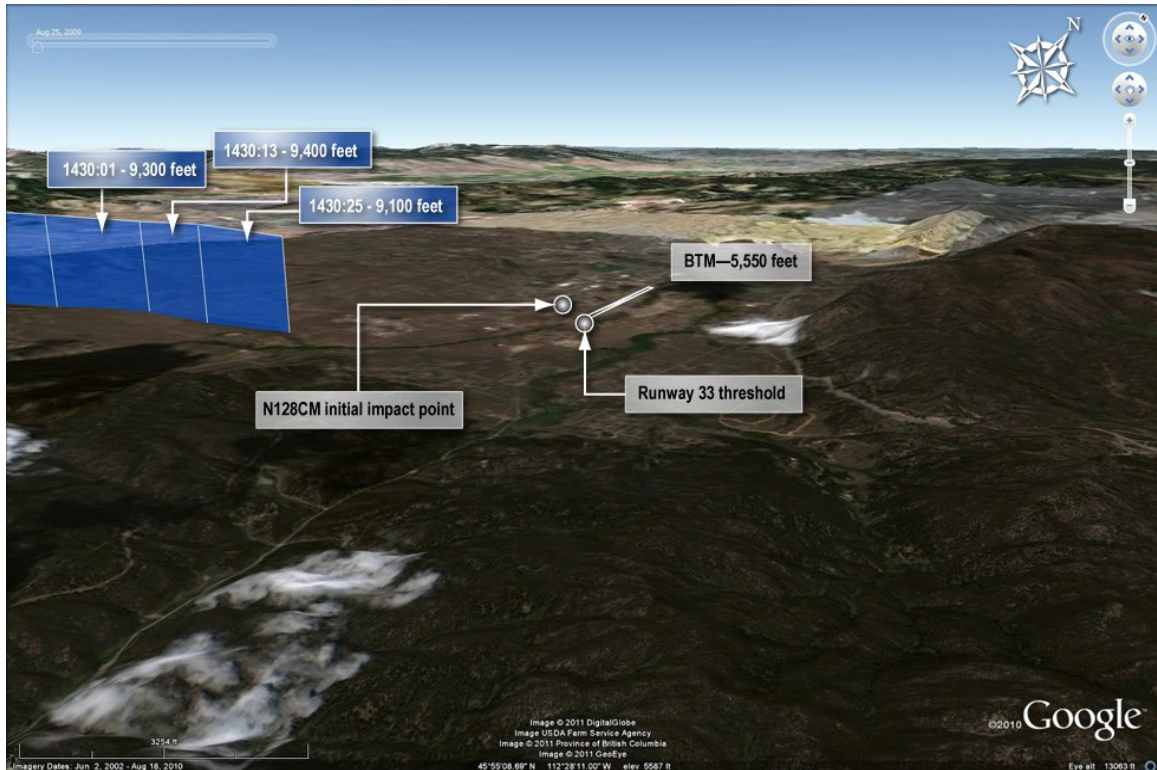
**Figure 2.** Final radar targets and terrain surrounding Butte, Montana (looking northwest).

The airplane impacted the ground about 2,100 feet west of the runway 33 centerline. The first emergency call reporting the accident to police was received at 1432:26. Witnesses to the accident reported that the airplane was approaching runway 33 at a higher altitude than other airplanes that land at the airport. The witnesses also reported that the airplane had entered a steep left turn at an estimated altitude of 300 feet agl and that the nose of the airplane then pitched down suddenly. No witnesses reported any indications of smoke or an in-flight breakup.<sup>18</sup> CAWS data, along with radar data and assumptions about fuel burn (described in section 1.16.3) indicated a left-wing-heavy fuel condition before the accident occurred.

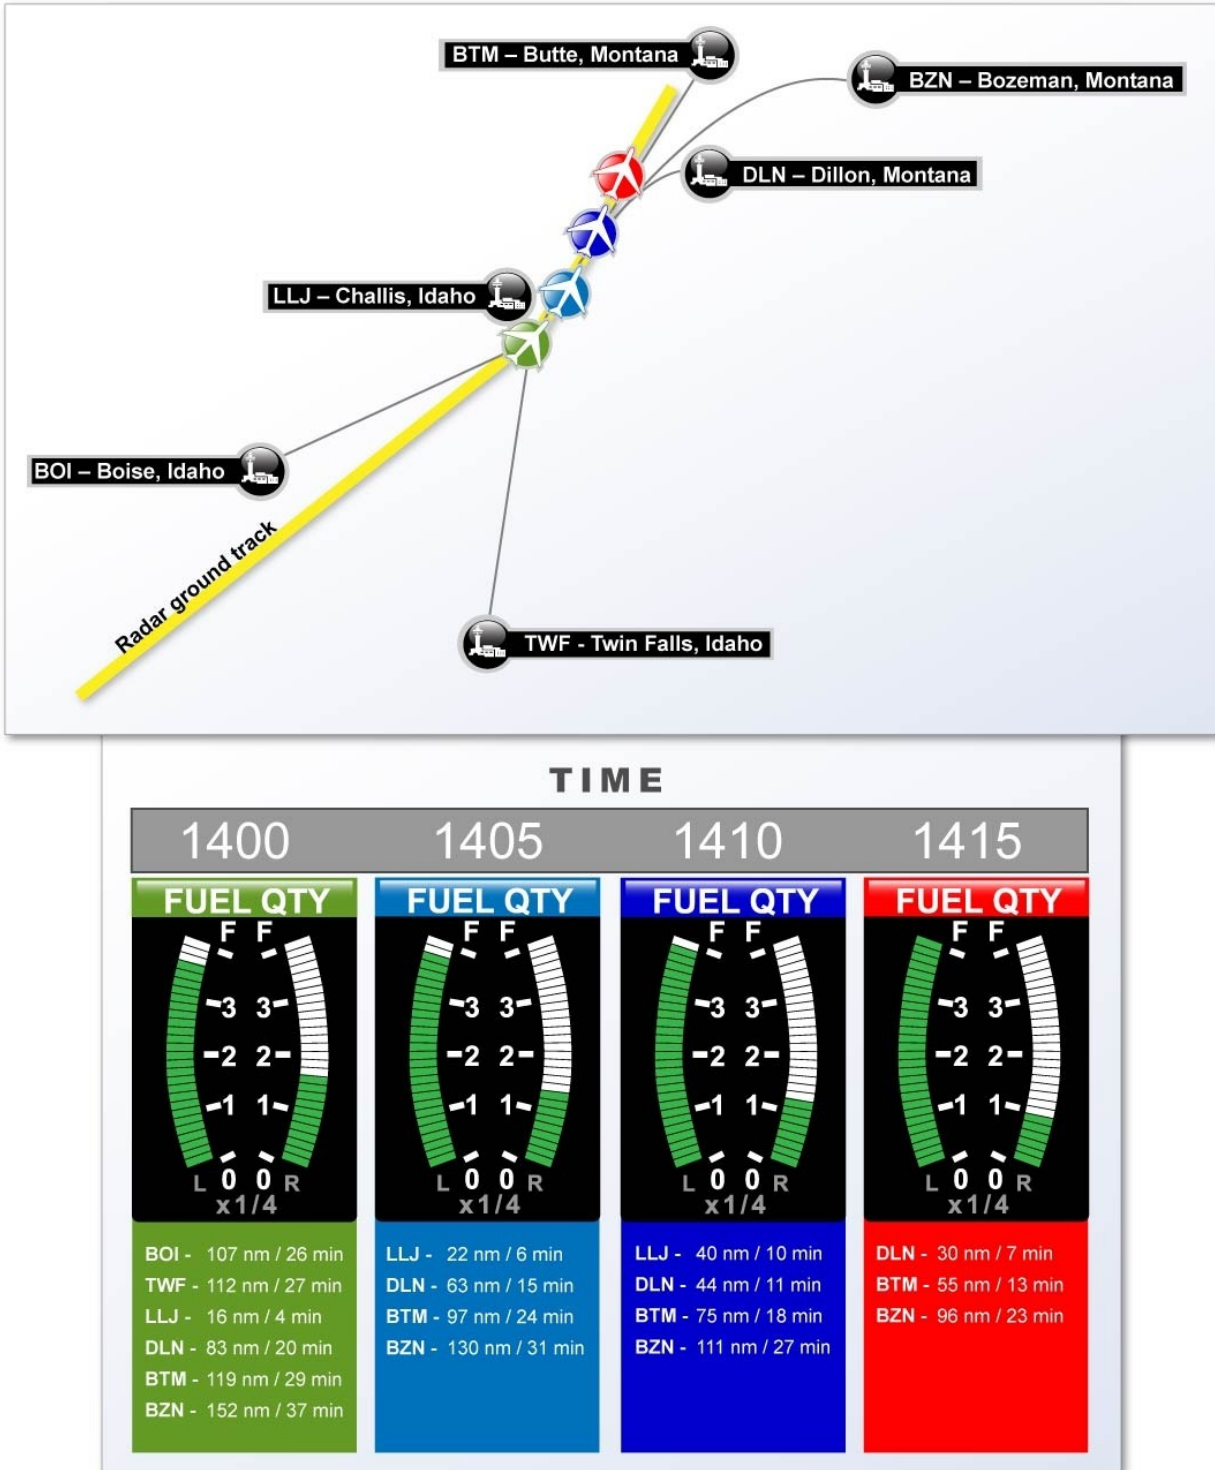
Figures 6 and 7 show the airplane's position along the route of flight in relation to the airports that were available for landing, the times and distances to the airports as the flight progressed, and the fuel imbalance at those times. The NTSB concludes that, if the pilot had diverted earlier in the flight to one of several suitable airports along the airplane's route of flight, the outcome of this flight would likely have been different because the airplane would have had a less severe fuel imbalance and the pilot would not have had to contend with the airplane's deteriorating performance as the imbalance steadily progressed.

Figure 7. Available airports about the time of the diversion to Butte, Montana.
