**[Docket No. FAA-2020-0442; Project Identifier AD-2020-00260-E; Amendment 39-21640; AD 2021-14-13]**

#### **Airworthiness Directives; Pratt & Whitney Turbofan Engines**

**ACTION:** Final rule.

**SUMMARY:** The FAA is adopting a new airworthiness directive (AD) for all Pratt & Whitney (PW) PW2037, PW2037M, PW2040, and F117-PW-100 model turbofan engines. This AD was prompted by a report of an uncontained engine failure resulting from cracks in the knife edge of the high-pressure turbine (HPT) 2nd-stage air seal assembly. This AD requires fluorescent penetrant inspections (FPIs) and visual inspections of the HPT 2nd-stage air seal assembly and, depending on the results of the inspections, replacement of the HPT 2nd-stage air seal assembly with a part eligible for installation. This AD also requires replacement of the affected HPT 2nd-stage air seal assembly, depending on the engine model, at either the next engine shop visit or the next piece-part opportunity. The FAA is issuing this AD to address the unsafe condition on these products.

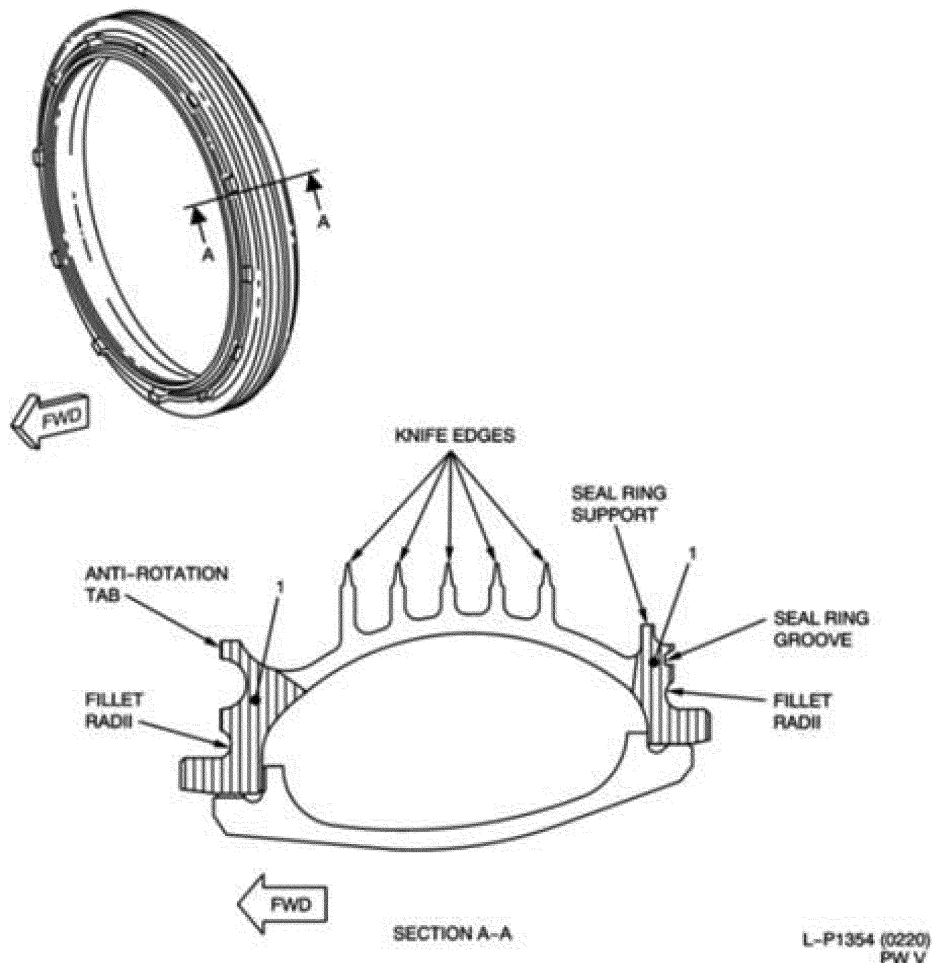
**Figure 1 to Paragraph (g)(1)(iii) – Crack Inspection Critical Areas**

The FAA did not revise this AD in response to this comment. A crack, as identified in the shaded regions of Figure 1 to paragraph (g)(1)(iii) of this AD (Figure 1), which extends towards the knife-edge region of the HPT 2nd-stage air seal assembly, impacts the serviceability of the mating HPT 1st-stage disk and the HPT 2nd-stage hub. A crack identified in the shaded region of Figure 1 of this AD of the HPT 2nd-stage air seal assembly results in the requirement to remove the HPT 2nd-stage air seal assembly, mating HPT 1st-stage disk, and HPT 2nd-stage hub.

If a crack is found as identified in the shaded region of Figure 1 to paragraph (g)(1)(iii) of this AD (Figure 1) that extends toward the knife-edge region of the HPT 2nd-stage air seal assembly, this AD requires replacement of the HPT 2nd-stage air seal assembly, mating HPT 1st-stage disk, and HPT 2nd-stage hub.

This AD was prompted by a report of an uncontained engine failure resulting from cracks originating in the knife edge of the high-pressure turbine (HPT) 2nd-stage air seal assembly. The FAA is issuing this AD to prevent failure of the HPT 2nd-stage air seal assembly. The unsafe condition, if not addressed, could result in uncontained HPT 2nd-stage air seal assembly release, damage to the engine, and damage to the airplane.

(iii) During the visual inspection or FPI required by paragraph (g)(1)(i) of this AD, if a crack is found in the shaded regions of the HPT 2nd-stage air seal assembly identified in Figure 1 to paragraph (g)(1)(iii) of this AD (Figure 1), which extends towards the knife-edge region of the HPT 2nd-stage air seal assembly, remove the HPT 2nd-stage air seal assembly, mating HPT 1st-stage disk, and HPT 2nd-stage hub from service, and replace the parts with parts eligible for installation. In order to return the mating HPT 1st-stage disk and HPT 2nd-stage hub to service, the inspections of the HPT 2nd-stage air seal assembly cannot reveal a crack identified in the shaded regions of Figure 1, which extends towards the knife-edge region.

(ii) If a crack is found in the HPT 2nd-stage air seal assembly during the visual inspection or FPI required by paragraph (g)(1)(i) of this AD, remove the HPT 2nd-stage air seal assembly from service and replace it with a part eligible for installation.
