National Transportation Safety Board

WPR22FA151

ADASD ENGINE MONITOR

Specialist's Factual Report

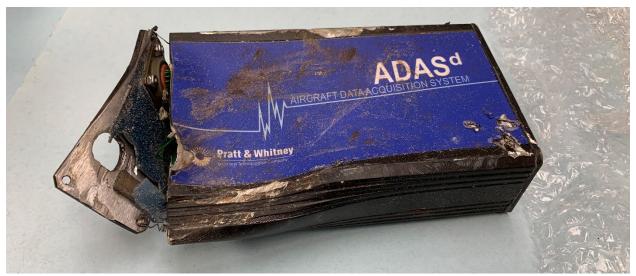
The ADASd was damaged in the event. The extent of the damage is shown in figures 1 and 2. The extraction of the memory module is shown in figure 3. After the external case was removed, it was determined that the circuit board was bent near the non-volatile memory chips during the accident.

Figure 1. Recorder as received

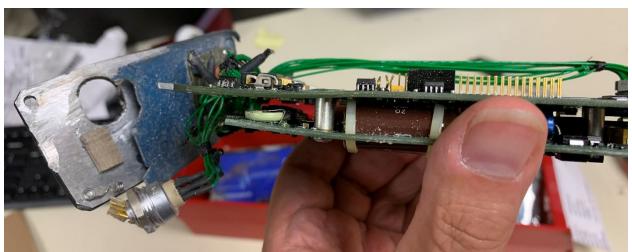
Figure 2. Bent circuit board near non-volatile memory chips

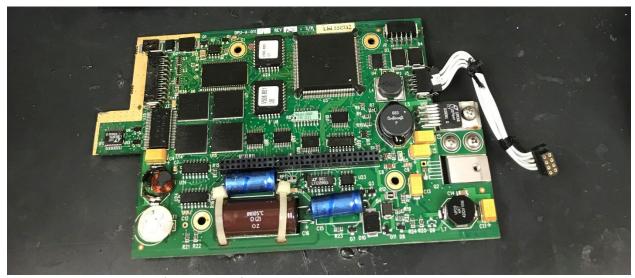
Figure 3. Circuit board after removal from case and disassembly.
