## **NATIONAL TRANSPORTATION SAFETY BOARD**

# **AIRFRAME AND ENGINE EXAMINATION SUMMARY**

<b>NTSB Number:</b>	<b>ANC19FA019</b>
<b>Location:</b>	Metlakatla, Alaska
<b>Date:</b>	May 20, 2019
<b>Aircraft:</b>	N67667 de Havilland DHC-2
<b>Investigator-in-Charge (IIC):</b>	Noreen Price
<b>Parties to the Investigation:</b>	Jon Percy, FAA Aviation Safety Inspector IIC Michael O'Brien, Taquan Party Coordinator

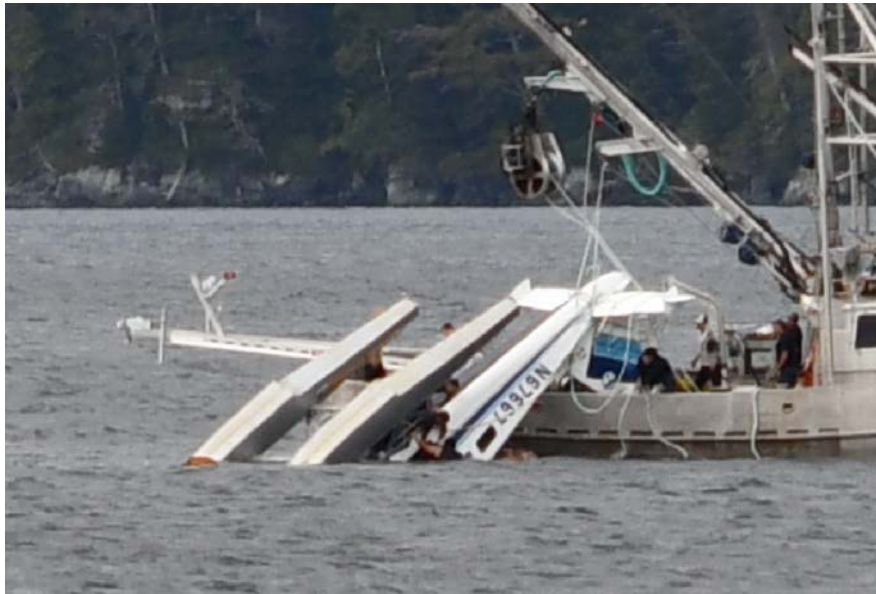
*Figure 2. Rescue boat pulling airplane out of water with ropes around empennage*

The empennage exhibited buckling and pinched skin throughout the aft section. The aft 4 inches of the dorsal fin skin was torn downward, likely a result of ropes pulling the airplane out of the water. The vertical stabilizer was attached and intact with some deformation at the top edge. The rudder and rudder trim were attached, yet deformed in various directions, likely due to mechanical damage during haul out. The horizontal stabilizers were attached and intact. The right horizontal exhibited one compression dent on the leading edge at the mid span.

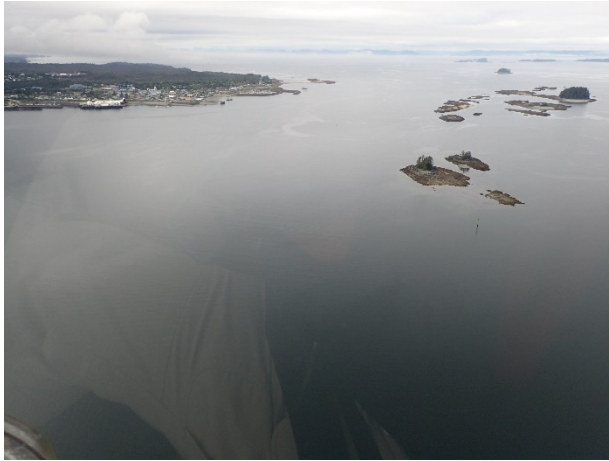
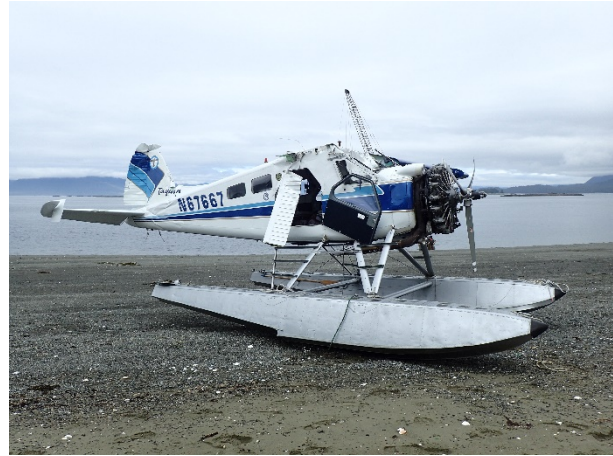
The NTSB participated in a flyover of the accident site after the airplane was moved to the beach. The harbor consists of rocky islands in the center with tidal rocks marked with green markers. The area is large with numerous approach options. Mountainous terrain was present to the east of the harbor. According to the police chief, the wreckage was turned upright and floated to a high beach to the west of the accident scene. Refer to figure 3.

Figure 3. Metlakatla Harbor and N67667 on the beach.

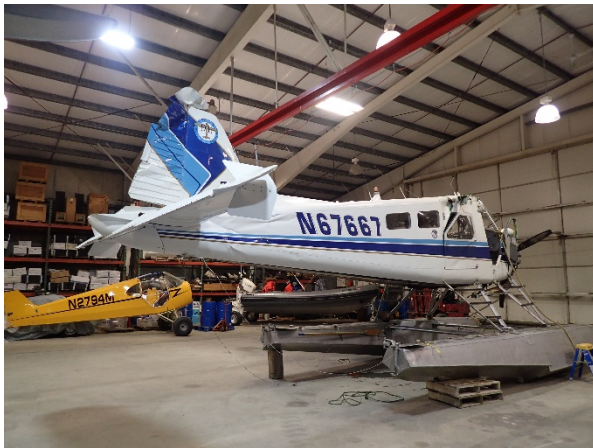
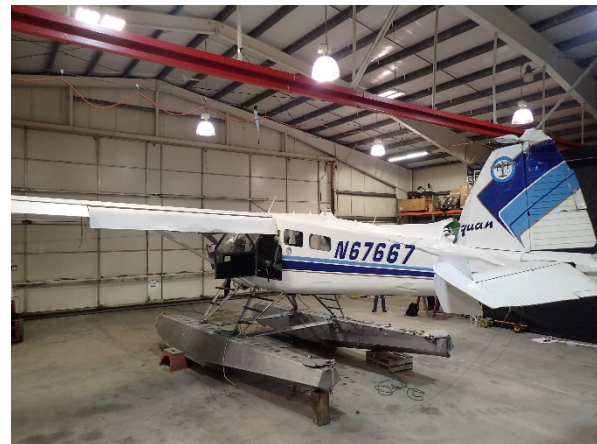
Figure 4. N67667 in examination hangar

The airplane and floats were intact. The right wing and strut had separated from the fuselage at the attachment points and fractured lower strut bracket. The metal around the fractured mounts was deformed in a rearward direction, consistent with separation upon impact. The right flap was attached to the inboard bracket with fractured control rod attached. The right fuselage had impact indentations consistent with the outline of the inboard flap edge in the land flap configuration. The engine cowling was also missing. The top of the forward fuselage above the cockpit was fractured at the upper center windshield brace and the forward upper skin was deformed inward/downward into the cockpit. About 80% of the windshield glass was fractured and missing.

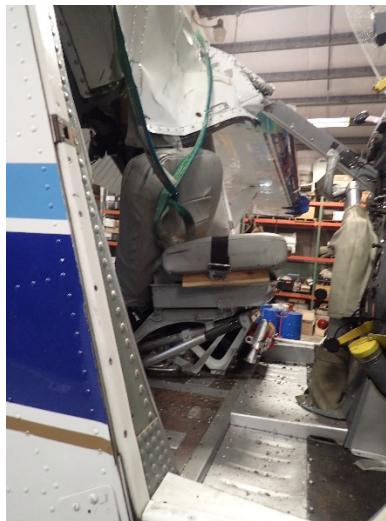
The left front (pilot) seat was secure to the floor and exhibited fractured attachment at left lower tube and some downward deformation. Refer to figure 5. The restraint system was a traditional three point design with inertial reel shoulder harnesses. The pilot's lap belt ends were secure to the seat and the shoulder harness was connected to the left lap belt clasp. The pilot's upper harness strap was secure in the inertial reel and full functionality was demonstrated. Neither the right front seat (passenger's) nor the lap belt were present, and the upper right harness strap was secure in the inertial reel with a cut evident about 2 feet from the upper end. (reported cut by 1<sup>st</sup> responder) All webbing was in excellent condition. The four corners of the cargo net were secure to attachment points behind the cockpit, with cuts about 5 inches from each corner. (Cut by 1<sup>st</sup> responders.) The netting was recovered in one piece. One of the two second row seats was present and secure to the floor. The remaining seats were recovered by boats at the scene. The ELT was secure behind the aft cabin bulkhead attached to the antennae in off position.

*Figure 5. Pilot seat and cockpit view from right front door*

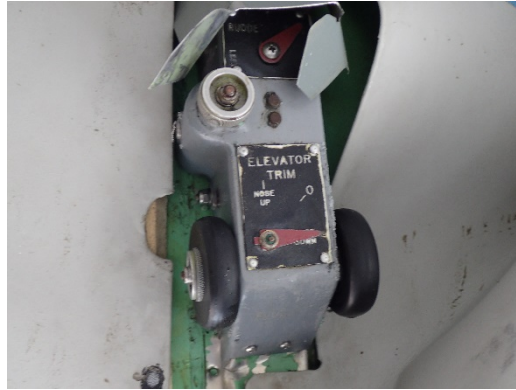
Flight control continuity was established from the pilot's control wheel to the left aileron and right wing aileron pulley, as well as the elevator. Control continuity was also established from the pilot's rudder pedals to the rudder. All control surfaces that were present exhibited full functionality. The rudder and elevator trim wheel rotated with corresponding trim cable movement; however, the cable did not extend or retract. Trim cable continuity was established to the aft trim tabs; however, movement could not be established due to airframe deformation and cable constriction forward of the cockpit upper trim wheels. Refer to figure 6.

*Figure 6. Elevator and rudder trim indicators*

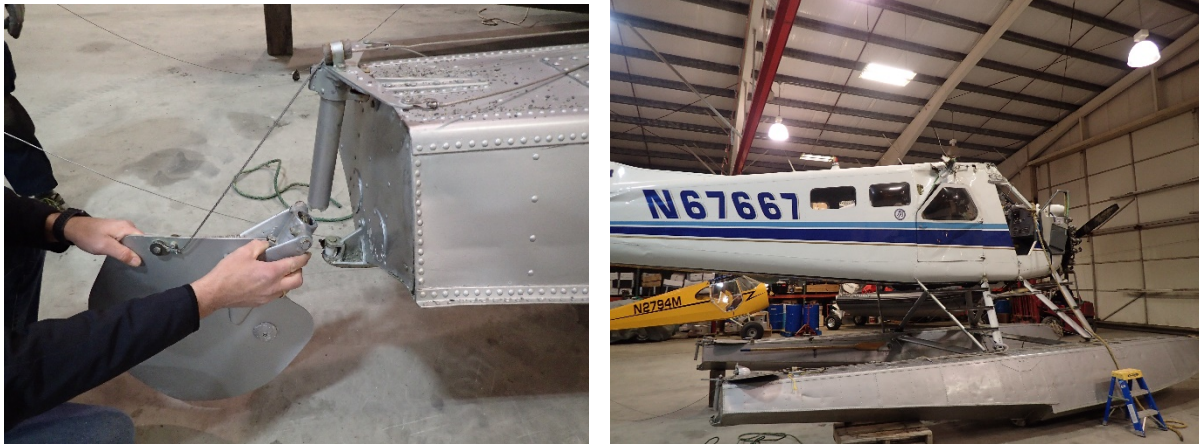
The left and right floats (Edo model 679-4930) were secure in place and intact. The support struts were all secure as well. All pulleys were secure with cable loosely wrapped, except for the right rear belly pulley which had a fractured bracket. The right and left rudders were each fractured at the lower welds and each exhibited mild bending in the rudder. Control continuity was established from the cockpit rudder lever and rudders to the sea rudders. Refer to figure 7.

*Figure 7. Left Sea Rudder and floats*

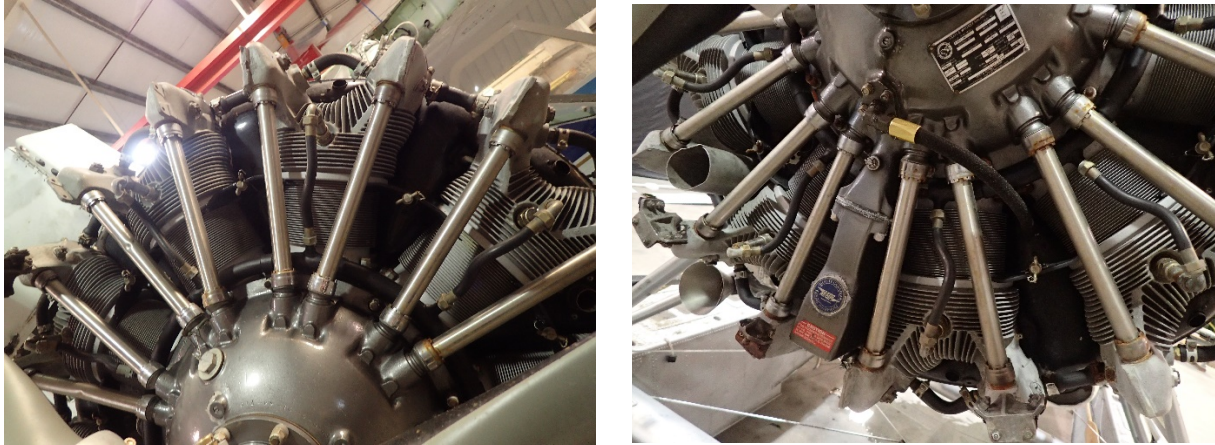
*Figure 8. Pratt and Whitney R-985 engine front top and bottom*

The engine and engine mounts were all intact with all fuel, oil, ignition and electric lines connected and secure. All spark plugs and cylinders were secure intact. There were no visible leaks present. The induction and exhaust systems were attached and undamaged. The magnetos were secure at the accessory mounts. The propeller rotated easily when turned by hand. Seawater was expelled from the exhaust system as each piston moved with propeller rotation. Refer to figure 8.

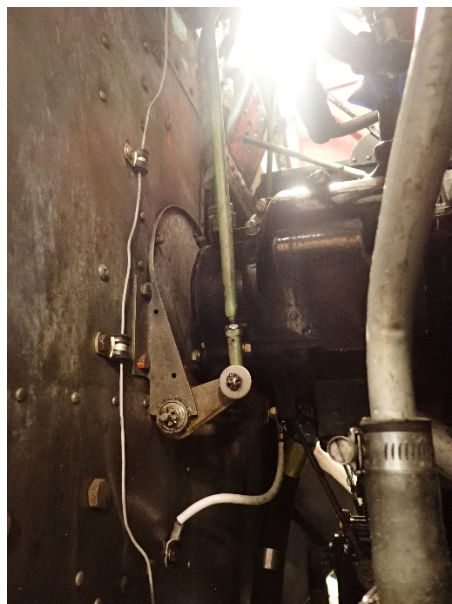
The engine throttle was connected securely to the throttle valve which moved from stop to stop when the control level was moved. The mixture and propeller cables were connected to their prospective control rods and exhibited full movement. Refer to figure 9.

*Figure 9. Engine controls*

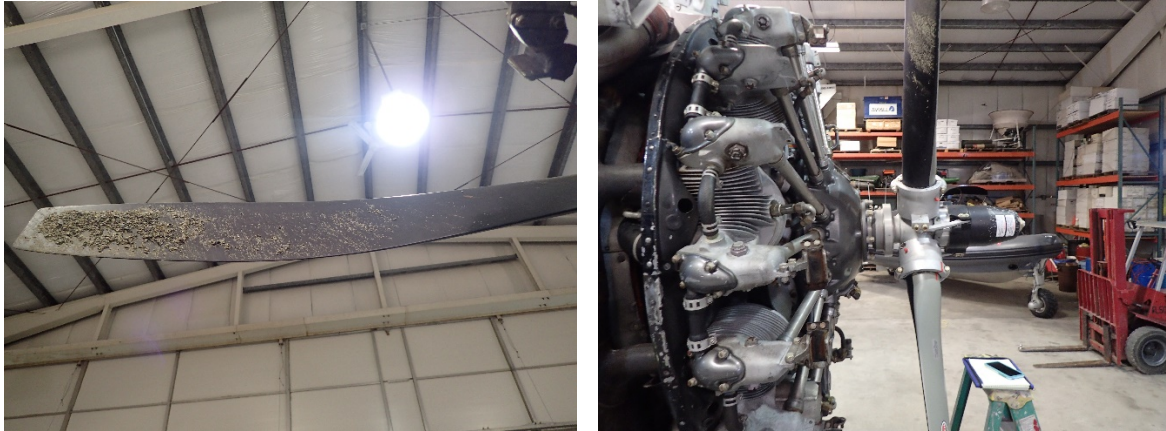
The propeller (HC-B3R30-4B) was secure to the engine and each blade was secure to the hub. The pitch of each blade was uniform at a moderate flat pitch. A blade labeled “A” was slightly curled aft through the whole span, with some scrapes and sand on the aft side, indicative of recovery damage as it was dragged to the beach. The other two blades were straight with no damage indicated.

*Figure 10. Hartzell propeller and blade “A” with mild bend*
