NATIONAL TRANSPORTATION SAFETY BOARD

Factual Report

METEOROLOGY

ANC19FA033

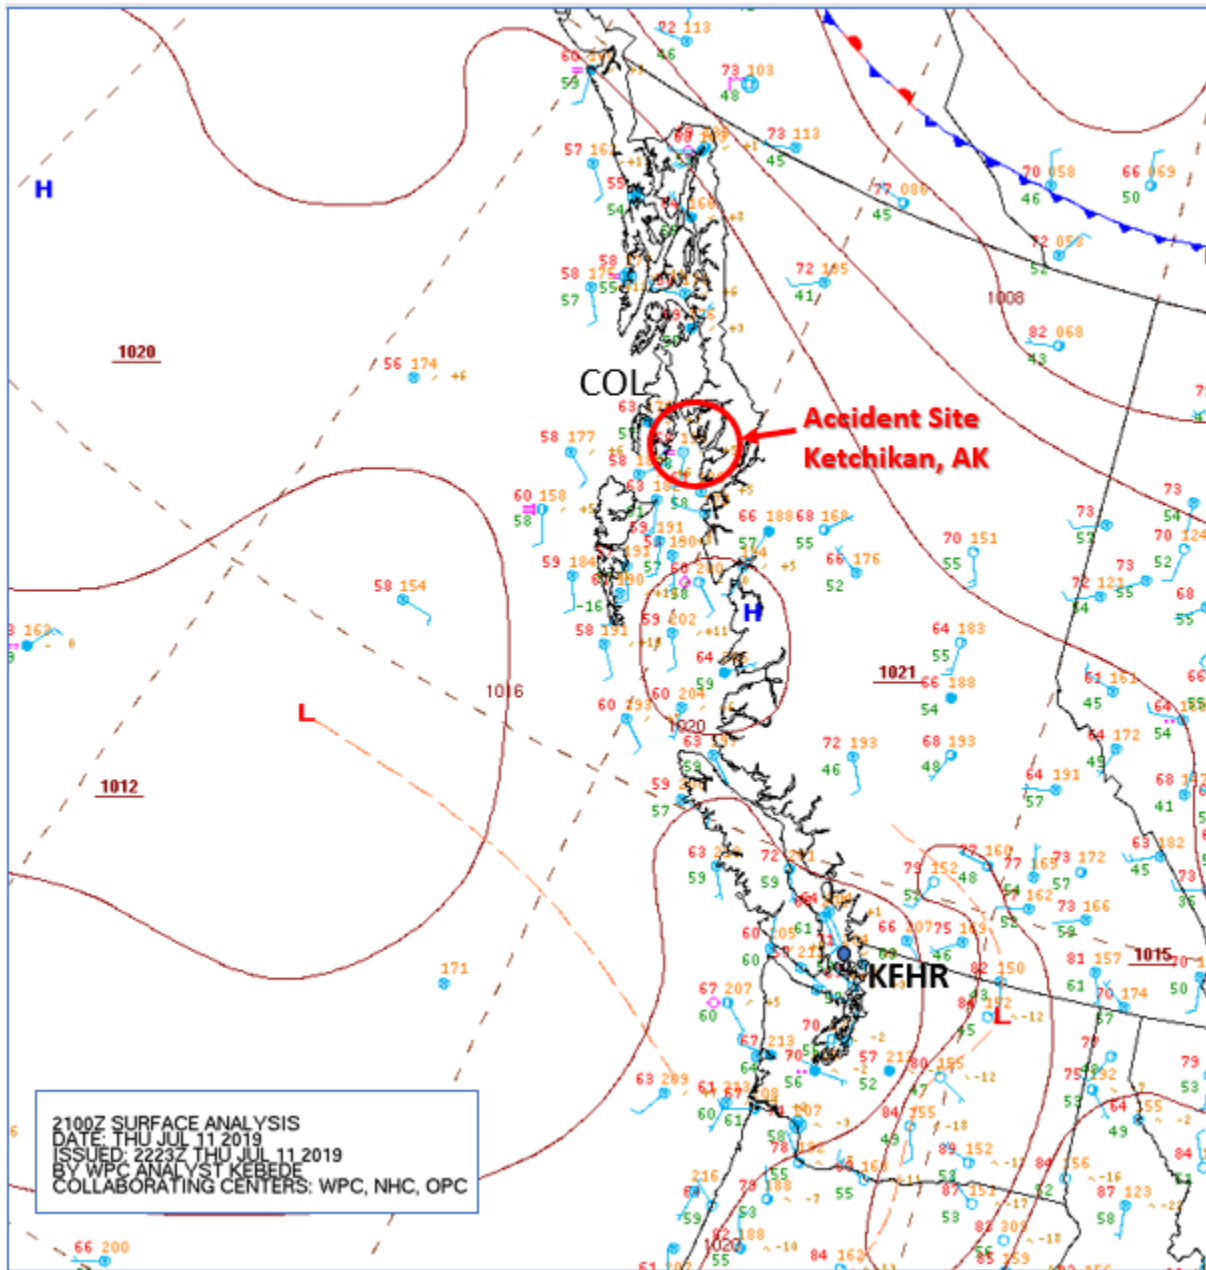
Figure 1 - Northwest section of the Surface Analysis Chart for 1300 AKDT

The Pacific northwest coastal section of the NWS Surface Analysis Chart for 1300 AKDT (2100Z) displaying the departure location and the accident site is included as figure 1, with the accident site located within the red circle. The chart depicted a high-pressure system at 1021-hectopascals (hPa) located southeast of the accident site over western British Columbia, Canada, which dominated over the southern portion of the route. Another high-pressure area at 1020-hPa was located west of the accident site over the Gulf of Alaska, with a ridge of high pressure extending eastward. The chart also depicted a low-pressure system at 1012-hPa in the Pacific Ocean off Washington with a trough of low pressure extending east-southeastward to near the Washington and Oregon coast. A col or natural point between two high and low pressure systems extended over southeast Alaska in the vicinity of the accident site, with a relatively weak pressure gradient over the region.

The station models on the chart depicted general south to south-southeast winds of 10 knots, variable cloud cover from scattered to broken clouds over the route, with temperatures in the mid to upper 60's degrees Fahrenheit (F), with dew points in the high 50's °F. A ship report in the Dixon Entrance approximately 40 miles south of Ketchikan depicted wind from the south at 10 knots, visibility restricted in mist, sky obscured, temperature 58° F, and a dew point temperature of 58° F.

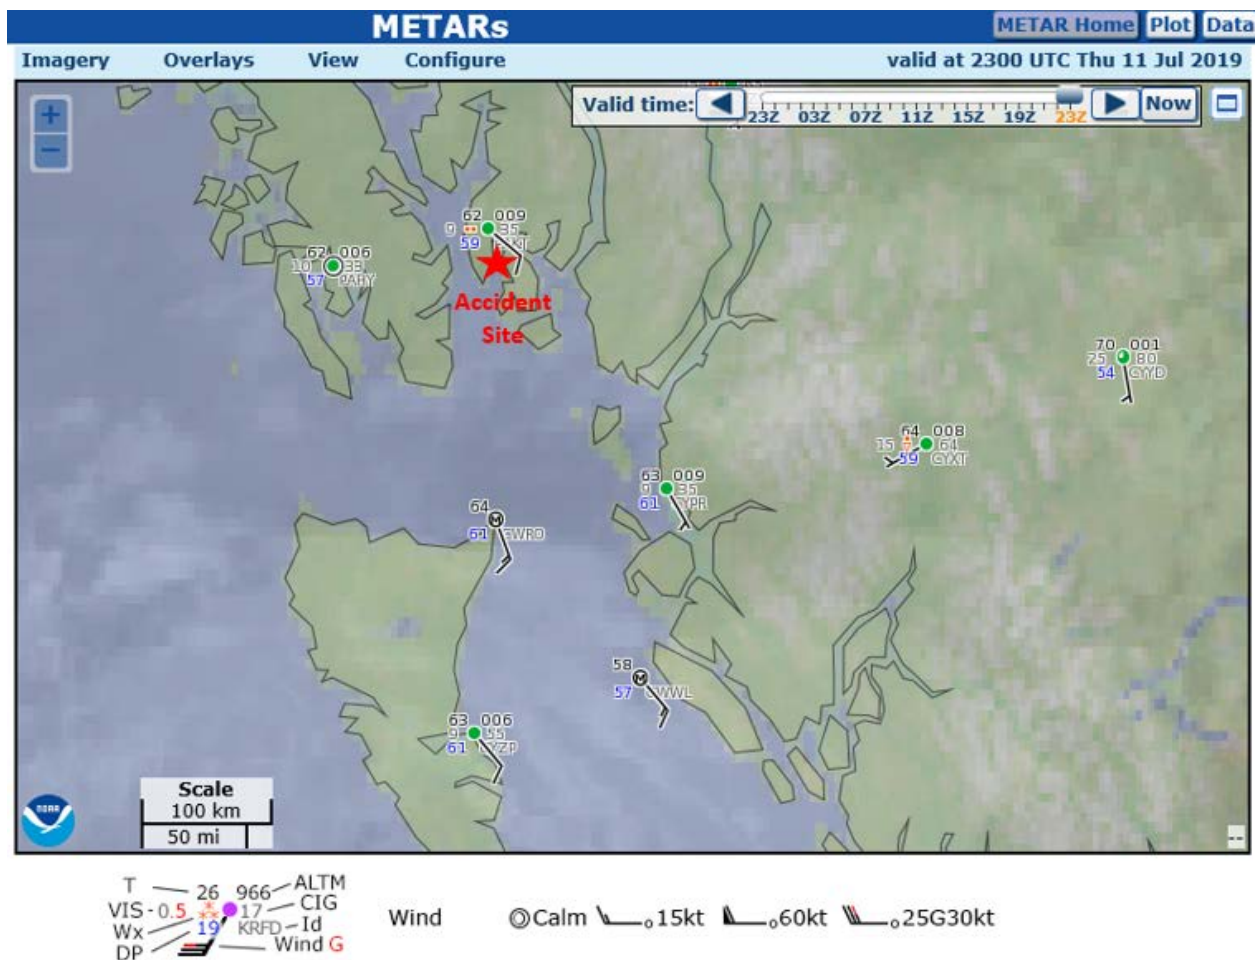
Figure 2 - NWS Aviation Weather Centers website METAR display for 1500 AKDT

A display of the observations from the NWS Aviation Weather Centers (AWC) website for 1500 AKDT (2300Z) immediately after the accident is included as figure 2 with the approximate accident site noted by a red star. The display depicted general VFR conditions being reported over the region from the two reporting sites in the area, with all the surrounding stations reporting southeasterly winds of 15 knots or less, overcast cloud cover, with visibility 9 miles or more with several stations reporting light rain, with temperatures in the low 60's °F, and dew points 50's °F or less.

The observations from Rose Split (CWRO) and Bonilla Island (CWWL), British Columbia, Canada, approximately 63 miles south and 115 miles south-southeast of the accident site,

respectively, provided wind, temperature, and dew point temperature information only and did not report visibility, present weather or sky cover required for determining the general flight category. In addition, the observations for PANT and PAMM listed above, which were reporting LIFR to IFR conditions during the period, were also not included in the display.

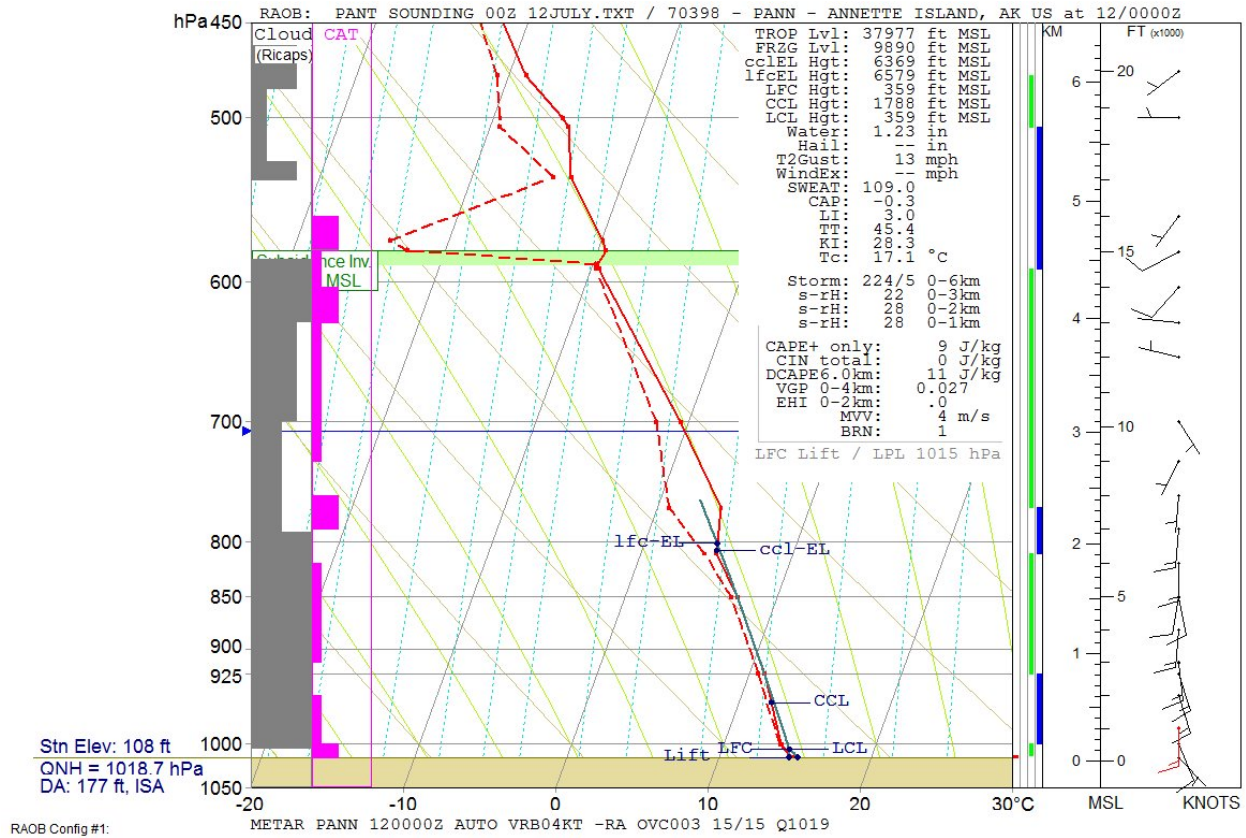
Figure 3 - PANN 1600 AKDT sounding

The sounding wind profile indicated a surface wind from the southeast or 140° at 6 knots with wind veering to the south immediately above 1,000 ft where a low-level wind maximum from 180° at 15 knots was identified with winds from the south through 9,000 ft with little directional variation. Above 9,000 ft the winds veered to the west with speeds of approximately 10 knots or less. The mean 0 to 6 kilometer (18,000 ft) steering wind was from approximately 190° at 13 knots, and no strong jet streams were identified on the sounding. The tropopause was at approximately 38,000 ft. The sounding indicated a potential for moderate turbulence near 160 ft and near 7,600 ft due to moderate vertical wind shears near those levels.

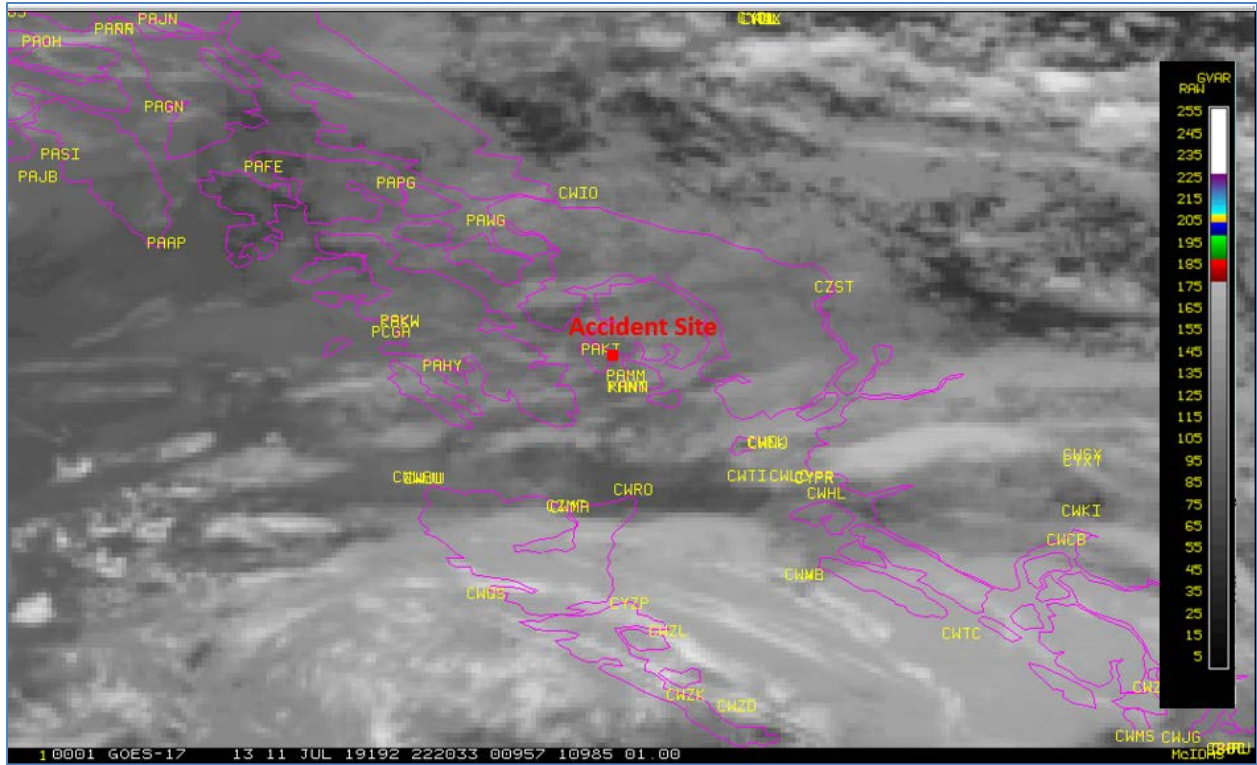
Figure 5 - GOES-17 infrared image at 1420 AKDT at 4X magnification with a standard enhancement curve

Figure 5 is the GOES-17 infrared image for 1420 AKDT at 4X magnification with a standard MB temperature enhancement curve applied to highlight the higher and colder cloud tops, with the accident site marked by the red square. The area was covered by low to mid-level clouds with approximate cloud tops near 9,500 ft.

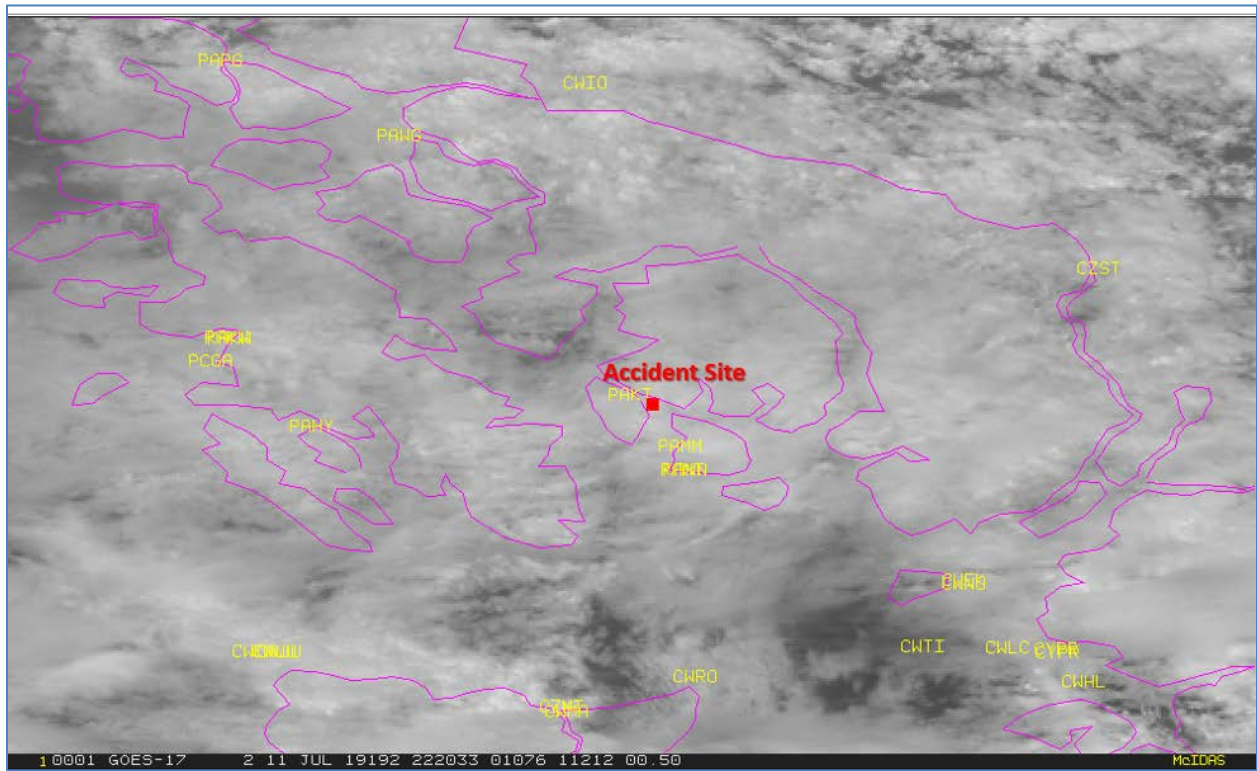
Figure 6 - GOES-17 visible image at 1420 AKDT at 2X magnification

Figure 6 is the GOES-17 visible image for the same period at 2X magnification showing more details of the low and mid-level broken to overcast cloud cover over the accident site.

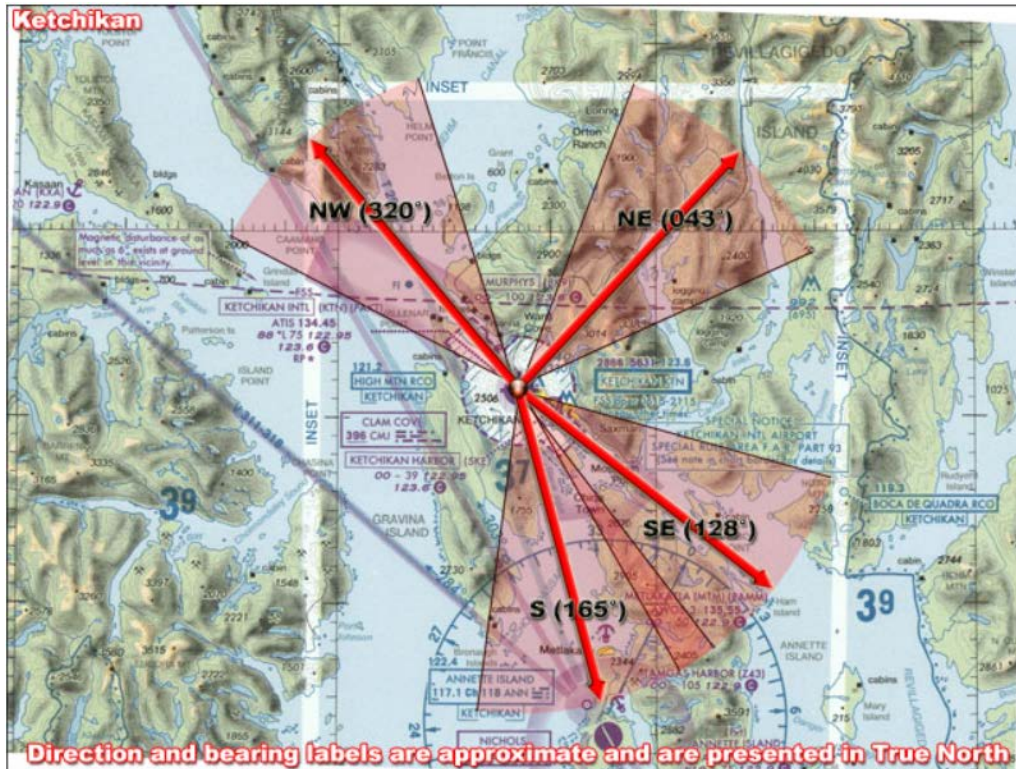
Figure 7 - FAA Weather Cameras for Ketchikan and viewing directions over a sectional chart

The FAA Ketchikan southeast (128°) and south (165°) viewing weather cameras surrounding the period were obtained and are documented below. Figure 7 is a depiction from the FAA website indicating the approximate viewing area of the cameras, with the accident site located within the overlapping views between the two southeast and south viewing cameras.

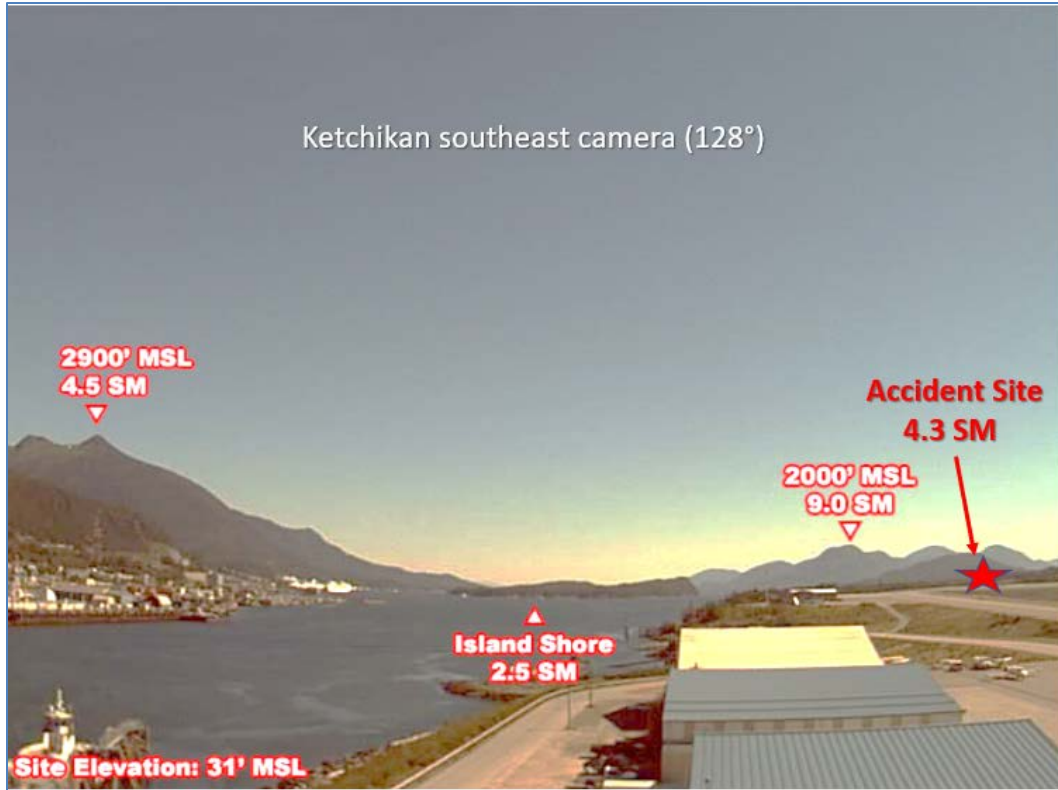
Figure 8 - Ketchikan southeast camera view on a clear day

Figure 8 is the Ketchikan southeast camera view on a clear day with the various landmarks and elevations noted. The approximate accident site location is marked approximately 4.3 statute miles (SM) off to the bottom right of the image. Pennock Island was located approximately 2.5 SM southeast and was referenced as Island Shore and Judy Hill is also visible in the image, with higher terrain on Annett Island at 9.0 SM at an elevation of 2,000 ft. The camera is mounted on the airport terminal at a height of 31 ft msl.

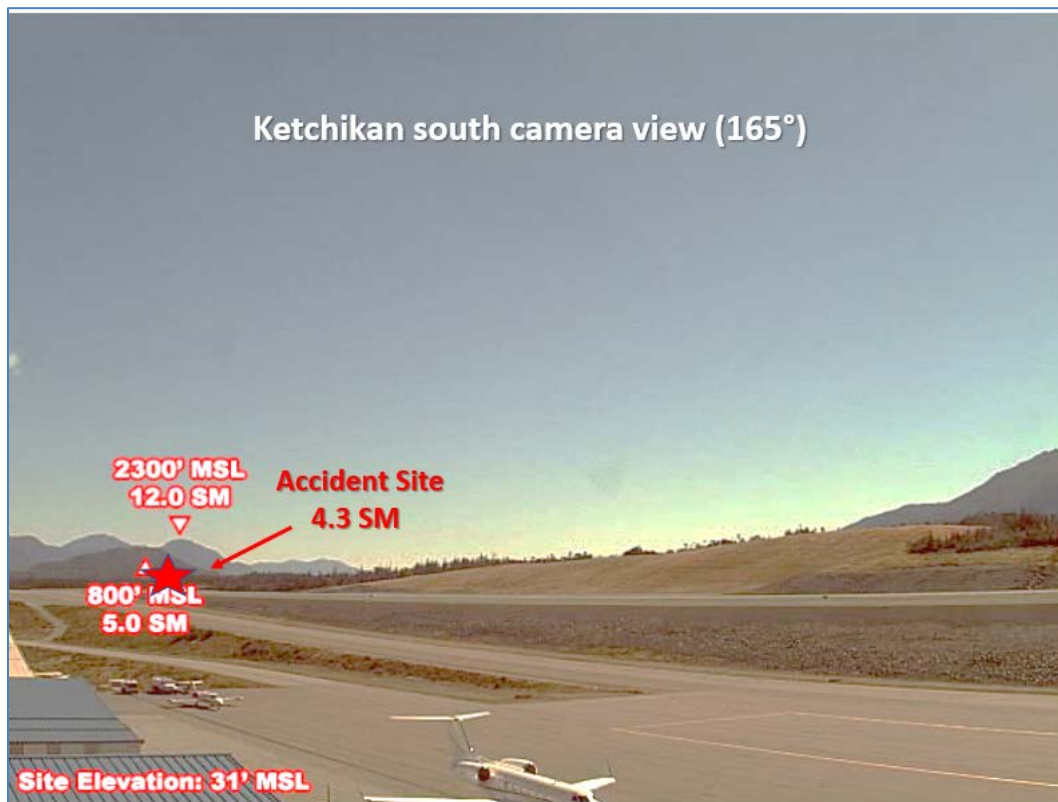
Figure 15 - Ketchikan south camera view on a clear day

Figure 15 is the Ketchikan south camera view on a clear day with the visual references noted and the approximate accident site located near the bottom left side of the image about 4.3 SM or near the base of Judy Hill.

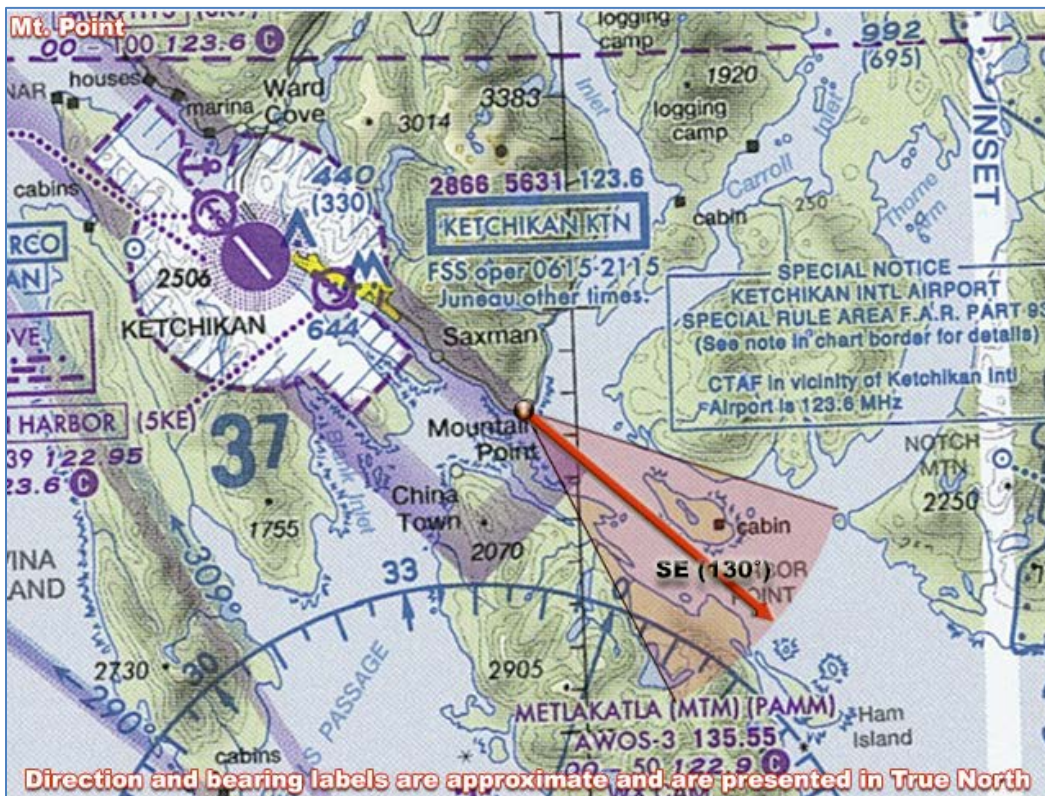
Figure 22 - Mountain Point southeast camera view

A third party weather camera site run by Taquan Air was located near Mountain Point located about 4 miles east-southeast of the accident site at an elevation of 183 ft and provided a camera view viewing southeast down the Revillagigedo Channel and depicting the conditions approaching the Ketchikan area. Figure 22 is a sectional map with the Mountain Point camera location and southeast view, with figure 23 the southeast view towards 130° reference points on a clear day with the camera at an elevation of 183 ft msl.
