NATIONAL TRANSPORTATION SAFETY BOARD
Office of Aviation Safety

STRUCTURES GROUP CHAIRMAN'S RUDDER LOADS STUDY

ANC20LA059

Operator: Private
Location: Anchorage, Alaska
Date: June 8, 2020
Time: 0945 Alaska Daylight Time (ADT)
Aircraft: Piper PA-12
Registration: N3188M

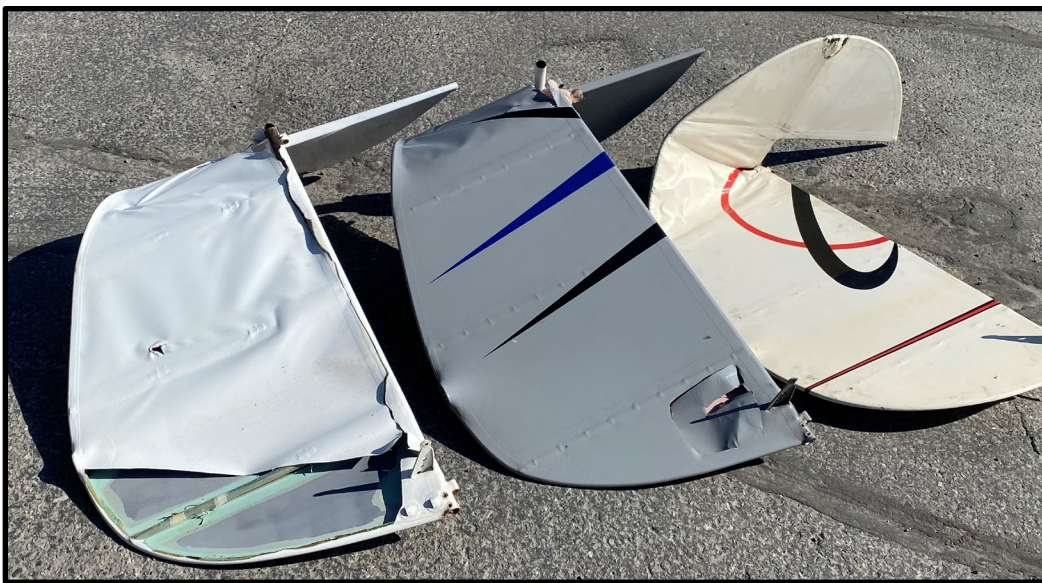
The accident airplane was equipped with a 160 HP¹ Lycoming O-320 engine and a McCauley propeller. The airplane had EDO 2000 floats installed per an STC. The rudder post was fractured at the upper end of the upper hinge barrel and the top of the rudder was folded over to the left. There was a Whelen Model 9052051 LED strobe light installed at the top of the rudder post. The data tag on the strobe light indicated it weighed 0.65 lb. A LED tail navigation light/strobe was also installed on the rudder trailing edge in place of the original navigation light.

Figure 1-PA-12 fractured rudders; grey rudder is from accident airplane.

Available information indicated that the white painted rudder came off a wheel equipped PA-12 airplane with a 180 HP Lycoming O-360 engine and the cream painted rudder came off a wheel/ski equipped PA-12 airplane with a 150 HP Lycoming O-320 engine. The white painted rudder post was fractured about ½ inch above the upper edge of the upper hinge barrel and the top of the rudder was folded over to the left. There was evidence of a light being installed at the top of the rudder post, but it wasn't installed when received. The cream painted rudder post was fractured about 1 inch above the upper edge of the upper hinge barrel and the top of the rudder was folded over to the right. There was evidence of a light being installed at the top of the rudder post, but it wasn't installed when received.

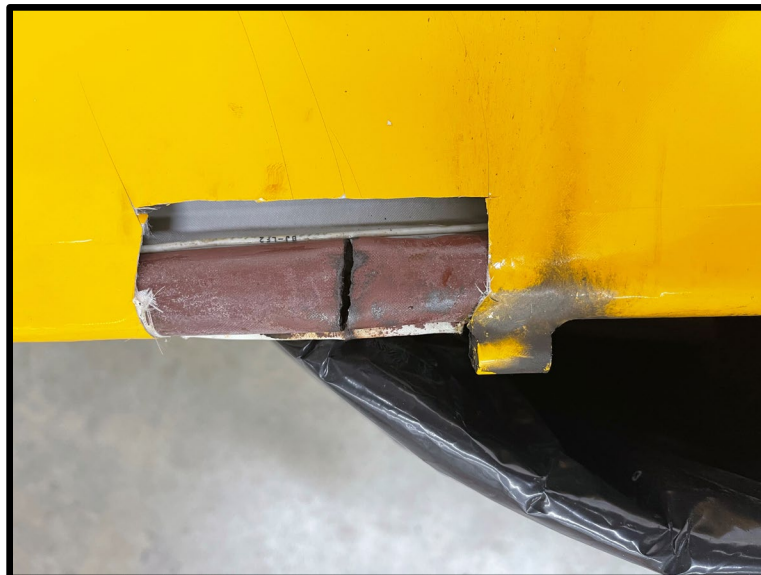
Figure 2-PA-18 fractured rudder post.

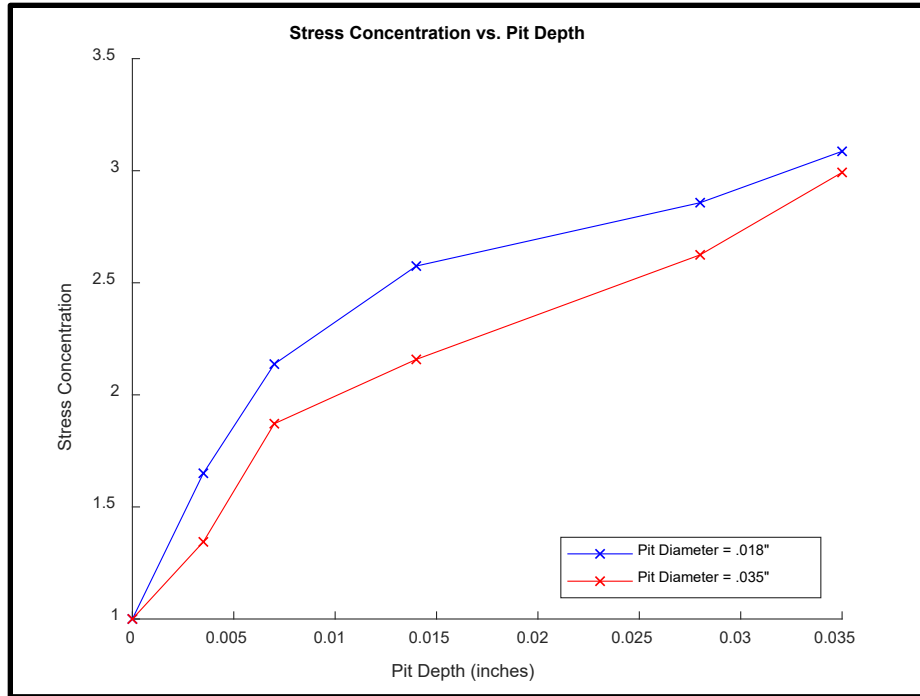
post in the vicinity of the fractures. Rudder A had visible pitting in the vicinity of the fracture and Rudder C had a scratch associated with the fracture location. The pitting or scratching will act to increase the localized stress due to the loss of cross-sectional area and due to the stress concentration at the pit or scratch tip. Additionally, rudders A, B and C had faceted features and surface roughness consistent with being grit blasted. The angular features would also tend to locally increase the stress in the rudder post. The stress concentration factor, K_t , affects the nominal stress according to the following.

Figure 6 – Stress Concentration due to corrosion pit.

The results show an initial steep increase in the stress concentration up to a depth about 0.007-inch followed by a more gradual increase up to the tube wall thickness where the stress concentration approaches 3. A stress concentration of 3 agrees with data published in *Peterson's* for a hole in a thin infinite plate in bending. The stress concentration for the smaller diameter pit is higher throughout as expected. At the pit depth of 0.007-inch the stress concentration for the 0.018-inch diameter pit is 2.137 and for the 0.035-inch diameter pit is 1.871.
