## **NATIONAL TRANSPORTATION SAFETY BOARD**

### **Group Chairman's Factual Report**

# **AIRWORTHINESS**

ANC20MA010

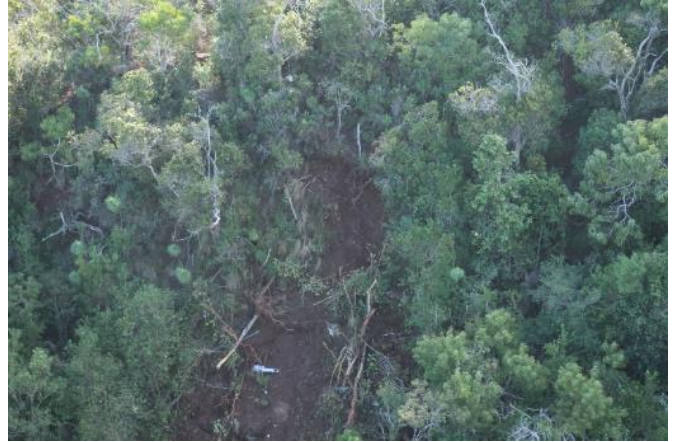
The wreckage was located in tropical mountainous terrain at about the 3,003-foot level (Figure 2). Evidence of terrain impact was against a 33° vertical face of a ridge that transitioned to a 64° angle where the wreckage came to rest about 100 feet below the ridge. The impact area was on the north face of a ridge that descends to a small canyon running east-west with disturbed terrain evident slightly below the ridge top (Photo 1). The impact area dimensions were about 100 feet vertical distance and 30 feet wide, with the wreckage halfway between the ridge top and valley below. Aerial observation of the wreckage confirmed a post-crash fire (Photo 2).

Photo 2 - Aerial view of the accident site.

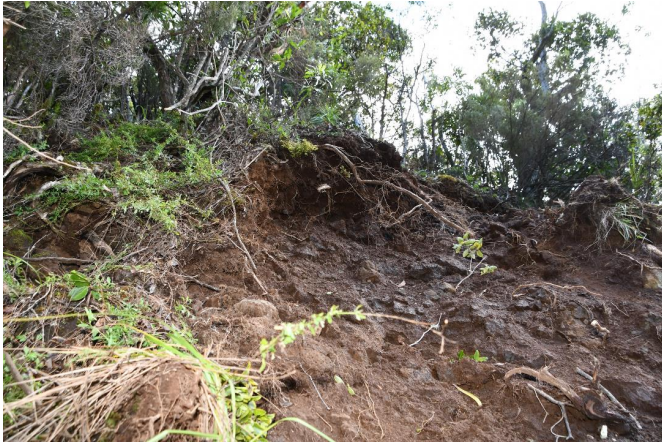
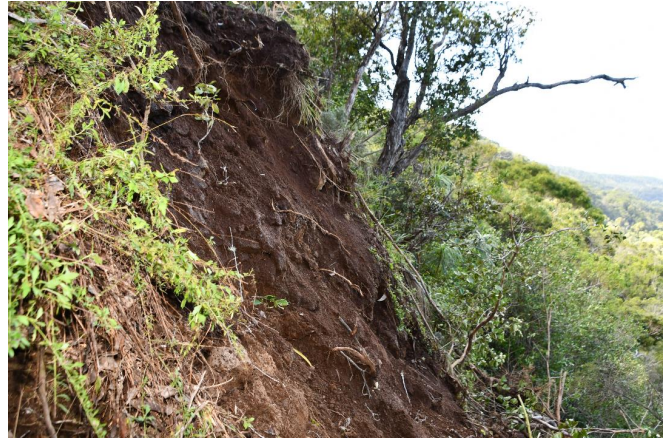
Photos 3 & 4 – The initial impact zone where surface soil has sloughing away revealing the underlying rock.

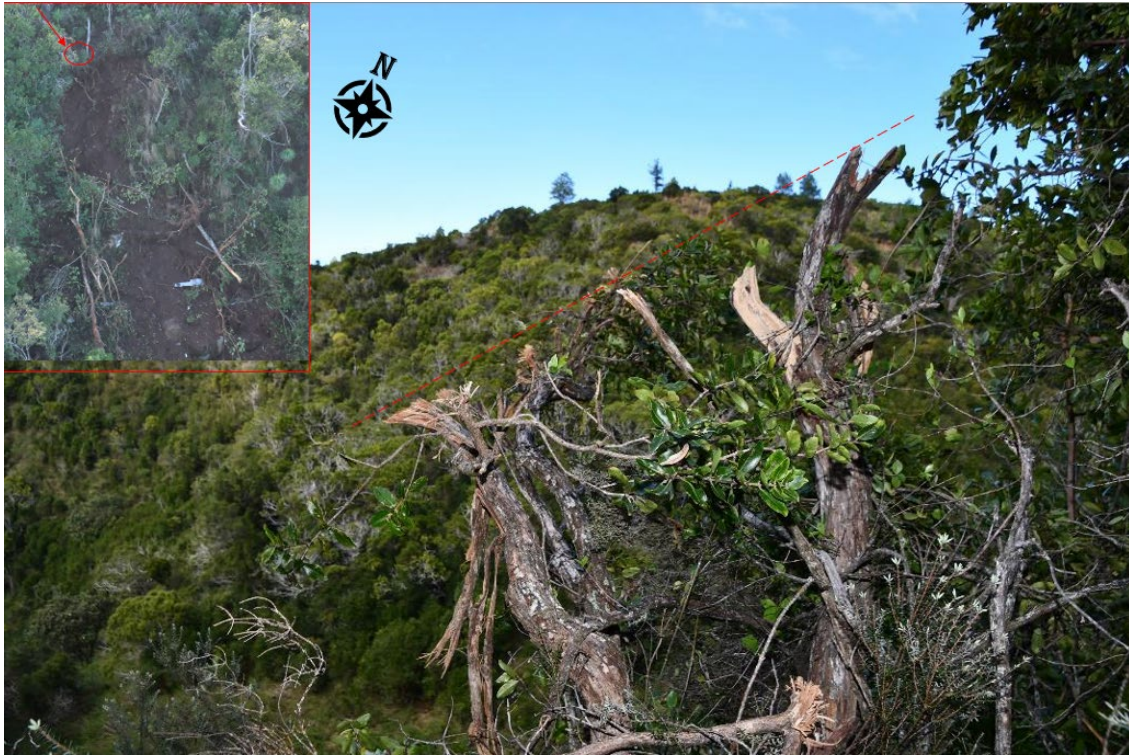
Photo 5 - Rotor cut, viewed looking from the accident slope towards the center of the canyon.

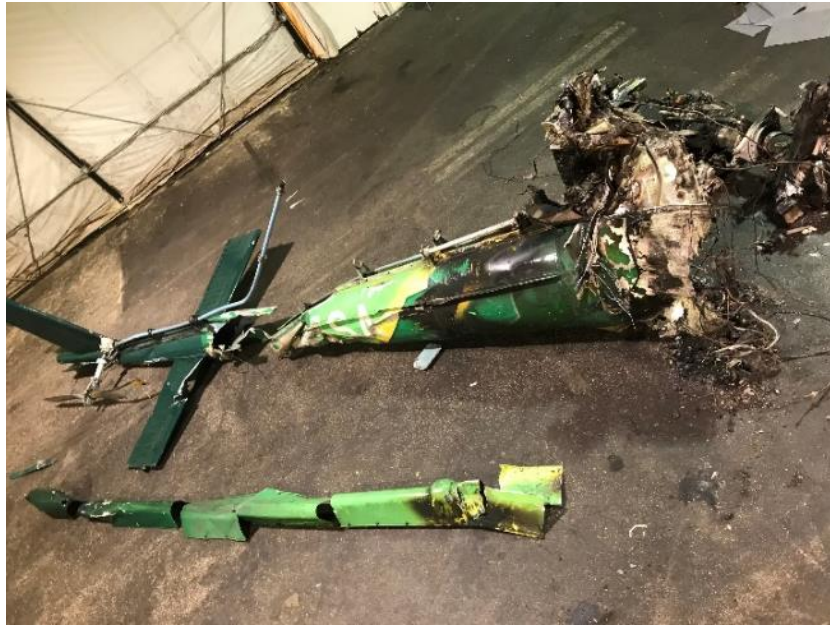
The tail boom had fractured into 3 sections. The mid-length fracture exhibited twisting and buckling. The vertical tail section had separated aft of the tail rotor gear box (TRGB), exhibited twisting and buckling in the clockwise direction when looking forward. The dorsal fin was bent up, left, and aft. The vertical fin appeared undamaged.

Photo 7 - Tail section.

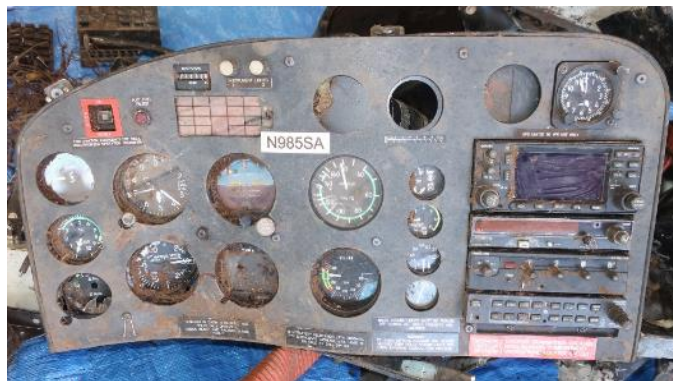
The instrument panel remained relatively intact but had separated from the cockpit cabin structure. All readings recorded below are approximate values as found after recovery.

Photo 8 - Cockpit instrument panel.

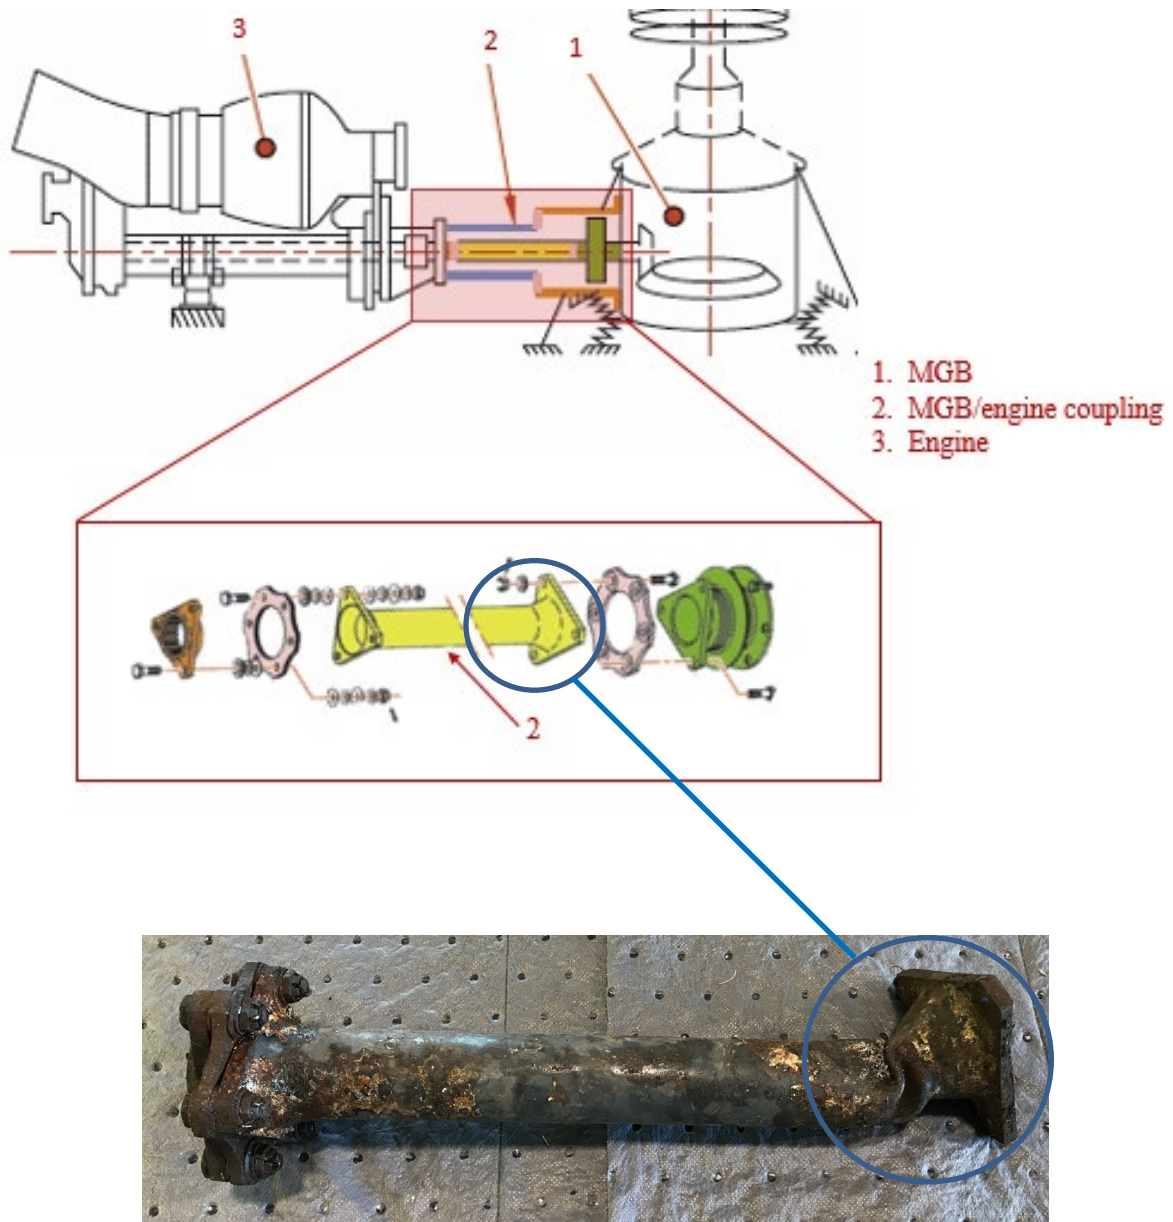
The MGB-engine coupling shaft (transmission shaft) was torsionally twisted in the engine driven direction (Figure 3). One of the bolt holes was deformed opposite the direction of drive rotation. The engine side splined adapter had smeared splines as did the splines on the freewheel shaft drive. All these signatures are consistent with power at the time of rotor impact.

Figure 3 - MGB-engine coupling shaft exhibiting torsional deformation.

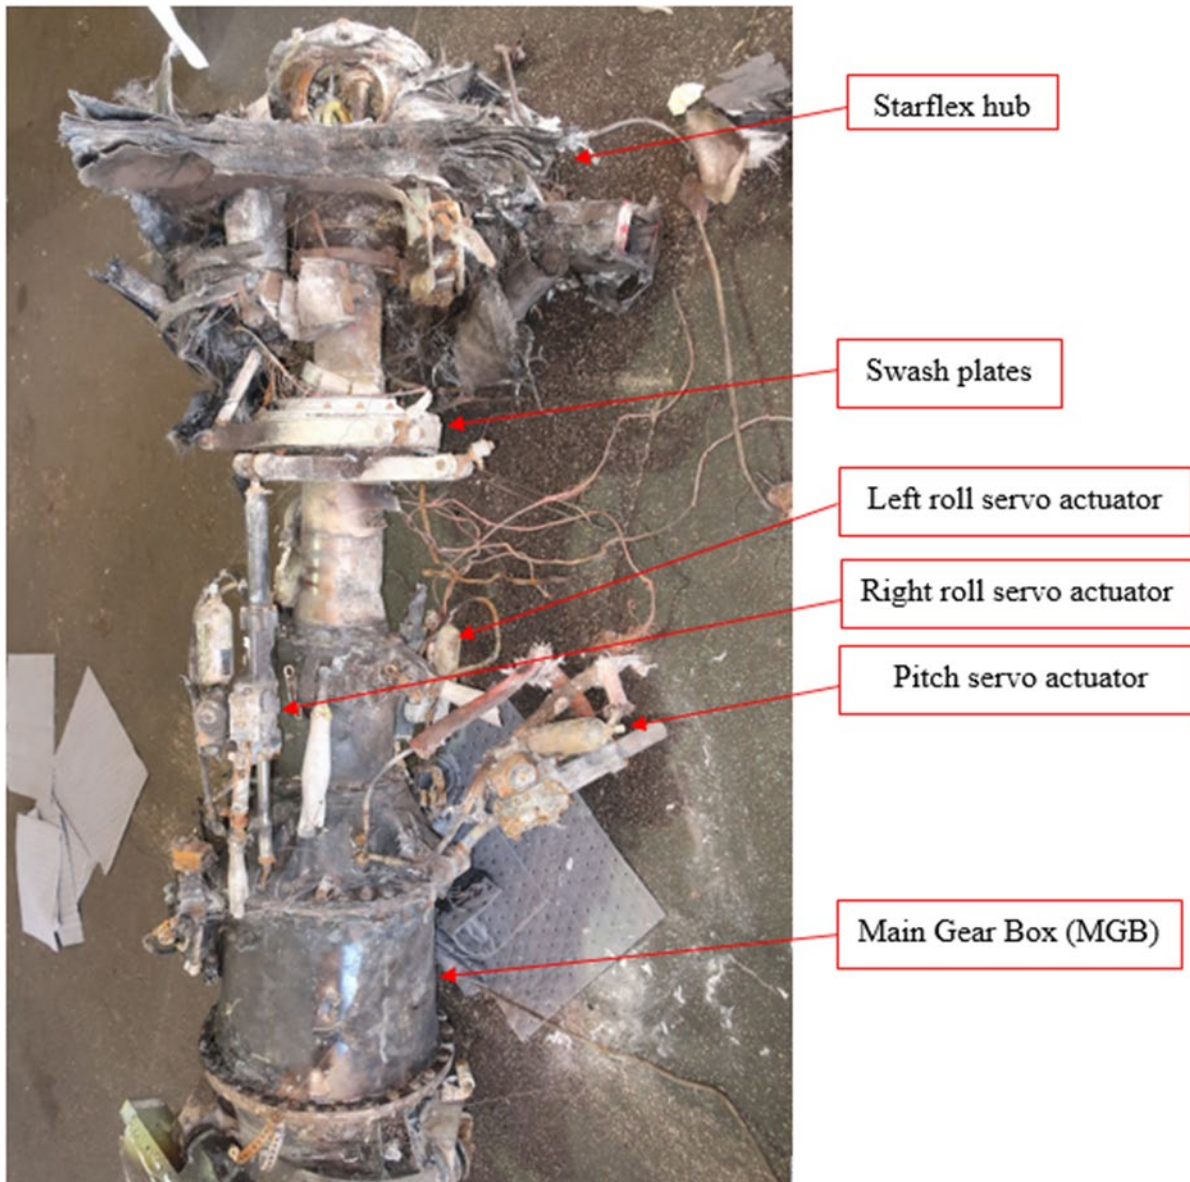
The transmission and rotor head remained connected as a single unit but had separated from the aircraft structure and exhibited extreme thermal damage (Photo 5).

Photo 9 - Main rotor head, rotor mast, servo actuators, and main gearbox (transmission).

All three pitch change links connecting the rotating swash plate to the blade control horns were thermally separated. The rod ends for each link remained attached to their respective connecting points. The composite Starflex hub exhibited heavy thermal damage. Each star arm was fractured at an angle, indicative of power. The blade attachment sleeves were located in the vicinity of the rotor head. The main rotor drive scissor was connected. Two of the vibration dampening springs were separated from rotor head and exhibited thermal damage. The third spring remained in the rotor head.

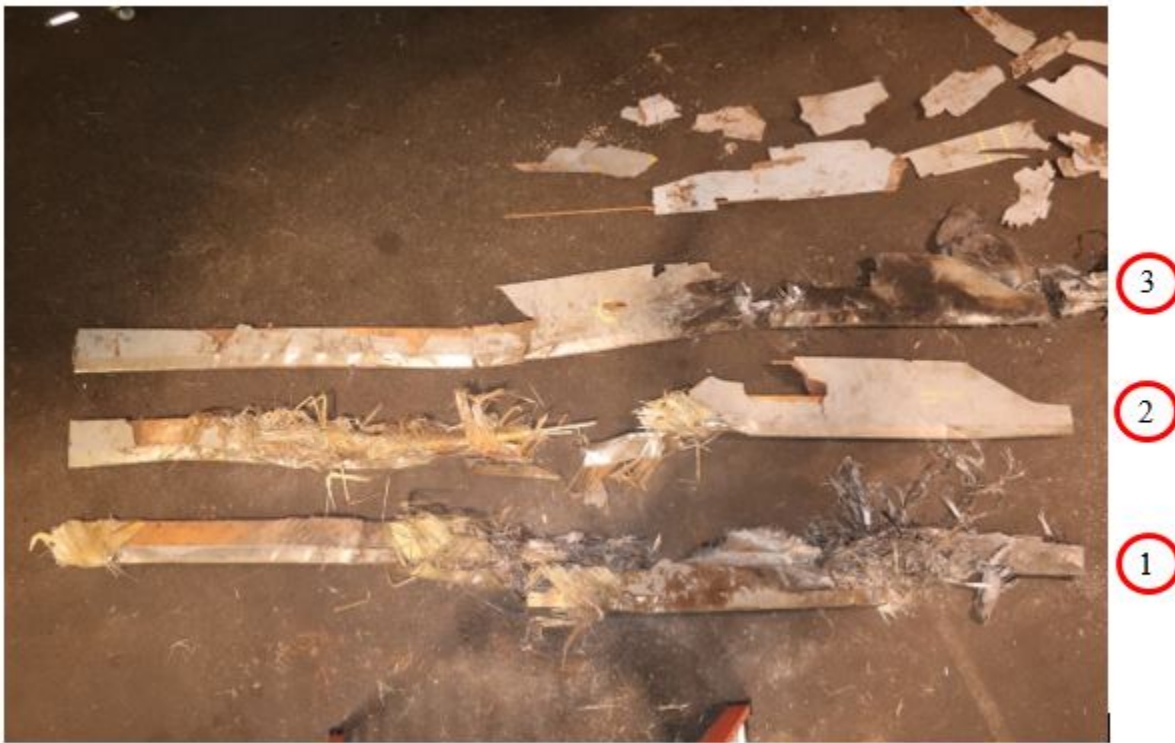
The majority of all three rotor blades were located with the wreckage. All three blades were cut off at the root by recovery personnel. Miscellaneous fragments of blade skins were recovered. Blades were arbitrarily identified by the investigators as 1, 2, and 3 (Photo 6).

Photo 10 - Main rotor blades laid out and labeled.

Thermal separation was evident approximately 3 feet from the root. The mid-section was separated and 3 inches of blade tip was missing. The trailing edge, upper and lower blade skins were missing or separated. The composite structure was frayed at the tip and mid span.

Fractured at mid span with extensive damage to the outboard  $2/3^{\text{rds}}$  of the blade. The trailing edge and blade skin was not present. The core composite structure exhibited extensive fraying damage. The blade tip remained attached.

Thermal damage and separation along the first  $1/3^{\text{rd}}$  of the blade outboard of root. There were leading edge divots. The blade had been cut mid span by recovery personnel. The trailing edge was not present. Blade tip was present on the blade.

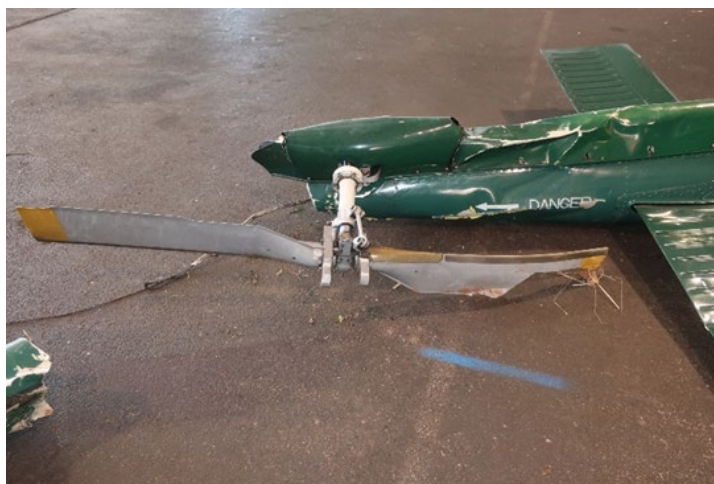
Photo 11 – Tail rotor blades remained attached to the hub and gearbox.

Tail Rotor assembly remained attached to the TRGB (Photo 7). One tail rotor blade exhibited trailing edge separation at midspan and was bent inboard. The other tail rotor blade was relatively intact, no damage was evident. Both pitch links were connected, pitch change movement was achieved by hand manipulation, with free and easy movement. The pitch change push-pull rod had separated from its actuation lever to the midspan break of the tail boom. TRGB moved freely with no binding. The tail rotor drive shaft was connected to the TRGB via the forward splined shaft. A torsional twist was

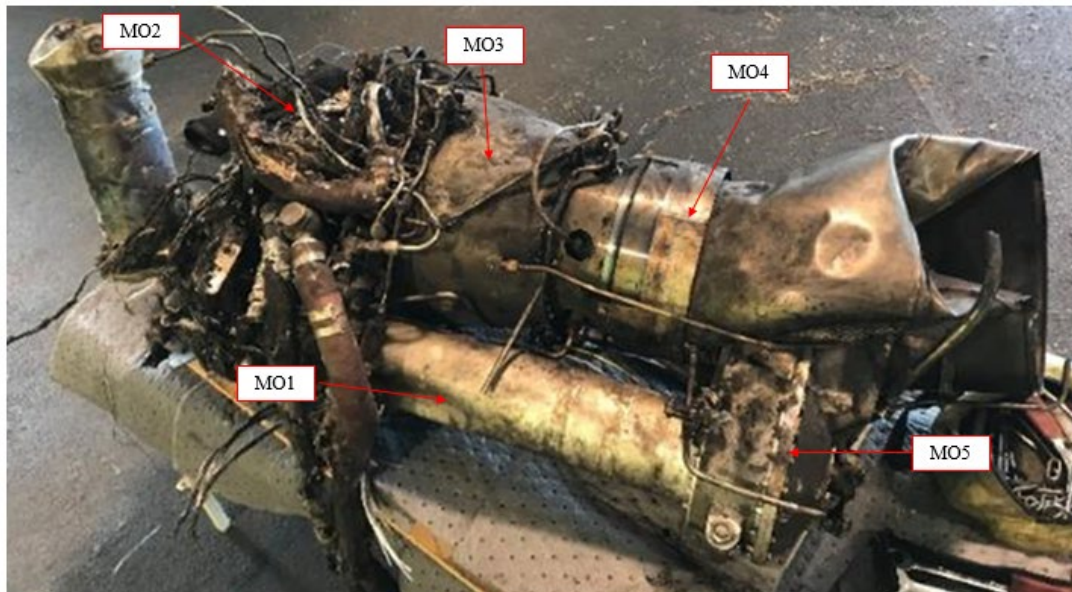
Photo 12 - External view of the engine.

The engine was examined after being recovered from the accident site. It had been thermally damaged by the post-crash fire (Photo 8). Several of the accessories and attaching fuel and oil lines were thermally damaged or consumed. The fuel control unit (FCU) had broken off at its mount to the accessory gearbox but remained attached by the fuel and air lines. Neither the FCU throttle nor anticipator Teleflex cables were still attached.
