NATIONAL TRANSPORTATION SAFETY BOARD

Group Chairman's Factual Report

OPERATIONAL FACTORS / HUMAN PERFORMANCE

ANC20MA010

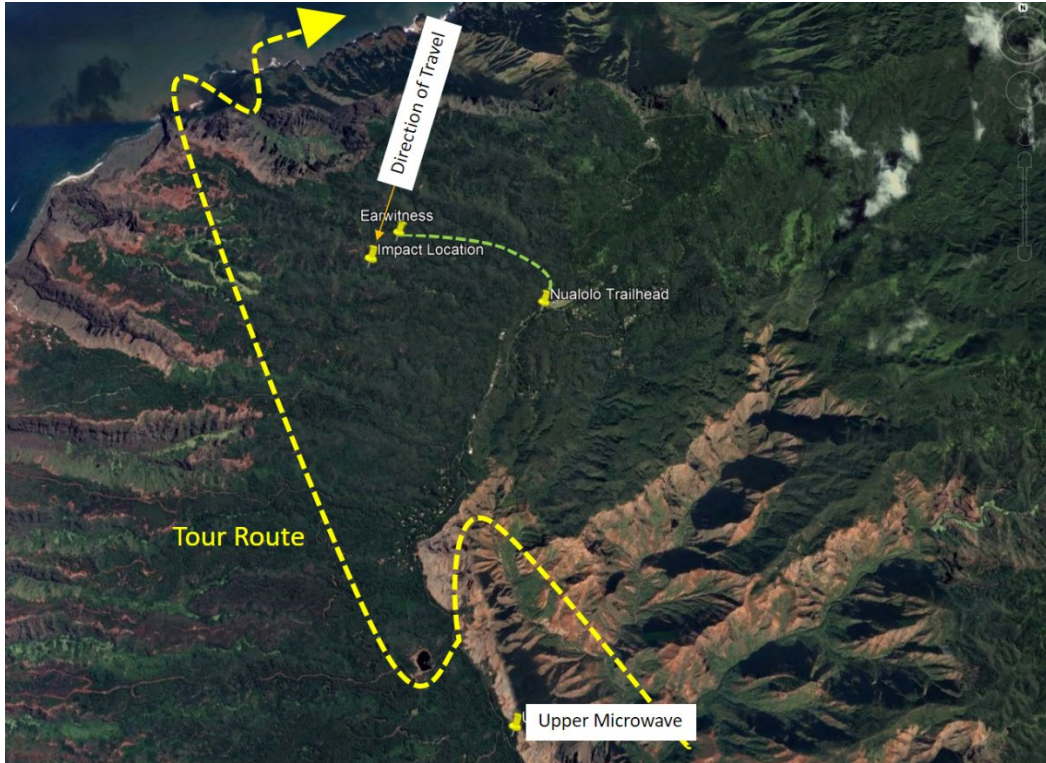
The accident site was about a half-mile east of the standard tour route. The helicopter was traveling in a southerly direction when it struck terrain (see figures 3-5 for illustrations of the helicopter's approximate direction of flight at time of impact, the location of the standard tour route segment for that part of the island, and terrain surrounding the accident site).

Figure 3. Overhead view of the normal tour route, accident and witness locations.

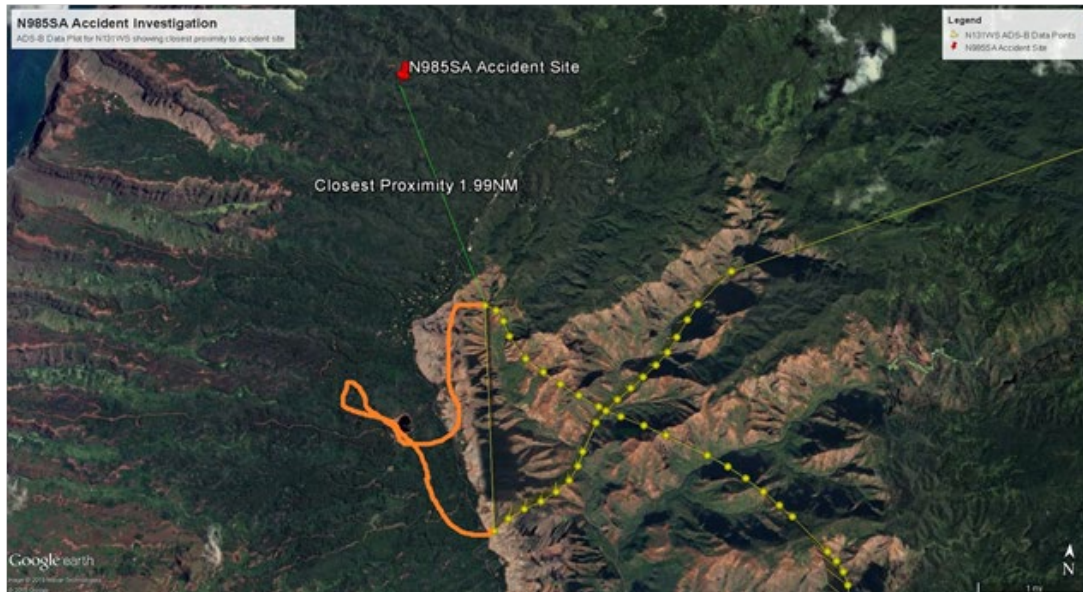
About a minute and a half after climbing over the northwest rim of the canyon, the Sunshine Helicopters pilot reversed course, crossed back over the rim of the canyon about 1701, and descended back into the canyon before diverting northeast to Wainiha. The Sunshine Helicopters helicopter was equipped with an automatic dependent surveillance broadcast (ADS-B) unit that broadcast the helicopter’s position during this flight, however, some returns were missing because of terrain interference. During a post-accident interview, the Sunshine Helicopters pilot sketched his route of flight west of Waimea Canyon in an area where ADS-B returns for his flight were not received. This sketch (orange line) is reproduced in Figure 6 alongside the ADS-B returns that were available for his flight.

Figure 6: Accident location and ADS-B track of Sunshine Helicopters. The orange track was drawn by the Sunshine Helicopters pilot to estimate his ground track in an area that lacked ADS-B coverage.

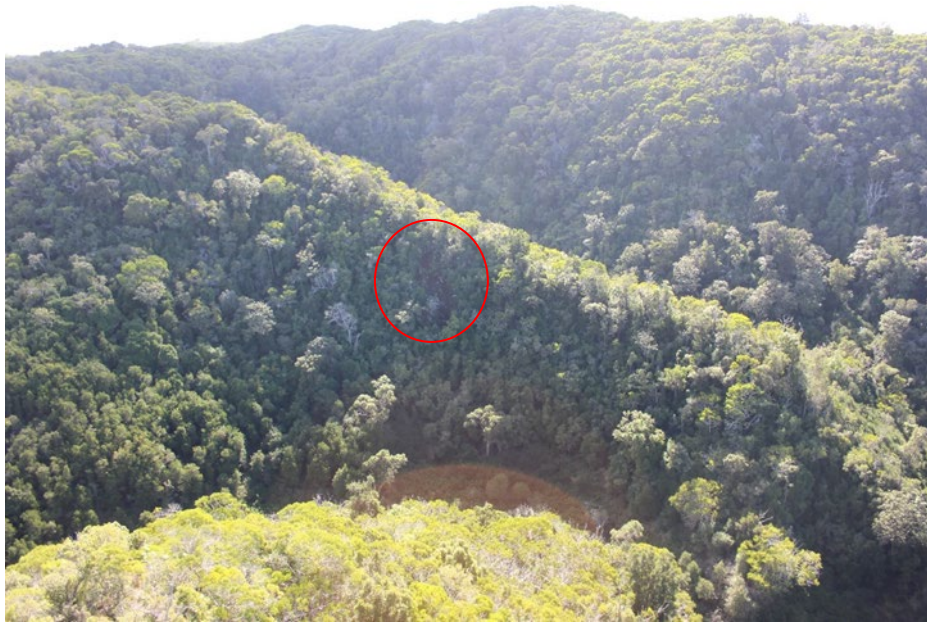
On December 27, 2019, at 0931, the aircraft wreckage was spotted by a rescue helicopter. The wreckage was in a ravine in an uninhabited area of Koke’e State Park. The helicopter had impacted the north side of a small ridge while flying in a south/southeasterly direction. Photos of the accident location are shown in figures 7 and 8.

Figure 7: Photo showing the north face of the ridge impacted by the helicopter (red circle highlights impact location)

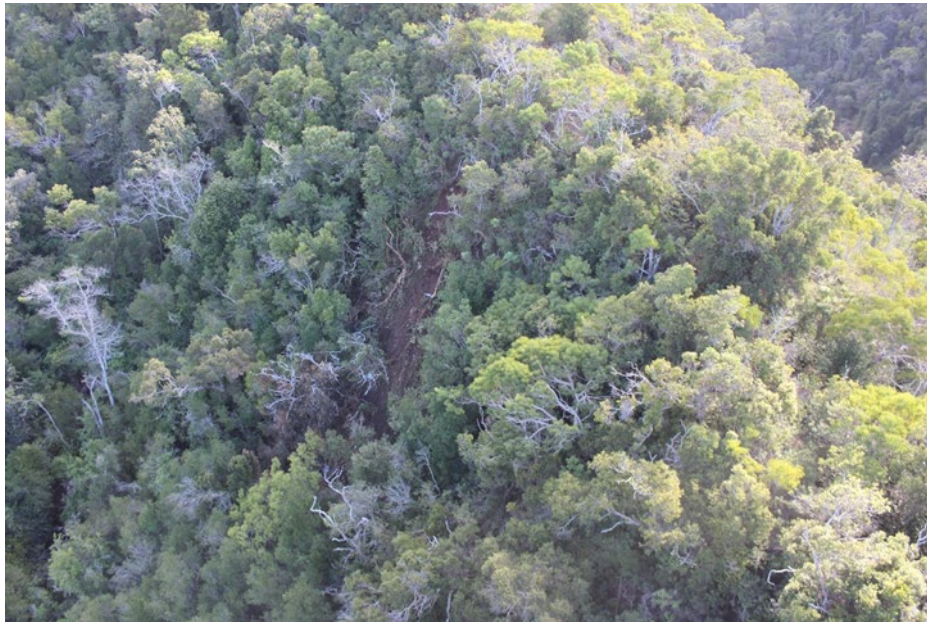
Figure 8: Photo showing terrain scarring from the impact oriented on a south/southeasterly direction.
