NATIONAL TRANSPORTATION SAFETY BOARD

STRUCTURES GROUP CHAIRMAN'S FACTUAL REPORT

A. ACCIDENT: **ANC21FA015**

Operator: Copper Valley Air Service
Location: Chitina, Alaska
Date: February 4, 2021
Time: 1051 Alaska Standard Time
Aircraft: Cessna A185E
Registration: N9725Z

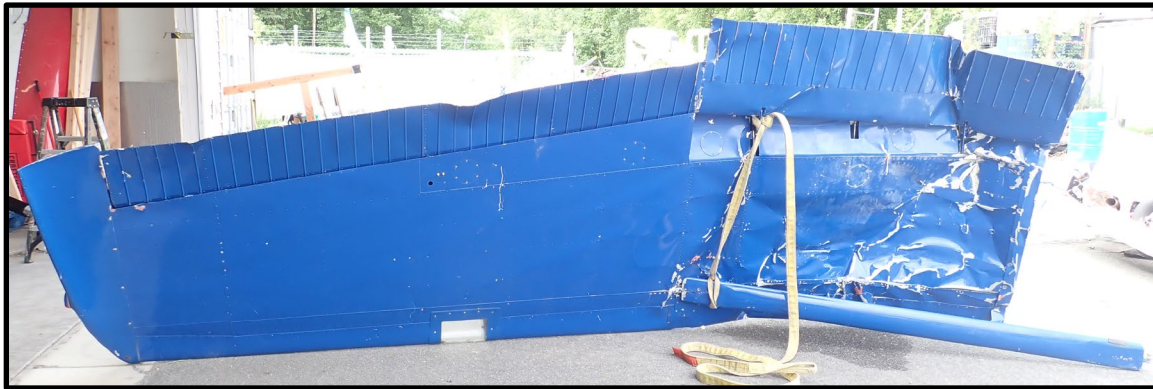
Figure 2-Left wing, lower surface.

The left wing was mostly intact and partially attached to the fuselage at the main wreckage site as described earlier. The left aileron and flap were intact and remained attached to the left wing (Figure 2). The left wing strut was intact and remained attached to the wing at the upper attach point with no obvious damage. The lower end of the left wing strut was separated from the fuselage. The lower strut bolt was intact and installed in the strut clevis fitting. The paint around the rivets attaching the upper and lower strut fittings to the strut was cracked and flaked (Figure 3). There was a rectangular impact impression in the lower surface of the left strut at the upper end consistent with the shape of the lower spar cap outboard of the strut. The wing outboard of wing station (WS) 100 was mostly undamaged and had no obvious deformation. There were two small downward deformations of the aileron trailing edge. The inboard wing area was buckled and compressed with the upper and lower skins closer together. The flap was deformed coincident with the buckling damage. The fuel bladder was breached at the inboard side. The forward spar lower cap and strut fitting on the spar had upward buckling and damage at the strut attach point.

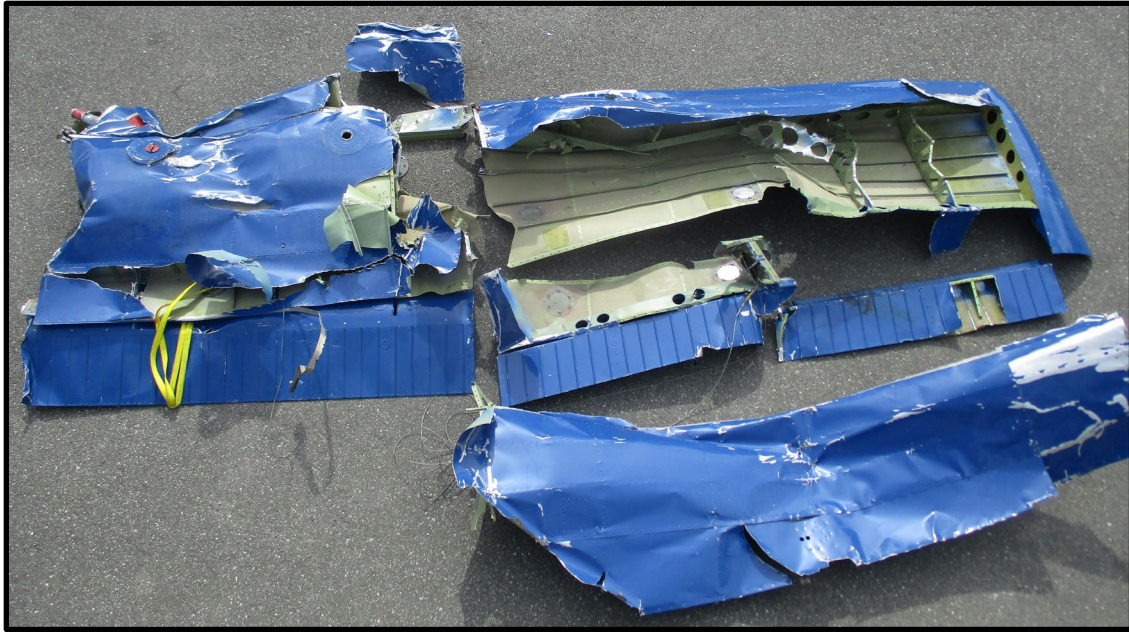
Figure 4-Right wing wreckage layout (strut not shown).

The right wing fractured into 5 pieces during the accident. One piece was further separated into 2 pieces for recovery yielding 6 separate pieces that were laid out (Figure 4).

The right inboard wing was mostly intact but damaged from the wing root at WS 23.6 to about WS 86 at the forward spar and WS 100 at the aft spar. There was a large semi-circular impact impression in the leading edge and upper skin with vertical scratching and gouging centered near WS 44. The upper and lower wing skins were pillowed outward in the fuel tank area. The forward wing spar was fractured near WS 86 and the upper cap, lower cap, and web were deformed and twisted consistent with the outboard portion of the forward spar rotating leading edge down with respect to the inboard portion. The aft spar was deformed upward with buckling damage between about WS 86 and WS 100 and the spar was fractured near WS 100. The three lower stringers between the spars had splices installed between about WS 91 and WS 99. The forward spar wing attach bolt remained installed through the wing lug fitting and fuselage clevis fitting but the fuselage clevis fitting was pulled from the fuselage. The fuselage fitting was jammed in a position about 45° up. The aft spar wing attach bolt was intact and installed in the fuselage clevis fitting. The aft spar upper cap wing lugs were fractured from the wing and remained installed in the fuselage fitting. The aft spar web was fractured through the attach point hole. The right flap remained attached to the inboard wing section. There was a tear in the upper skin aft of the aft spar from the outboard end to inboard end consistent with a cable pull through.

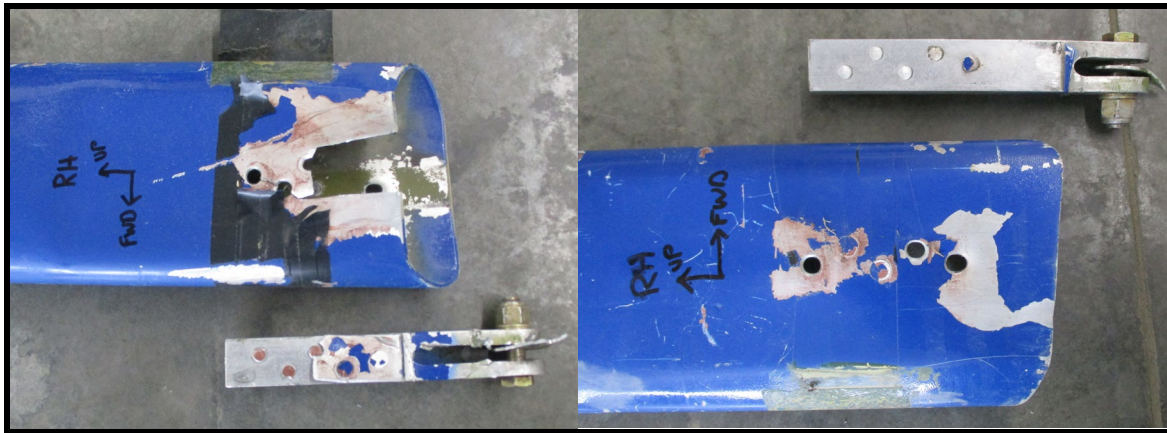
Figure 5-Right wing strut and lower fitting, upper surface (left) and lower surface (right).

The right wing strut was separated from the airplane and remained attached to a small section of forward spar. The spar section spanned from about WS 86 to WS 100. The upper spar cap near WS 100 had spanwise buckling deformation adjacent to the fracture. The lower spar cap near WS 100 was deformed upward. The upper strut attach bolt remained intact and installed through the strut clevis and forward spar. The right strut wing spar fitting was fractured through the lower bolt hole. The lower portion remained with the strut and the upper portion remained attached to the forward spar outboard of WS 100. The strut was unbolted from the spar during the examination. The lower strut fitting was separated from the strut and recovered at the main wreckage site. The lower strut attach bolt was intact and installed in the clevis and there was a

piece of the fuselage lug retained. The rivets on the lower side of the strut fitting and 3 rivets on the upper side of the strut fitting were all deformed and sheared upward (Figure 5). The corresponding holes in the strut were ovalized. There was buckling damage to the upper strut skin and a small portion of the strut skin remained attached to the fitting on the upper side. There was a dent in the upper surface of the right strut about 39 inches from the upper end. The strut appeared straight. There was a rectangular impact impression in the lower surface of the right strut at the upper end consistent with the shape of the lower spar cap outboard of the strut.

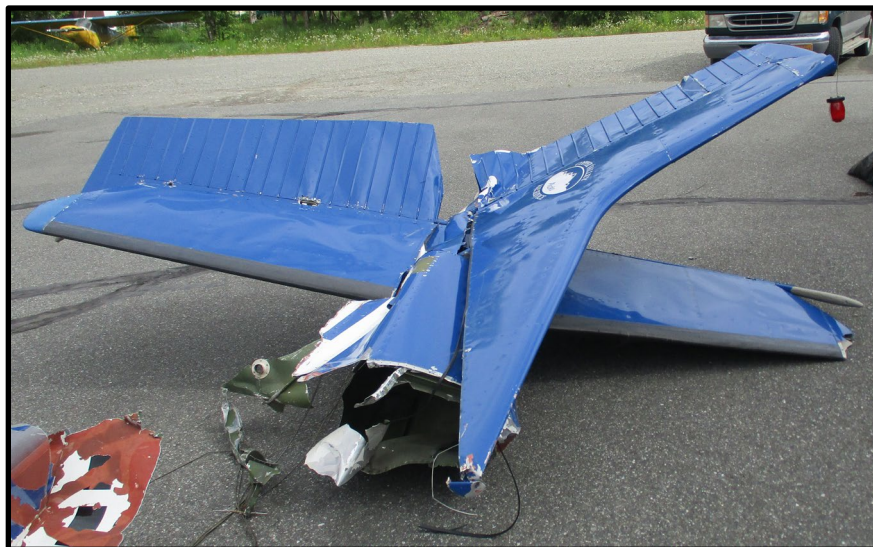
Figure 6-Separated empennage.

The empennage separated from the airplane at the FS 172 bulkhead location and was mostly intact. The horizontal stabilizer, elevators, vertical stabilizer, and rudder remained attached to the empennage. There was a cable tear through on the right side of the empennage from FS 172 aft to about FS 204. There was no obvious deformation of the horizontal stabilizer or stabilizer shelf. The vertical stabilizer and rudder were deformed to the left. The vertical stabilizer attach bolts were all intact and installed. The right forward, right aft and left aft attach holes in the vertical stabilizer forward and aft spars were fractured consistent with the left deformation of the vertical stabilizer. The left aft attach hole in the empennage bulkhead was fractured consistent with the left deformation of the vertical stabilizer. The right and left trim actuators were separated from the lower surface of the horizontal stabilizer. The attach bolts were intact and installed in the trim actuators and the brackets were deformed and fractured consistent with upward movement of the leading edge of the horizontal stabilizer relative to the actuators. The trim chain was pulled through the actuator gears such that the left cable to chain junction was jammed in the left actuator gear. The horizontal stabilizer aft attach point bolts were intact and installed. The aft left attach point on the stabilizer shelf was fractured and deformed up. The left and right elevators remained intact and installed on the horizontal stabilizer. The right elevator was jammed in a trailing edge up position and the left elevator was jammed in a trailing edge down position which was consistent with on scene photos. The right elevator torque tube flange was fractured and separated from the center bell crank with torsional deformation consistent with the right elevator deflected trailing edge up with respect to the left elevator. The right elevator center hinge was pulled from the elevator spar. There was damage to the upper and lower right elevator skins consistent with over travel up and down.

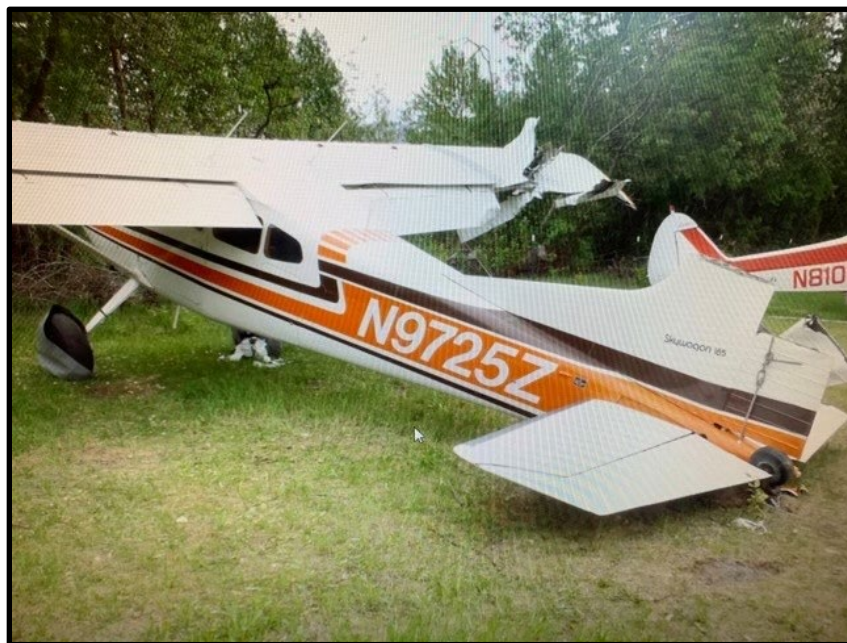
Figure 7-Airplane N9725Z after the collision.

On May 26, 2014, the parked and tied down accident airplane was impacted by another airplane that lost control during landing. The collision damaged the right wing, right horizontal stabilizer and elevator, and the vertical stabilizer and rudder. Photos supplied to the NTSB showed the damage to the accident airplane after the collision (Figure 6).

The first maintenance logbook entry after the collision was dated February 20, 2016, with a total aircraft time of 5,473.6 hours. The entry stated that the “aircraft was repaired by replacing cabin roof skin, replacing front spar and top skin on vertical stabilizer, applying patch to horizontal stabilizer, and repairing tip of replacement right hand wing”. The FAA Form 337 associated with the wing repair indicated that the WS 208 center rib, top skin, bottom skin, and outboard auxiliary spar were replaced on the right wing. The Form 337 for the horizontal stabilizer repair indicated a patch was installed on the right horizontal stabilizer outboard top skin. There was no Form 337 for the vertical stabilizer repair. A new tachometer was installed at this time with a reading of 0. The airplane was also repainted white and blue, and a weight and balance was performed.

According to the mechanic that repaired the airplane, the right wing installed on the accident airplane was removed from a 1969 Cessna 180H, N91399, SN 18052069, repaired and installed. Textron provided detailed information on the differences between the Cessna 180 and Cessna 185 wing as built. The Cessna 180 wing installed had different shaped holes in the aft spar web at two locations with a thicker doubler installed at one of the locations, an updated fitting, and several updated parts.
