**ANC21FA069**

**September 22, 2021**

**Dehavilland DHC-2 Beaver, N1249K**

**NTSB EXAMINATION POWERPLANT REPORT**

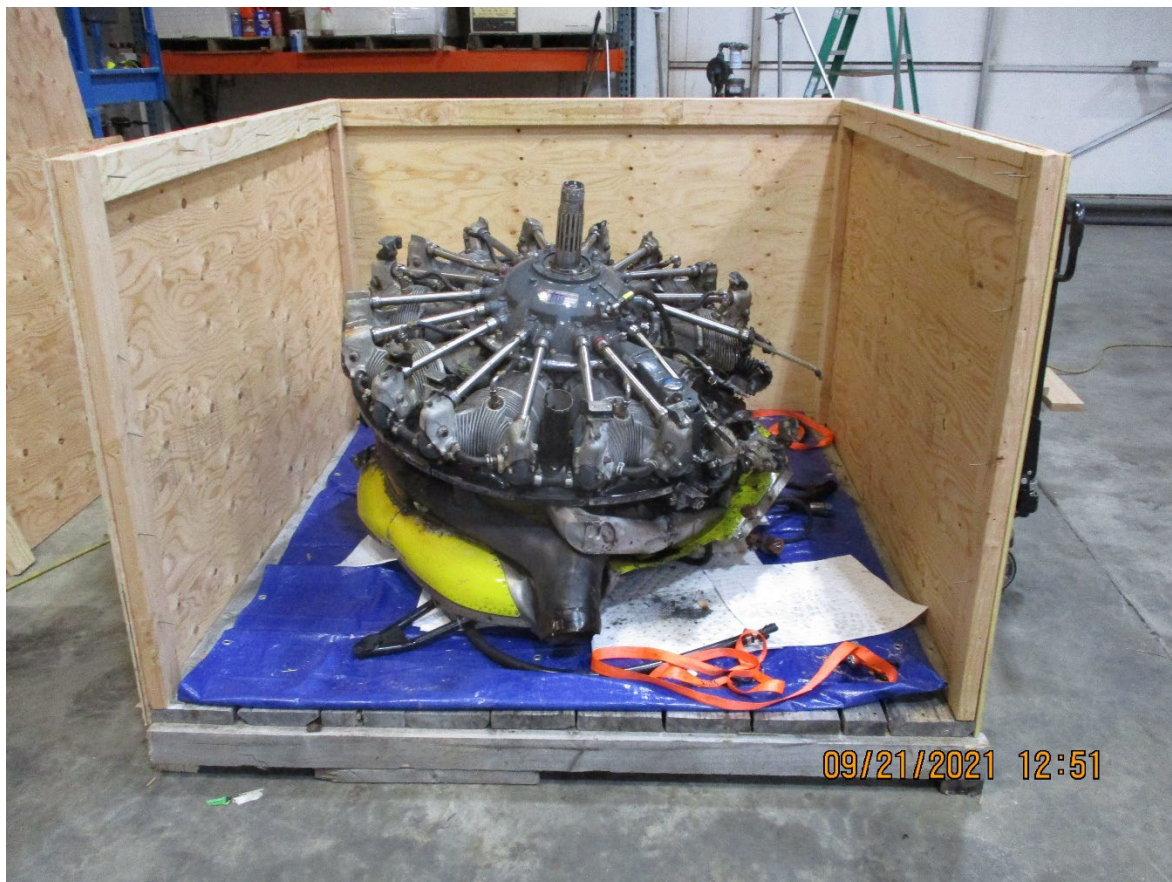
Examination of N1249K engine was completed on September 22, 2021, at a Temsco hangar, in Ketchikan, Alaska. The engine was in a crated box when the examination began. (See figure 1.)

*Figure 1 engine in crate.*

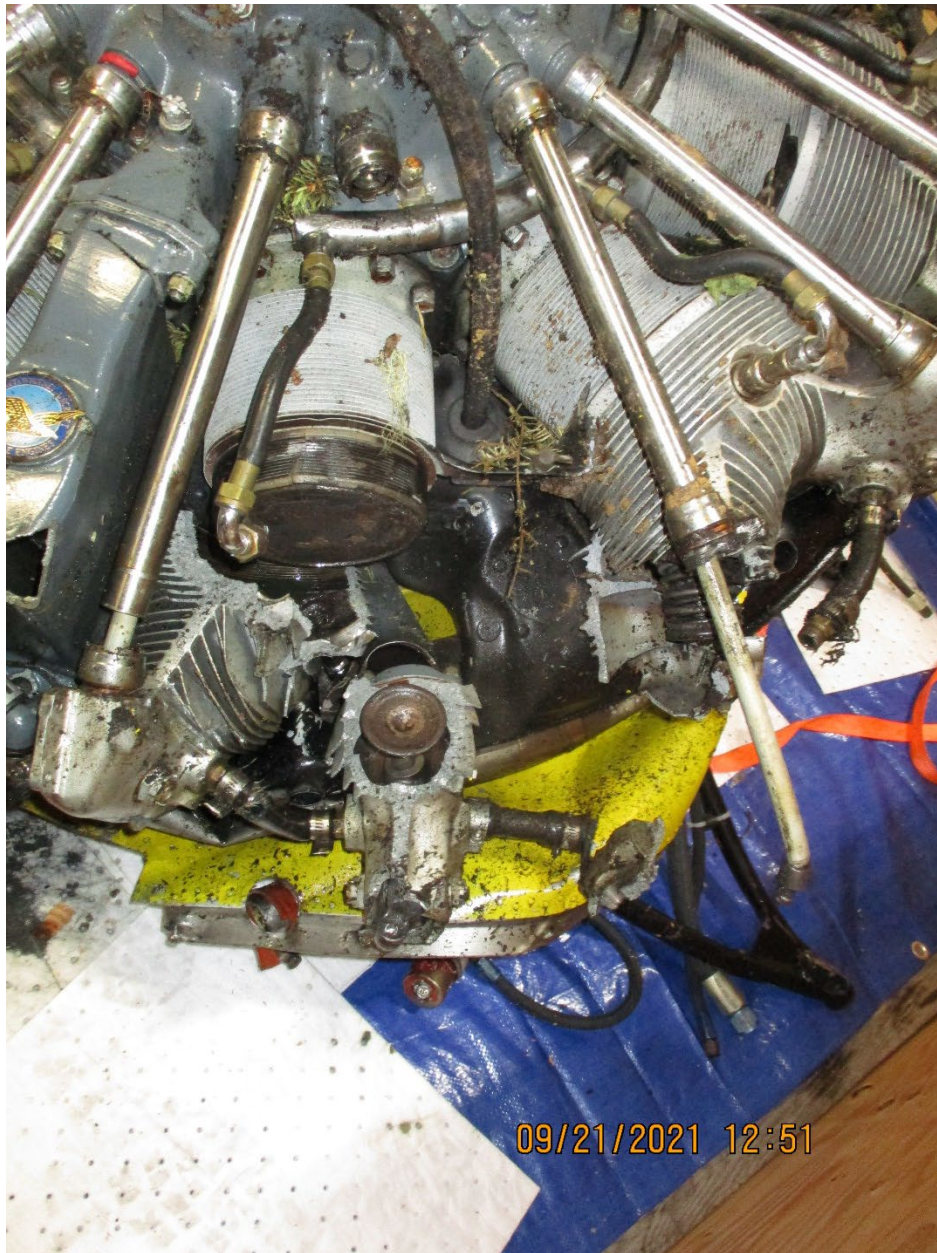
During initial examination, it was noted that the No. 6 cylinder head was fractured off by impact forces. The spark plugs were missing, and the rocker arms and housing were attached by the oil return lines. The No. 7 exhaust rocker arm and housing was fractured off the cylinder head. All cylinder fins were intact, however, tree branches were jammed in between the cooling baffling and cylinder fins throughout the engine. (See figure 3.)

*Figure 3. View of Nos. 6 & 7 cylinder damage. Note tree debris in cylinder fins.*

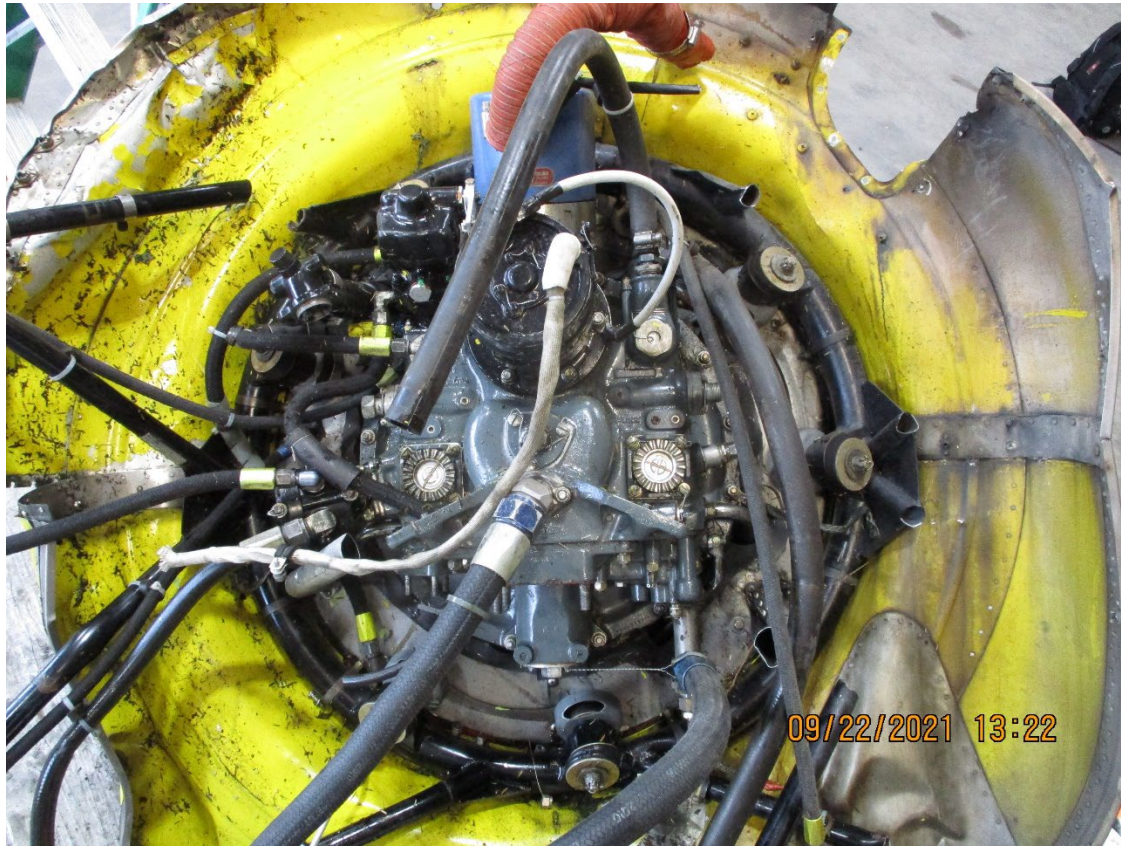
The fuel lines were fractured off at the bulkhead. (See figure 4.)

*Figure 4. Aft view of engine and fractured fuel lines.*

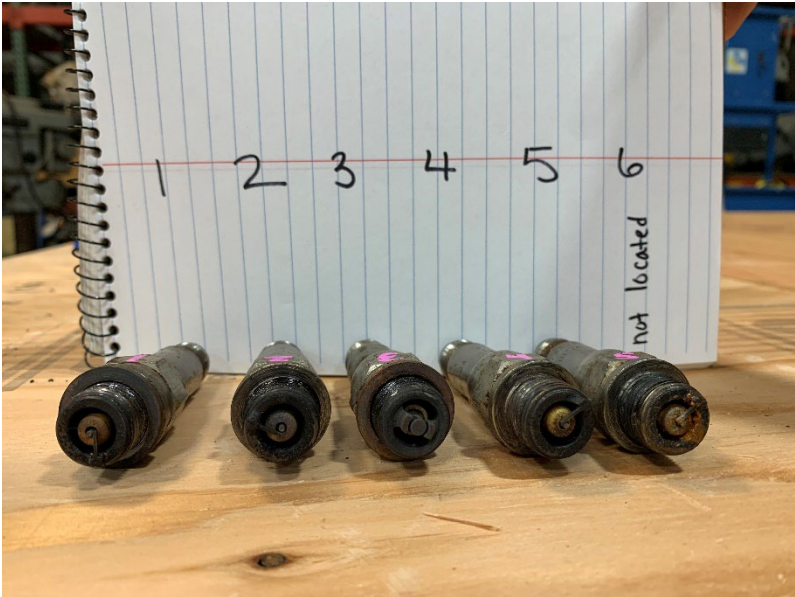
Figure 5 engine spark plugs, 1-5

The front spark plugs were removed to facilitate a boroscope examination. The spark plugs were a mix of fine wire and massive electrode style. Normal wear was exhibited on the spark plugs, however evidence of water ingestion from impact forces showed corrosion. (See figure 5-6.)

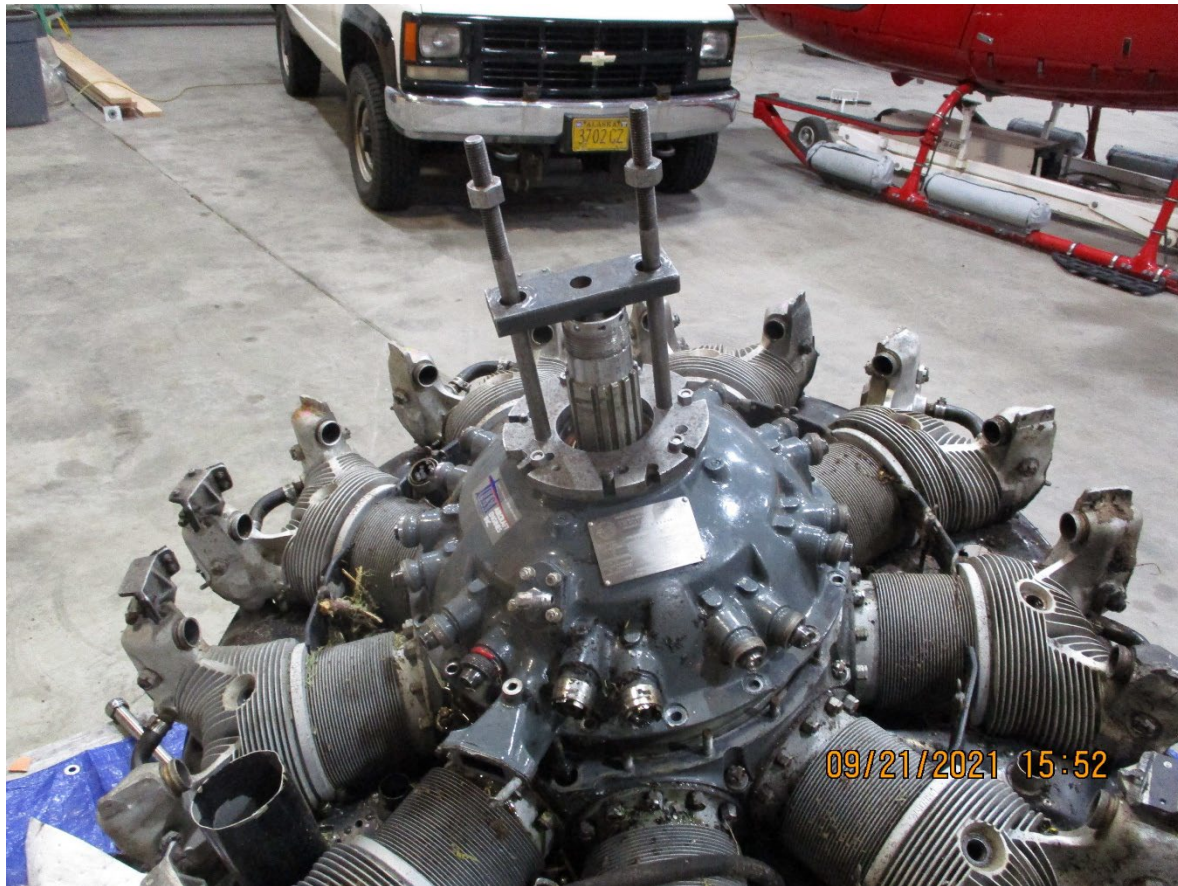
The rocker arm caps were removed, and the tension was released from the springs to facilitate push rod removal and front case removal. All the push rods exhibited normal wear. (See figure 7.)

*Figure 7. View of nose cone prior to removal.*

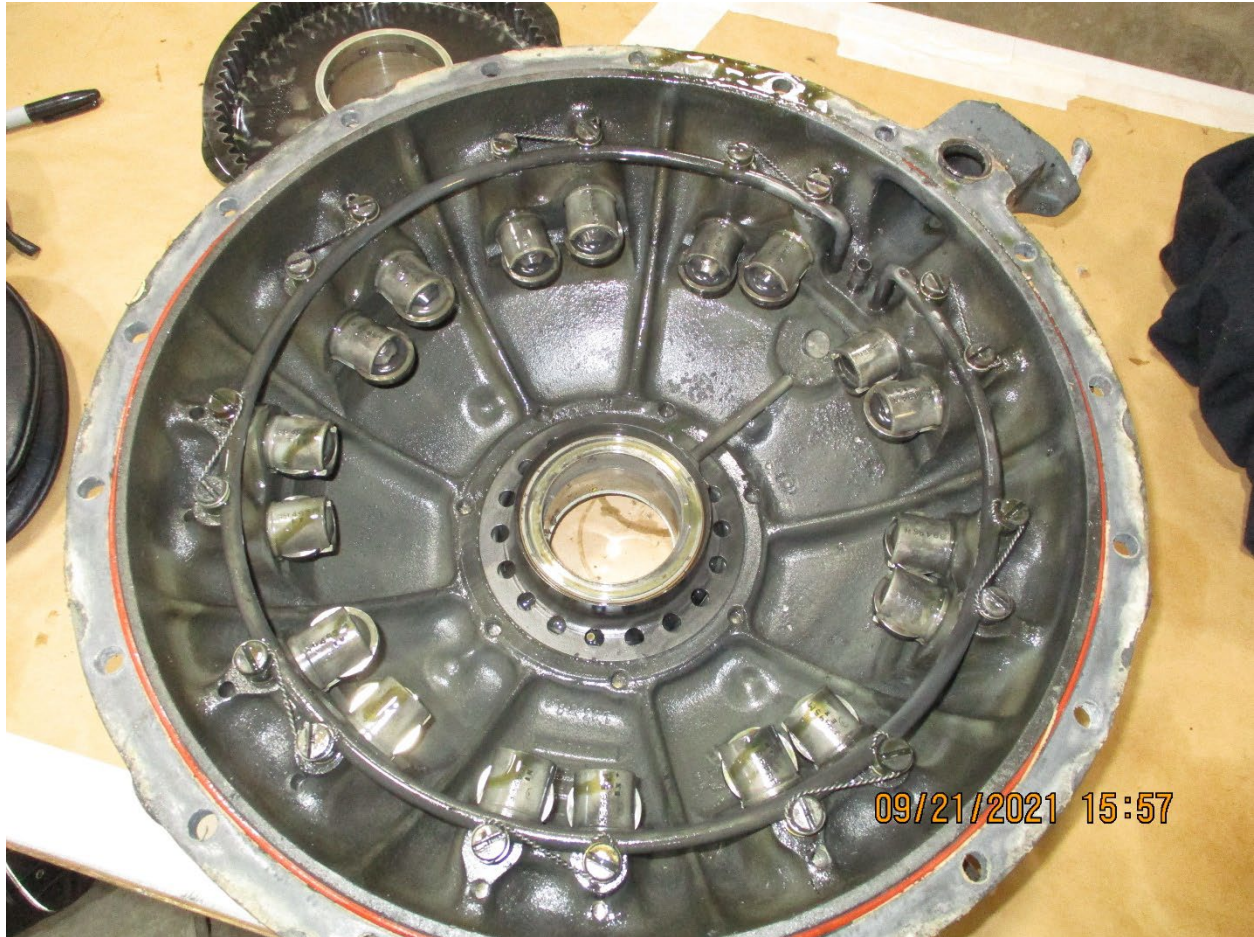
The front case was removed, and no anomalies were noted with the lifters and rollers. Furthermore, the lifters and rollers moved without resistance. (See figure 8.)

*Figure 8. View of lifters and rollers inside of nose cone.*

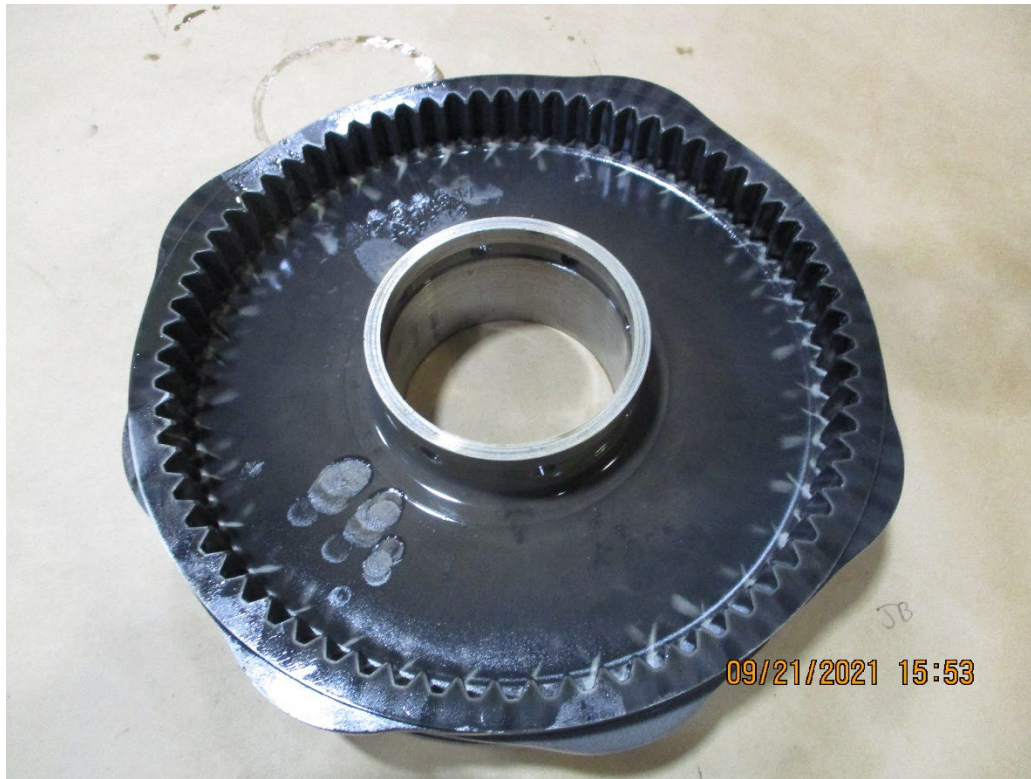
*Figure 9. Cam plate and interior gears.*

The cam assembly was removed and no anomalies were noted. The cam lobes exhibited normal wear. In addition, the cam plate gears were all present and no anomalies were noted. (See figure 9.)

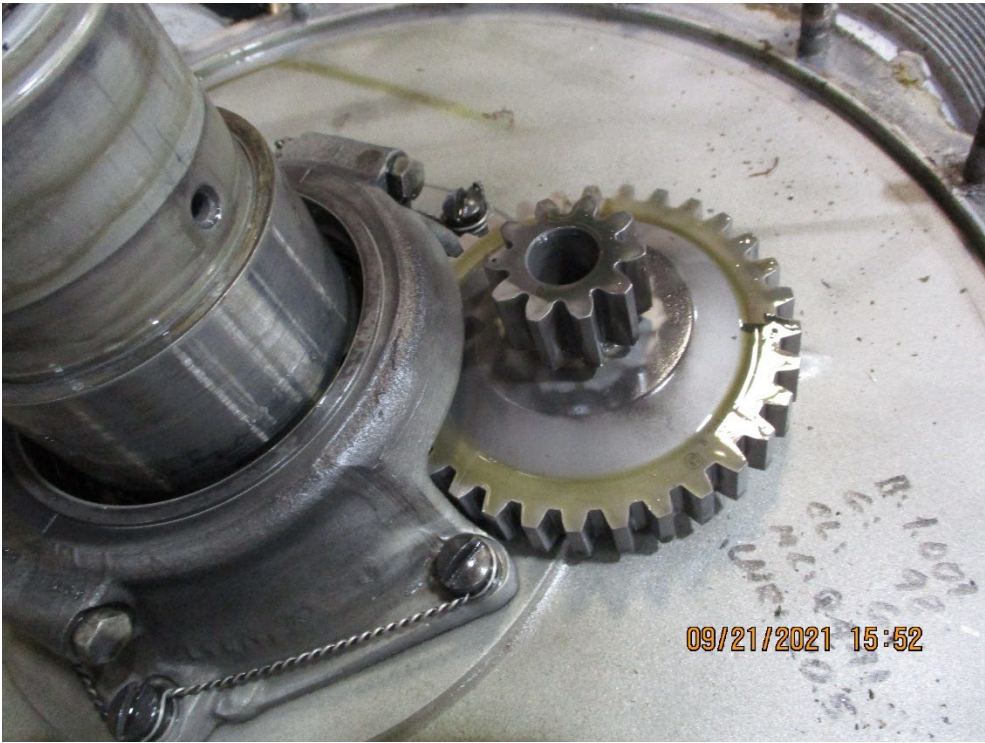
Figure 10. Cam gear

The cam assembly gears exhibited normal wear. (See figure 10.)

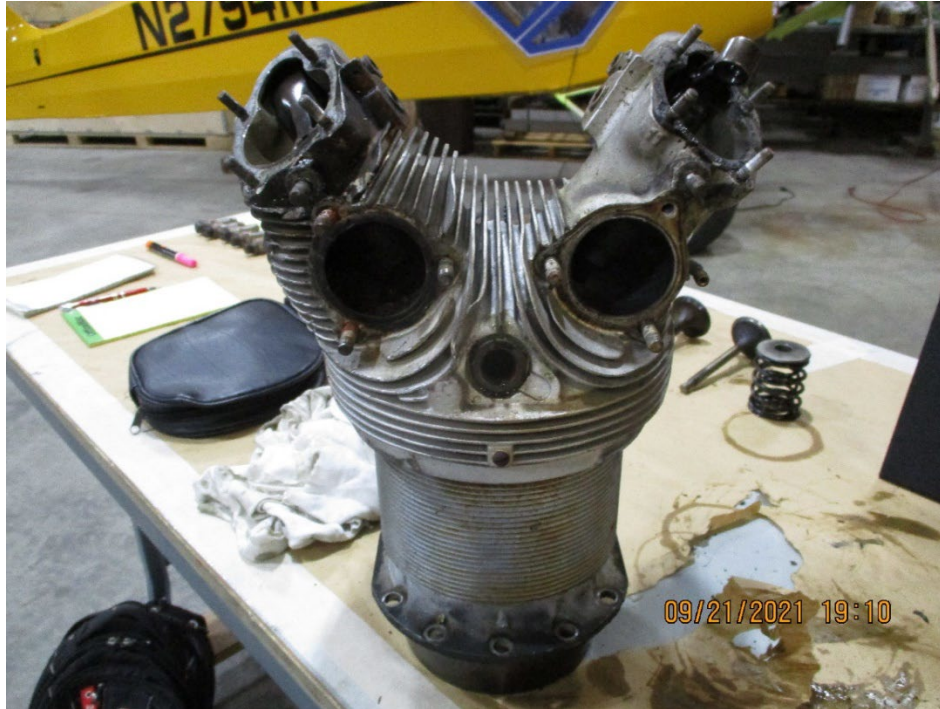
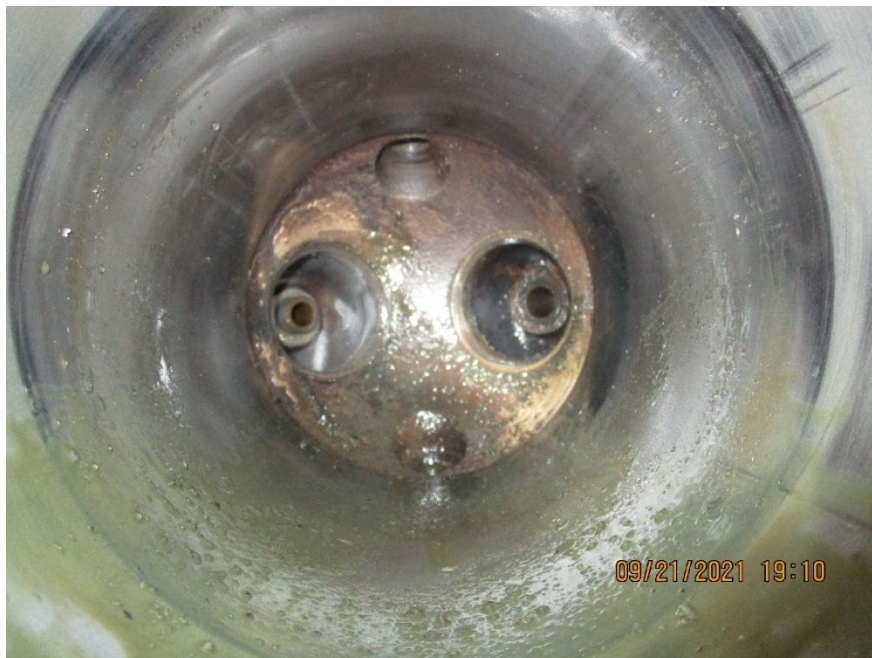
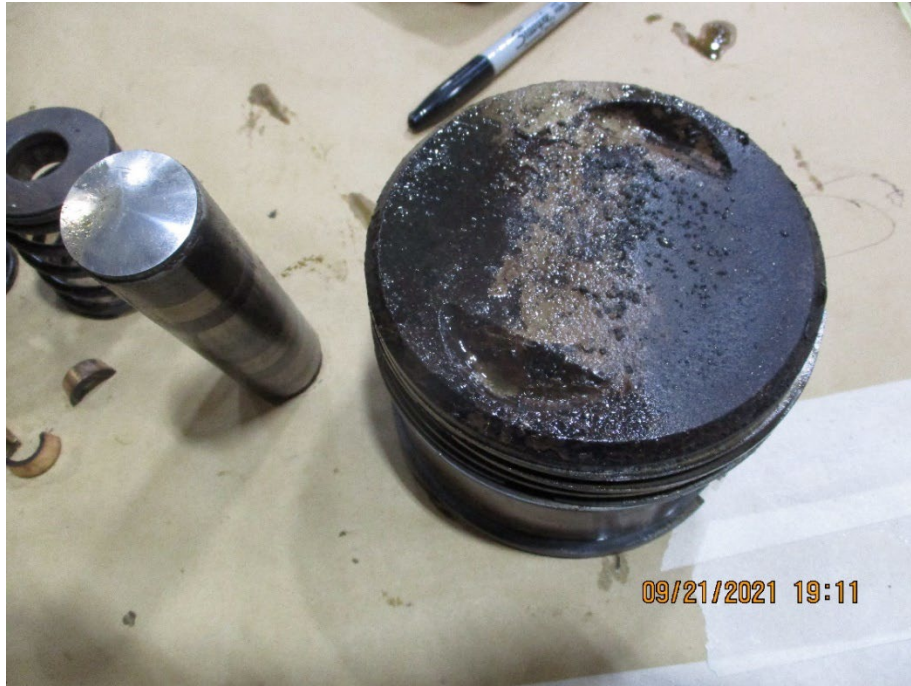
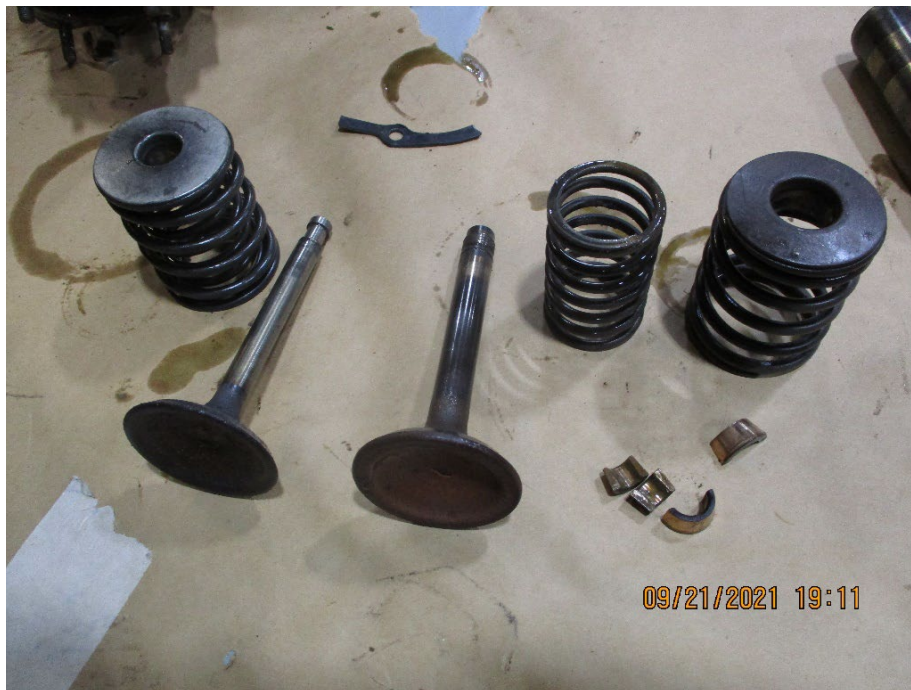
The No. 1 cylinder, piston, valves, valve guides, springs, and valve keepers were examined, and no anomalies were noted. (See figures 11-14.)

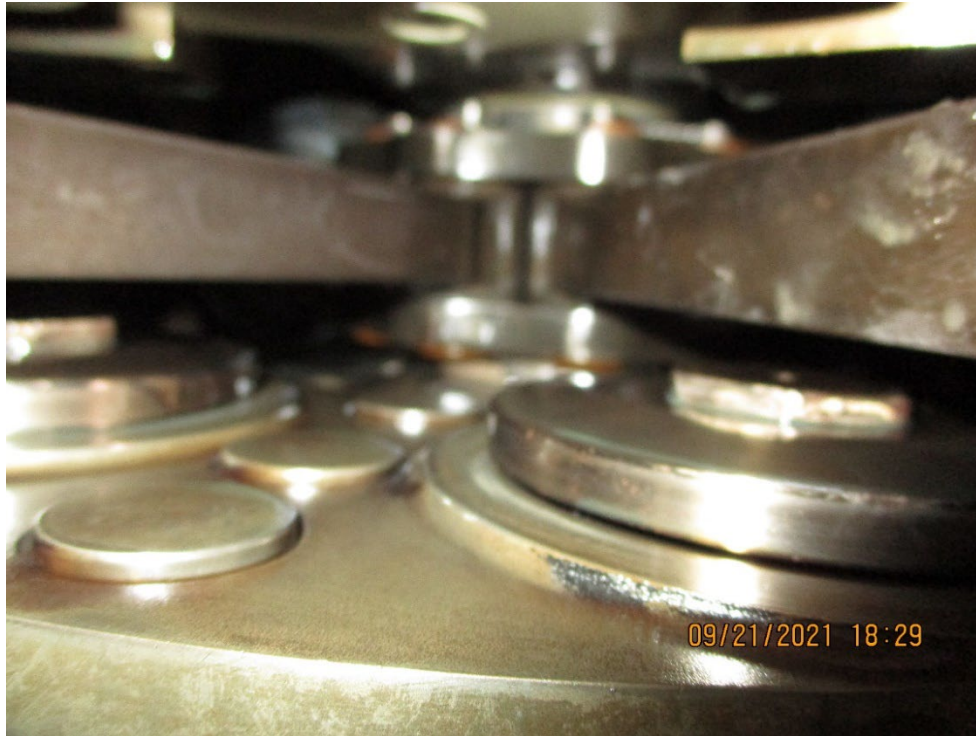
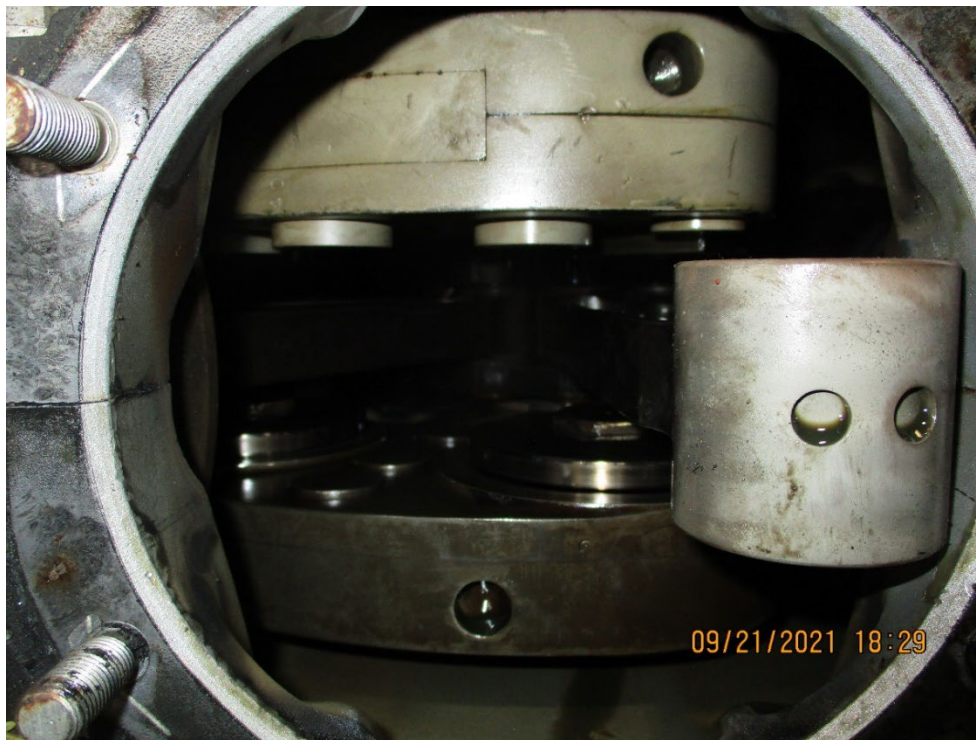
The internal examination of the crankcase revealed that the connecting rods and counterweight balance had no anomalies noted. (See figure 15, 16.)

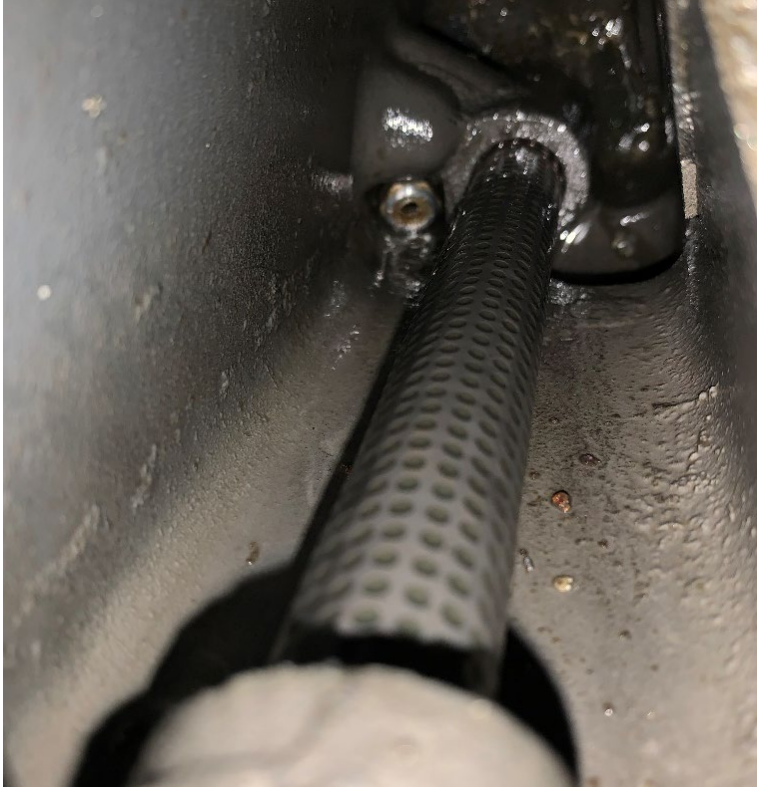
*Figure 17. Oil suction screen.*

The oil suction screen was examined, was not obstructed, and no metallic debris was noted.

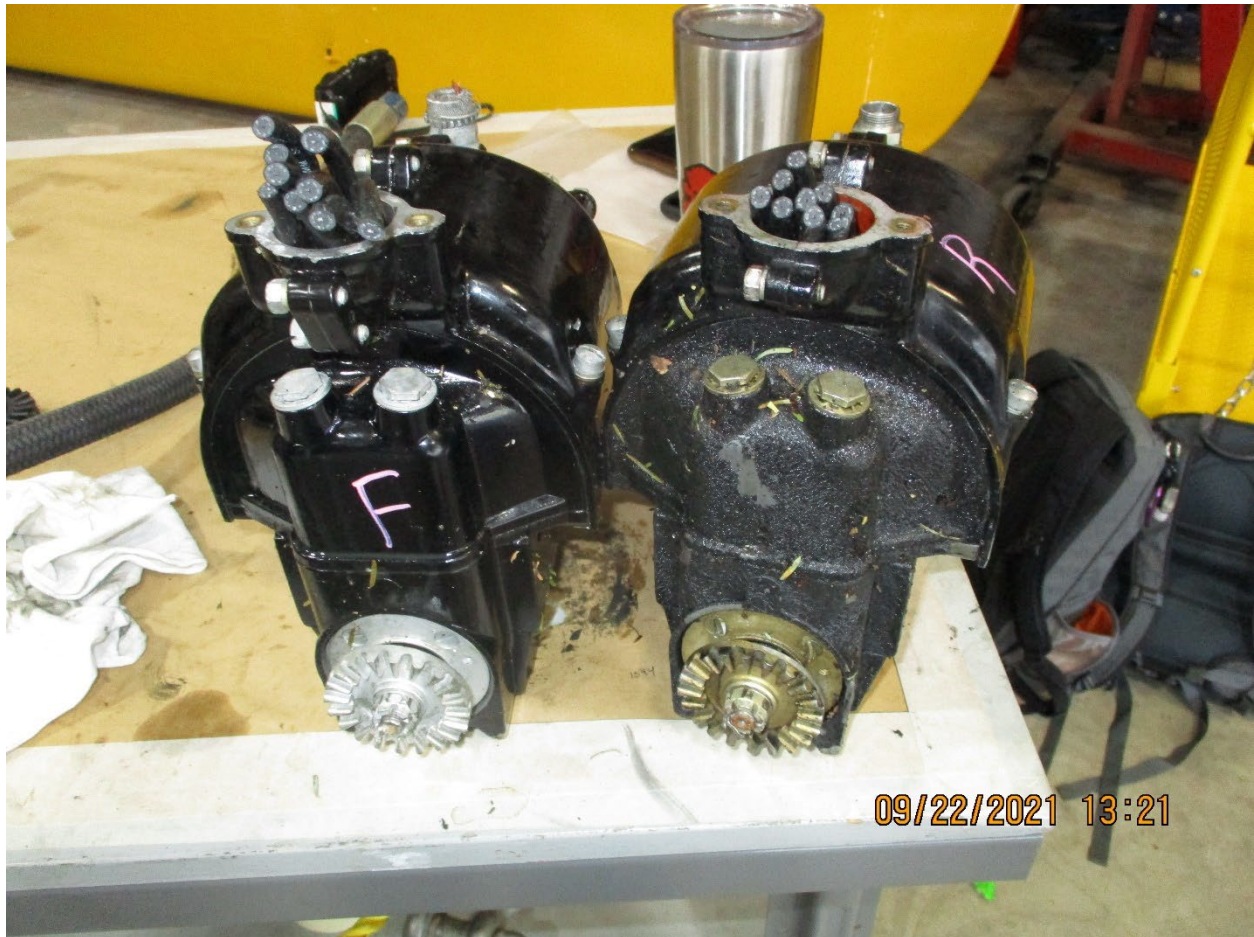
*Figure 18. Right and Left magnetos.*

The left (rear) and right (front) magnetos were removed and rotated by electric screwdriver. Each lead exhibited spark. No anomalies were noted. (See figure 17.)

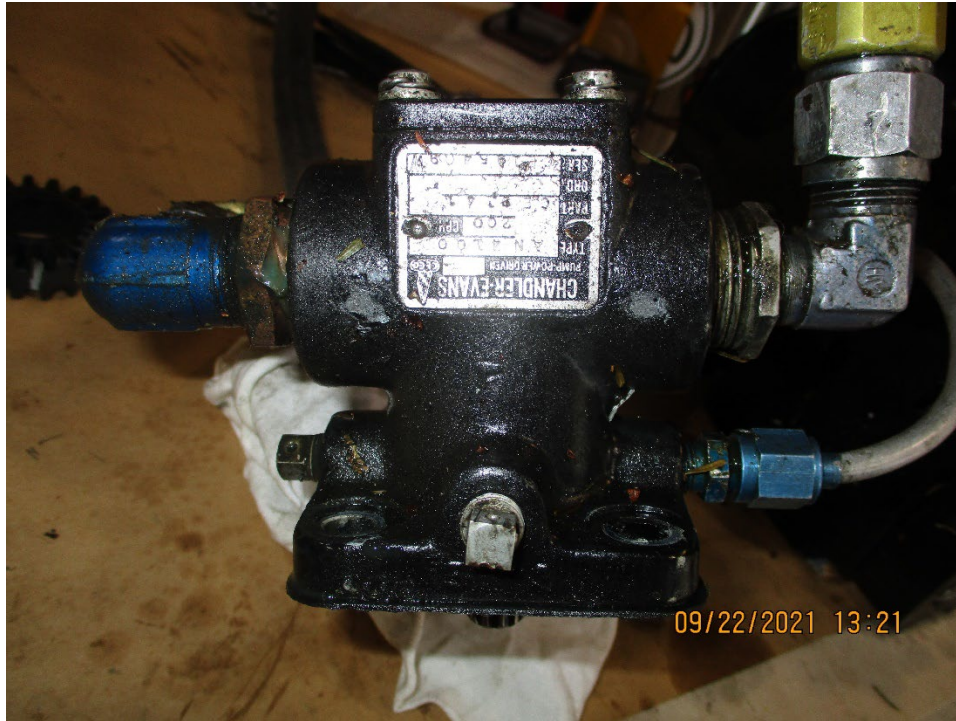
*Figure 19. Mechanical fuel pump*

The mechanical fuel pump was removed and rotated by electric screwdriver. Suction and pressure were established in the fuel lines. (See figure 18.)

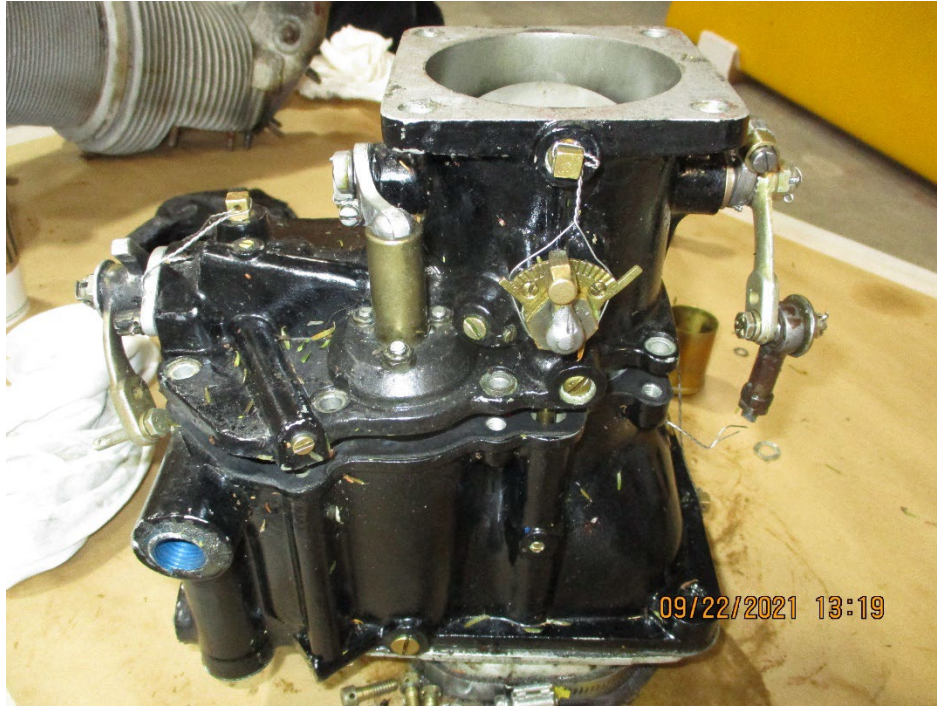
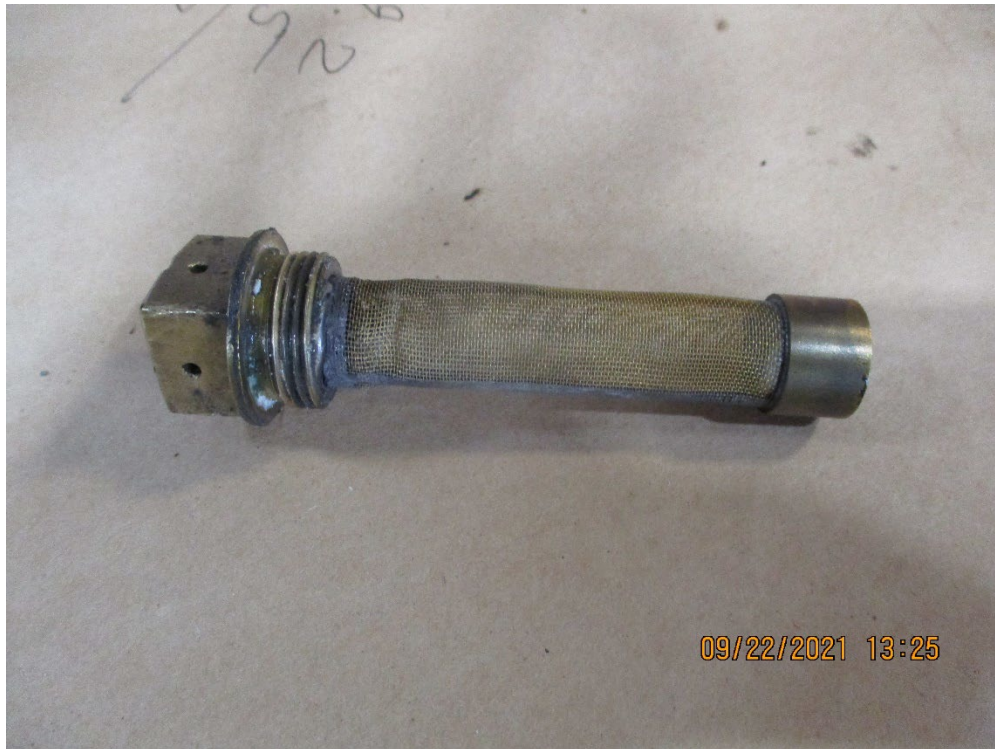
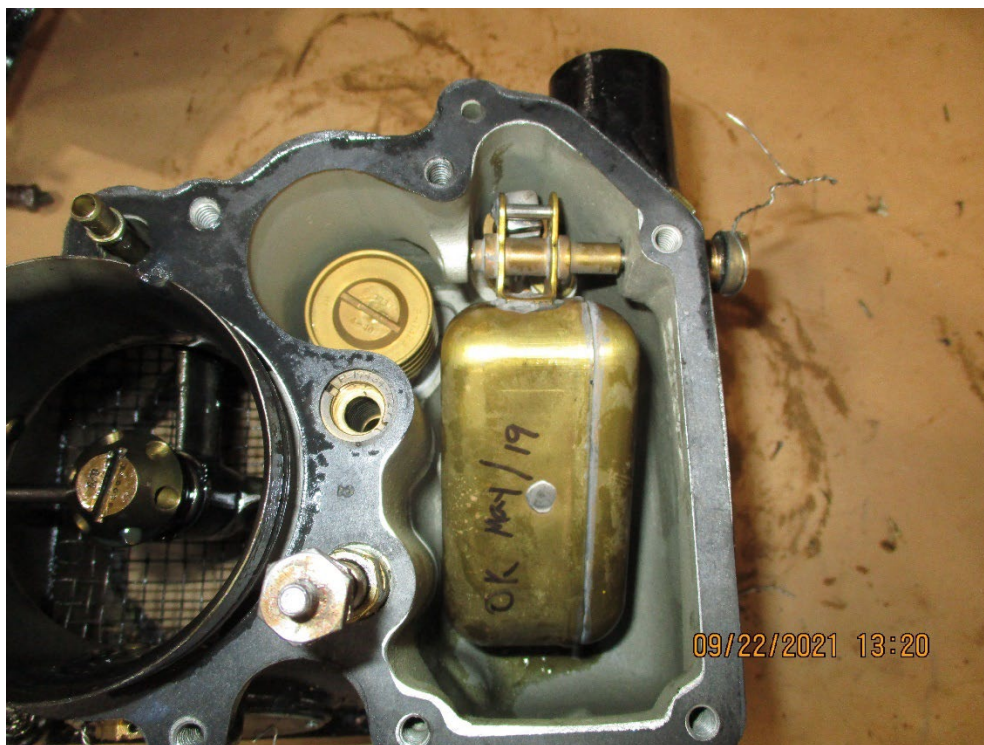
The carburetor was removed for examination. The screen was clear of debris. The float was intact and no anomalies were noted. The fuel seat and accelerator pump were examined and no anomalies were noted. The butterfly valve and accelerator pump moved freely when the throttle arm was manipulated by hand. (See figure 19-21.)
