**ANC21FA069**

**September 22, 2021**

**Dehavilland DHC-2 Beaver, N1249K**

**NTSB EXAMINATION POWERPLANT REPORT**

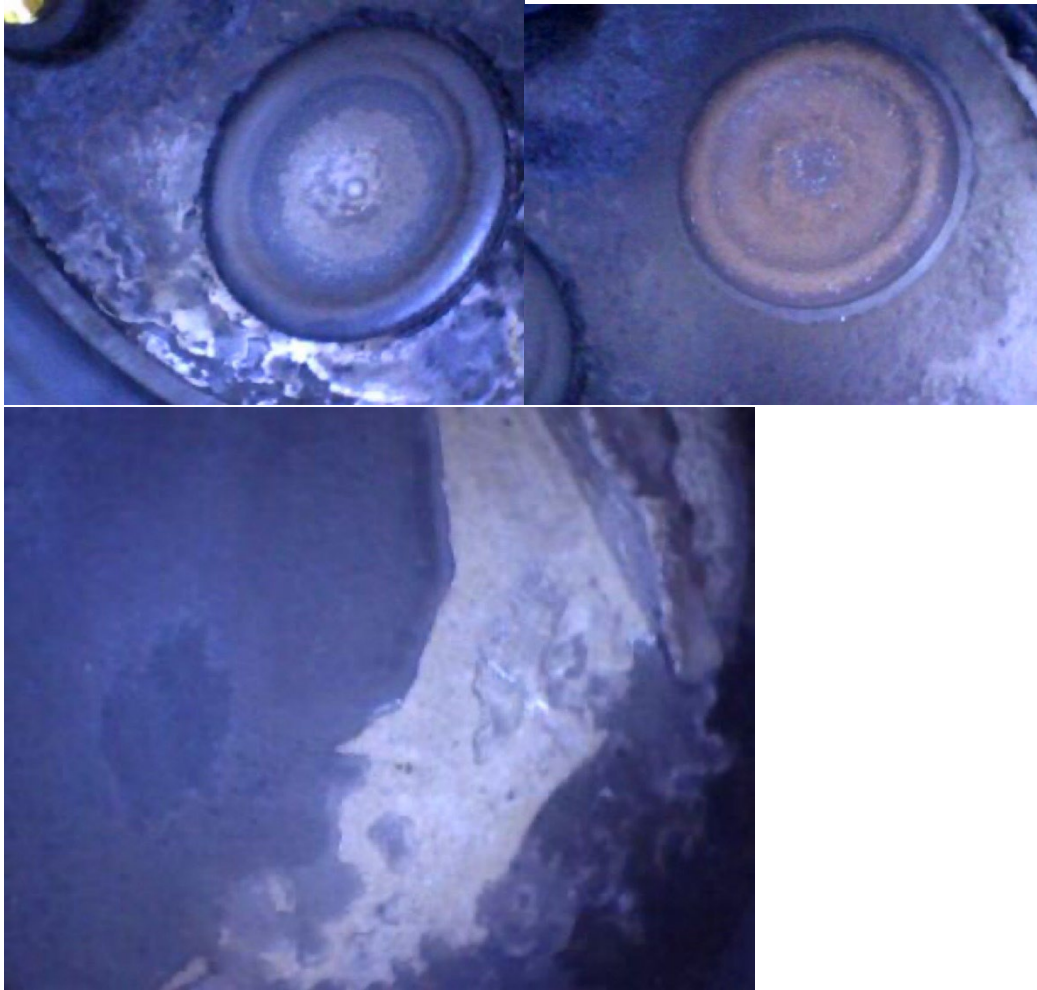
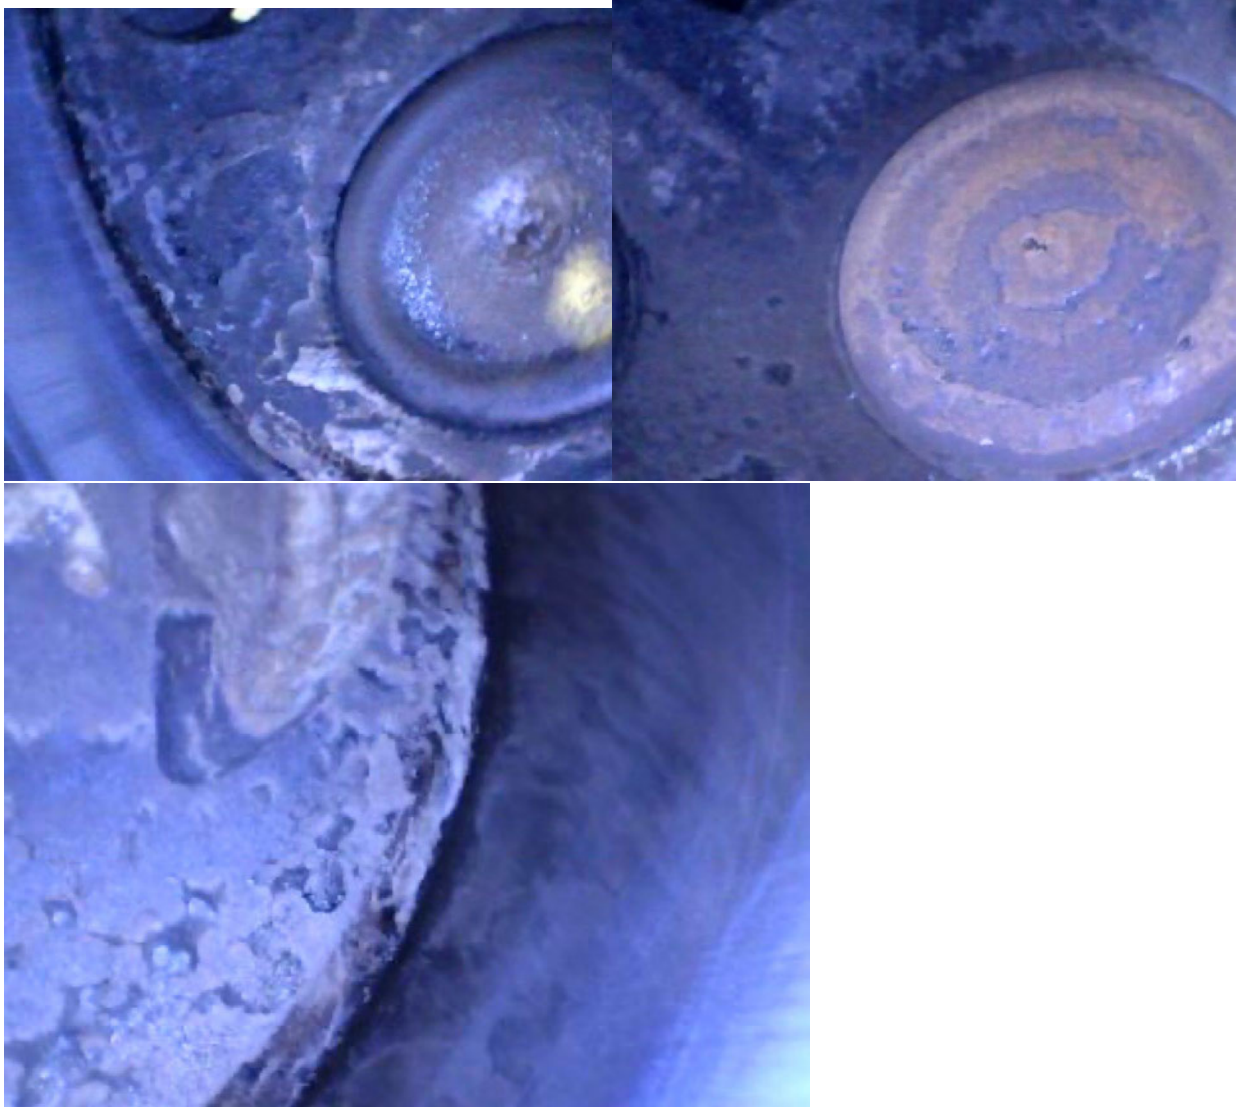
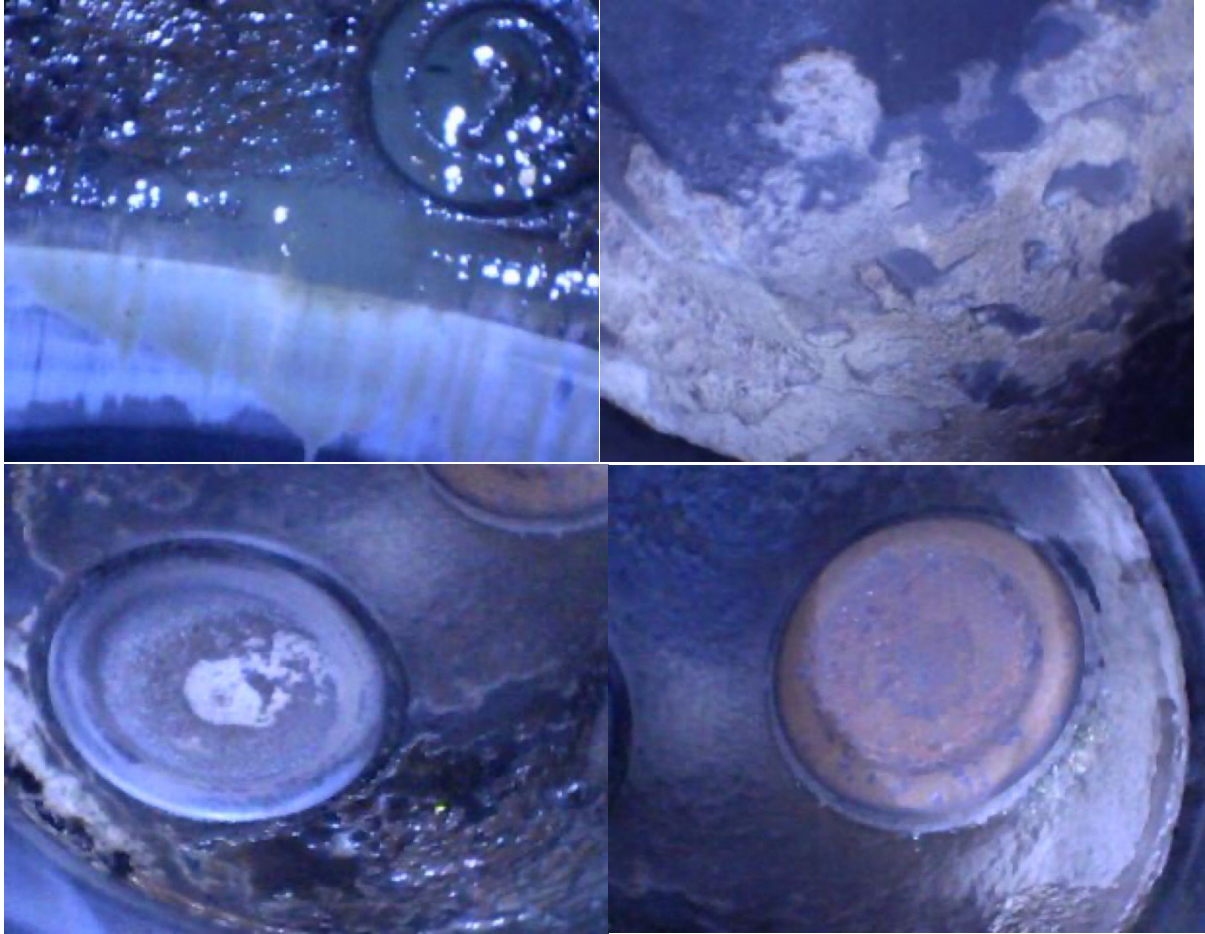
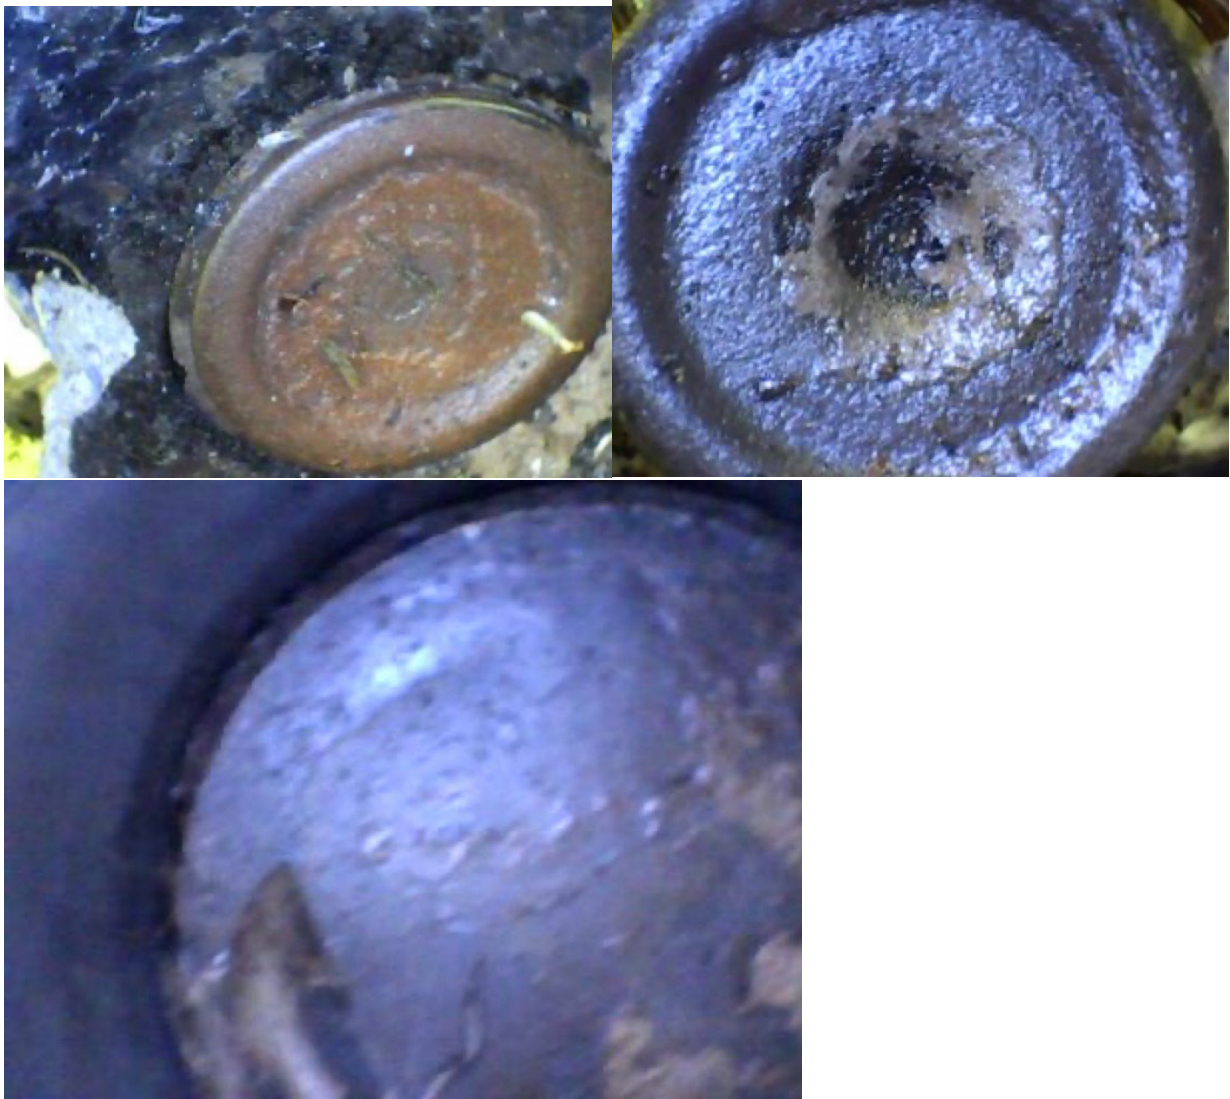
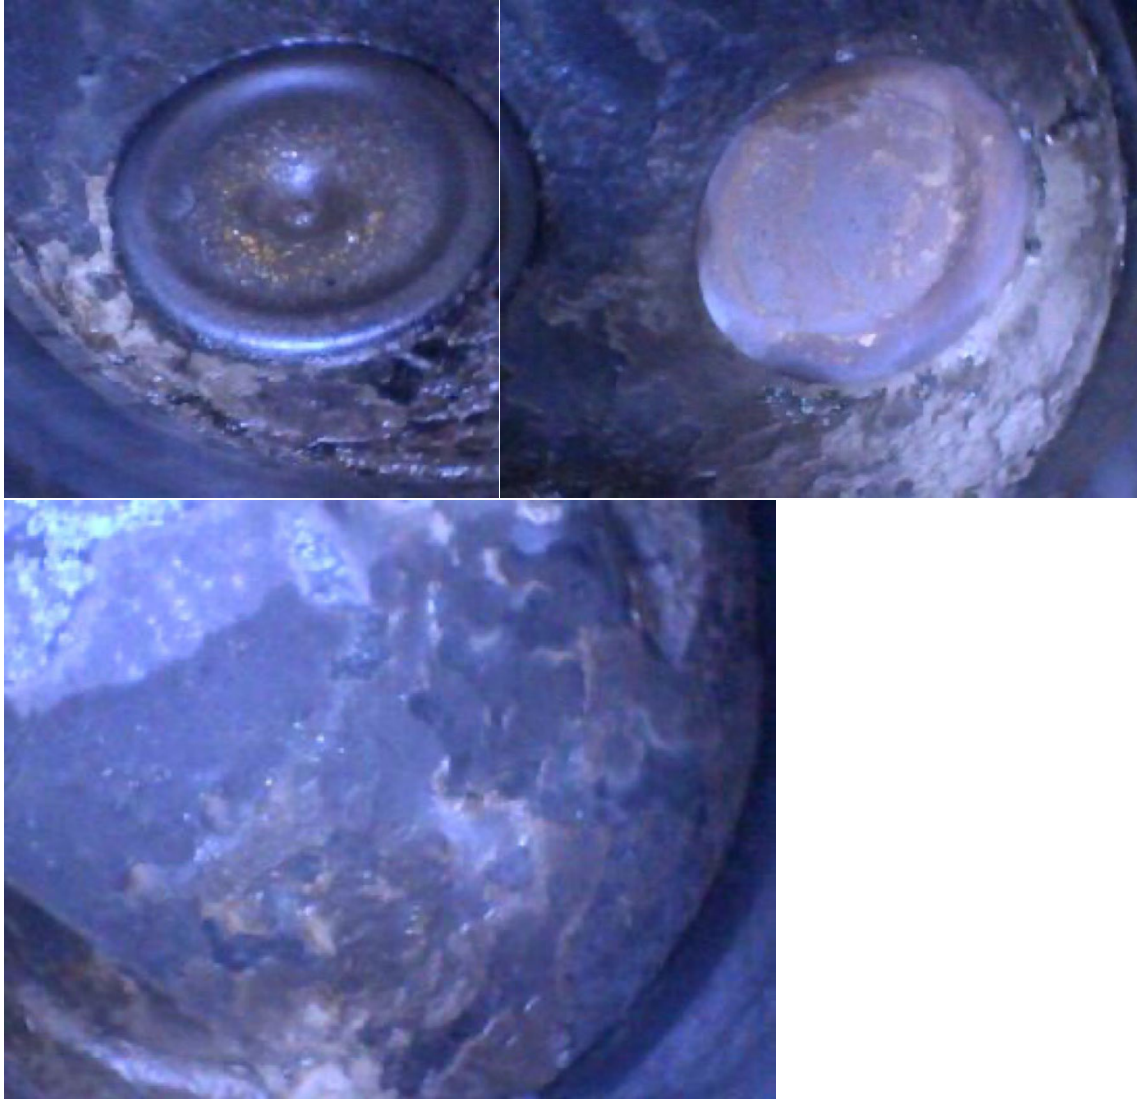
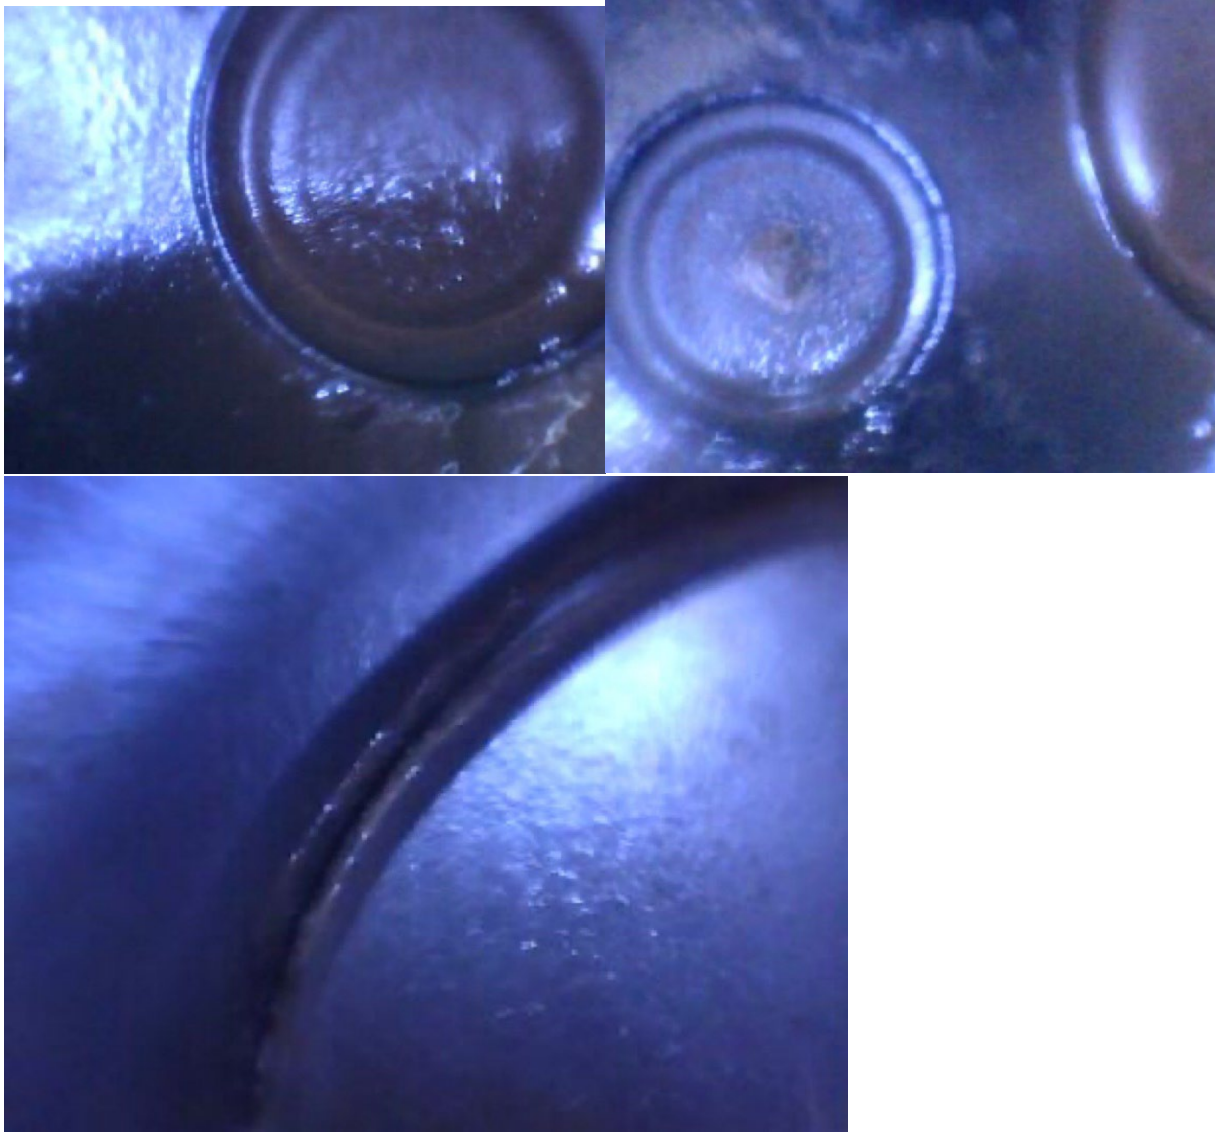
A lighted boroscope was used to examine all cylinder walls, pistons, and valves. No anomalies were noted. (See figure 22-29.)

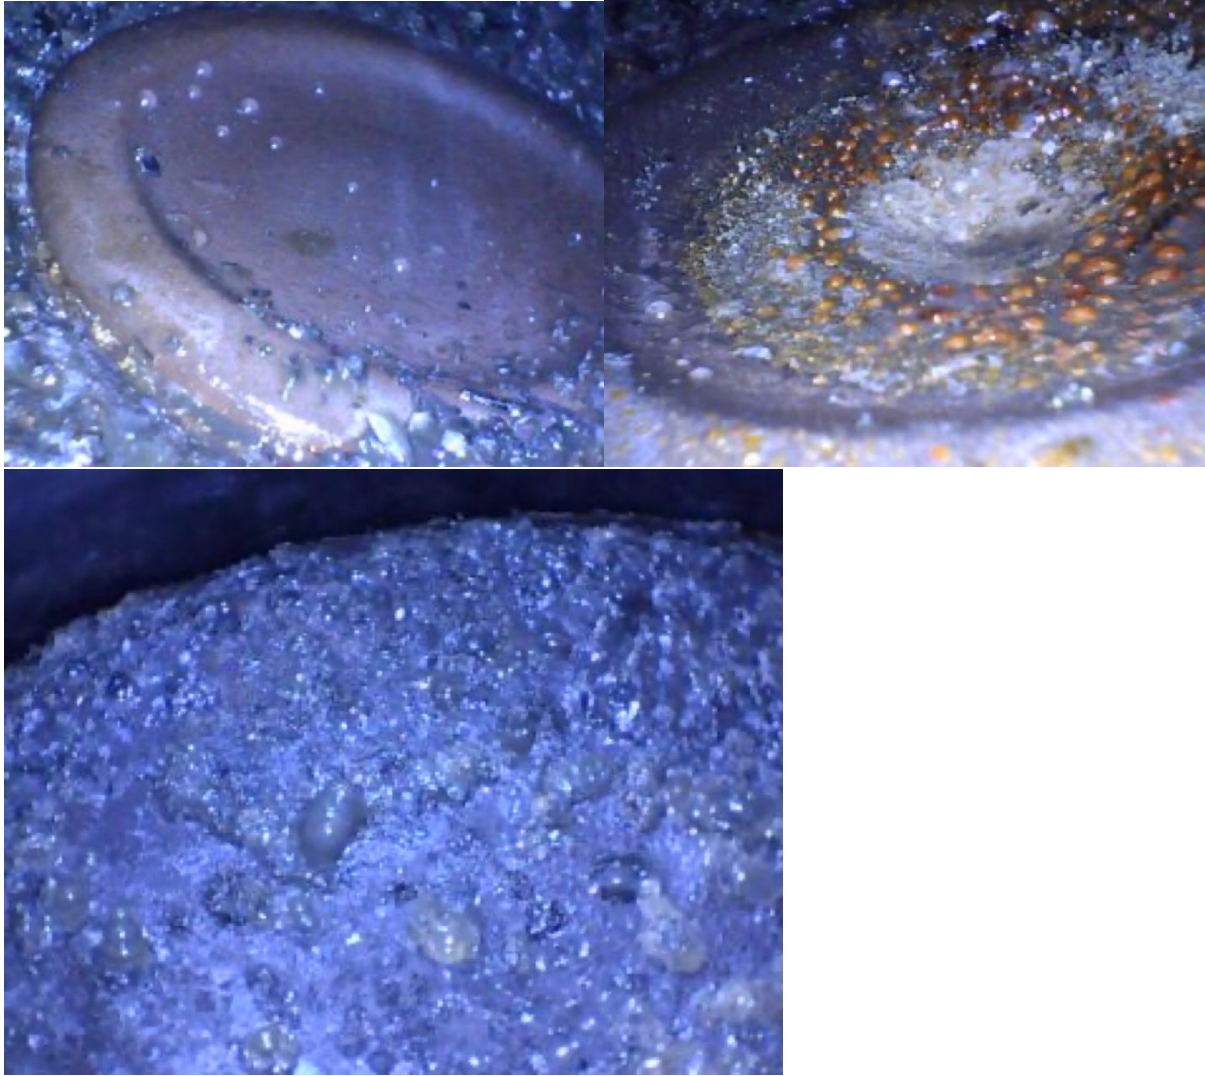
*Figure 26. Cylinder No. 5 Intake valve, Exhaust Valve, and Piston Top. Note water droplets on the piston top.*

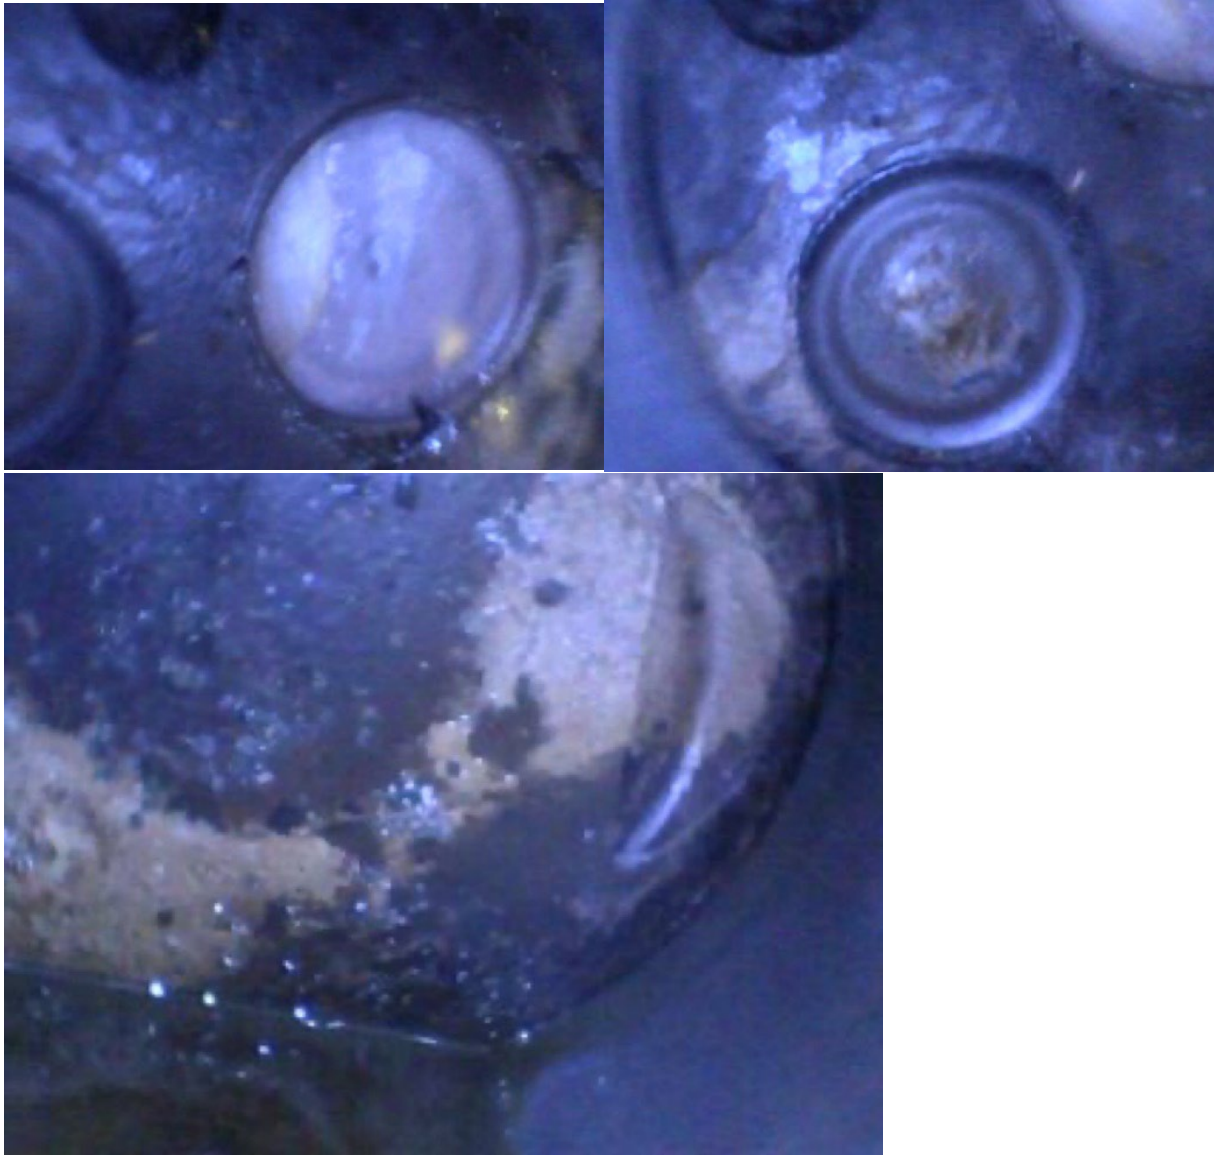
*Figure 29. Cylinder No. 8 Exhaust Valve, Intake Valve, and Piston Top. Note oil in the cylinder.*
