NATIONAL TRANSPORTATION SAFETY BOARD

Group Chairman's Factual Report

METEOROLOGY

ANC21FA069

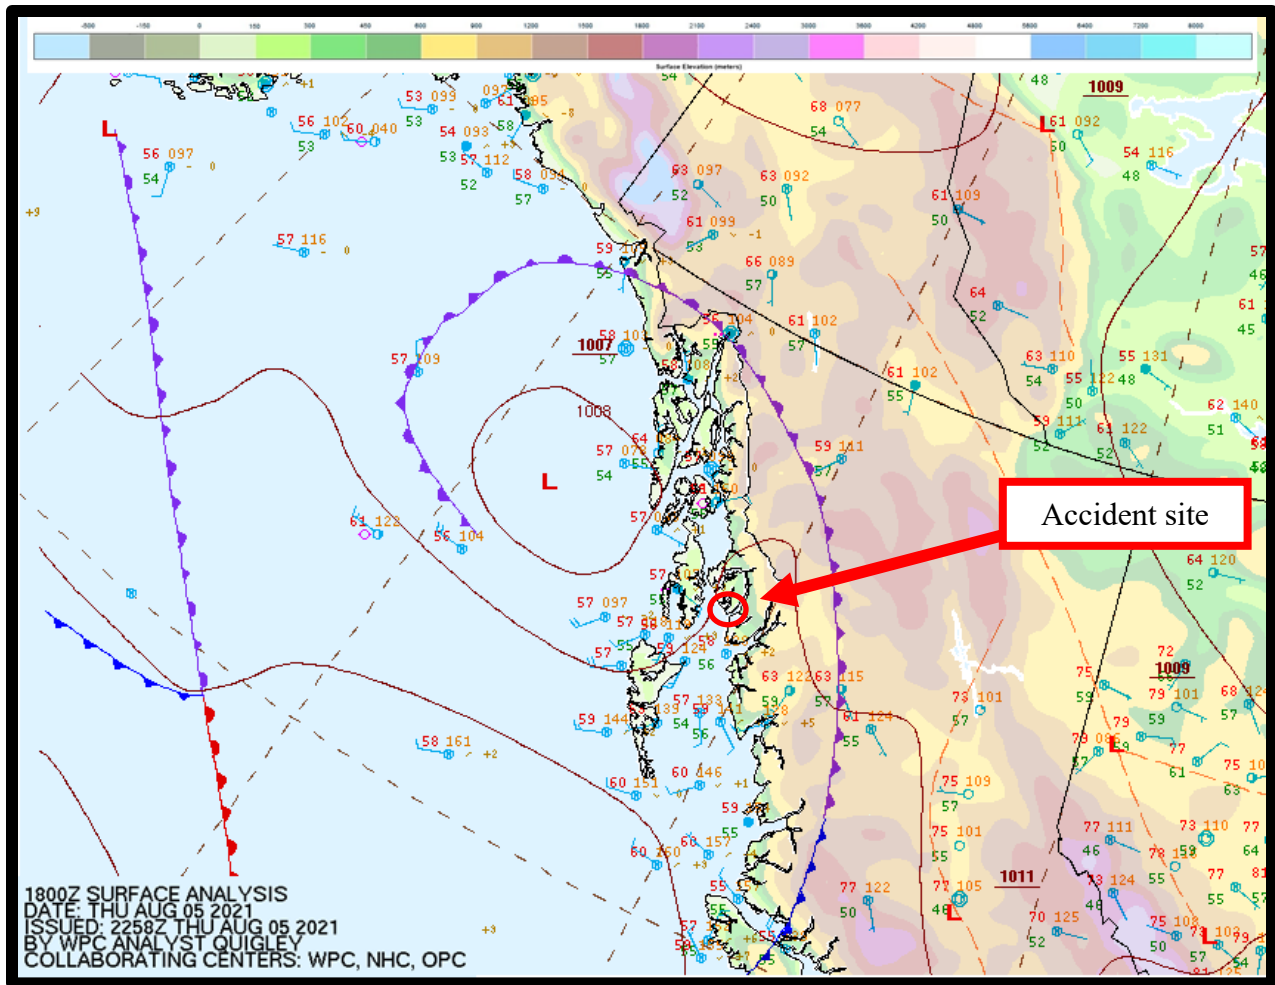
The NWS Surface Analysis Chart centered over southeastern Alaska for 1000 AKDT is provided as figure 1 with the approximate location of the accident site within the red circle. The chart depicted an occluded low-pressure system centered over the eastern Gulf of Alaska with a pressure of 1007-hectopascals (hPa). The associated occluded front was located east of the accident site in British Columbia.

The station models around the accident site depicted air temperatures in the high 50’s degrees Fahrenheit (°F), dew point temperatures in the mid 50’s °F with temperature-dew point spreads of 2°F or less, a south to southwest wind between 5 and 20 knots, and overcast skies with light rain.

Figure 1 – NWS Surface Analysis Chart for 1000 AKDT.

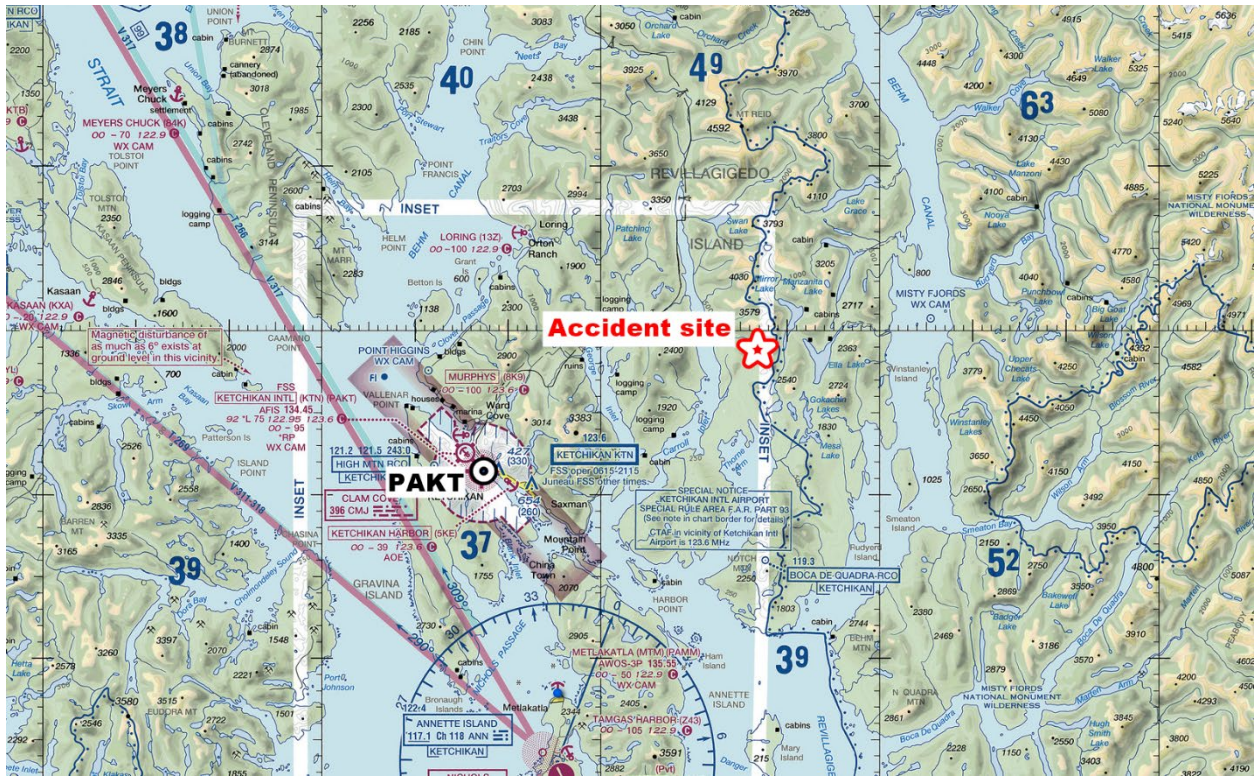
Figure 2 – Sectional map of the accident area with the location of the accident site and surface observation site.

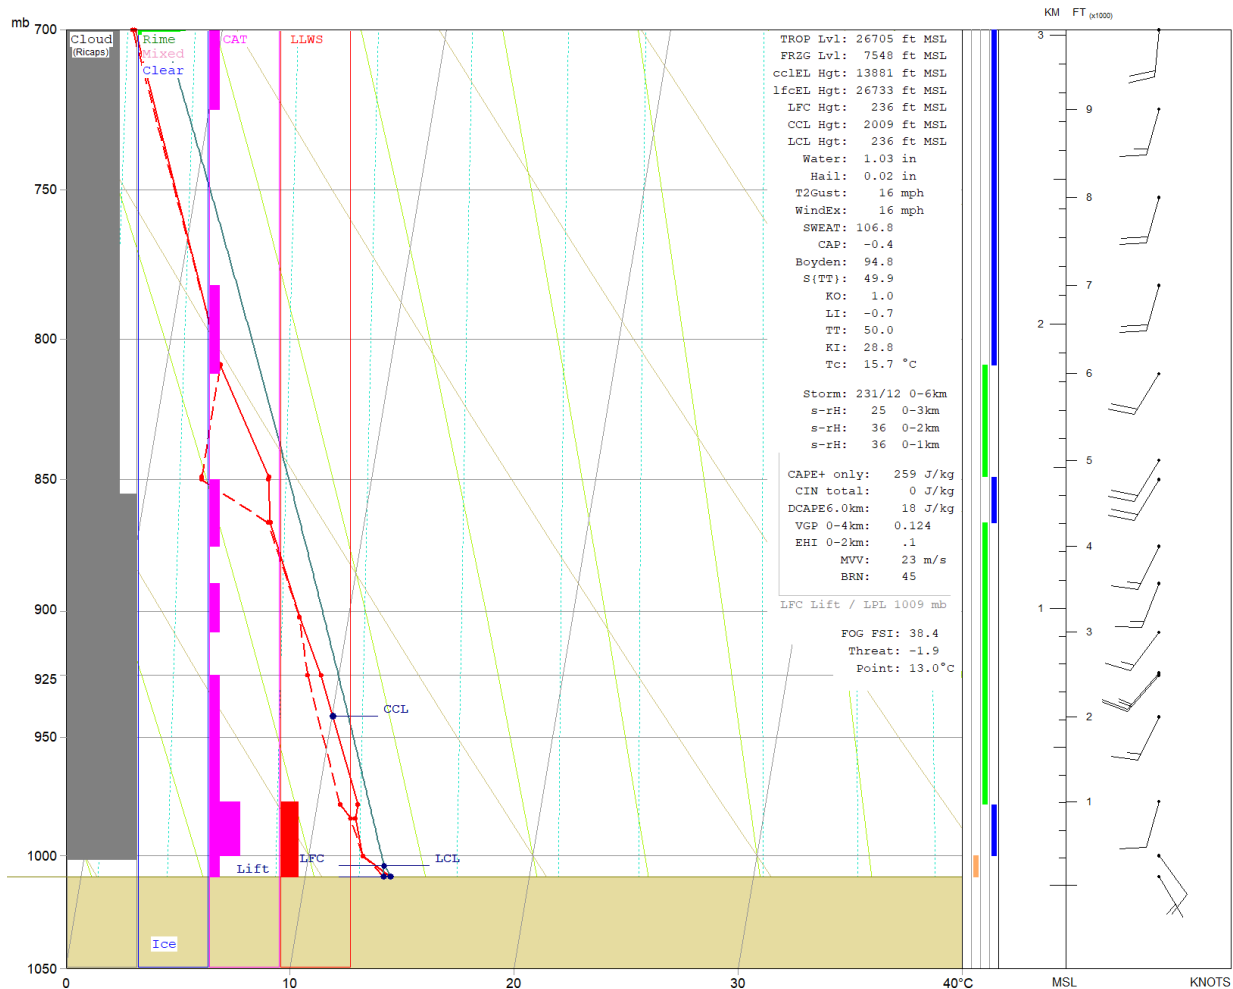
Figure 3 – 1600 AKDT PANT sounding.

The 1600 AKDT PANT sounding indicated a combination of unstable, stable, and conditional instability in several layers from the surface to 6,000 ft. RAOB indicated clouds from 300 ft agl through 10,000 ft and no icing conditions below 9,500 ft.

The 1600 AKDT PANT sounding wind profile indicated a surface wind from 150° at 5 knots with the wind increasing in speed to 15 knots from the southwest by 2,000 ft. RAOB indicated the possibility of light low-level wind shear (LLWS) between the surface and 1,000 ft. RAOB indicated the possibility of light to moderate clear-air turbulence in several layers between the surface and 10,000 ft. Near the accident site elevation (around 1,750 ft)¹⁵ the wind was from 200° at 14 knots with a temperature near 10.5°C and a dewpoint temperature near 9.8°C with a relative humidity of 95%.

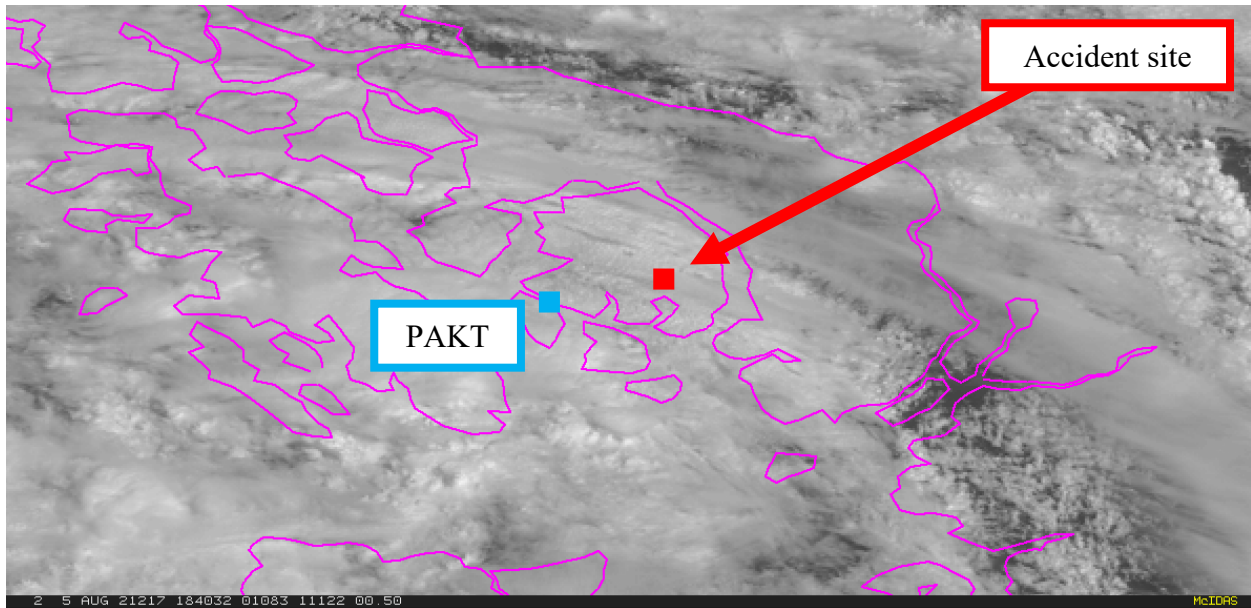
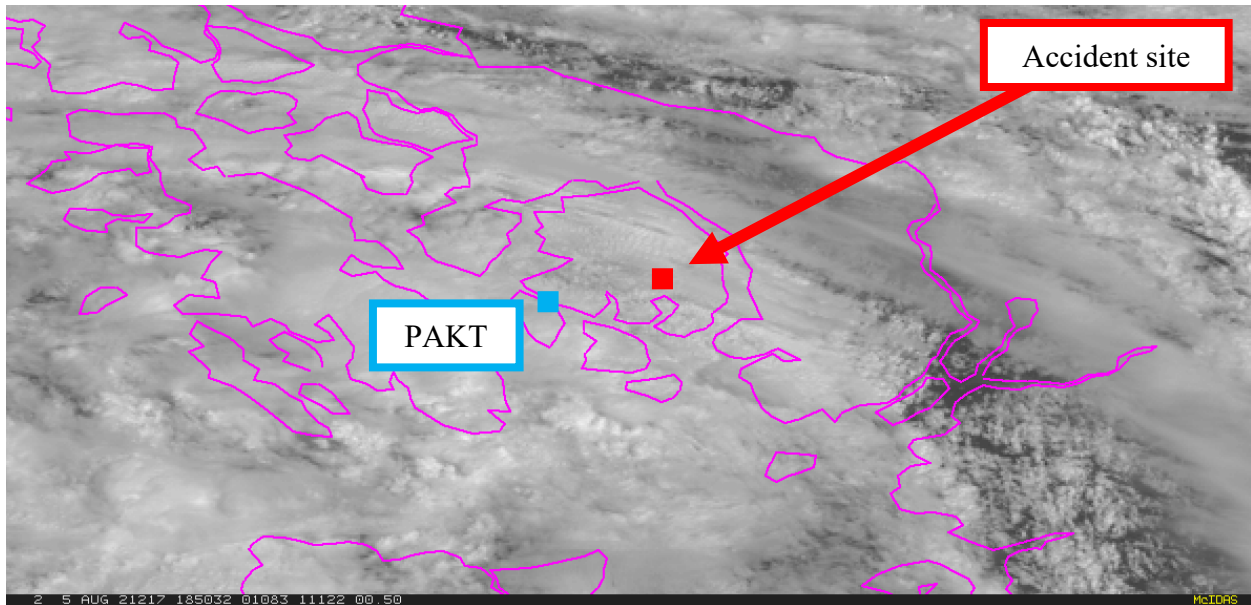
Figures 4 and 5 present the GOES-17 visible imagery from 1040 and 1050 AKDT at 2X magnification with the accident site highlighted with a red square. There was cloud cover above the accident site at the accident time with the cloud cover moving north-northeastward. Figures 6 and 7 present the GOES-17 infrared imagery from 1030 and 1050 AKDT at 6X magnification with the accident site highlighted with a red square. The lower brightness temperatures (green colors; higher cloud tops) were located near to and southwest of PAKT and east of the accident site in British Columbia. A band of lower brightness temperatures (yellow colors) increased in coverage and moved across the accident site between 1030 and 1050 AKDT. The brightness temperature of about 254 Kelvin would have been near 17,000 ft based on the vertical temperature profile provided by the 1600 AKDT PANT sounding (not shown in Figure 3). It should be noted these figures have not been corrected for any parallax error.

Figure 4 – GOES-17 visible image at 1040 AKDT.

Figure 5 – GOES-17 visible image at 1050 AKDT.

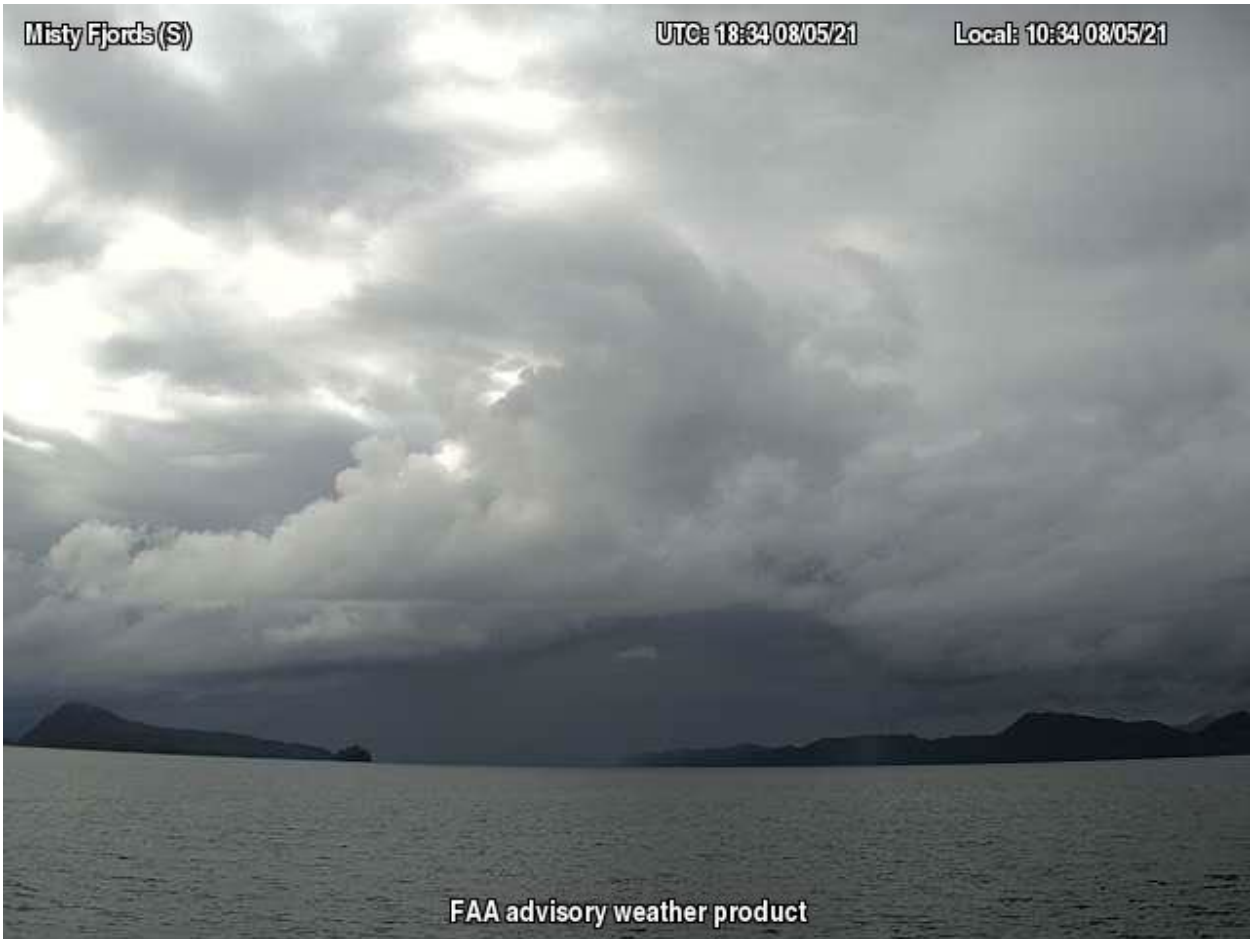
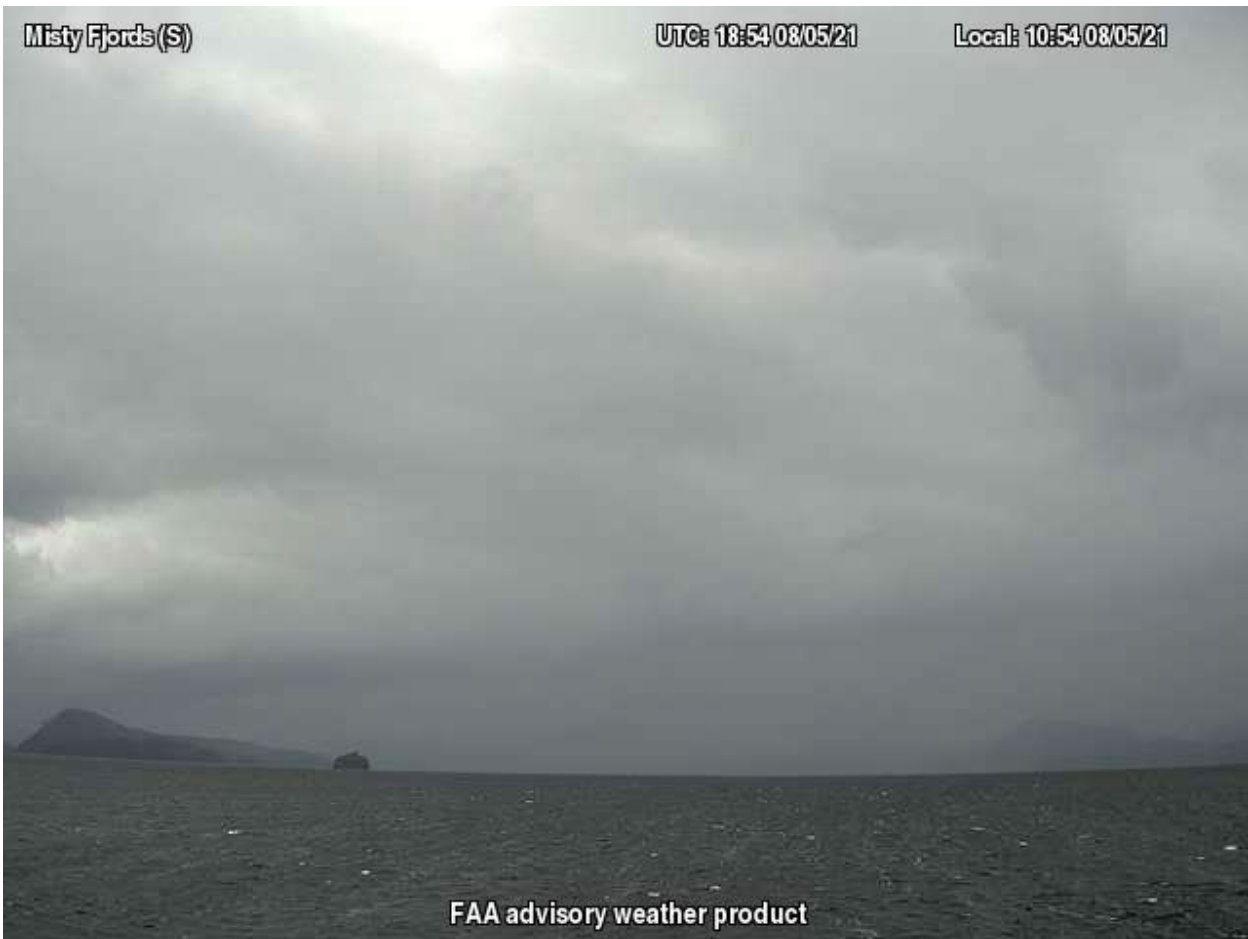
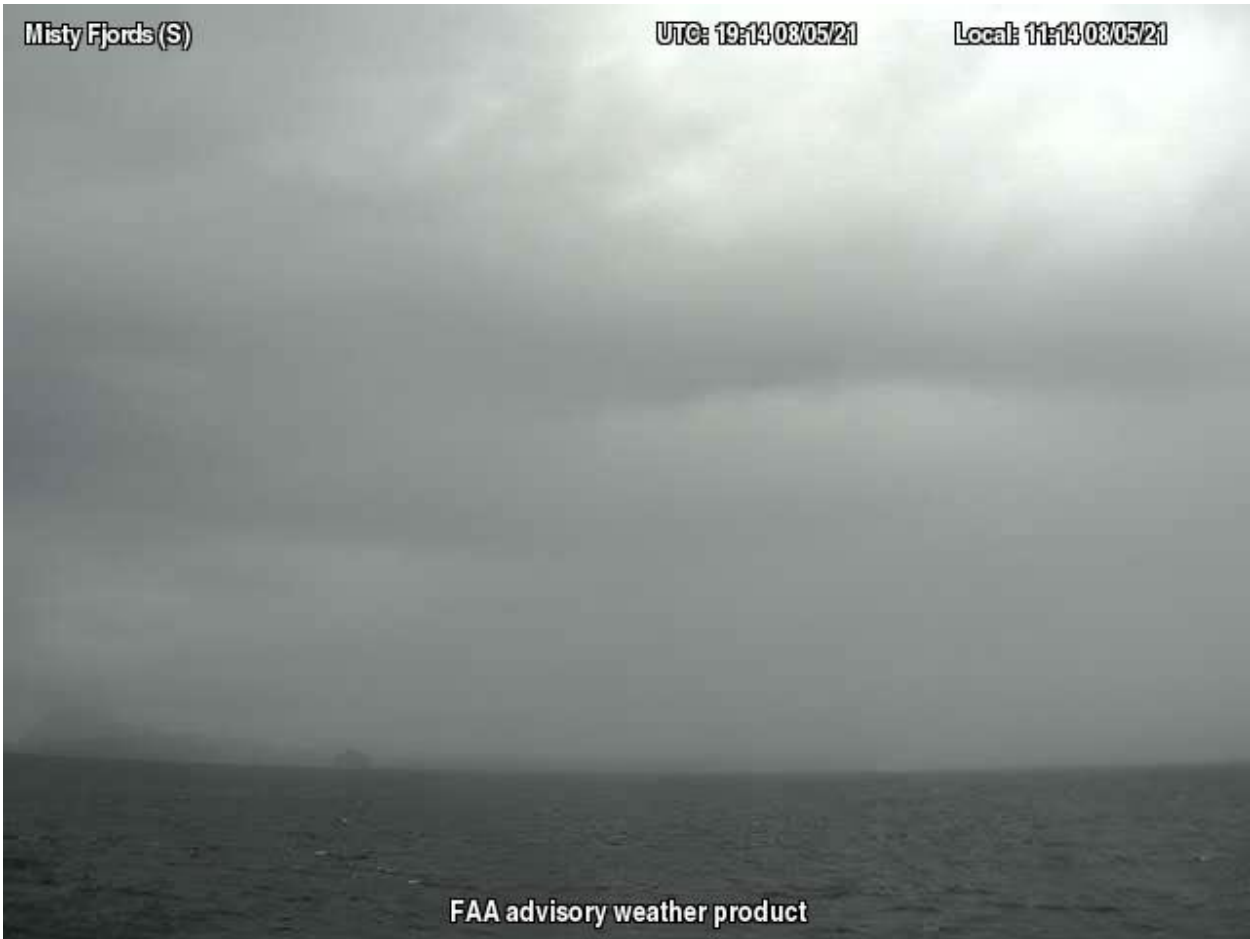
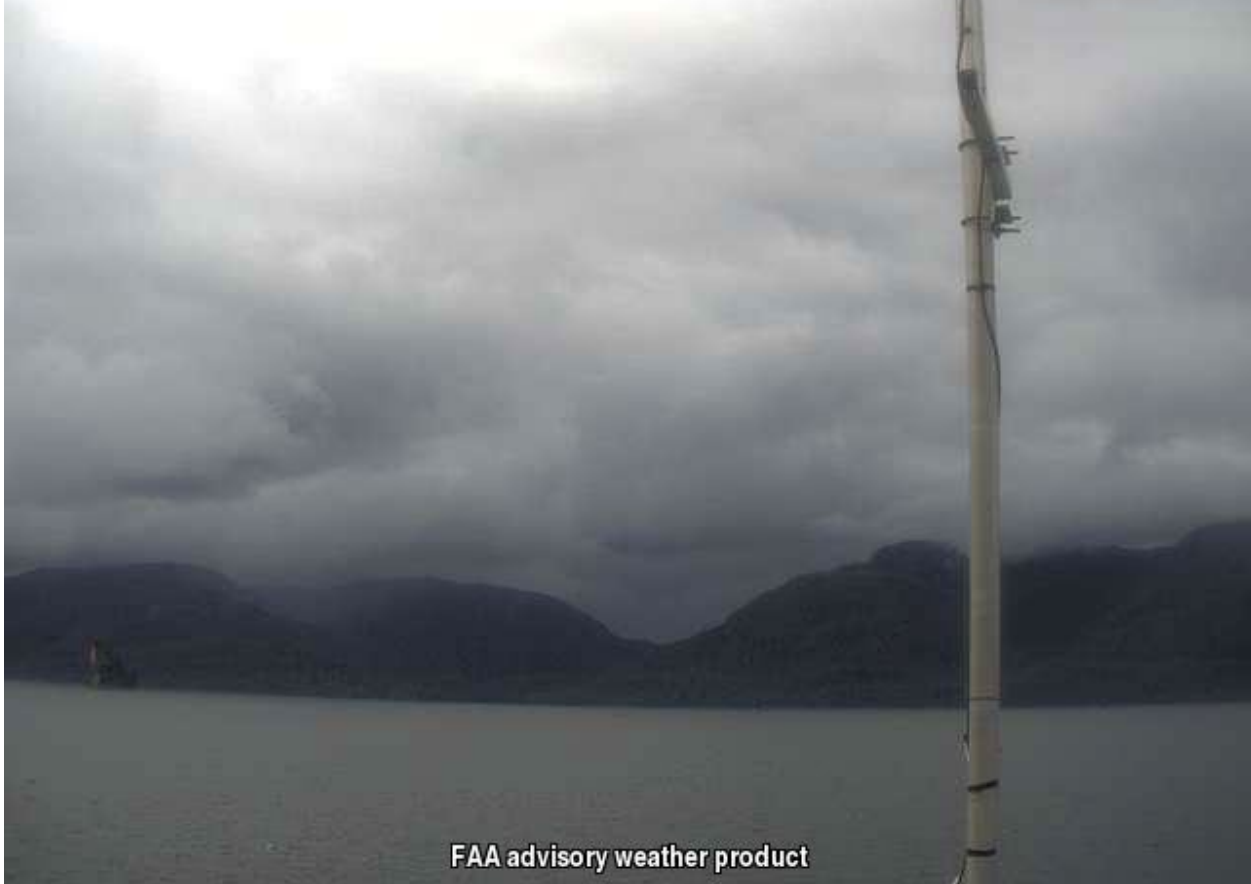
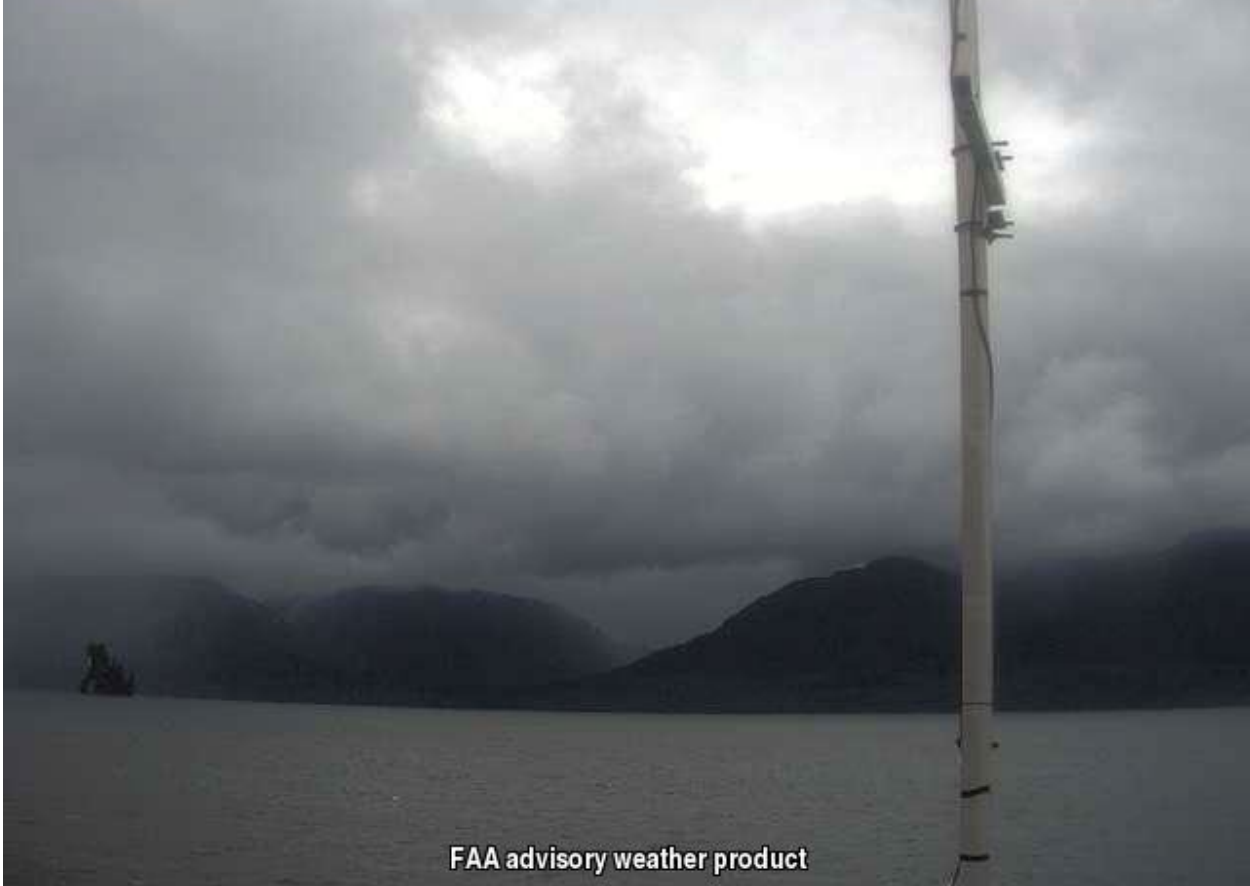
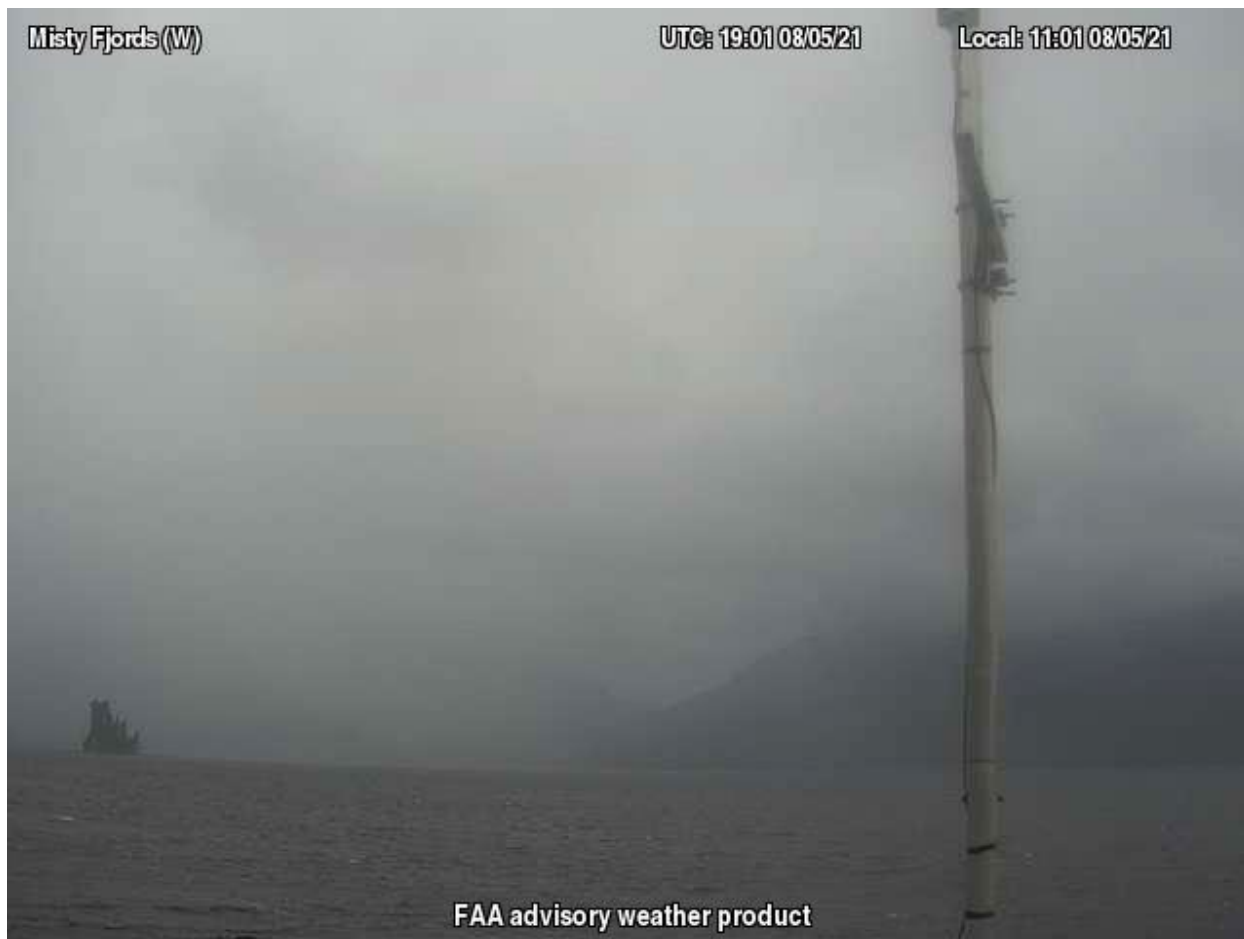
The weather cameras (figures 13 through 20) from Misty Fjords, located 11 miles east-northeast of the accident site, showed the weather conditions surrounding the accident time with the south-facing camera images provided in figures 14 through 16 with times at 1034, 1054, and 1114 AKDT. The south-facing camera images from Misty Fjords depicted a large amount of cloud cover with bases above the 750 ft msl hilltop, but the visibility below the cloud cover was less than 8.5 miles at 1034 AKDT, less than 6.0 miles at 1054 AKDT, and the visibility was less than 3 miles by 1114 AKDT (figure 16) as noted when compared with clear day visual reference markers (figure 13). The west-facing camera images are provided in figures 18 through 20 with times at 1041, 1051, and 1101 AKDT. The west-facing camera images from Misty Fjords also depicted a large amount of cloud cover with cloud bases near mountain tops at 2,000 ft msl. In addition, the visibility was greater than 5.0 miles at 1041 and 1051 AKDT, but the visibility dropped to between 2.5 and 1.0 miles between 1051 and 1101 AKDT (figure 19 and 20) as noted when compared with clear day visual reference markers (figure 17). Similar weather conditions were observed at the Ketchikan, Minx Island, and Twin Island weather cameras, with visibility and ceiling reductions observed as earlier as 0937 AKDT on the Twin Island weather cameras. Based on the southeast-facing camera images from PAKT between 0932 and 0952 AKDT, the accident pilot departed on the accident flight in visibility conditions less than 2.5 miles and precipitation (attachment 2, as noted when compared with clear day visual reference markers). For more information, images, and camera locations please see attachment 2.

Figure 14 – FAA weather camera from Misty Fjords south view from 1034 AKDT.

Figure 15 – FAA weather camera from Misty Fjords south view from 1054 AKDT.

Figure 16 – FAA weather camera from Misty Fjords south view from 1114 AKDT.

Figure 18 – FAA weather camera from Misty Fjords west view from 1041 AKDT.

Figure 19 – FAA weather camera from Misty Fjords west view from 1051 AKDT.

Figure 20 – FAA weather camera from Misty Fjords west view from 1101 AKDT.

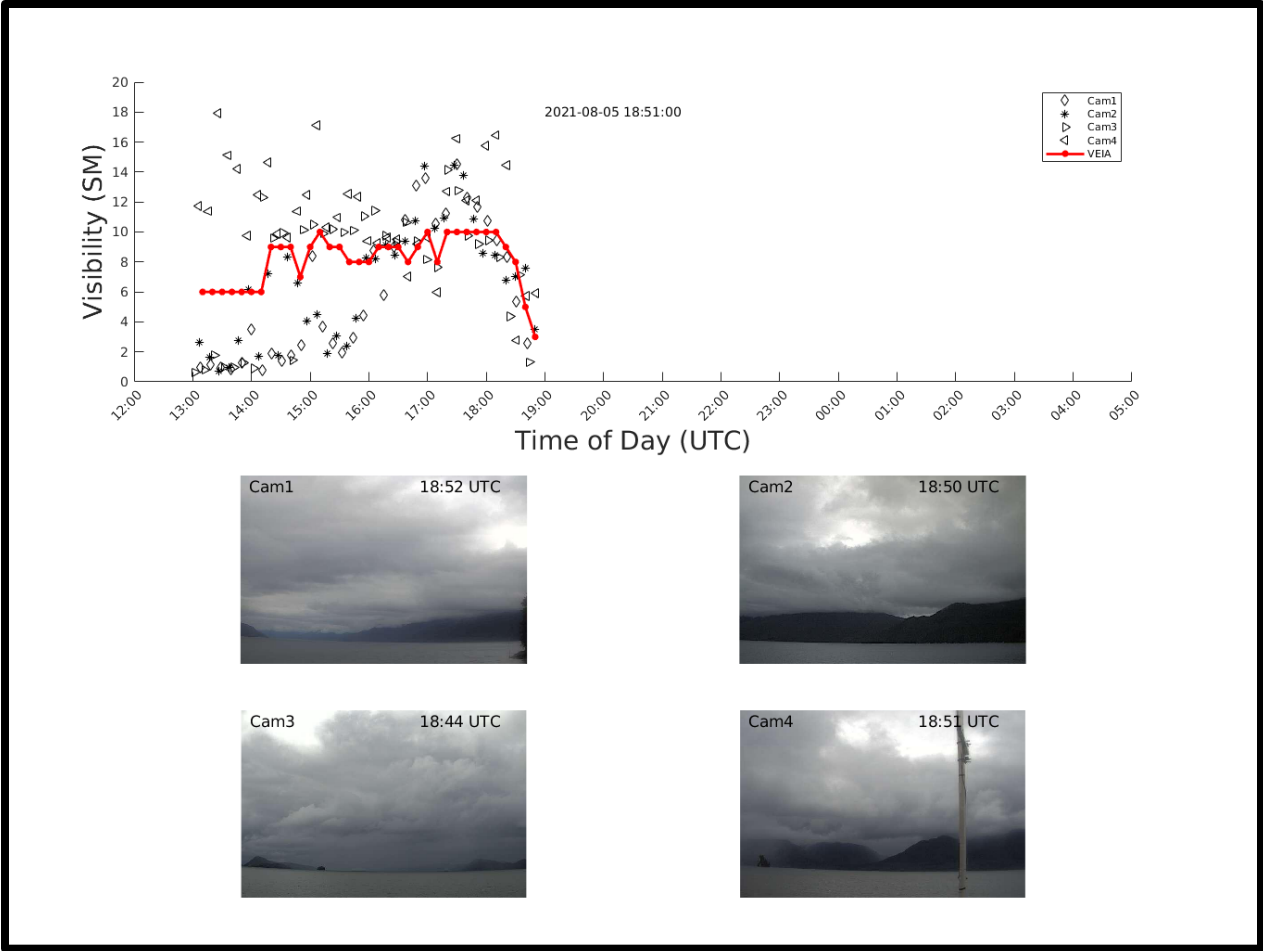
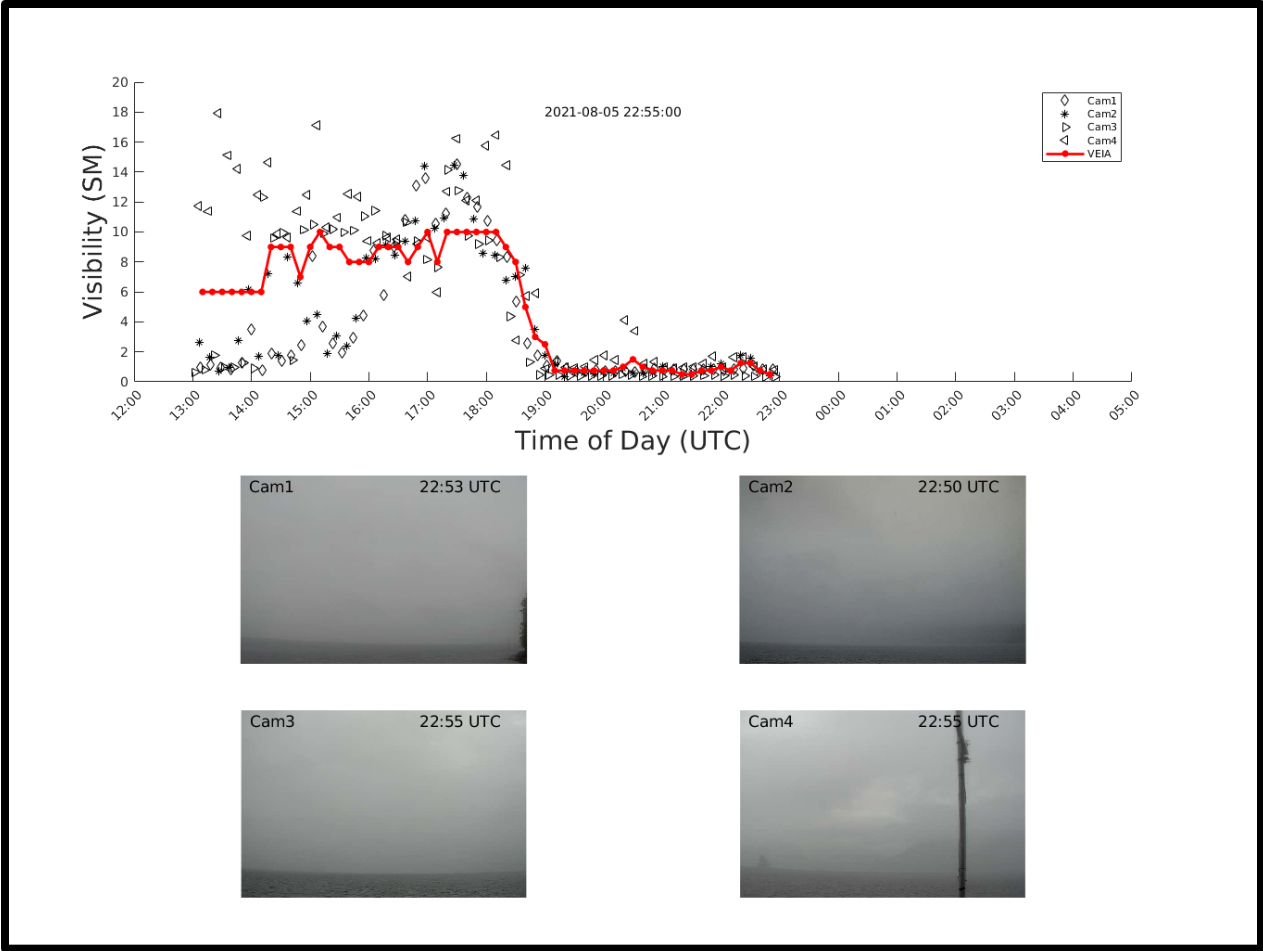
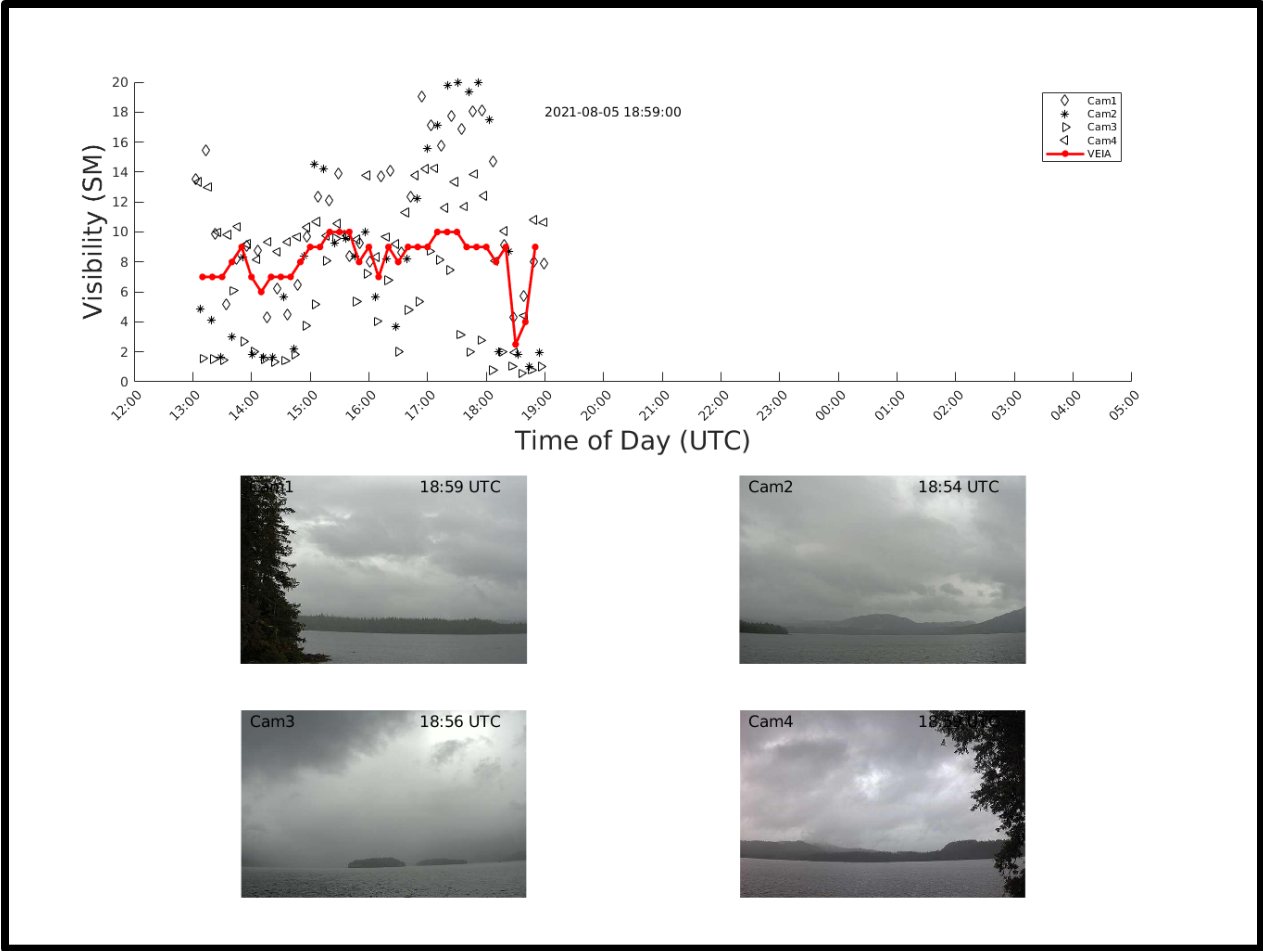
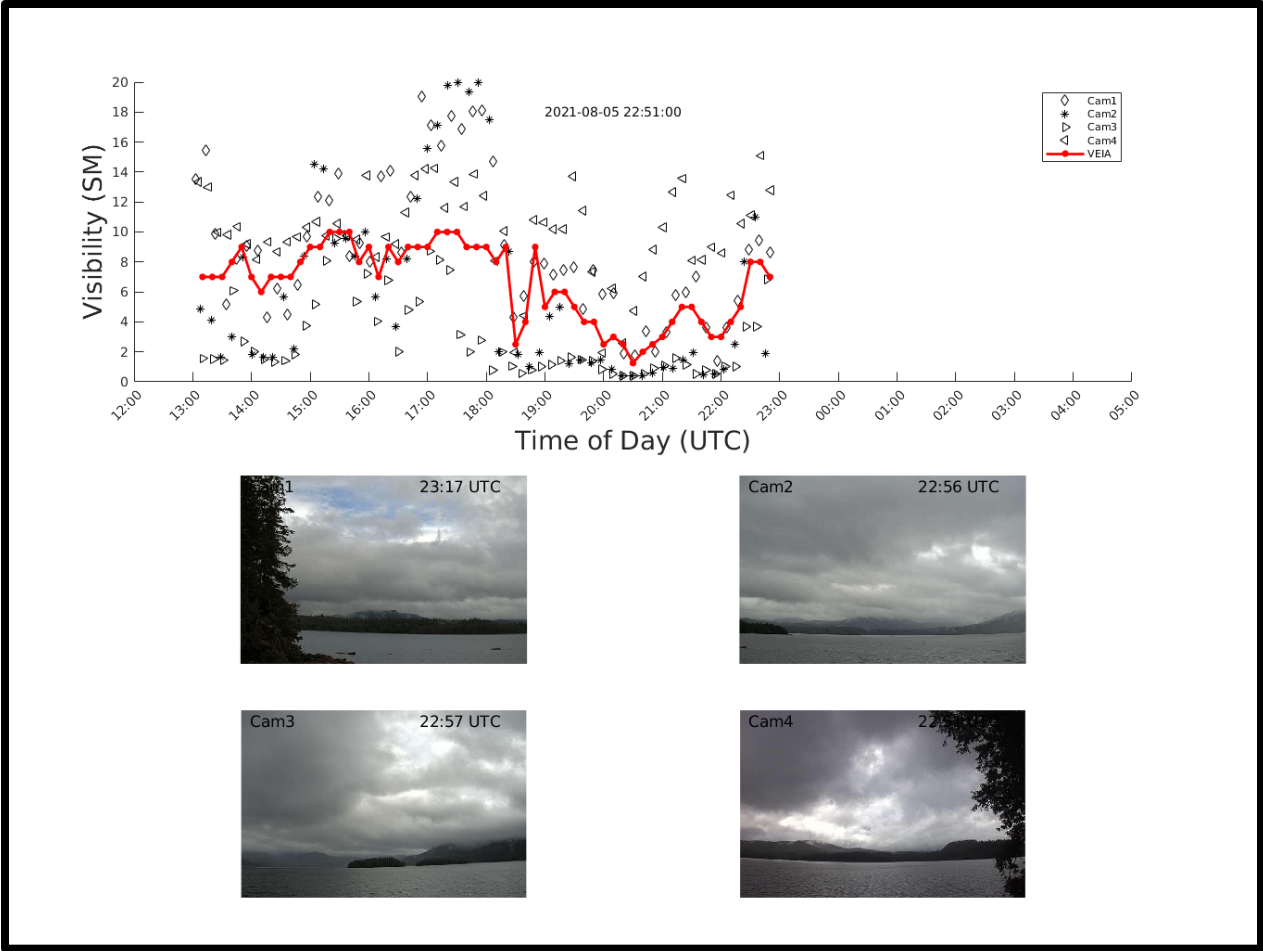
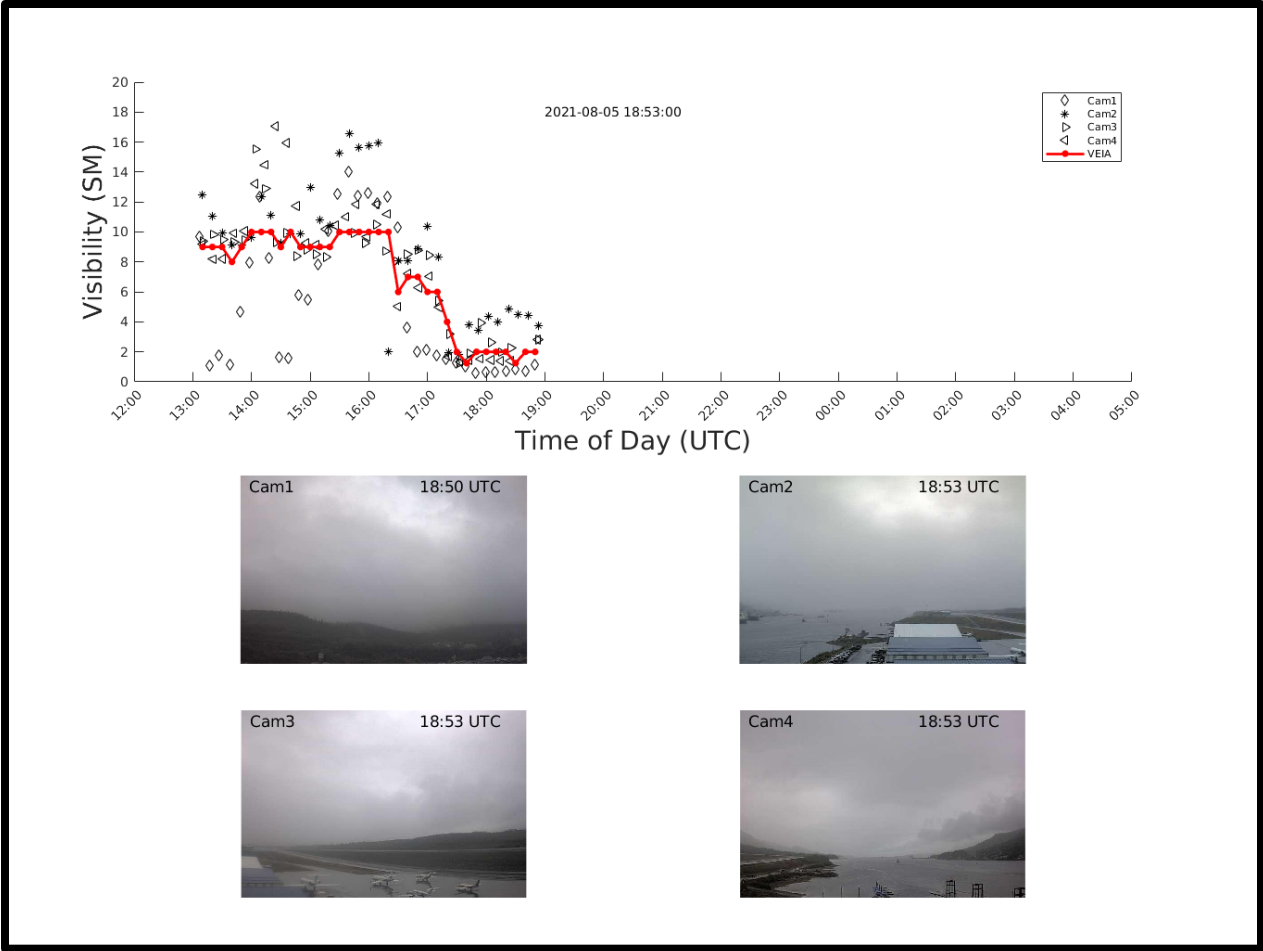
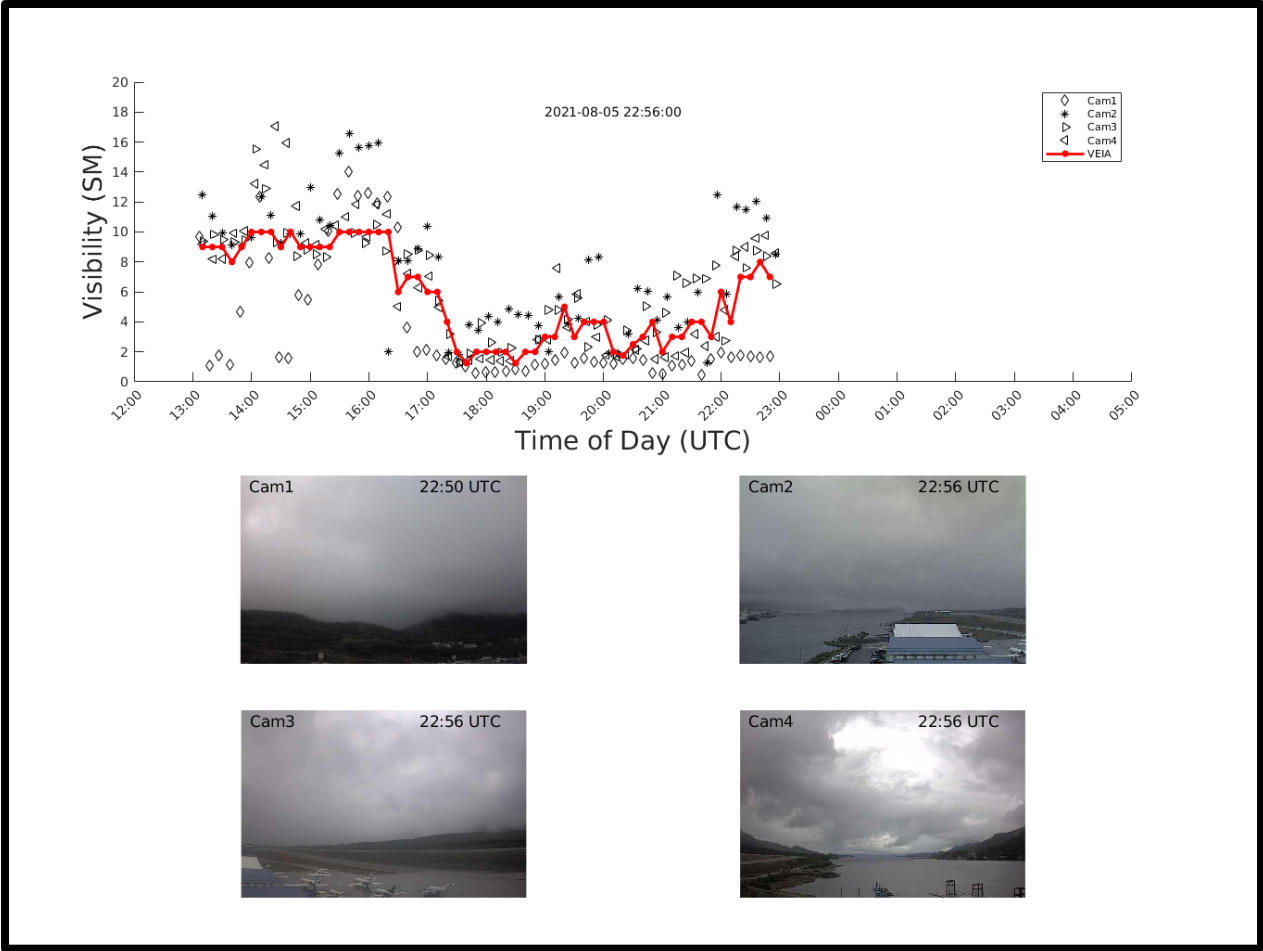
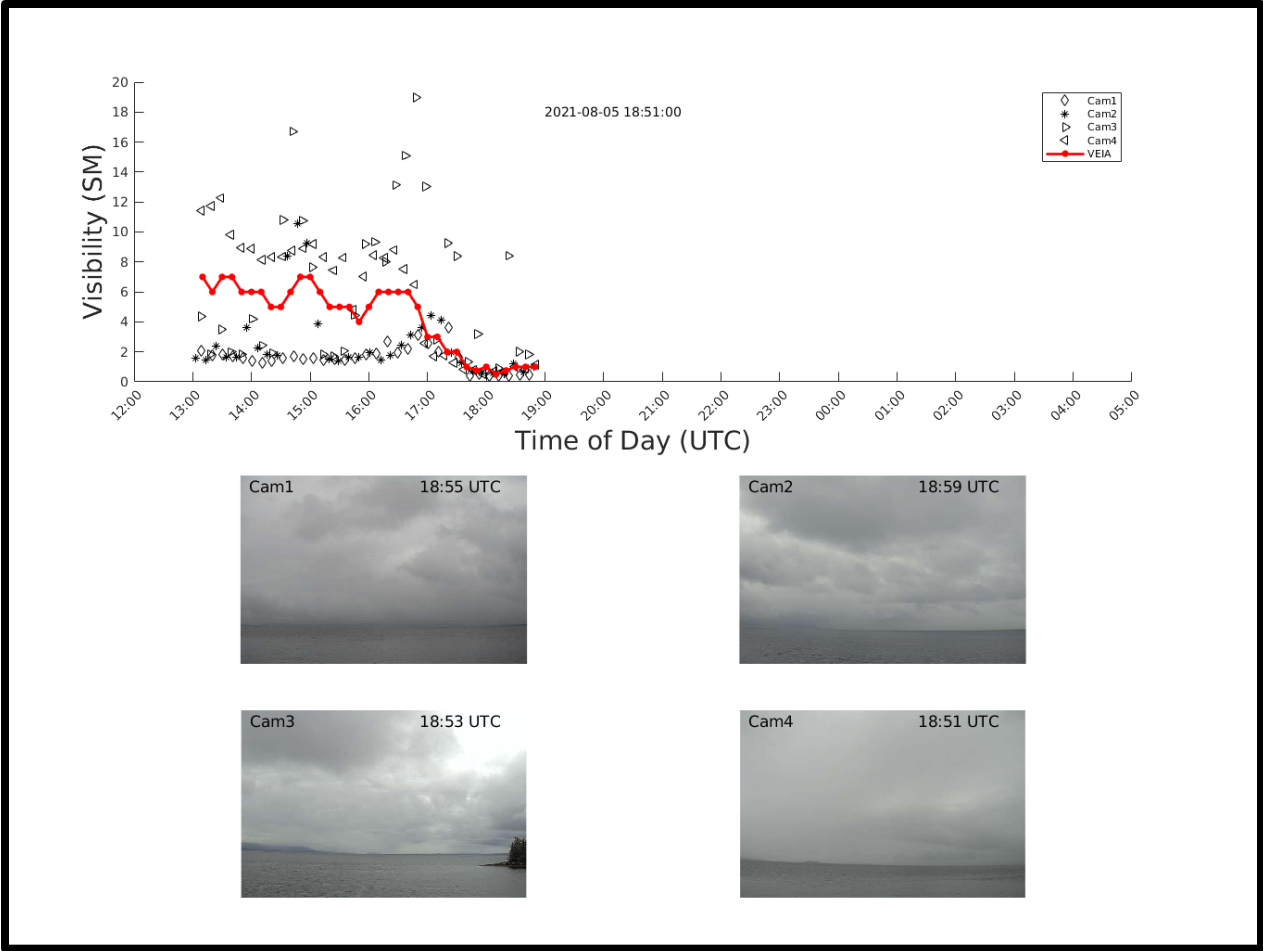
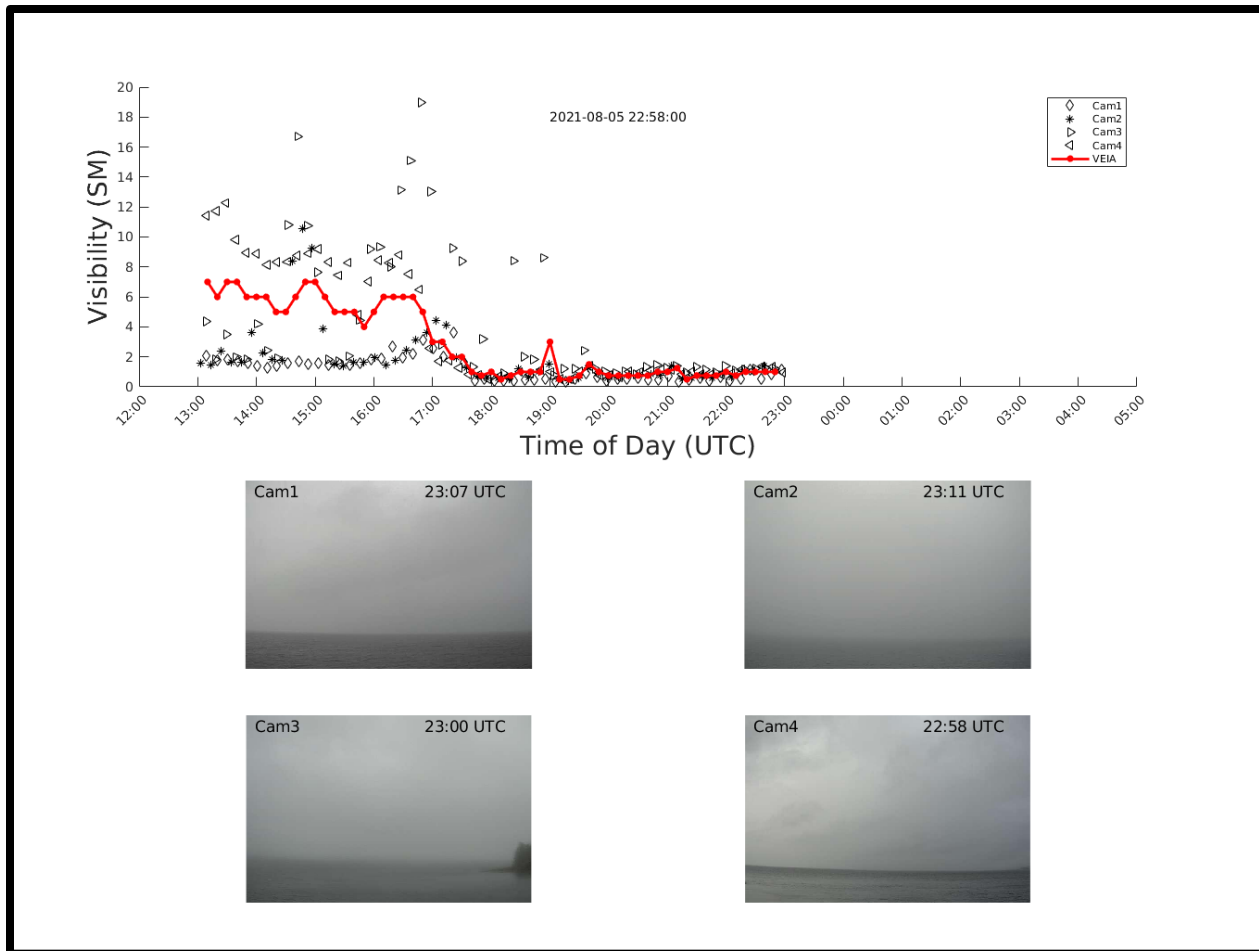
Figures 21 through 28 provide the VEIA imagery captured around the accident timeframe from the 4 FAA weather camera locations noted in figure 11. The VEIA algorithm uses the FAA weather camera imagery to produce a visibility estimate every ten minutes. VEIA data was not available operationally at the time of the accident; however, VEIA experimental data was provided by the FAA Aviation Weather Research Program. The estimated visibilities from each of the four cameras are plotted as black symbols. The prevailing visibility estimated by VEIA is plotted as a red line.
