NATIONAL TRANSPORTATION SAFETY BOARD

Group Chairman's Factual Report

METEOROLOGY

ANC21FA069

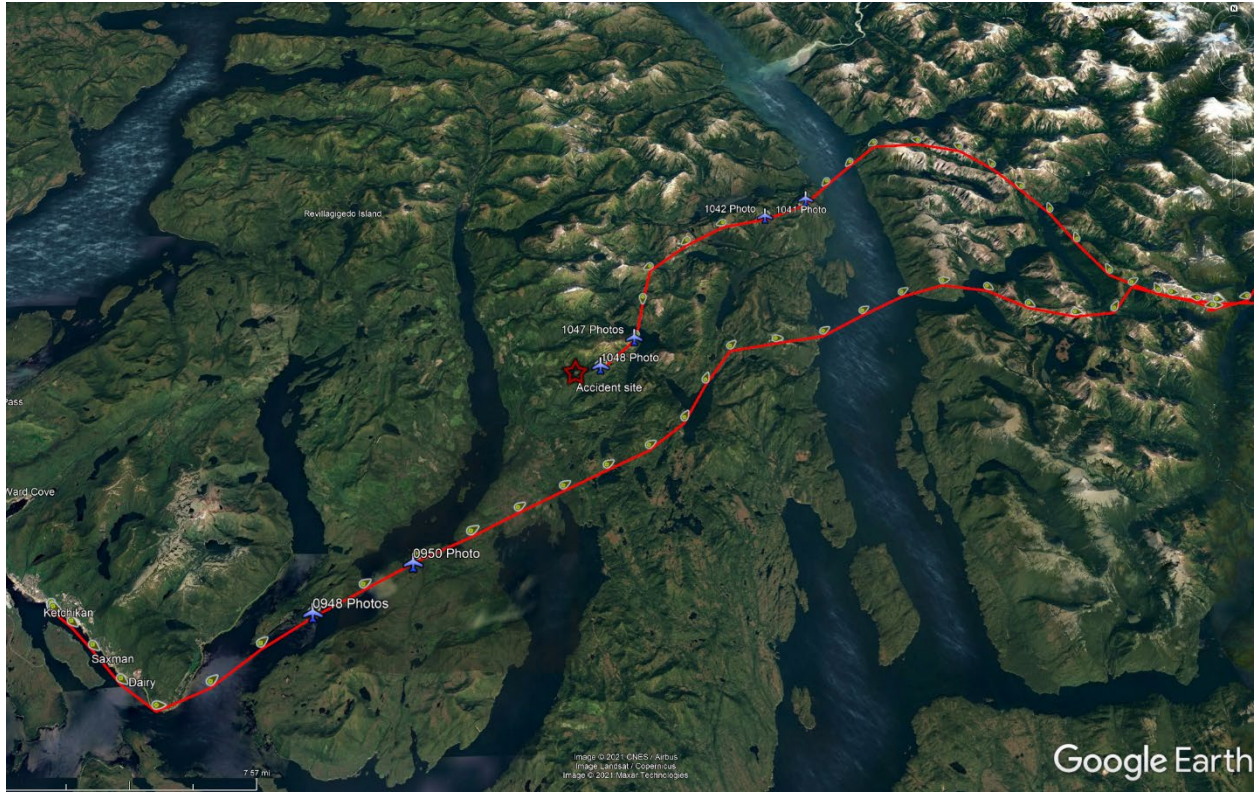
Figure 29 – Accident flight track data and locations and times of imagery from recovered PEDs.

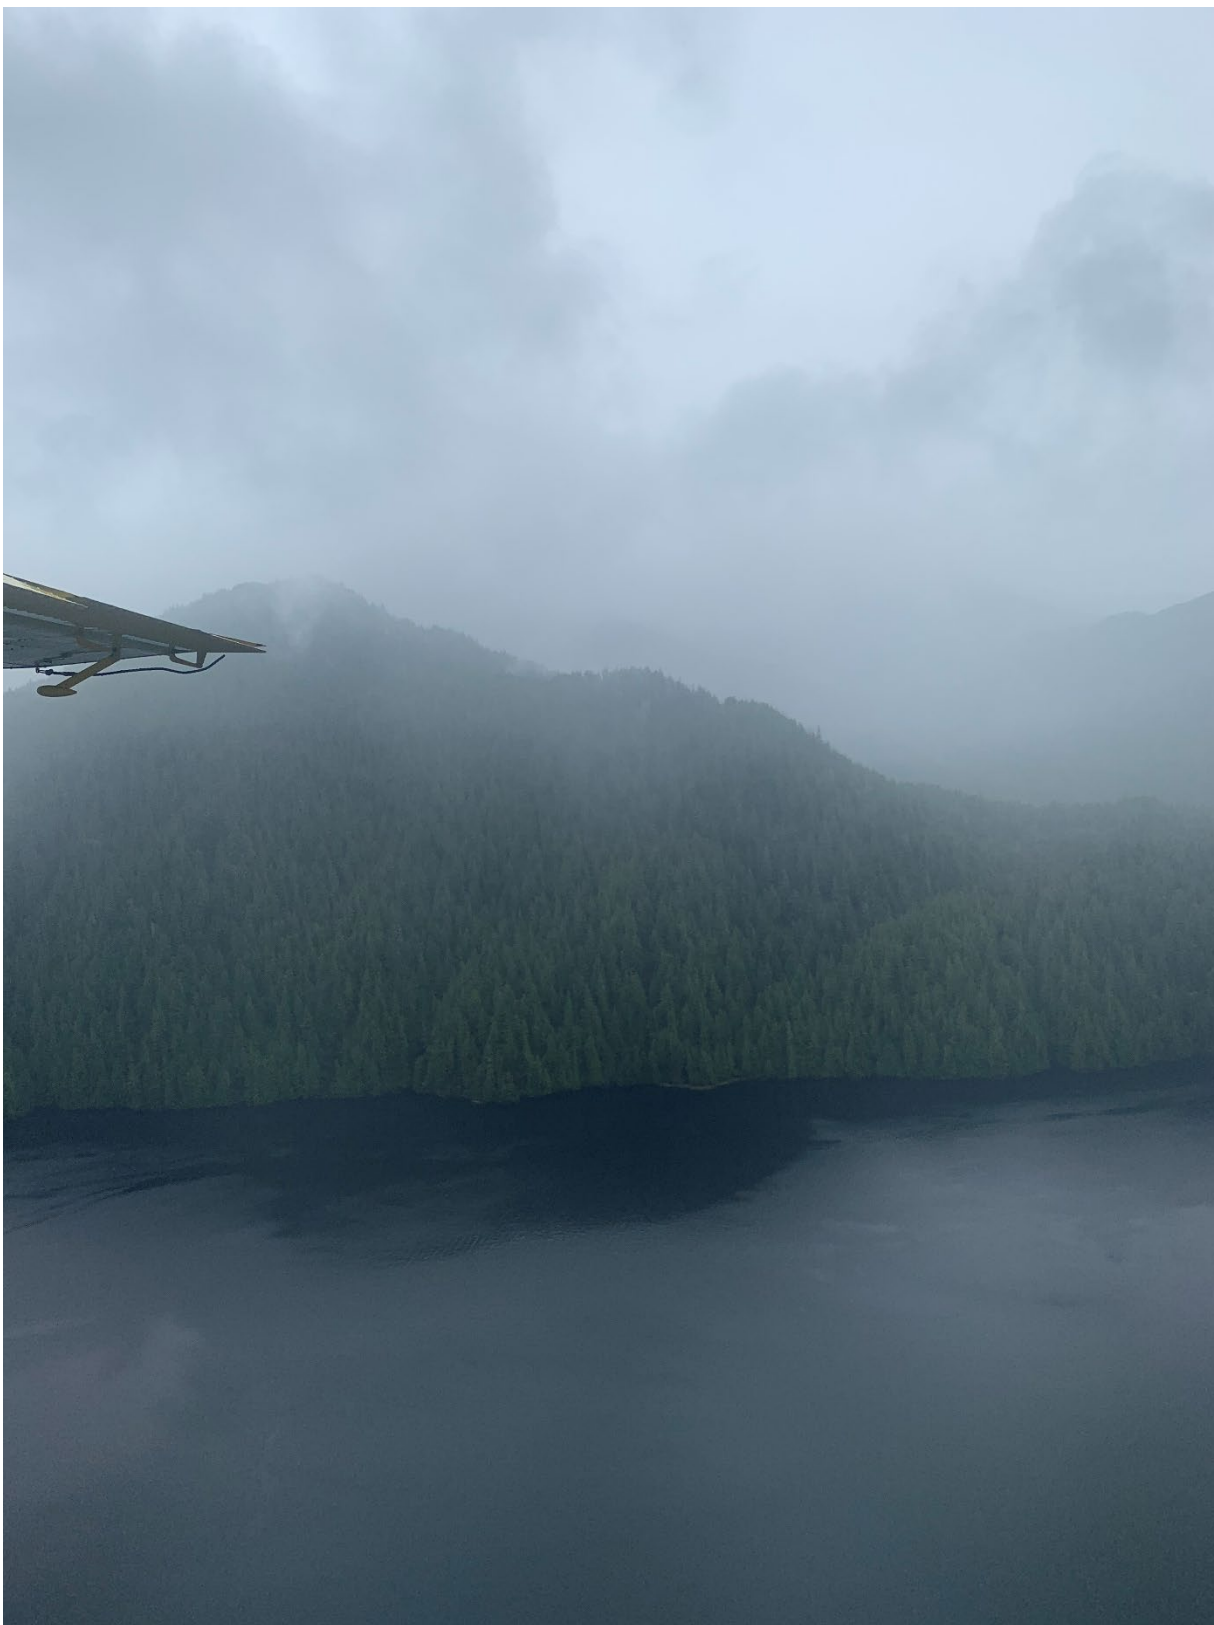
Figure 30 – Photo taken from an iPhone XR at 0948 AKDT from the right side of the accident airplane. It shows the western arm of Carroll Inlet looking to the southeast.

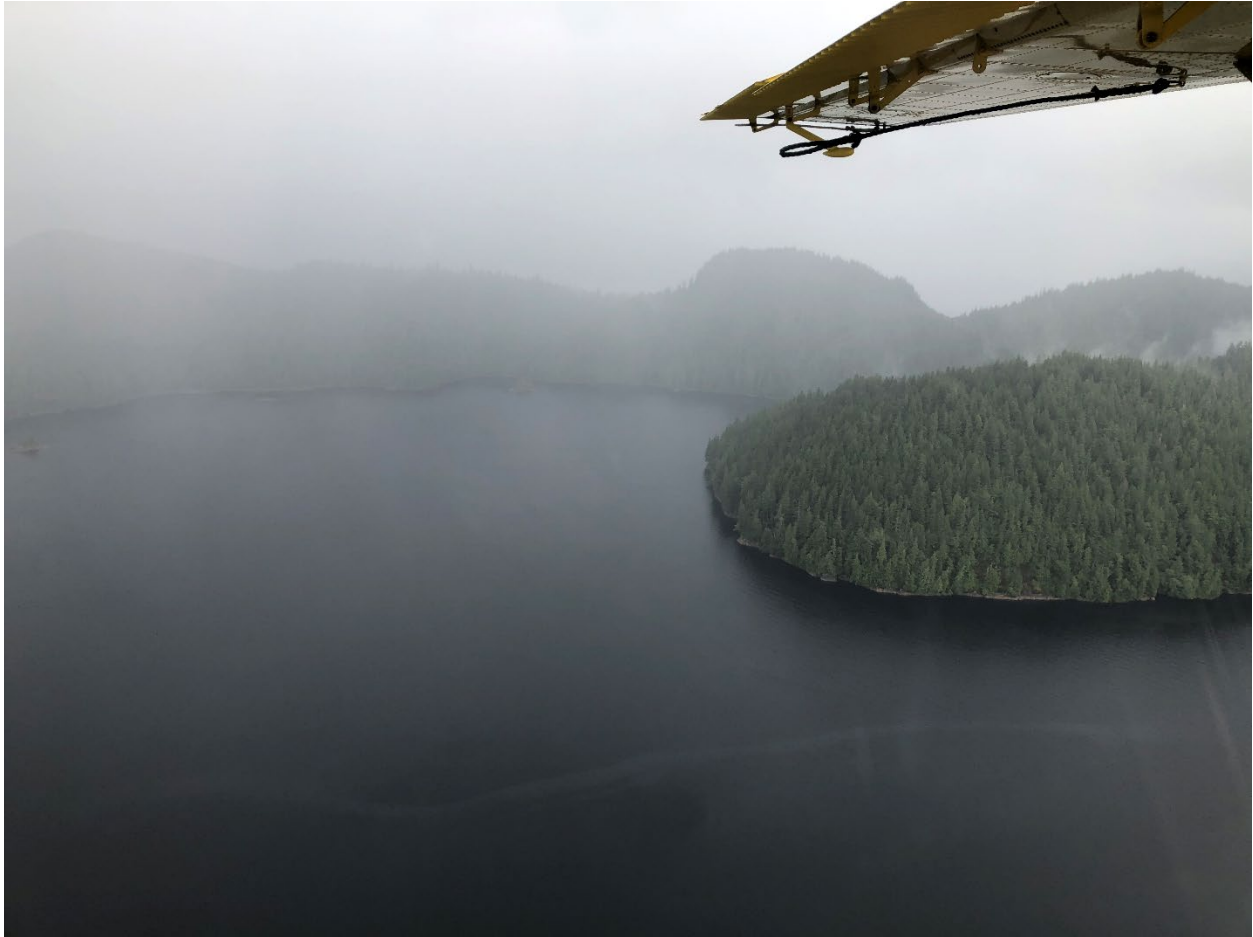
Figure 31 – Photo taken from an iPhone 8 at 0948 AKDT from the left side of the accident airplane. It shows the western arm of Carroll Inlet and California Cove looking to the north.

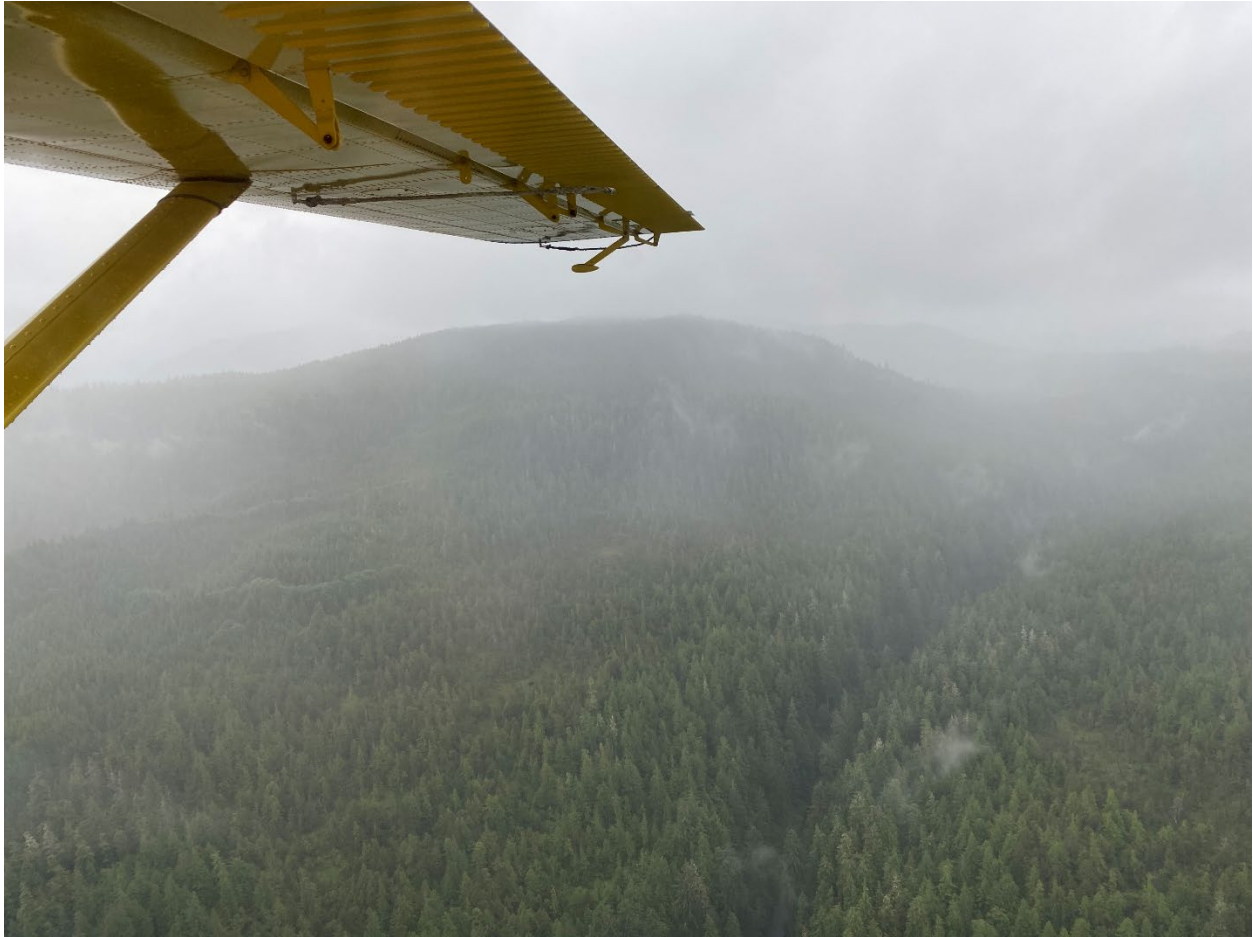
Figure 32 – Photo taken from an iPhone 11 at 0950 AKDT from the right side of the accident airplane. It shows Brunn Point looking southeast towards Throne Arm.

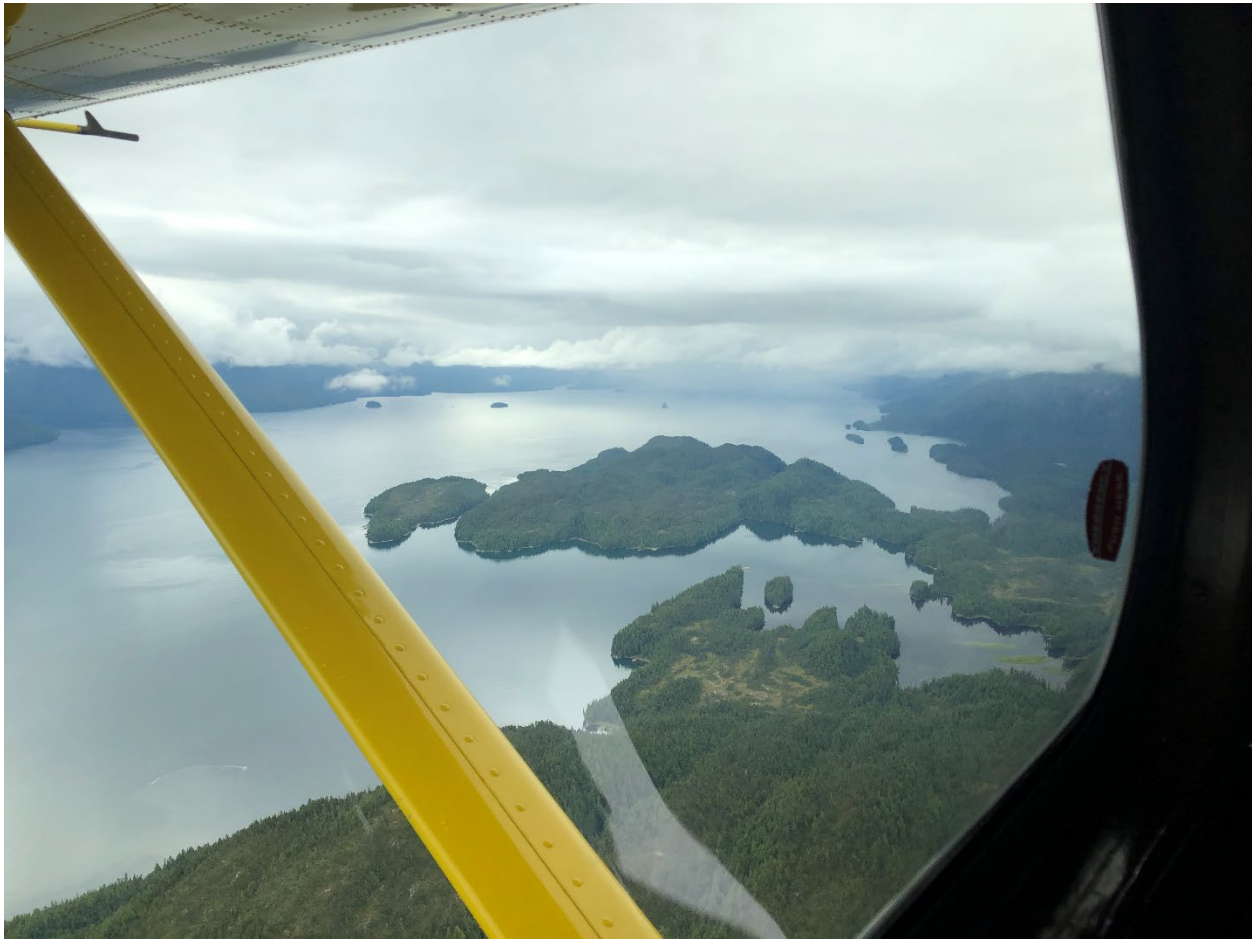
Figure 33 – Photo taken from an iPhone 8 at 1041 AKDT from the left side of the accident airplane. It shows Behm Canal looking to the southwest.

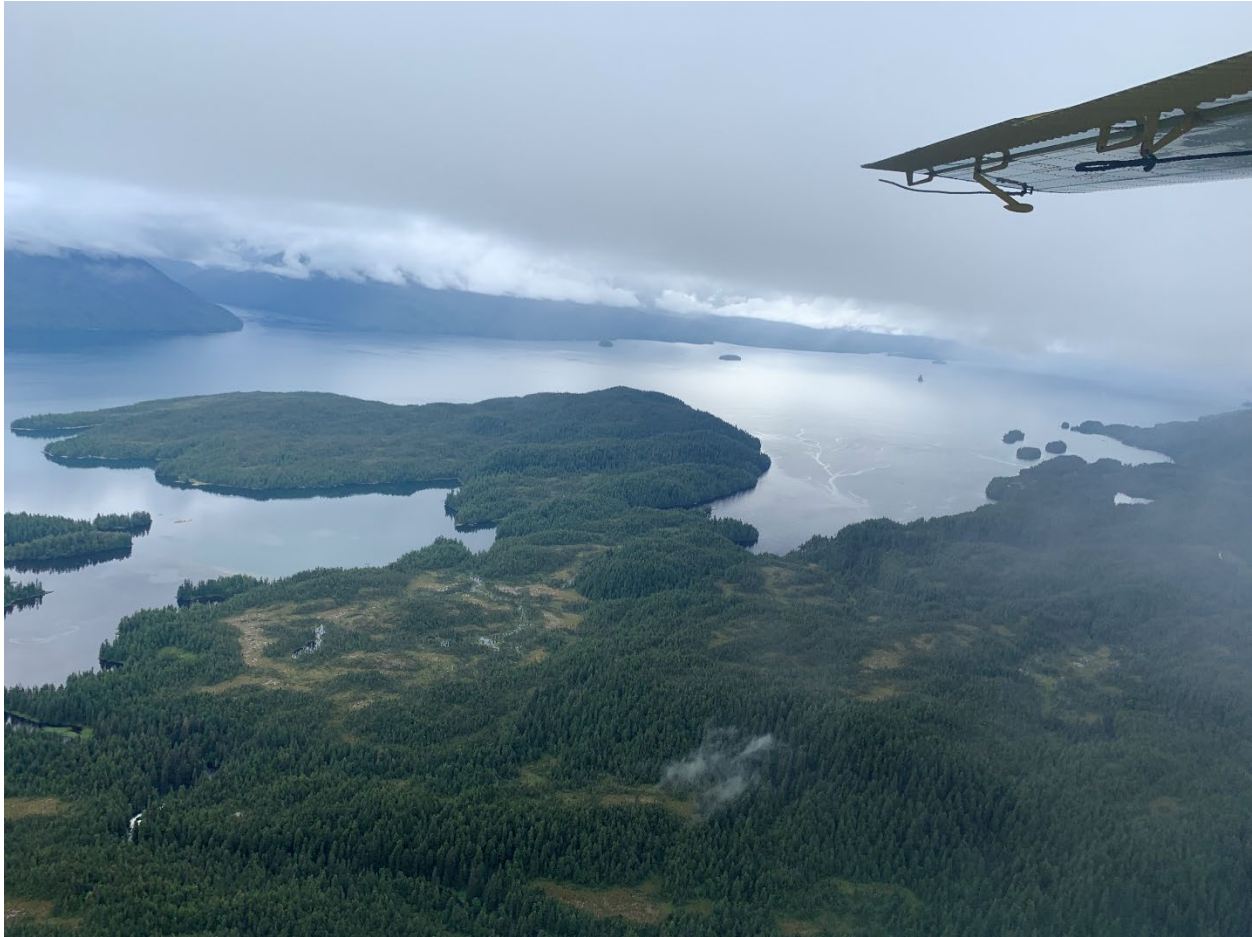
Figure 34 – Photo taken from an iPhone XR at 1042 AKDT from the left side of the accident airplane. It shows Behm Canal from Sargent Bay southward with image facing to the southwest.

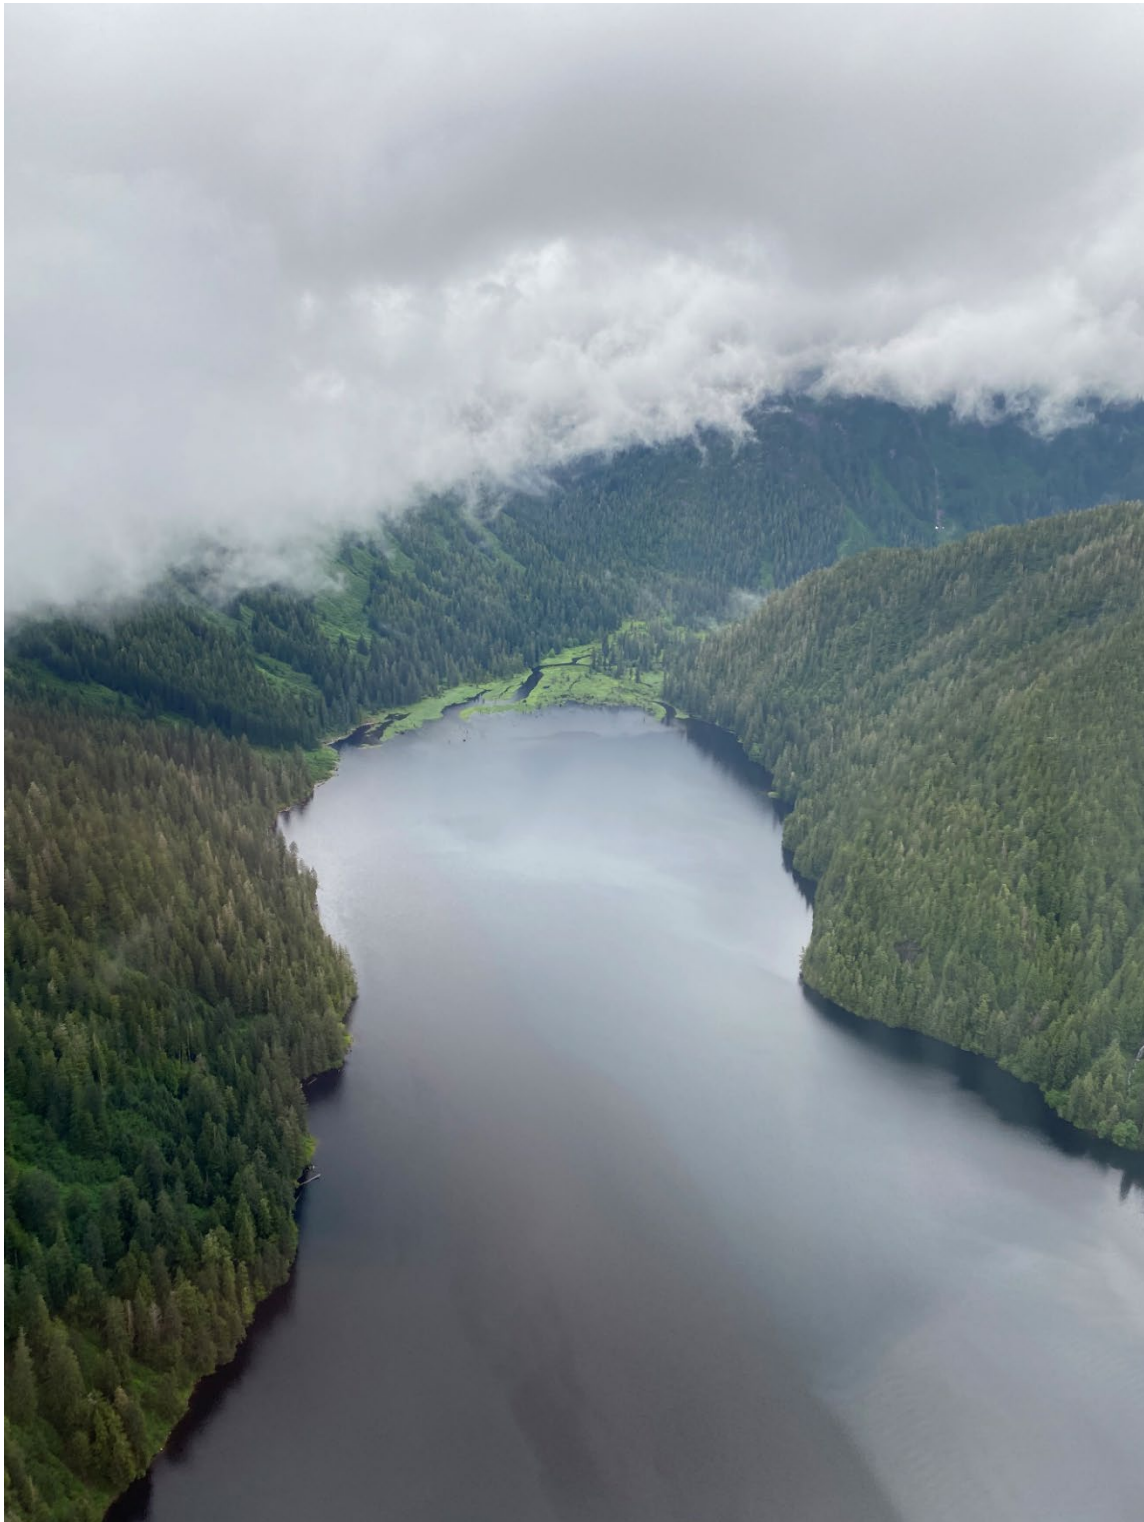
Figure 35 – Photo taken from an iPhone 11 at 1047 AKDT from the right side of the accident airplane. It shows the northern arm of Mirror Lake looking to the northwest.

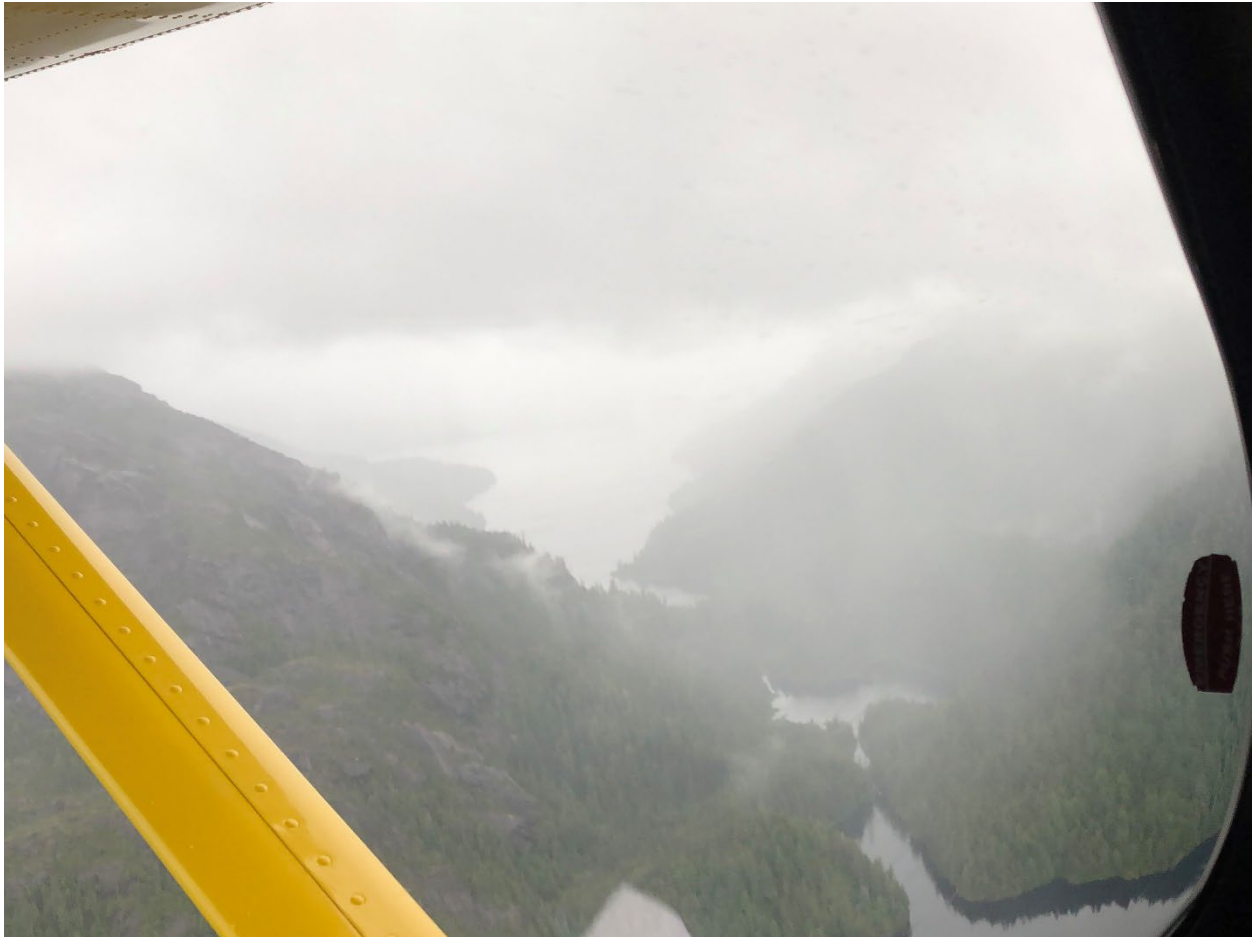
Figure 36 – Photo taken from an iPhone 8 at 1047 AKDT from the left side of the accident airplane. It shows the northwestern arm of Ella Lake looking to the southeast.

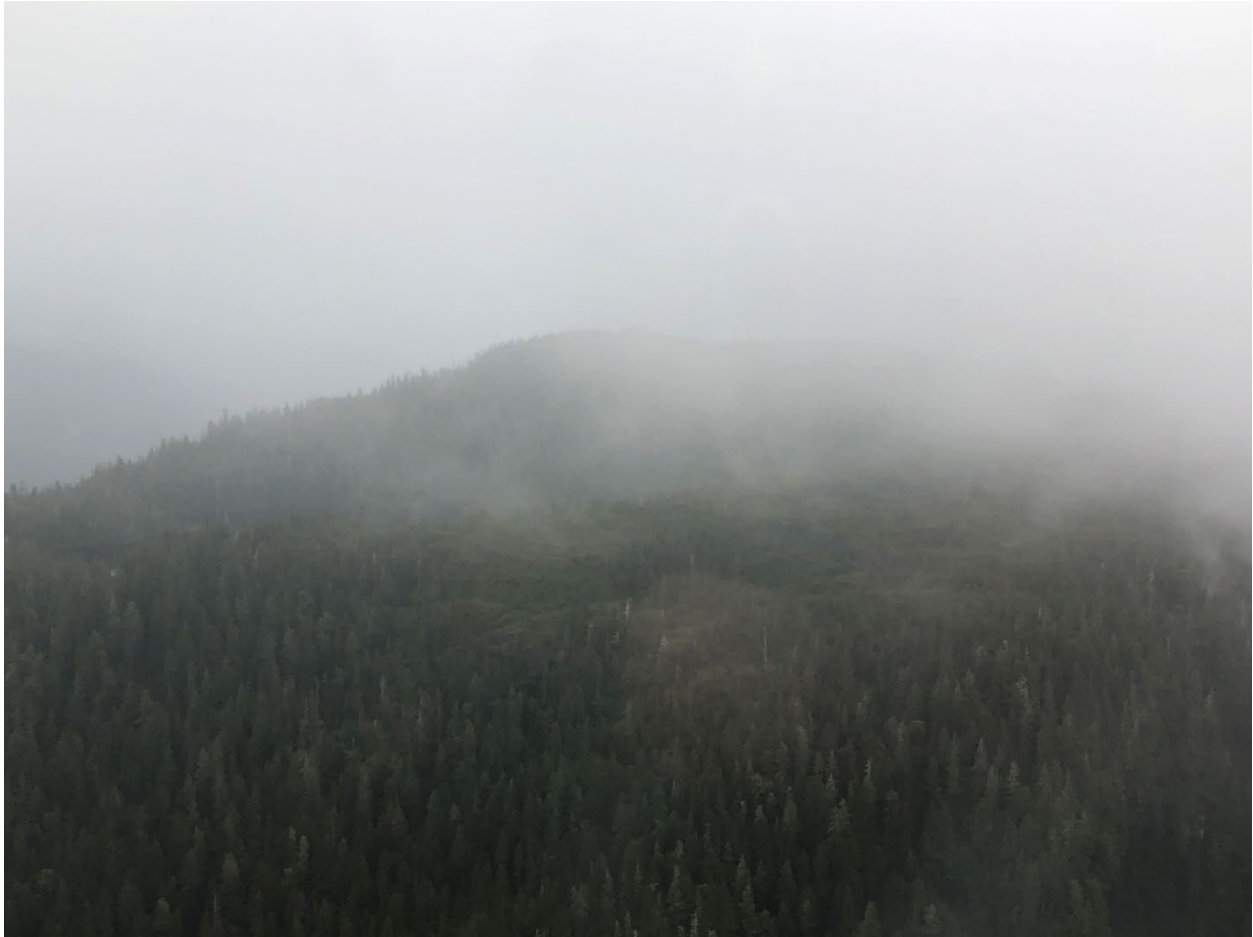
Figure 37 – Photo taken from an iPhone 8 at 1048 AKDT from the left side of the accident airplane. It shows portions of the terrain in between Mirror Lake and Big Lake looking to the south.
