NATIONAL TRANSPORTATION SAFETY BOARD

Specialist's Report

SURVIVAL FACTORS

ANC22FA041

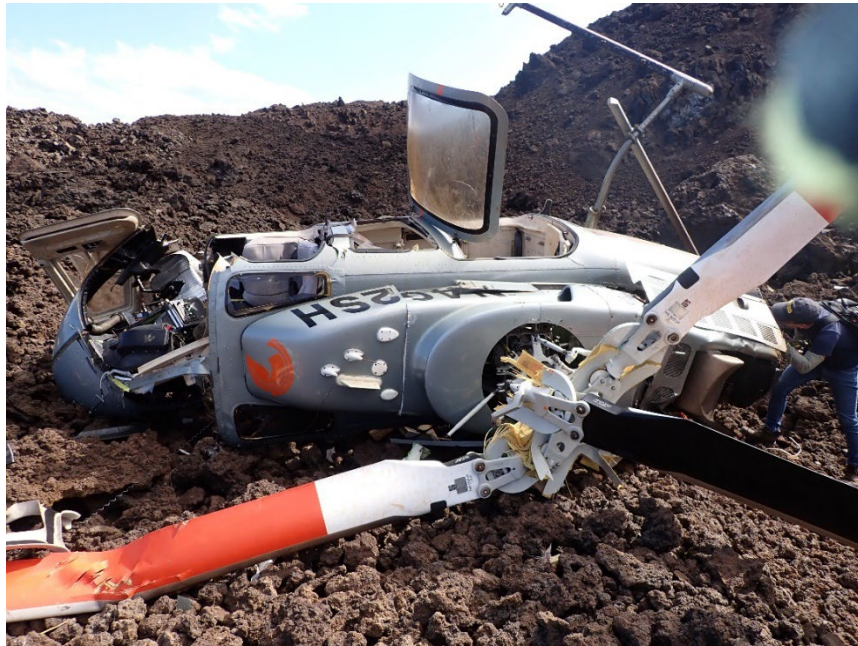
The helicopter was found lying on its left side with significant damage to the cockpit (see figure 3). The cabin had crushing that compromised the occupiable volume on the left side (see figure 4). The right-side cabin door came open during the impact sequence and remained held open by the pneumatic assist until the recovery crews detached it. The tail boom was separated and located 762 feet from

Figure 3. Top view of the accident helicopter N402SH.

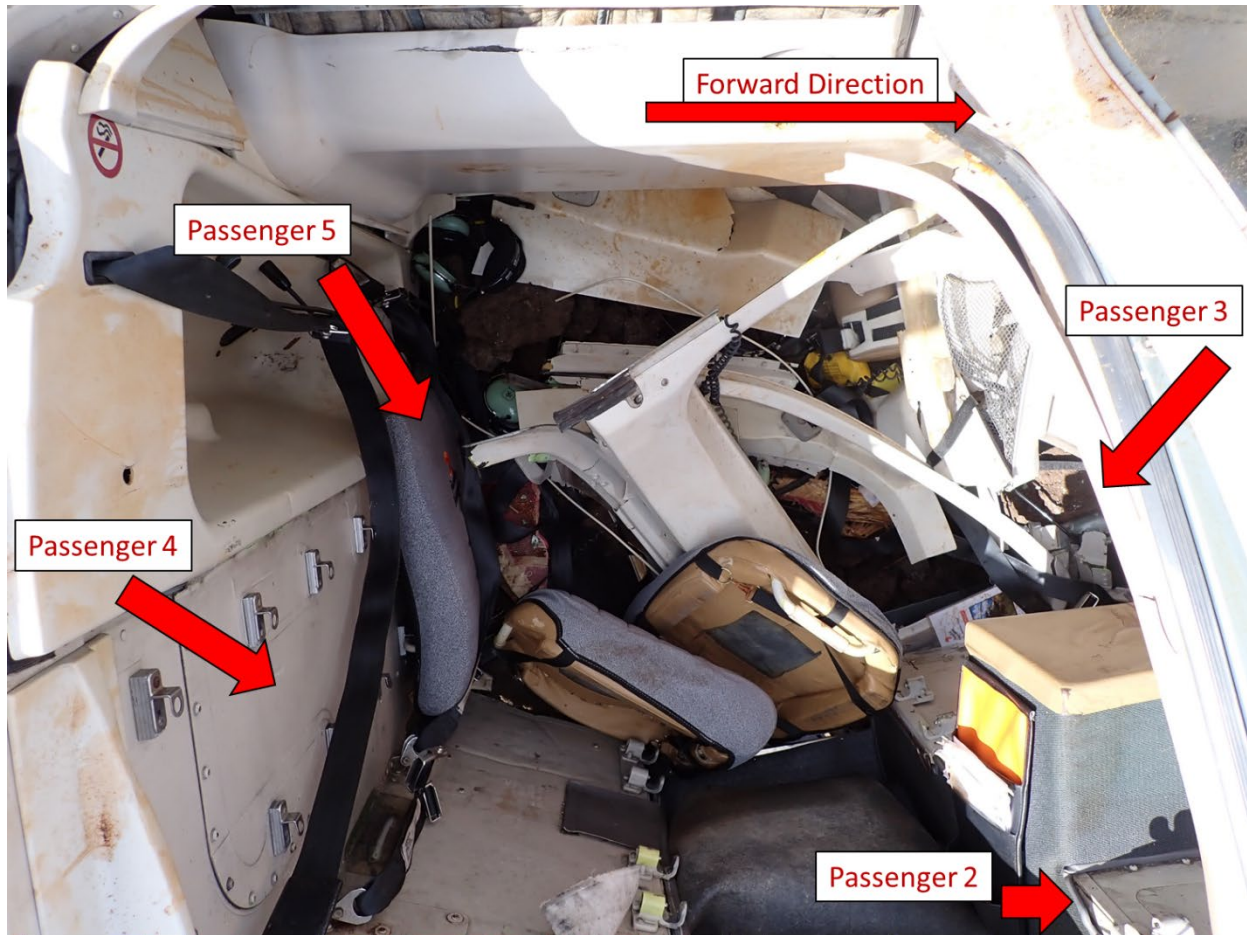
Figure 4. On-scene view from the right side of the helicopter looking down into the cabin interior.

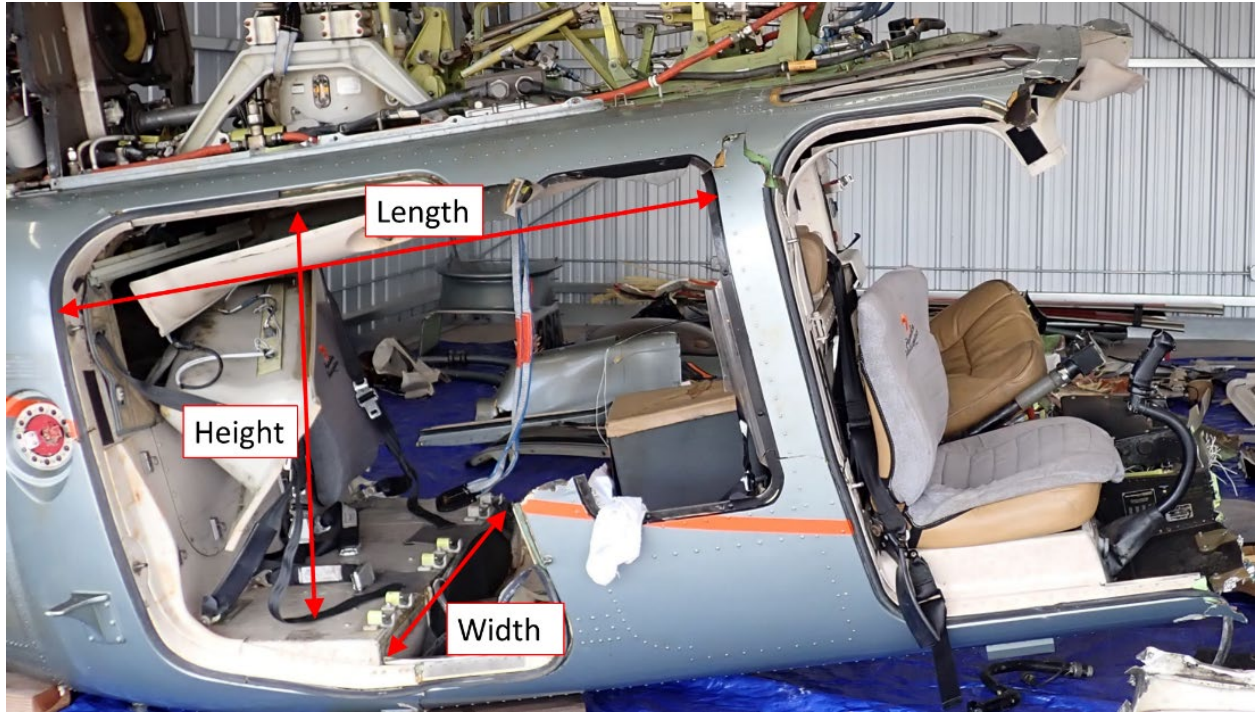
The cabin area was measured for length, width, and height, then compared to a sister ship N808PH (see table 1). The length was measured from the aft to the forward door frame structure (see figure 5). The height was from the center of the box structure of the aft forward-facing seat behind the pilot to the overhead structure. The width was from the door frame on the left to the right across the middle of the aisle between the passenger seats.

Figure 5. Measurements of the cabin volume of the accident helicopter.

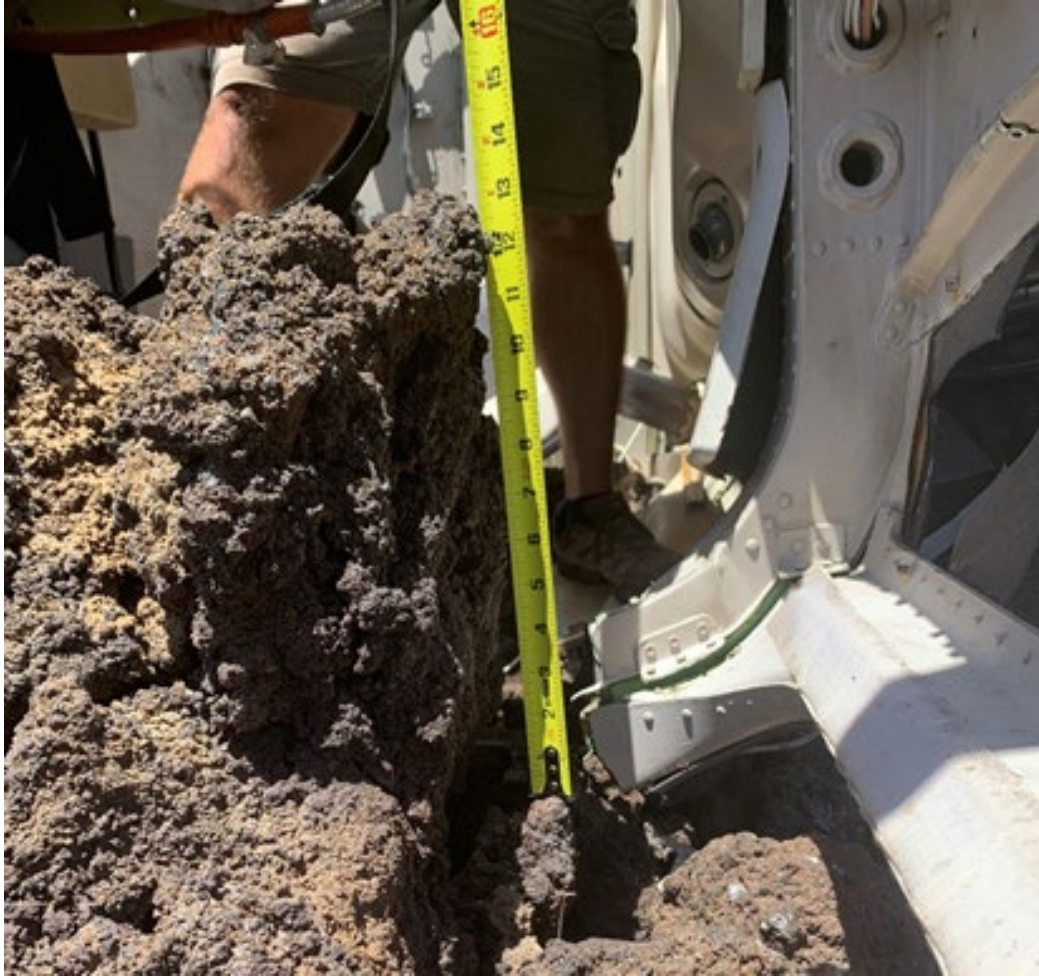
The structure around the copilot seat was compromised when the helicopter came to rest in the lava field. There was a large piece of lava rock that was penetrating approximately 13 inches into the cockpit area adjacent to the front passenger seat (see figure 6).

Figure 6. Photograph of lava rock that penetrated the cockpit area.

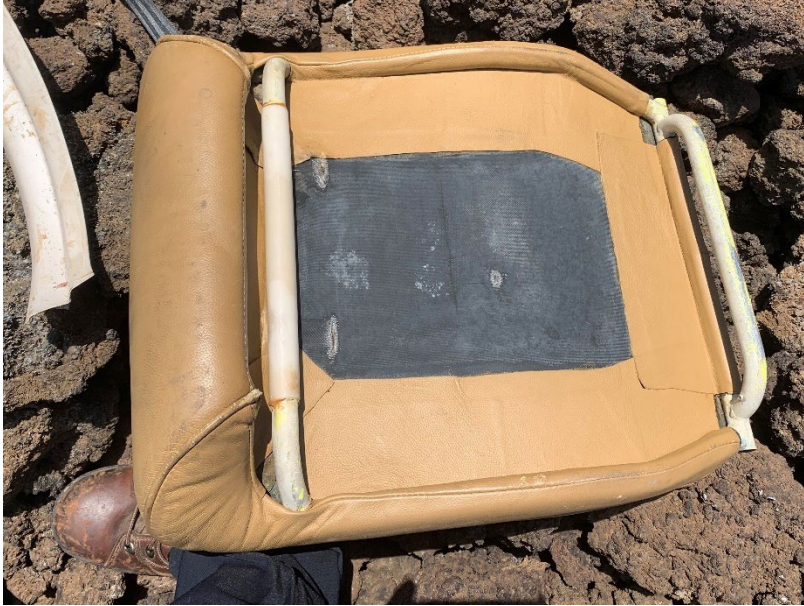
All seats were original equipment manufacturer (OEM) seats that were delivered with the helicopter. The seats were composed of a seatback and seat bottom cushion each attached to a tubular frame with fabric and adhesive (see figure 7). No labels were found on any of the cushion assemblies. The bottom cushion frame was secured to a box structure that was integrated into the fuselage. The seatback cushion frame for the pilot, copilot, and both aft-facing seats were secured to structure that separated the cockpit and the cabin. The forward-facing seatback cushion frames were secured to the aft bulkhead of the cabin.

Figure 7. Seat bottom cushion found at the wreckage site.

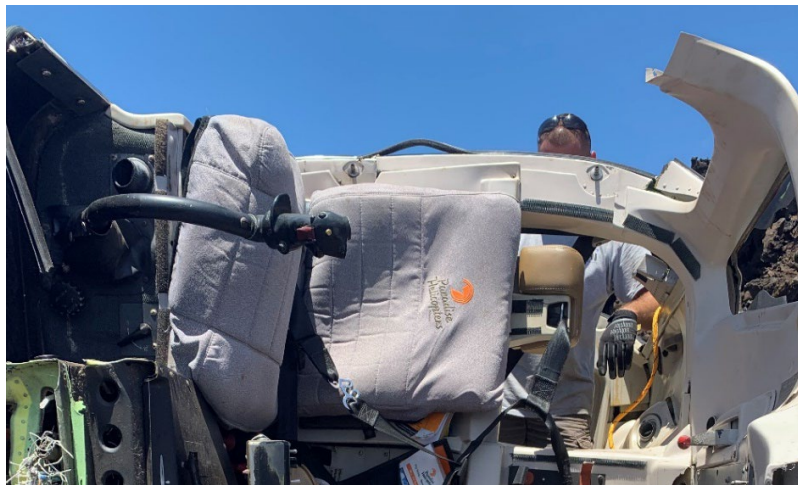
The pilot seat was located on the right-hand side of the cockpit, and had both cushions still secured to the seat structure (see figure 8).

Figure 8. Pilot seat as found at the wreckage location.

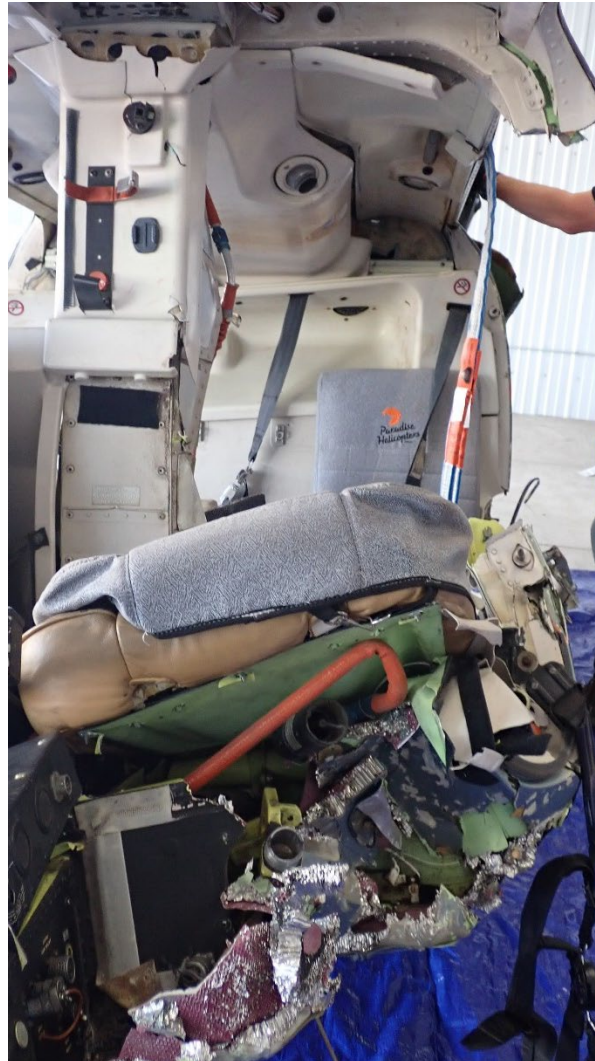
Passenger 1's seat was on the left-hand side of the cockpit. The structure located behind the occupant was destroyed during the impact and the seatback cushion was not found. The boxed structure under the seat bottom cushion, was deformed upward at the forward left-hand corner (see figure 9). The cyclic was

Figure 9. Co-Pilot seat which was occupied by passenger 1.

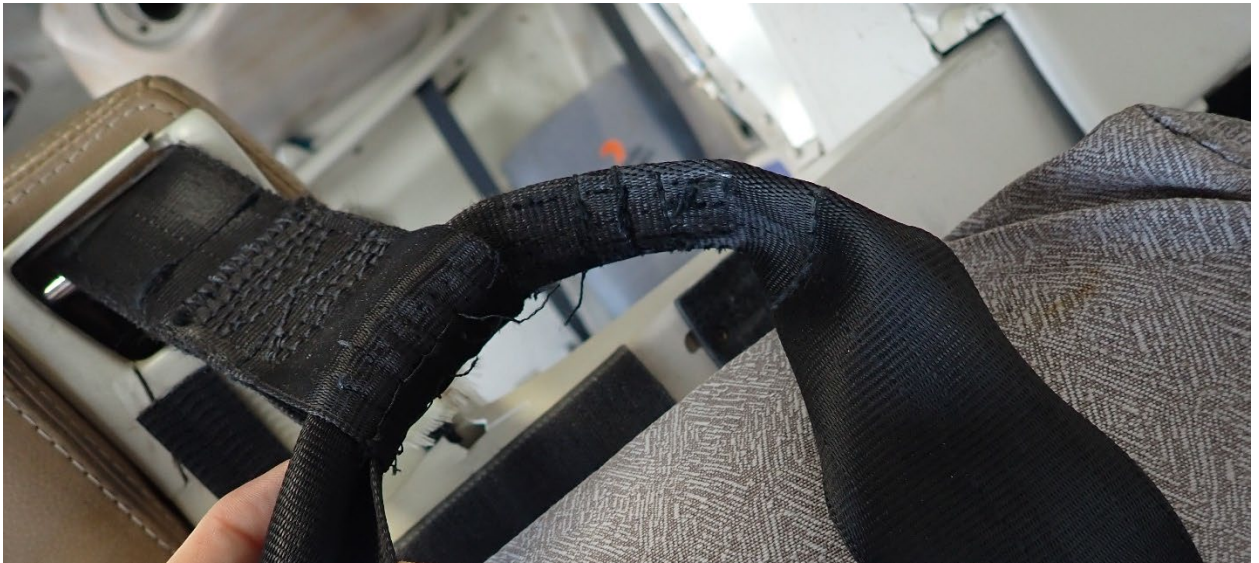
The pilot seat restraints were mostly undamaged, except for upper portion of the torso restraint yoke, which had ripped stitching (see figure 10). The pilot seat

Figure 10. The pilot torso restraint with ripped stitching.

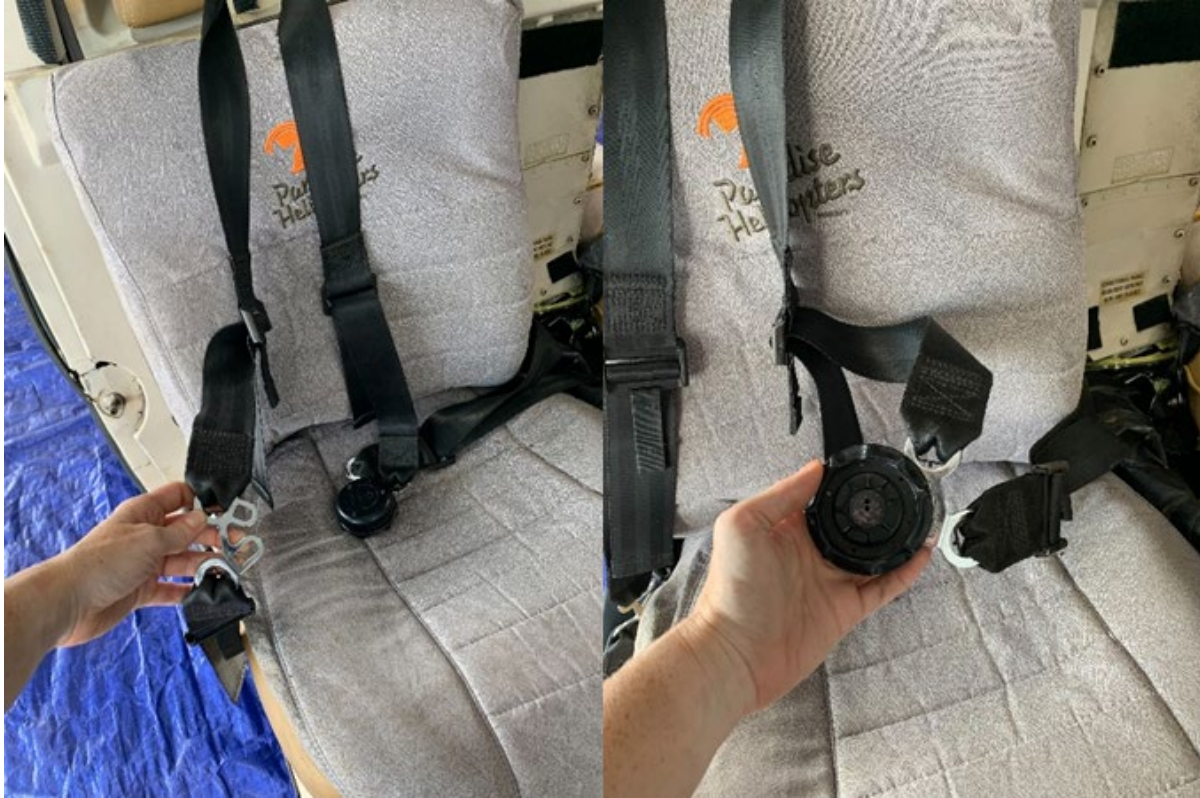
The passenger 1's right lap belt attachment point was separated from the anchor point. During recovery operations the shoulder belts were cut to facilitate removal of loose structure. The rotary buckle was labeled Schroth Safety Products GmbH - Arasberg/Germany, Type SL 15.7A, DATE 50/11.

Figure 11. Pilot and passenger 1 restraint system.

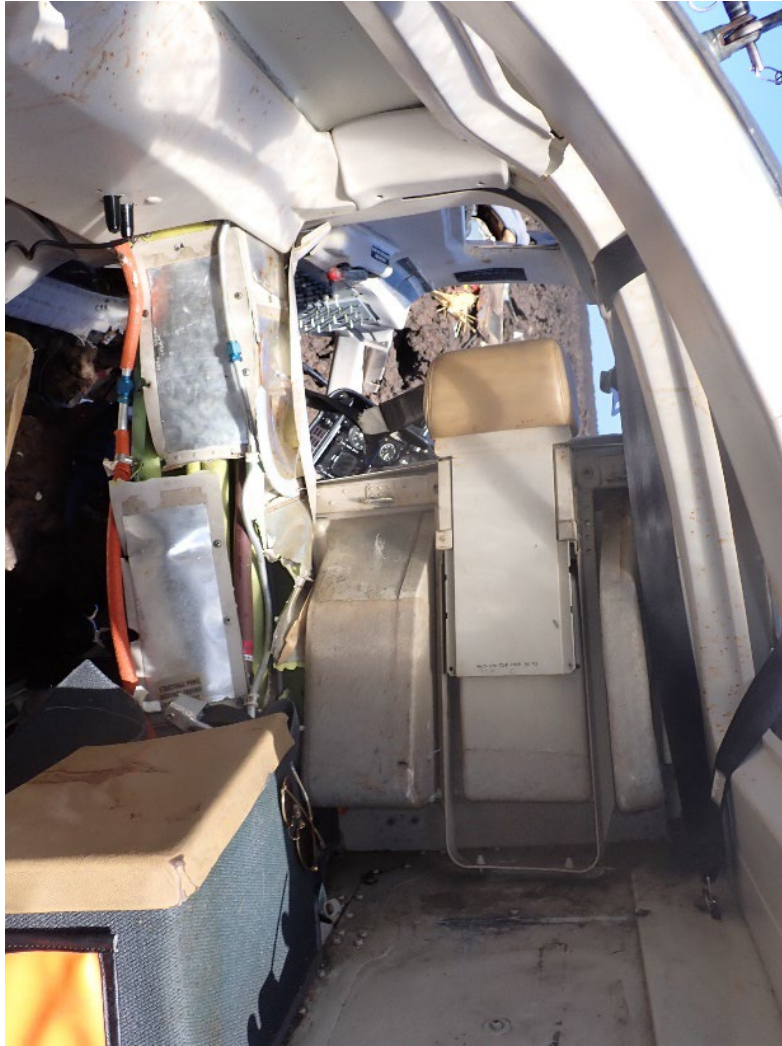
Passenger seat 2 was aft-facing in the cabin located behind the pilot. No cushions were found attached; however, the seating support structure was intact and showed no deformation (see figure 12). The surrounding structure was damaged but still present on-scene, including the right-side door.

Figure 12. Passenger 2 seat at the accident location.

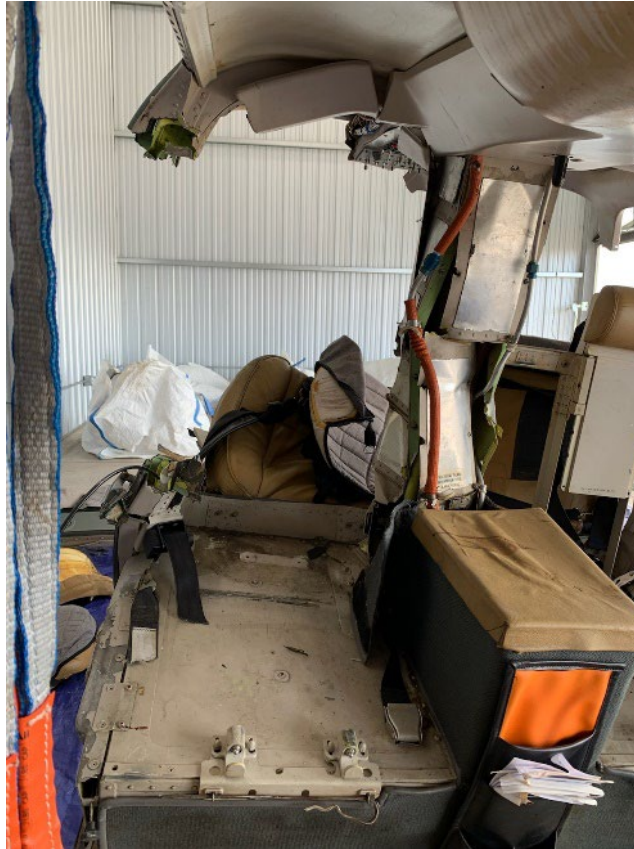
Passenger seat 3 was aft-facing located behind the passenger 1. No cushions were found attached; however, the bottom seating support structure was intact and showed no deformation (see figure 13). The structure behind the occupant had detached from the helicopter but was still contained in the cabin wreckage on-scene.

Figure 13. Passenger seat 3, aft-facing located behind passenger 1's seat.

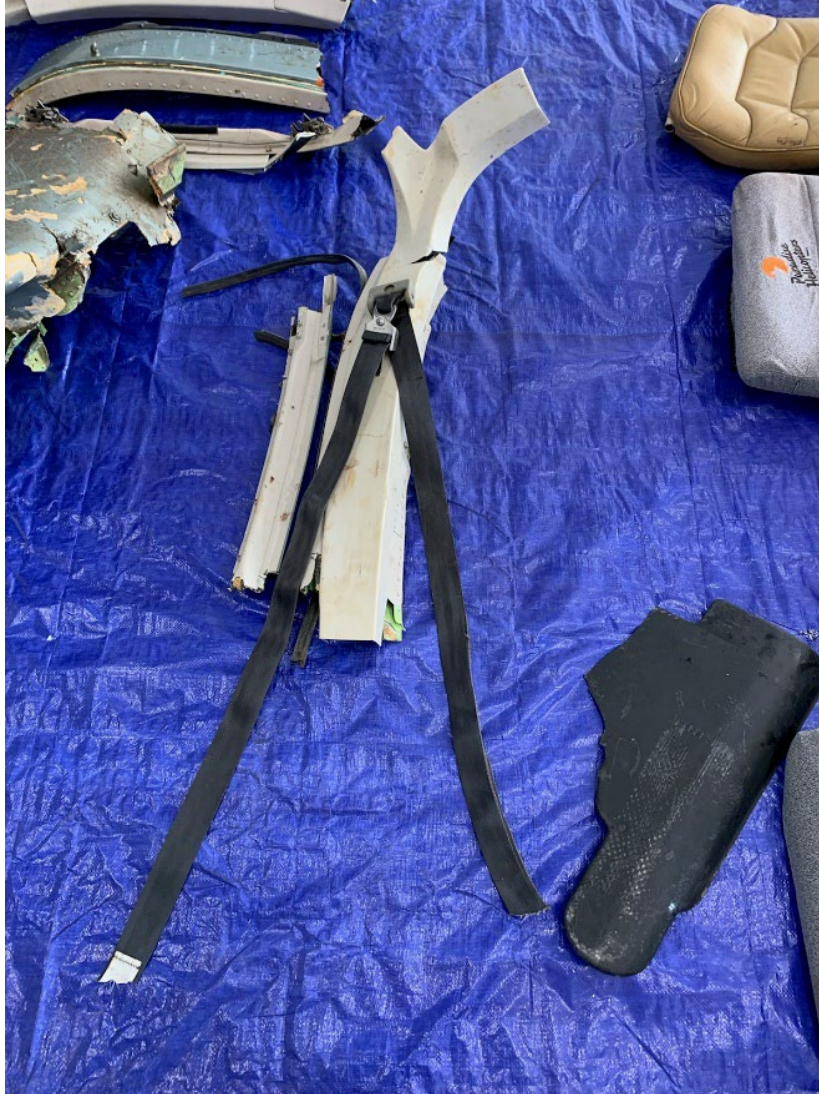
Passenger seat 3's shoulder belt, and right lap belt had been cut by passengers to help passenger 1 evacuate the helicopter, according to passenger 2. The left portion of the lap belt was intact, with no damage to the webbing or buckle. The shoulder belt and the right lap belt webbing were attached to structure that fell away when the wreckage was lifted (see figure 14). There was a fabric label on the lap belt that read:

Figure 14. Passenger seat 3 shoulder belt and lap belt webbing attached to structure that was damaged in the accident. The webbing was cut by passengers to help passenger 1 evacuate.

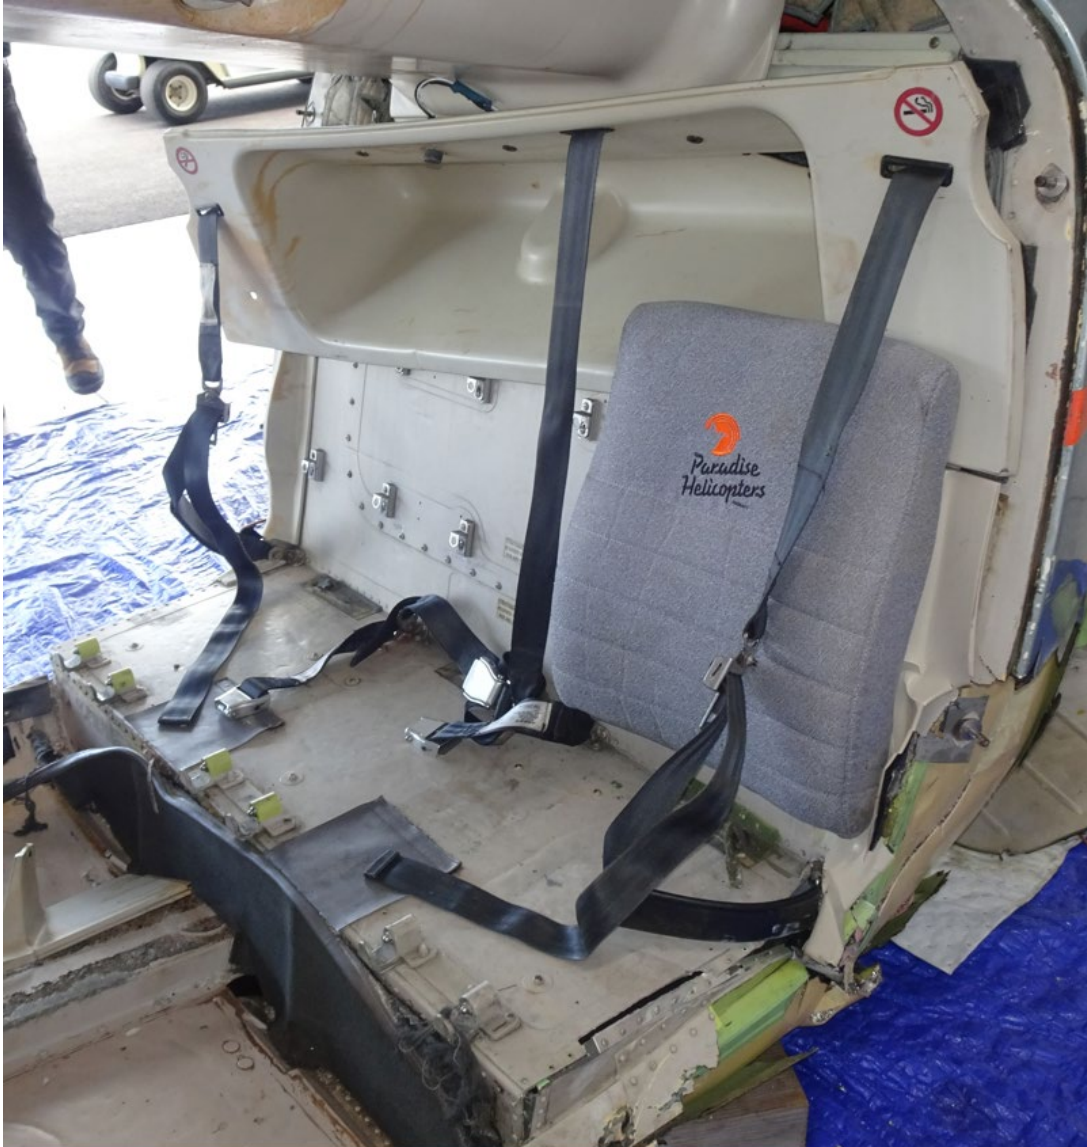
Passenger seats 4 and 5 were forward-facing seats located in the aft portion of the cabin. Seat 4 was located behind the pilot and 5 behind the copilot. Only the seatback cushion for seat 5 was found still attached. The bottom boxed support structure was intact and showed no deformation (see figure 15).

Figure 15. Passenger seats 4 and 5 located in the aft part of the cabin after recovery back to the airport.
