National Transportation Safety Board

ANC22FA047

AIRWORTHINESS

Group Chair's Factual Report

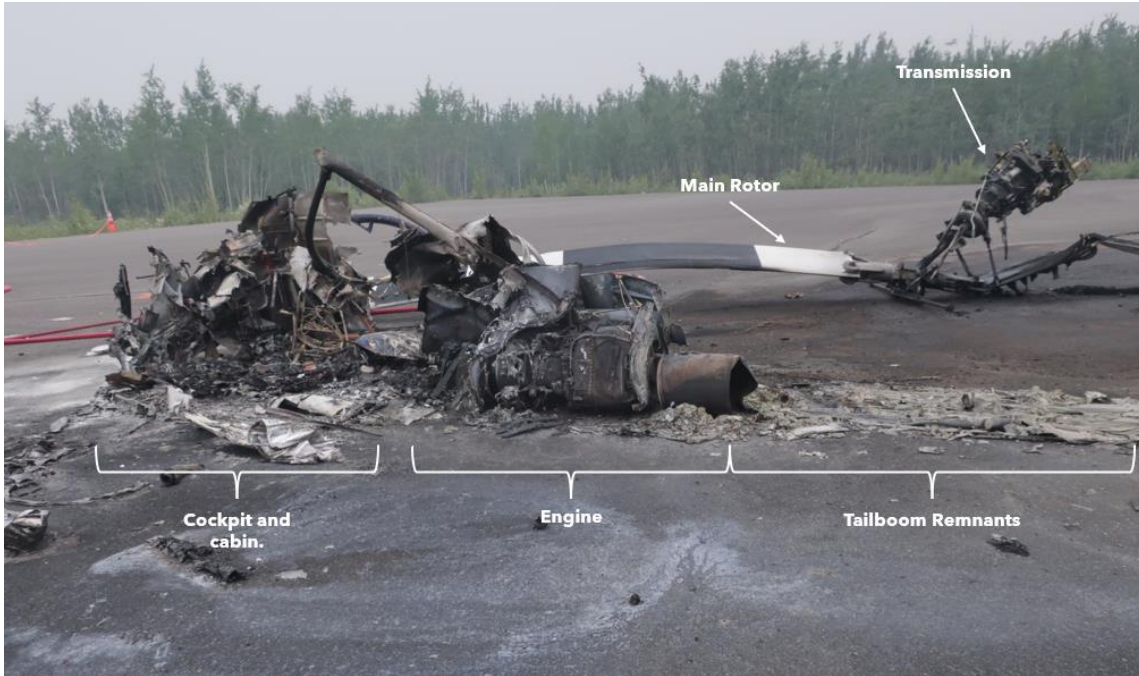
The wreckage was located in the center of a paved helispot used to stage and transport equipment and personnel for state forest fire fighting operations. The elevation of the accident site was 548 feet mean sea level (msl). The helicopter rested on its left side. The cockpit and cabin area had extreme damage from the post-crash fire. The engine was on its left side aft of the cabin. The main transmission, rotor mast, and rotor had been liberated during the accident sequence and was about 10 yards southeast of the main wreckage. One main rotor blade (identified as "B") had extreme fire damage, and the other rotor blade (identified as "A") exhibited a set downward bend. Both main blades remained attached to their blade grips on the rotor hub.

Figure 2. Main wreckage.

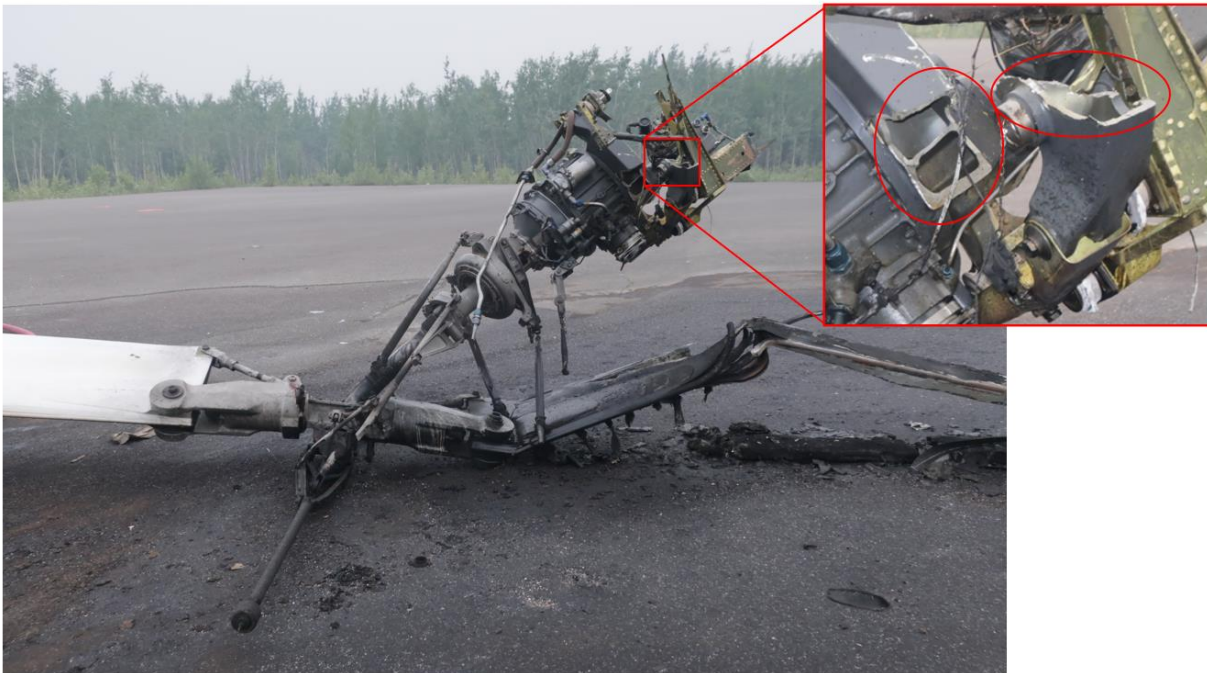
The main transmission, part number (PN): 204-040-01605, serial number (SN): AB6-109, had separated from the airframe structure. All five isolation mounts were present. The right rear mount had fractured the corner of the transmission case, leaving a portion of the transmission case attached to the isolation mount and airframe (Figure 3). The fracture surfaces were granular in texture, bright silver/gray in color, with 45° angular shear lips. The hydraulic and lubrication pumps were in place. There was no electrical generator installed on the transmission. The main transmission input was manipulated by hand and could be rotated in the freewheel direction and locked in the drive direction resulting in synchronous movement of the rotor mast.

Figure 3. Main rotor and transmission. Transmission support case fracture shown in the red inset box.

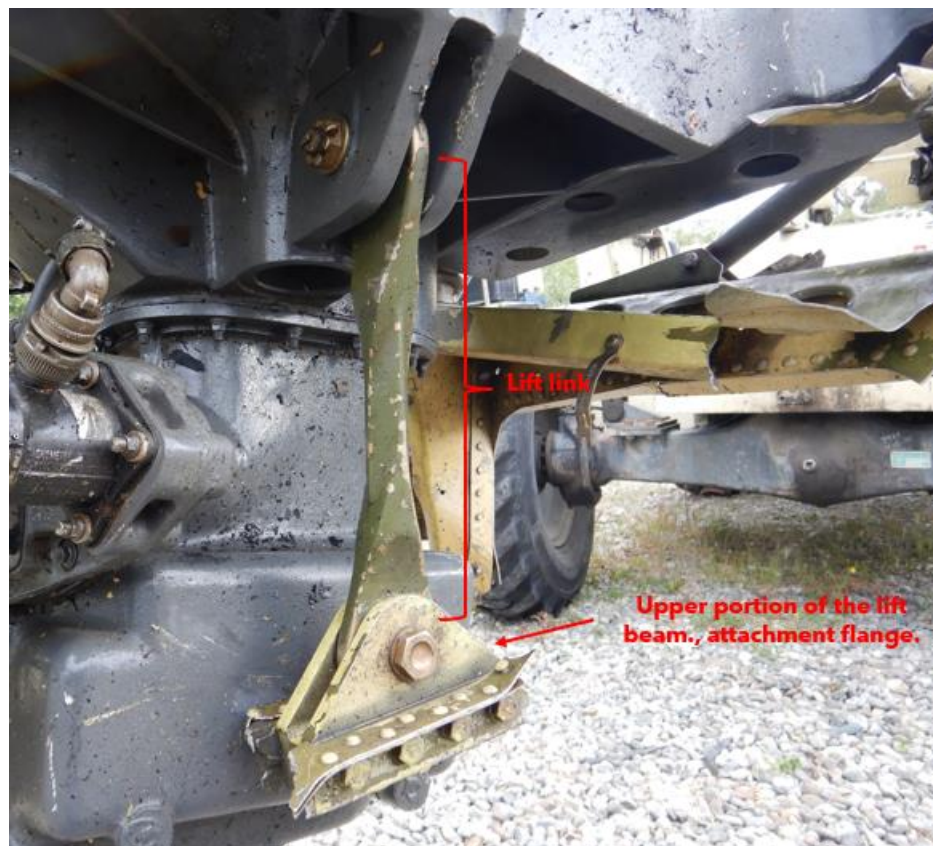
The lift link remained attached to the bottom of the transmission case (Figure 4). The end of the lift link that attaches to the airframe lift beam also remained attached to the lift beam flange. The lift beam flange had torn away from the lift beam box structure. The fracture surfaces of the lift beam web were jagged and matte gray in color, consistent with tension overload.

Figure 4. Lift link and attached airframe lift beam flange.

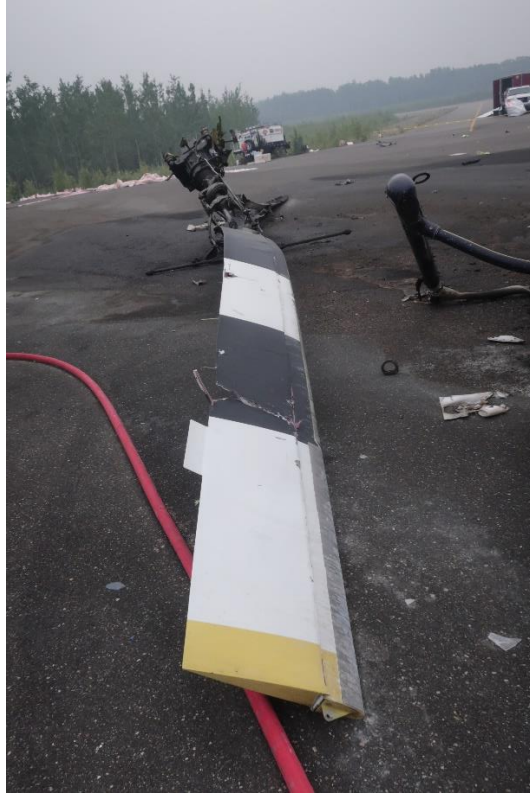
Figure 5. Blade "A"

Blade "A" was bent slightly down about 7 feet from the grip. There was afterbody spar separation present about 4 feet from the grip and extending to the tip. There was slight leading edge impact damage present from about 12 feet from the grip extending to the tip with blue/purple paint transfer observed. Chordwise scratching was present about span length 16 feet through 18 feet. Chordwise skin afterbody separations were present between span length 12 feet and 18 feet. The pitch horn had "pulled out" of the blade grip. No fretting was observed on faying surfaces. The inserts remained on the bolts. No pounding witness marks were identified on the stabilizer bar or pitch horn.

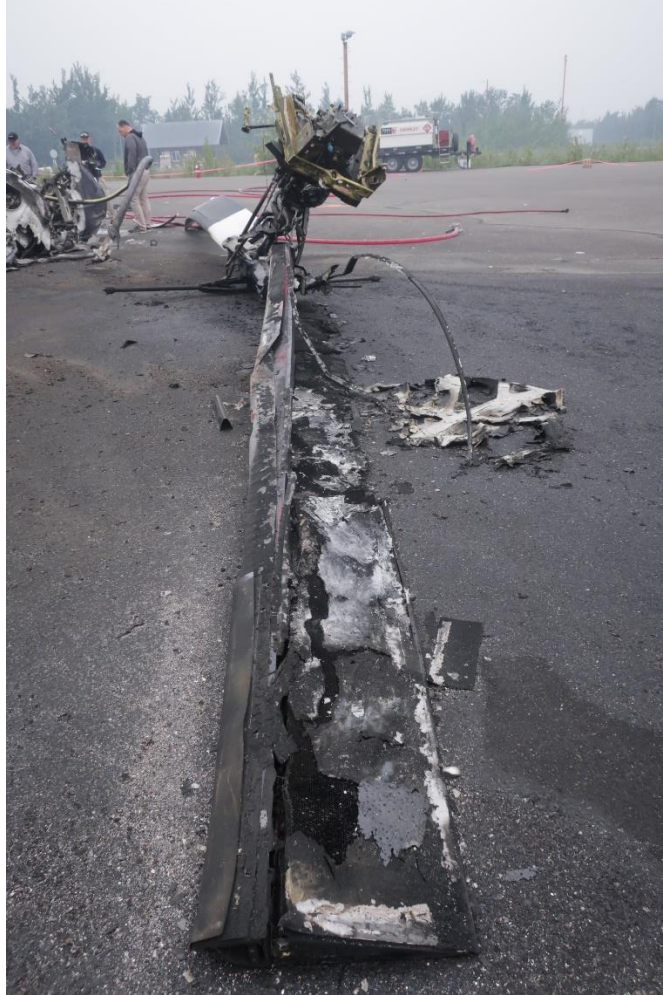
Figure 6. Blade "B"

The "B" was largely consumed by the post-crash fire. The outboard 6-inches sustained impact damage to the top side of the leading edge. Leading edge impact damage was present from about span length 13 feet through 15 feet. The blade was bent down near the grip. Leading edge separation and thermal debonding started between span length 4 - 4 ½ feet and was bent upwards starting at that point. Blade had come to rest inverted.

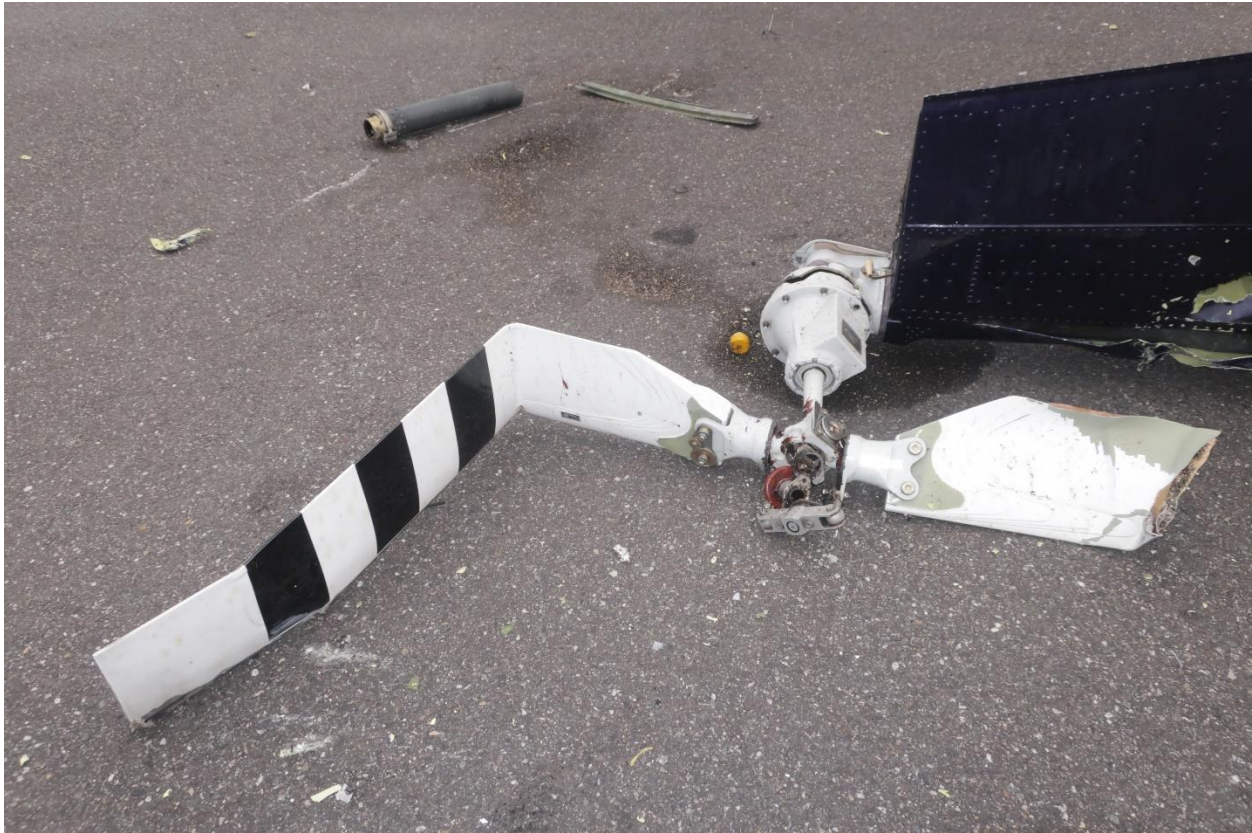
The tail rotor was attached to the tail rotor gearbox mast (Figure 7). One blade was bent 90°. The opposing blade was fractured chordwise at the furthest outboard root doubler.

Figure 7.. Tail rotor assembly

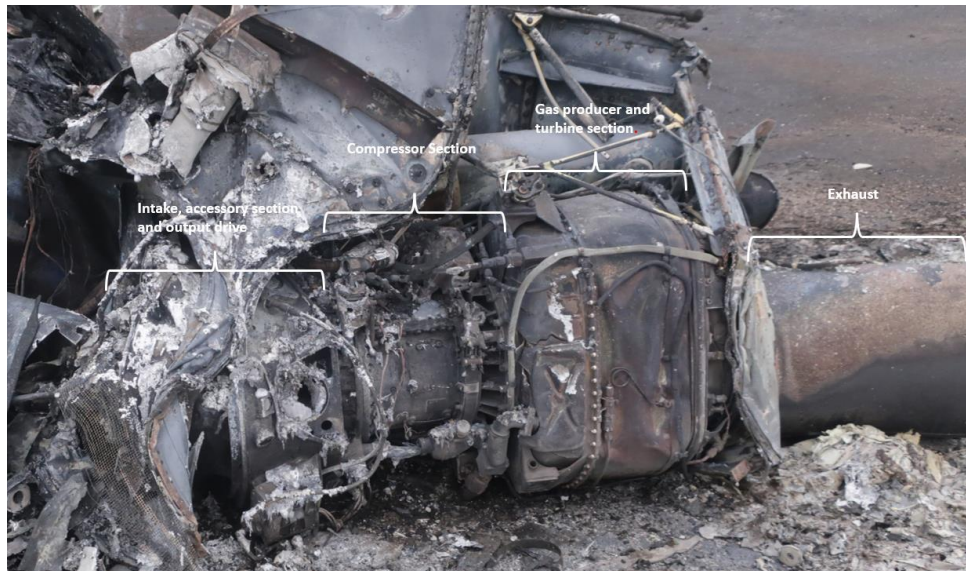
The Ozark T-53 engine was positioned on its left side in the wreckage (Figure 8) and was thermally damaged. The inlet had been consumed by the fire. A visual examination of the compressor inlet did not reveal any compressor blade damage

Figure 8. The engine as found in the wreckage.

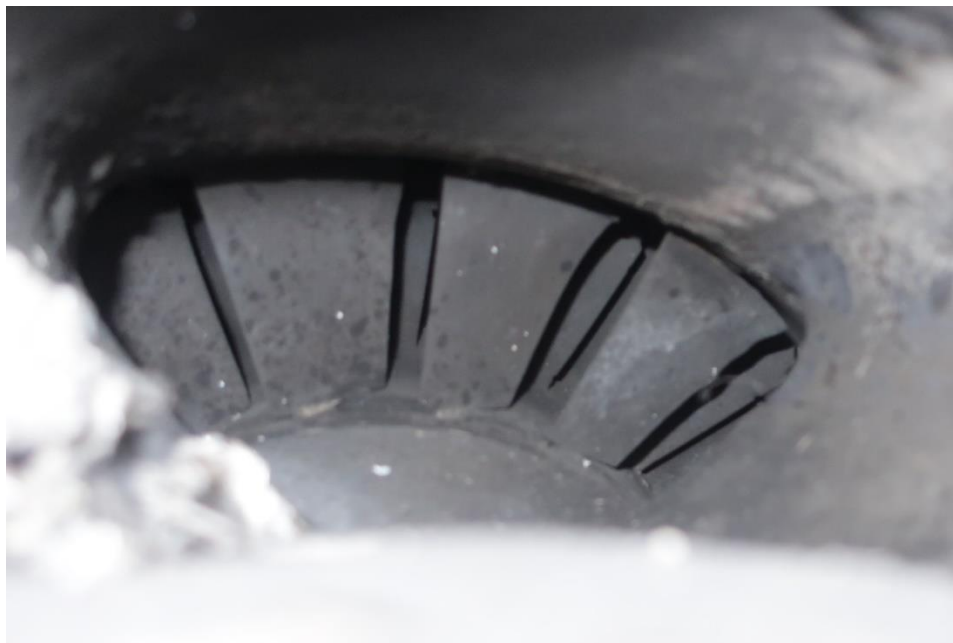
Figure 9. Compressor inlet, a section of the first stage compressor blades visible.

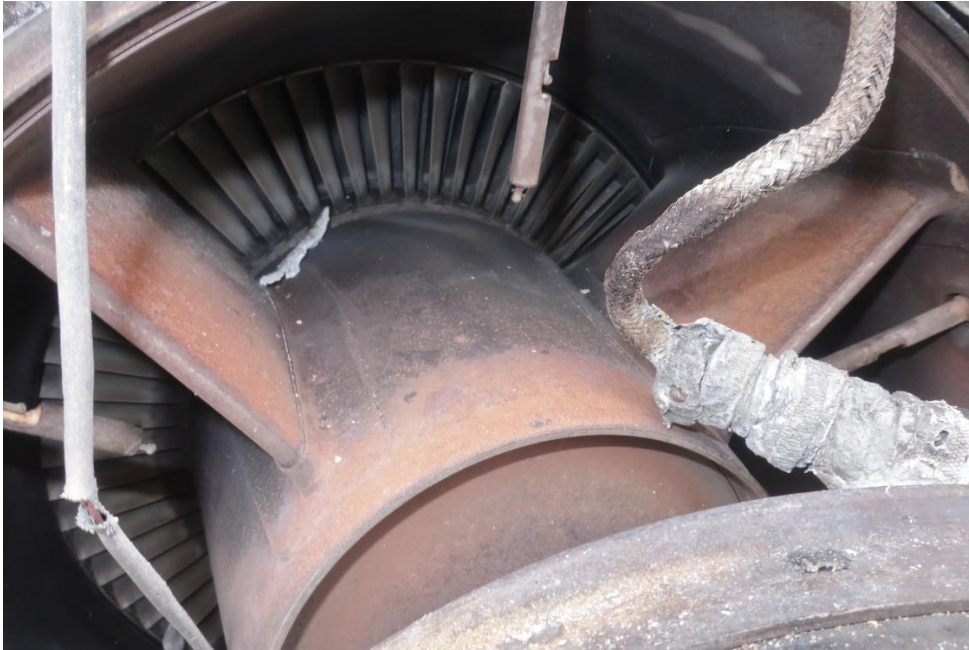
Figure 10. Second stage power turbine section showing no missing, ruptured, or burned blades.

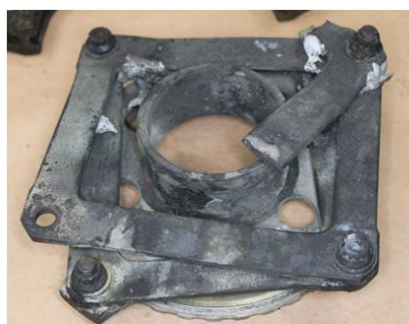
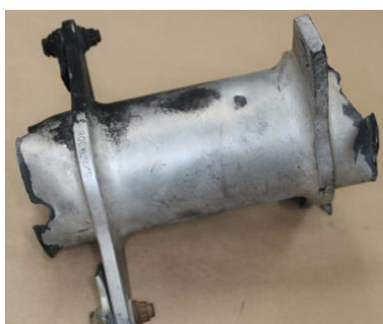
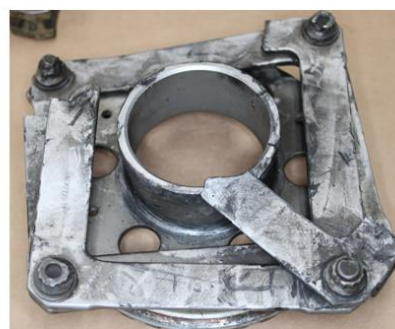
Figure 10. KAFlex assembly

Examination of the interconnect shaft and both end flanges showed evidence of contact between the interior of the interconnect shaft and the cup portion of each end flange, deforming the ends of the interconnect shaft. This contact evidence is consistent with the engagement of the drive shaft's failsafe feature, which can occur if there is a misalignment between the engine and transmission or a failure of a KAFlex component. Examination of each of the fractures of the square frames revealed bending, cracking of the Sermatel coating, granular fracture faces with cup-cone features, and 45° shear features. All fractures were consistent with overload characteristics.

The bolt and nut that attached the transmission side frame assembly to the interconnect flange was not present on the assembly as recovered from the accident site. The interconnect flange at this location was torsionally deformed and the flange bolt hole was out of round. The hole measurement deviated from design tolerance by 0.0037 inches. The flange displacement and hole dissymmetry are consistent with the fastener having been present and installed during the accident sequence. All remaining fastener holes were measured and found to be within design allowances. All bolts were measured for stretch and found to be within the specified design requirements. Three joints on the transmission side of the KAFlex were observed to have bolt-nut fasteners but were missing the two washers that constitute the joint assembly. Close examination of these three joints revealed impact marks on the bolt heads, nut heads, and/or the joint frame. Additionally, these joints exhibited no evidence of operating in a loose condition. The missing washer hardware is attributed to the evidence that the joints had been subjected to impacts during the accident sequence.

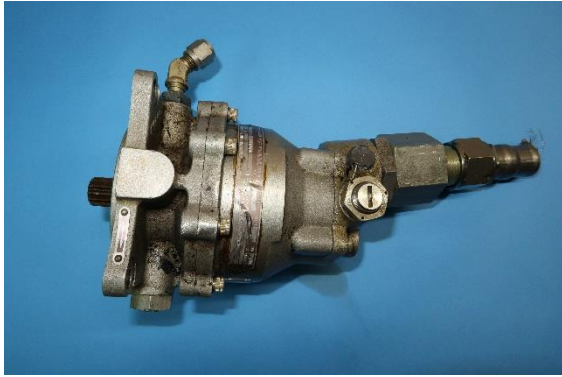
The majority of the hydraulic system had been destroyed by the post-crash fire. However, since the hydraulic pump was located on the main transmission and the transmission had not been exposed to the post-crash fire, the hydraulic pump was in good condition and removed for examination (Figure 13).

Figure 11. Hydraulic pump after removal from the transmission.

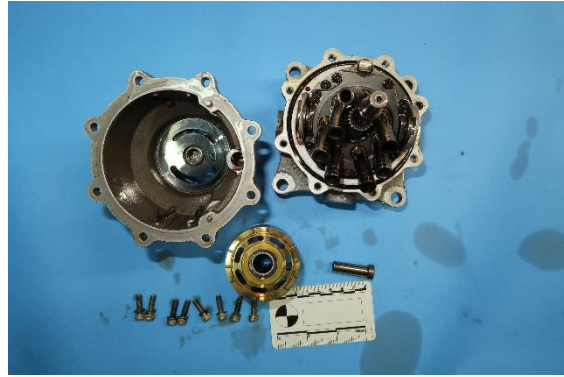
The splined driveshaft of the pump could be rotated by hand and felt smooth with no binding. Disassembly of the hydraulic pump (Figure 14) revealed that all components were in good condition and no evidence of gouging or overheating was observed. Residual hydraulic fluid (red fluid) retained its red color and viscosity.

Figure 12. Hydraulic pump disassembly.

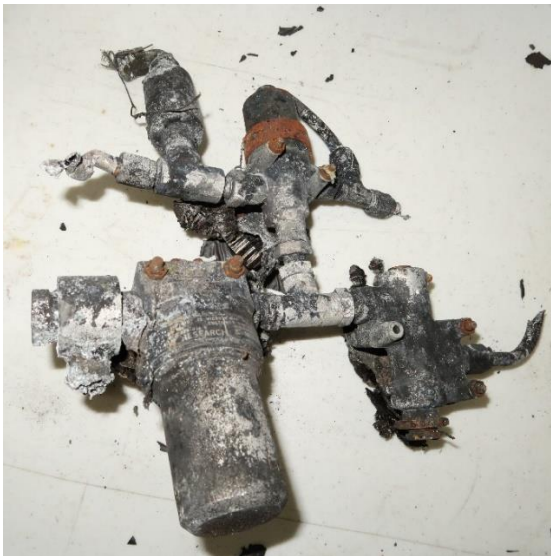
The hydraulic filter assembly and pressure switch (Figure 15) were located within the wreckage and recovered. The filter bowl was unscrewed, and the filter element removed (Figure 16). The paper element was carbonized but retained its shape. No metal particles were identified within the filter bowl or folds of the filter element.

Figure 13. Filter with attached pressure switch.

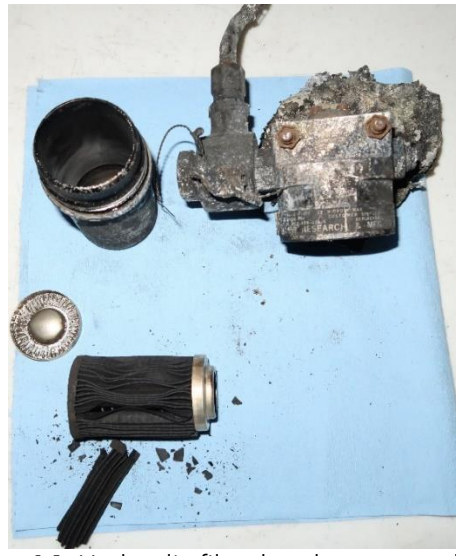
Figure 14. Hydraulic filter bowl unscrewed from the assembly and the filter element removed from the bowl.

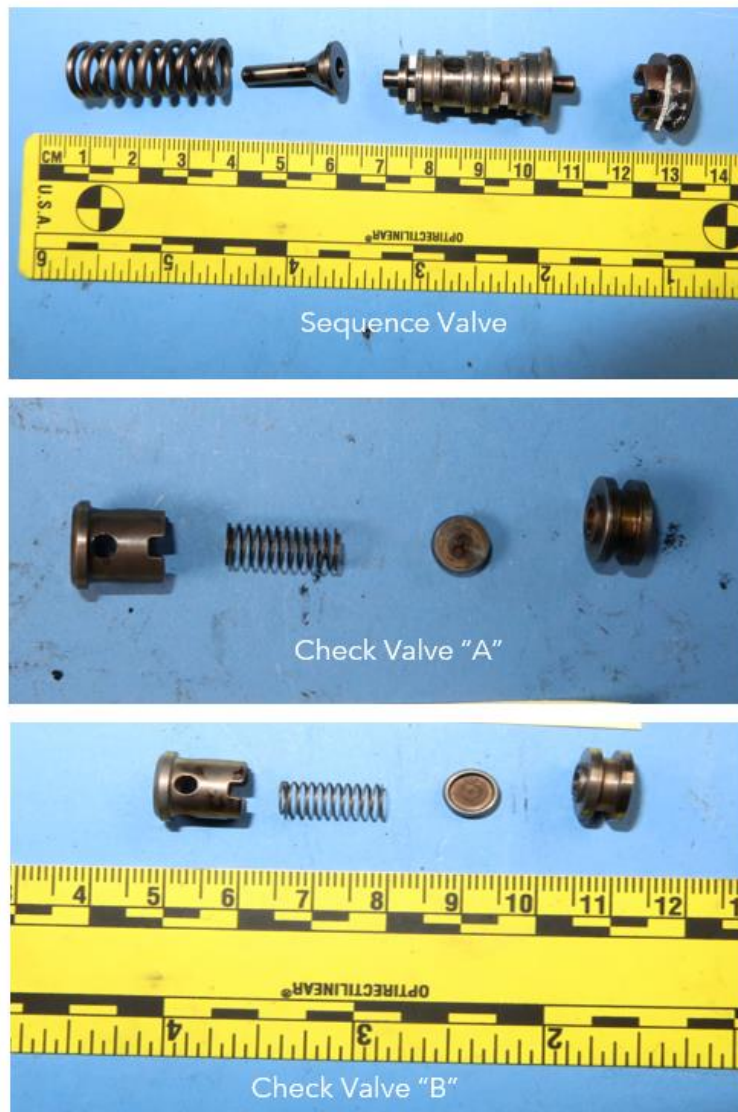
The irreversible valve assemblies from the collective and right actuators were partially disassembled to examine the condition of the sequence valves and check valves (Figures 19, 20, and 21). Heat damage to the valve bodies were evident. The sequence valves and check valves were seized in position. A combination of penetrating oil and heat was applied to allow removal of the various assemblies. During the disassembly, remnants of o-rings damaged by heat from the post-crash fire were identified within each o-ring groove. The metering ports of the spool and slide assembly of the sequence valves were clear of debris and the metering edges had no spurs or deformations. The poppet movement of each of the check valves were verified before removal from the valve body.

Figure 17. Right lateral irreversible valve components⁷.

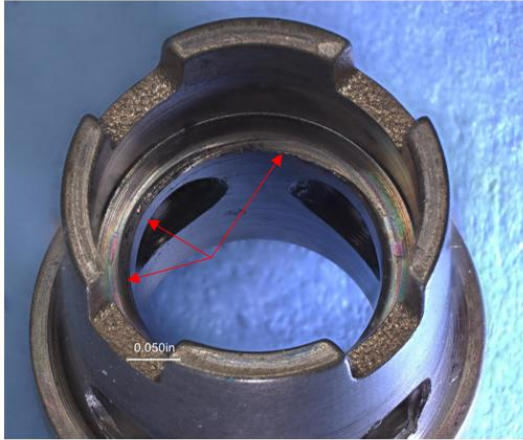
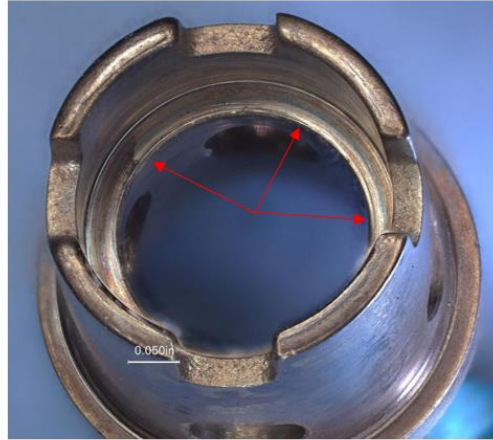
Figure 18. Right lateral check valves - heavy wear observed on the interior ring of the spring guide identified by the red arrows.

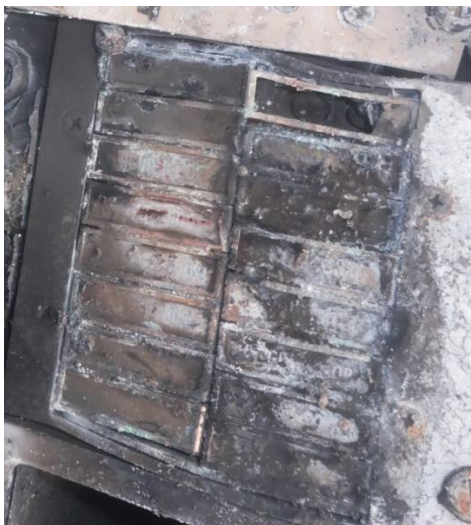
The caution panel (Figures 22 and 23) was removed from the cockpit instrument panel and sent to the NTSB materials laboratory for examination. Hot filament stretching can be an indicator that the light was illuminated during the accident impact sequence.

Figure 20. Caution panel as found installed in the instrument panel.

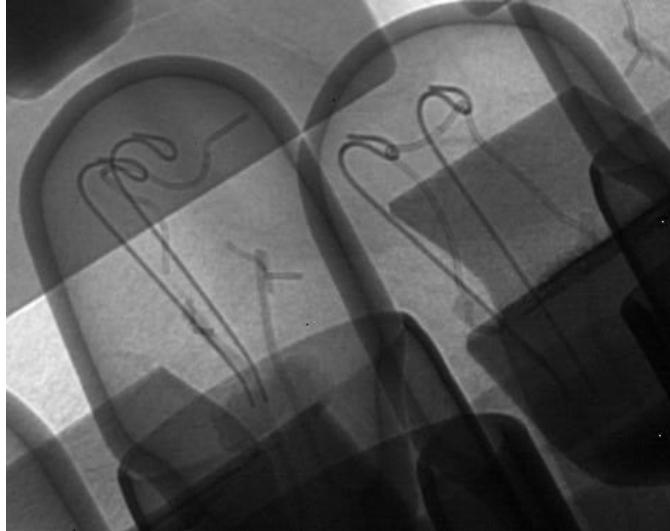
The annunciator panel consisted of sixteen (16) annunciator lights (two (2) columns with eight (8) lights in each column) (Figure 23). Each annunciator light contained two (2) incandescent bulbs. The annunciator was partially disassembled to allow for visualization of the individual bulbs within the annunciator lights. The annunciator lights were radiographed to determine the filament status of each of the bulbs within the individual annunciator lights. The layout of the panel with the filament status for each light is below. The actual layout of the accident panel could not be confirmed due to the fire damage to the faceplate of the panel. The radiograph for the HY PRESS light (according to the layout in the operations manual) is attached to this email. No hot filament stretching was found in any of the light bulb filaments in the accident panel. Figure 24 shows broken and unstretched filaments of the hydraulic pressure lightbulbs.

Figure 22. Radiograph showing broken and unstretched filaments of the HYD PRESS lightbulbs.

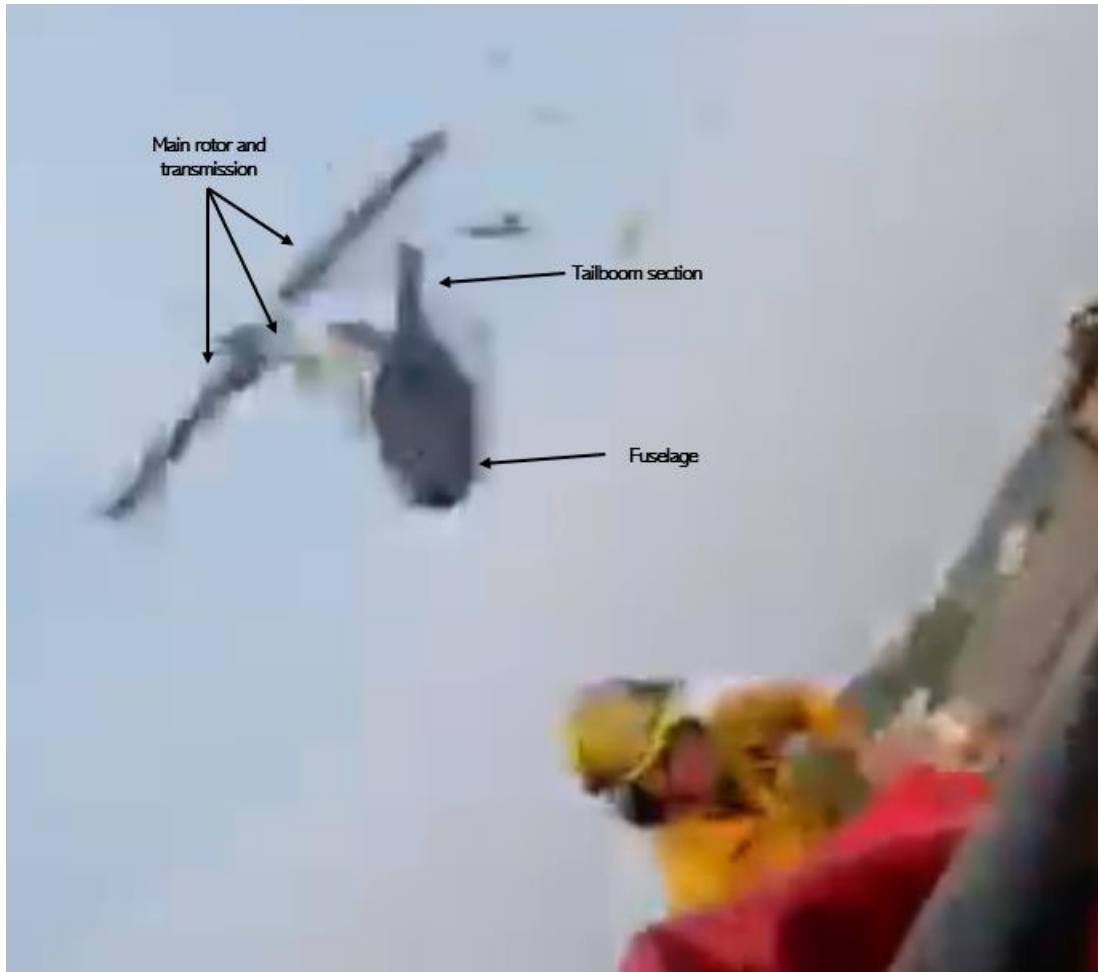
Figure 23. Screen capture of the end of the video showing the separation of the main rotor and transmission from the airframe before ground impact.

A full view of the helicopter belly is in the frame. The main rotor and transmission are departing. The tail boom is chopped at mid span (figure 22).

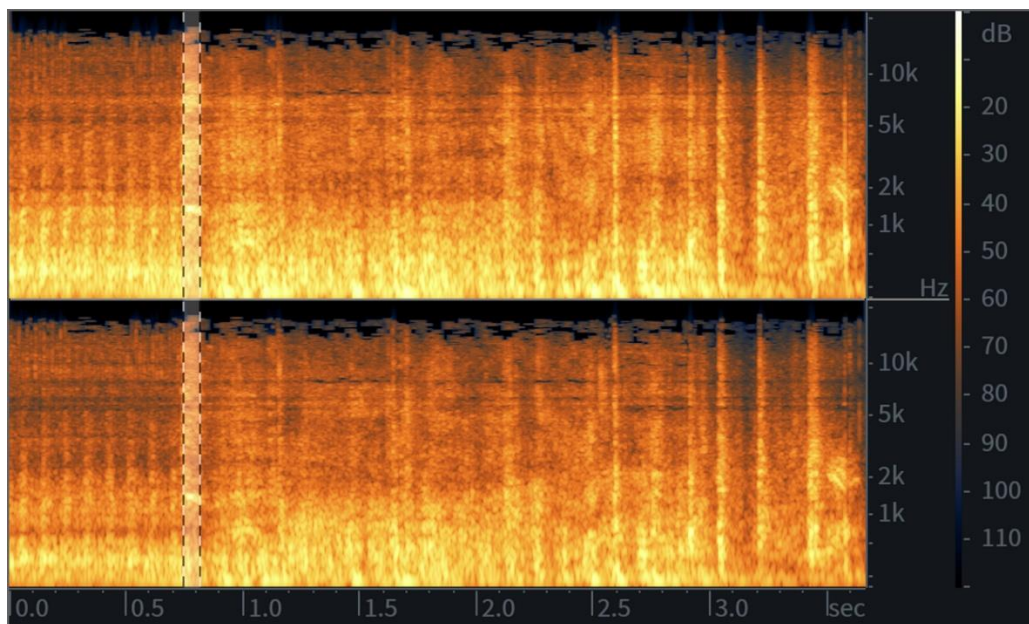
The momentary high-pitched sound at the beginning of the upset event could not definitively be attributed to the helicopter. The NTSB Vehicle Recorders Lab analyzed the sound spectrum and determined that the fundamental tone was about 1,380 hertz (Hz)⁹ with additional noise or overtone activity in the 7,500 to 8,000 Hz range. This frequency range could not be associated with any rotating equipment speeds identified in the US Army's maintenance manual¹⁰.

Figure 24. Fundamental tone of 1380 Hz isolated from the video of the accident associated with the initial upset.
