ANC23FA008

OPERATIONAL FACTORS/HUMAN PERFORMANCE

Group Chairs' Factual Report

Location: Kaupo, Hawaii
Date: December 15, 2022
Time: 2130 Hawaii Standard Time (HST)¹
December 16, 2022 at 0730 Universal Time Coordinated
Airplane: N13GZ, Raytheon Aircraft Company C90A, Serial Number LJ-1590

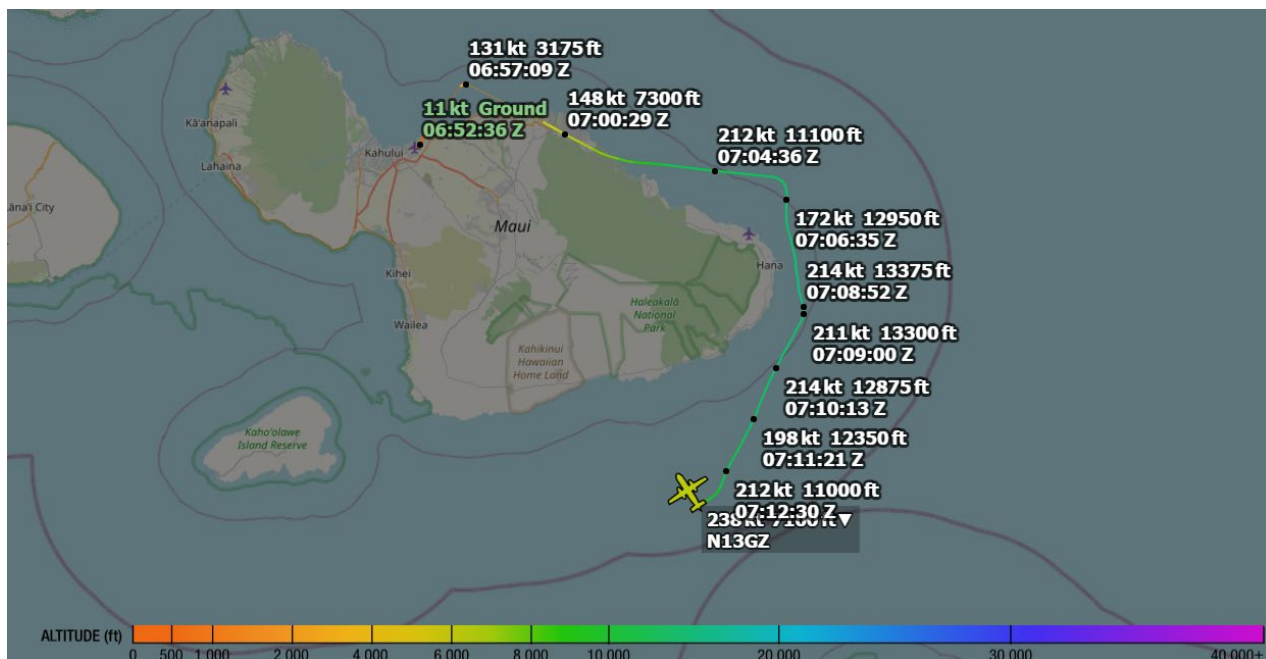
According to ADS-B³ data, the accident flight began taxiing from the east ramp at OGG about 2052. The flight taxied to runway 2 via taxiway K and taxiway E. The airplane taxied onto runway 2 and began the takeoff departure roll about 2054.

Figure 1: Accident Flight Ground Track (Source: ADSB Exchange) (Note: Time is in UTC)

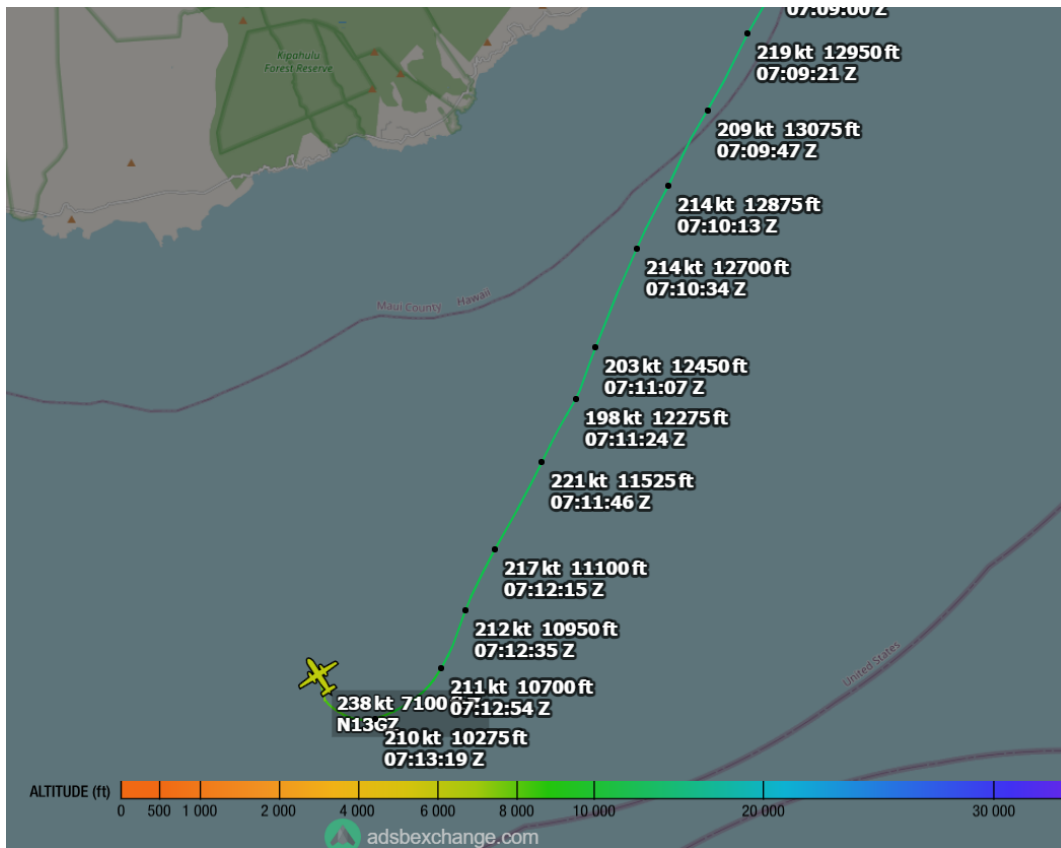
About 2106 and after reaching 13,000 ft, the airplane made a right turn to the south and continued on a southern ground track for about 3 minutes then turned towards the southwest.

FAA Air Traffic Control (ATC) recorded data showed that the part 91 flight had climbed to an altitude of 11,000 ft on a southeast heading to the east side of the island of Maui. ATC asked if the flight could climb to 13,000 ft to which the pilot replied in the affirmative. Approximately 4 minutes later, ATC instructed the pilot to turn right to a heading of 180° and then turn further right to 200°. About one minute later, ATC instructed the pilot to descend to 12,000 ft and about a minute later to descend to 8,000 ft. The pilot acknowledged and accepted both clearances. About two minutes later ATC instructed the pilot to fly a 180° heading, and subsequently cleared the flight direct to the TAMMI⁴ intersection, which was the initial approach fix for the RNAV (GPS) 4 approach to the destination (see section 6.1 for the RNAV (GPS) 4 approach chart). The pilot acknowledged the instructions. About 1 1/2 minutes later the controller queried the flight to verify they were direct to TAMMI. The pilot responded "13GZ is off navigation here." ATC instructed the pilot to turn right to a 170° heading and maintain 8,000 ft. about 10 seconds later the pilot was heard saying "Hang on." No further transmissions were received from the accident flight.

Figure 2: Last approximate 4 minutes of flight (Source: ADSB Exchange)
