National Transportation Safety Board

ANC23FA008

COCKPIT VOICE RECORDER

Specialist's Factual Report

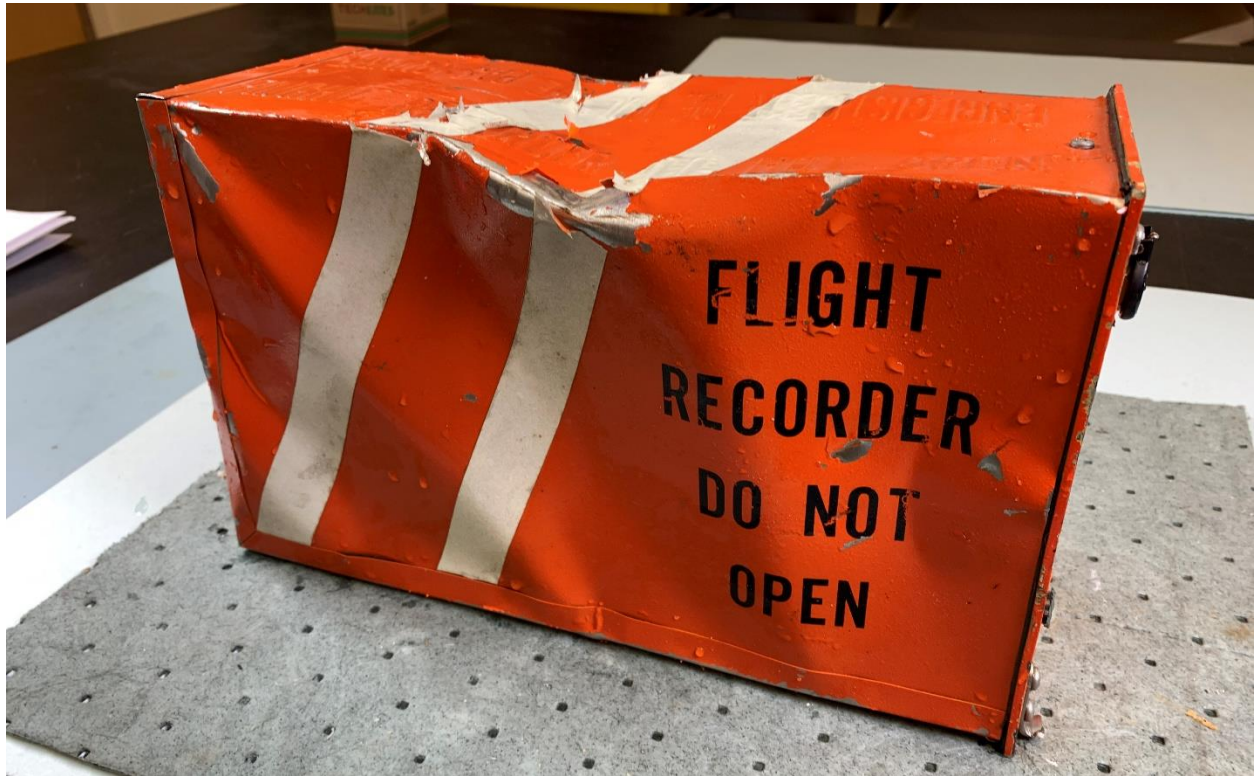
The CVR was submerged in approximately 6,500 feet of seawater for approximately one month. The CVR arrived at the laboratory in distilled water and appeared to have minor structural damage (see figure 1). The outer case was removed, and the interior crash-protected case did not appear to have any heat or structural damage, although some minor corrosion was noted. The memory board within the crash-protected case was checked for heat damage, structural damage,

Figure 1. The L3 A-100S CVR, as received.

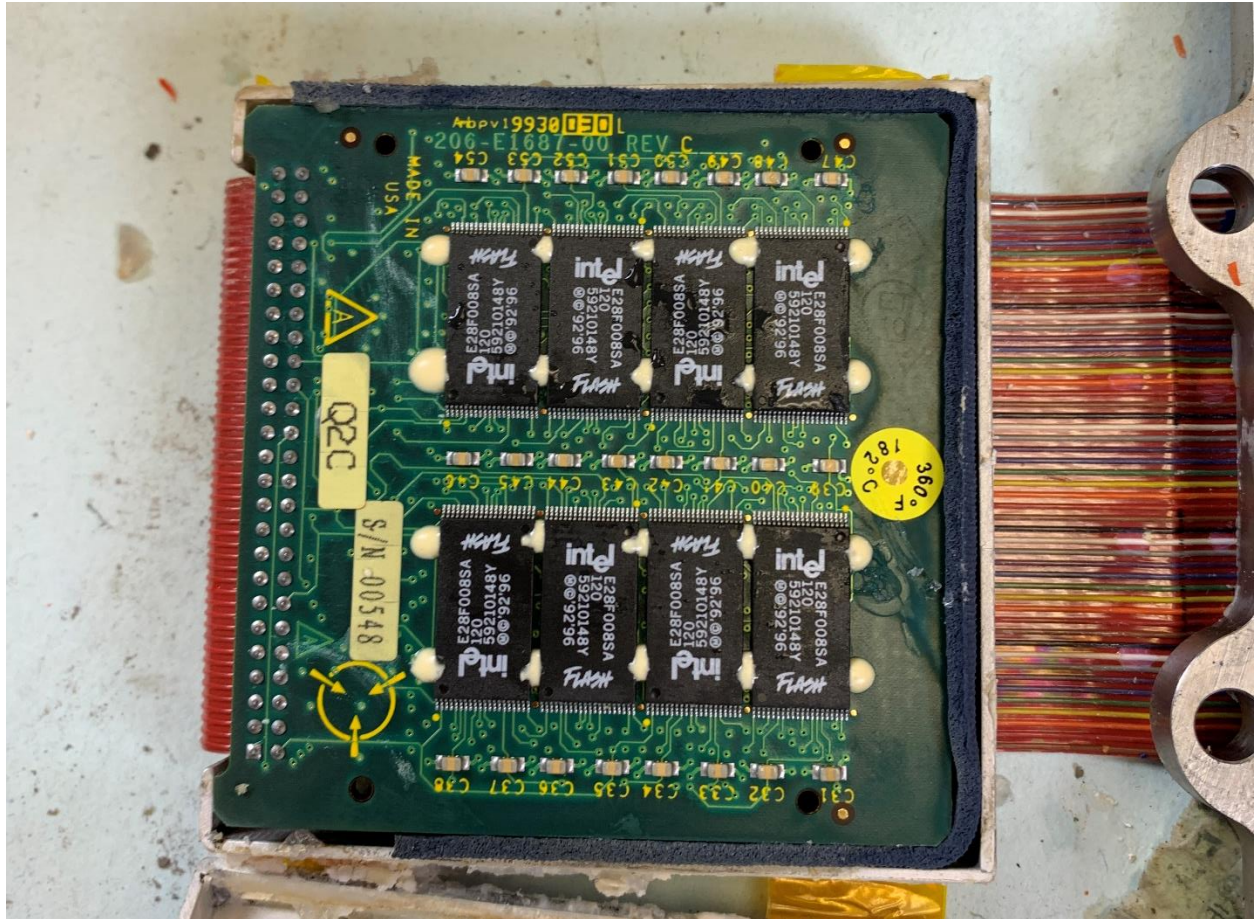
and corrosion, and none was readily apparent (see figure 2). The memory board was immersed in reverse osmosis deionized water to be cleaned, and digital audio was successfully downloaded using laboratory techniques.

Figure 2. The memory boards of the CVR, before cleaning.
