National Transportation Safety Board

ANC23FA031

ONBOARD VIDEO RECORDER

Specialist's Factual Report

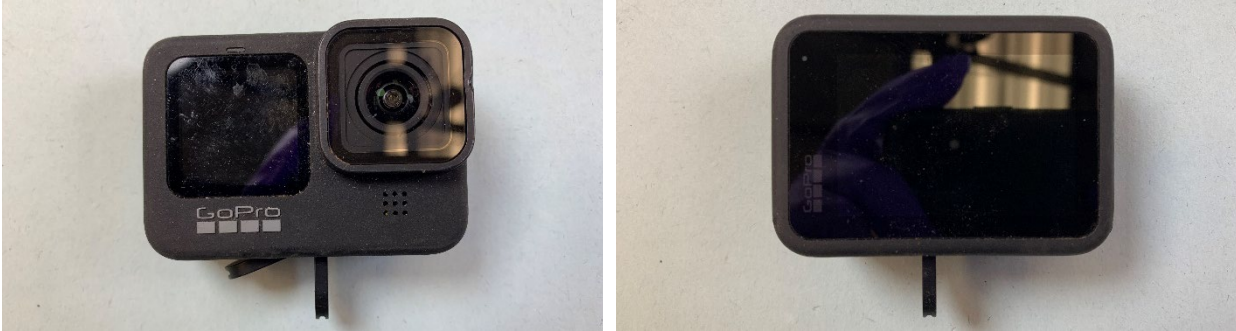
The GoPro HERO9 Black arrived in good condition with no visible exterior damage, as shown in Figure 1. A 64GB microSD card was found intact and seated securely in the memory card slot.

Figure 1. Condition of the front (left) and rear (right) of GoPro HERO9 Black, as received.

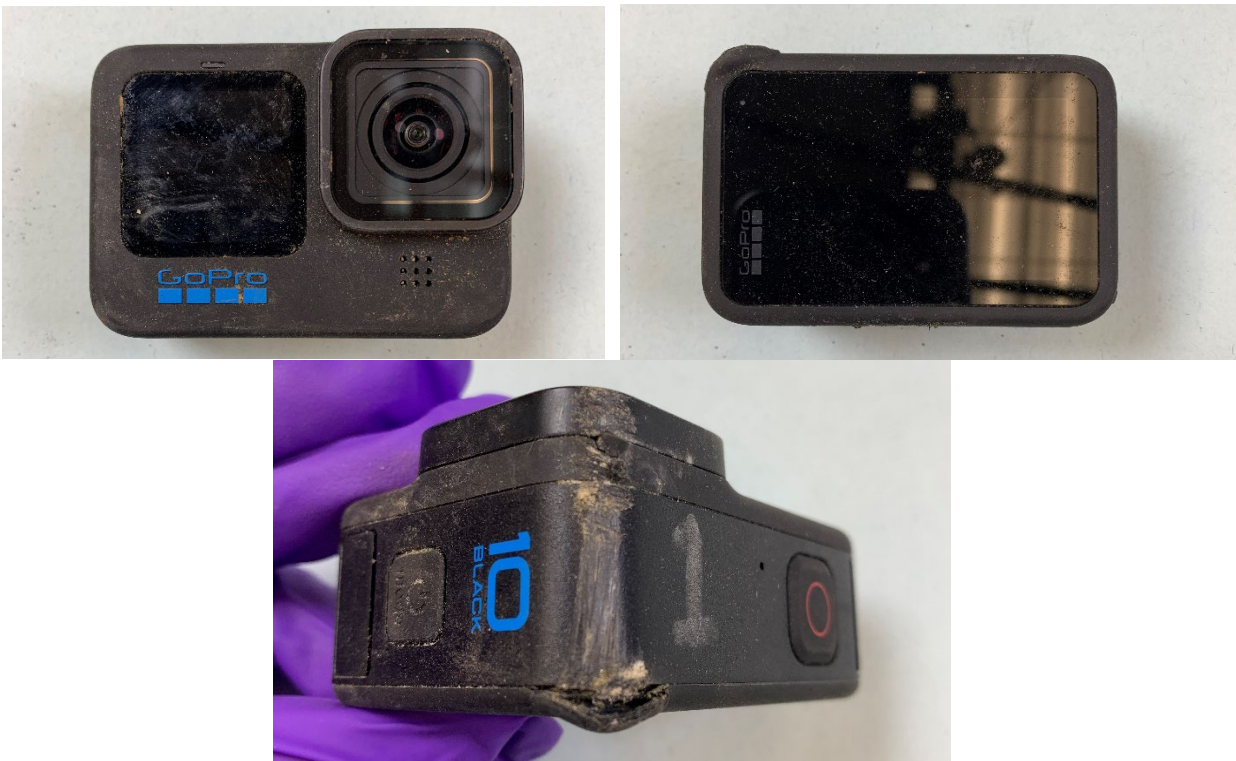
The GoPro HERO10 Black arrived with minimal exterior damage, as shown in Figure 2. A 256GB microSD card was found intact and seated securely in the memory card slot.

Figure 2. Condition of the front (upper left), rear (upper right), and side (lower center) of GoPro HERO10 Black, as received.

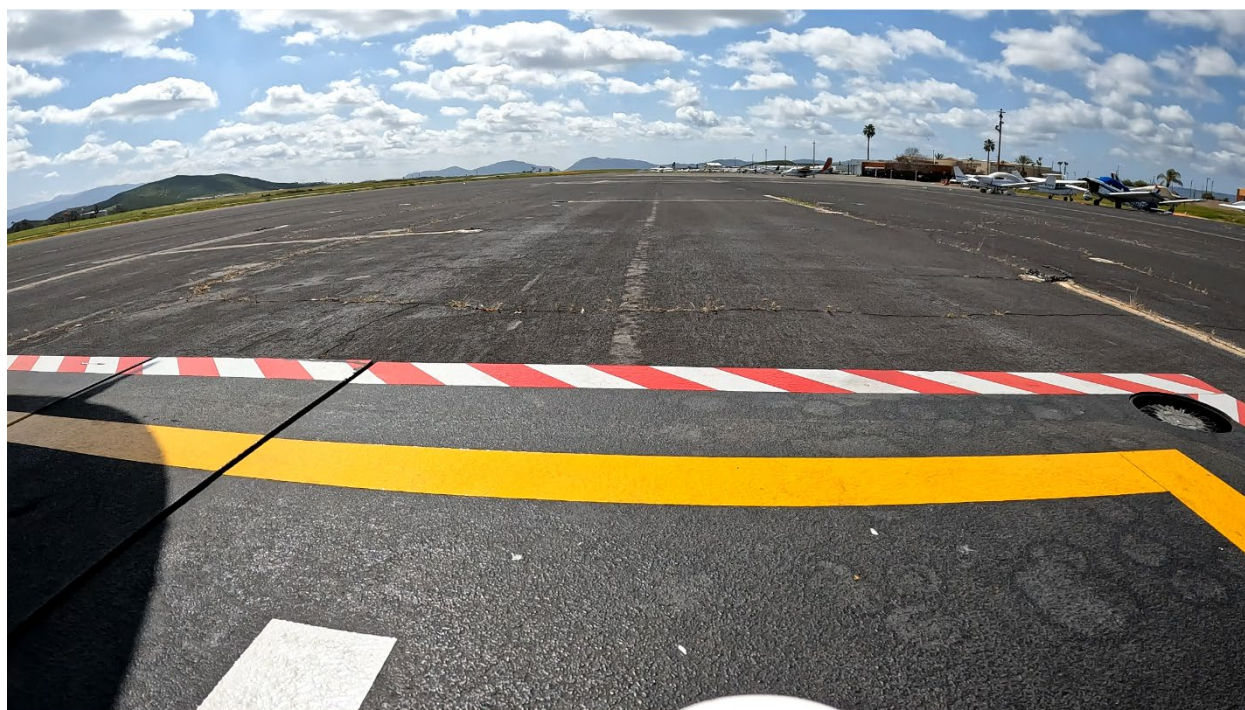
Metadata in the file indicated the accident flight video was recorded at a resolution of 3840x2160 pixels and a frame rate of 29.97 frames per second. An audio track was also recorded from the camera's internal microphone. The camera was mounted on the helicopter's exterior on the right landing skid and was forward-facing, as shown in Figure 3.

Figure 3. Field-of-view of the forward-facing camera when the helicopter was on the ground at F70.

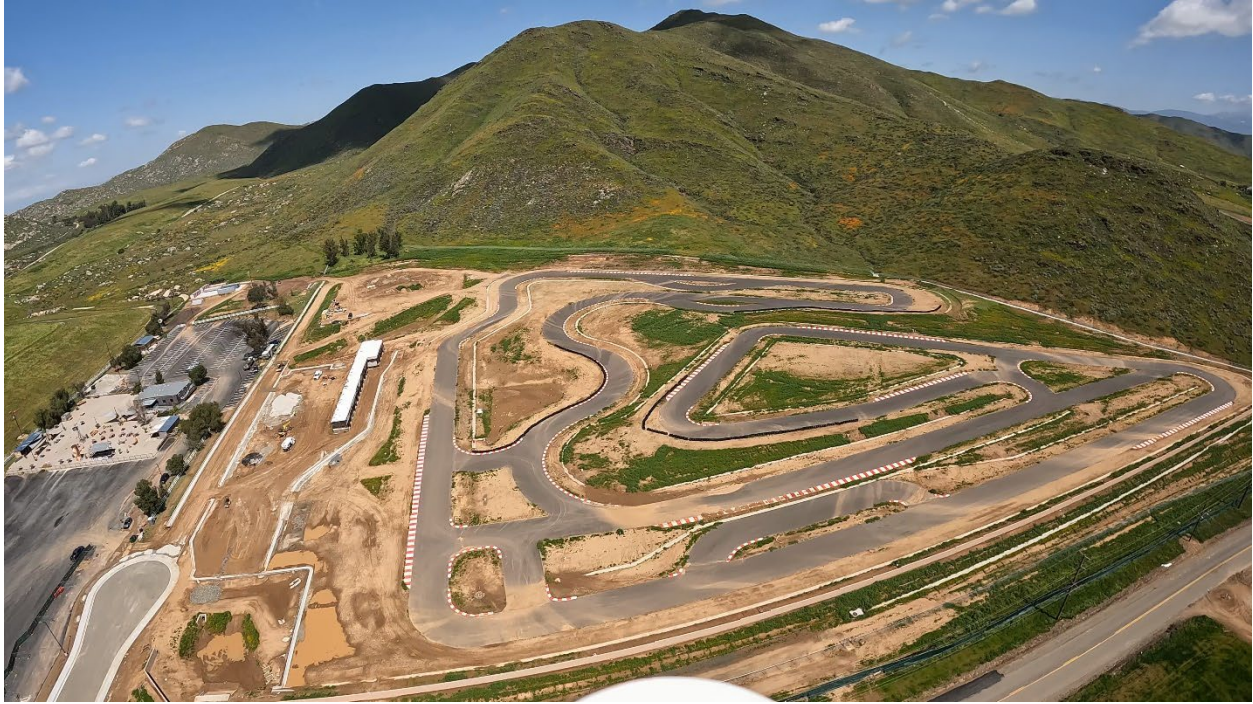
At 12:13:35, the helicopter approached a hill, as shown in Figure 4. Shortly thereafter, the helicopter started to pitch up to avoid the hill.

Figure 4. Video frame at 12:13:35.

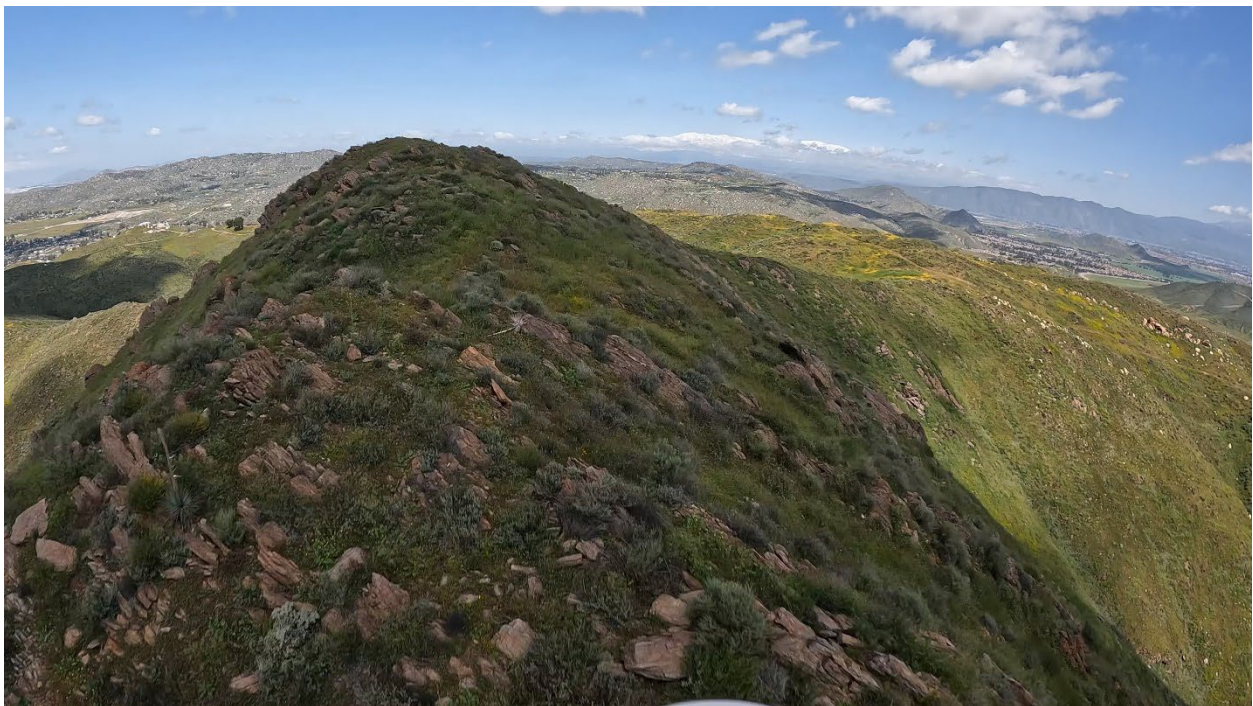
At 12:14:00, embedded GPS data indicated the helicopter traversed the crest of the hill at an altitude between 30 and 40 feet AGL, as shown in Figure 5. After traversing the hill, the helicopter continued to travel in a north-northwesterly heading.

Figure 5. Video frame at 12:14:00.

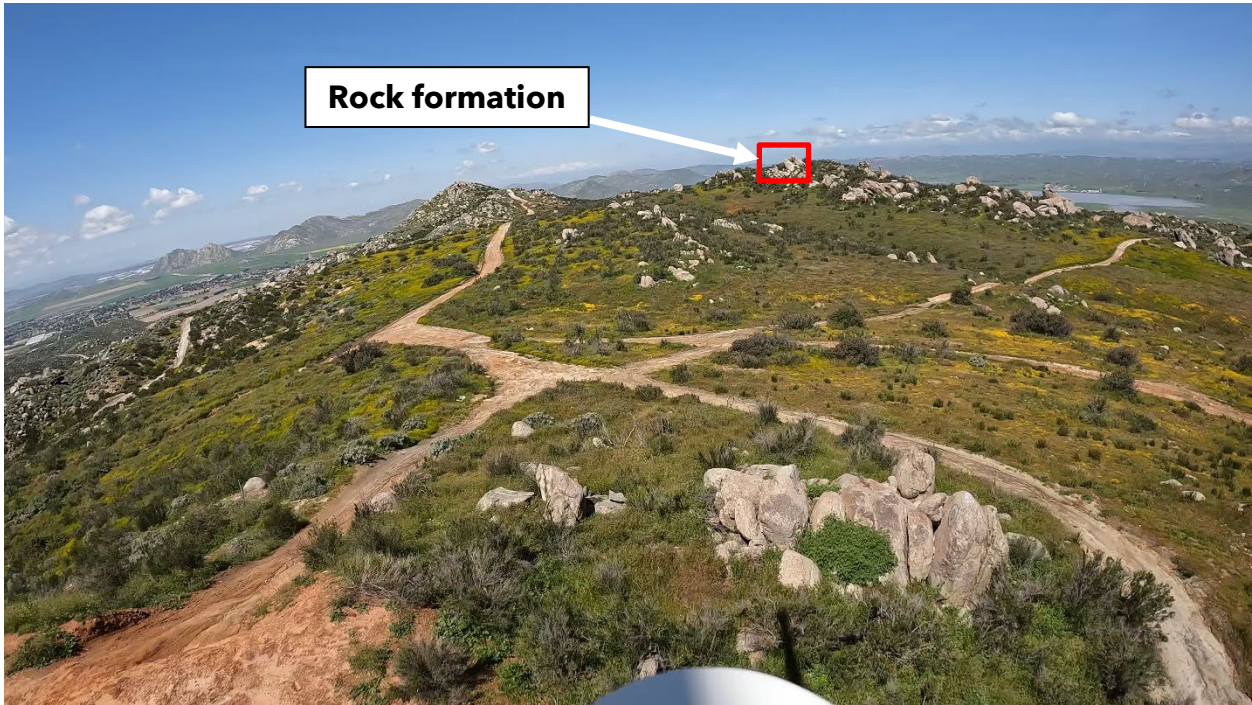
At 12:17:09, embedded GPS data indicated the helicopter traversed the crest at an altitude of about 30 feet AGL, as shown in Figure 6. At 12:17:13, the helicopter started a right bank and four seconds later, at 12:17:17, the helicopter clipped a rock formation on the hill. Fragments of the helicopter shedding were visible on the recording as shown in Figure 7.

Figure 6. Video frame at 12:17:09. A rock formation the helicopter clipped at 12:17:17 is shown in the red box.

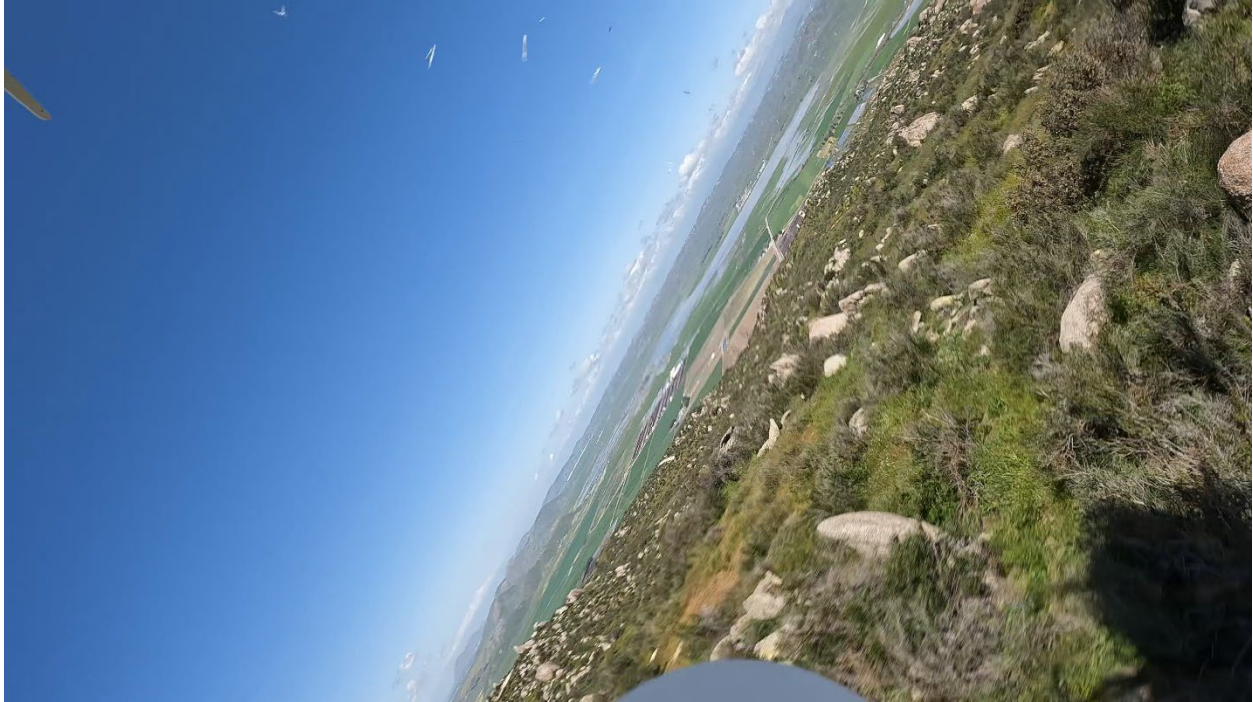
Figure 7. Video frame at 12:17:17. Fragments of the helicopter are seen at the top of the frame.

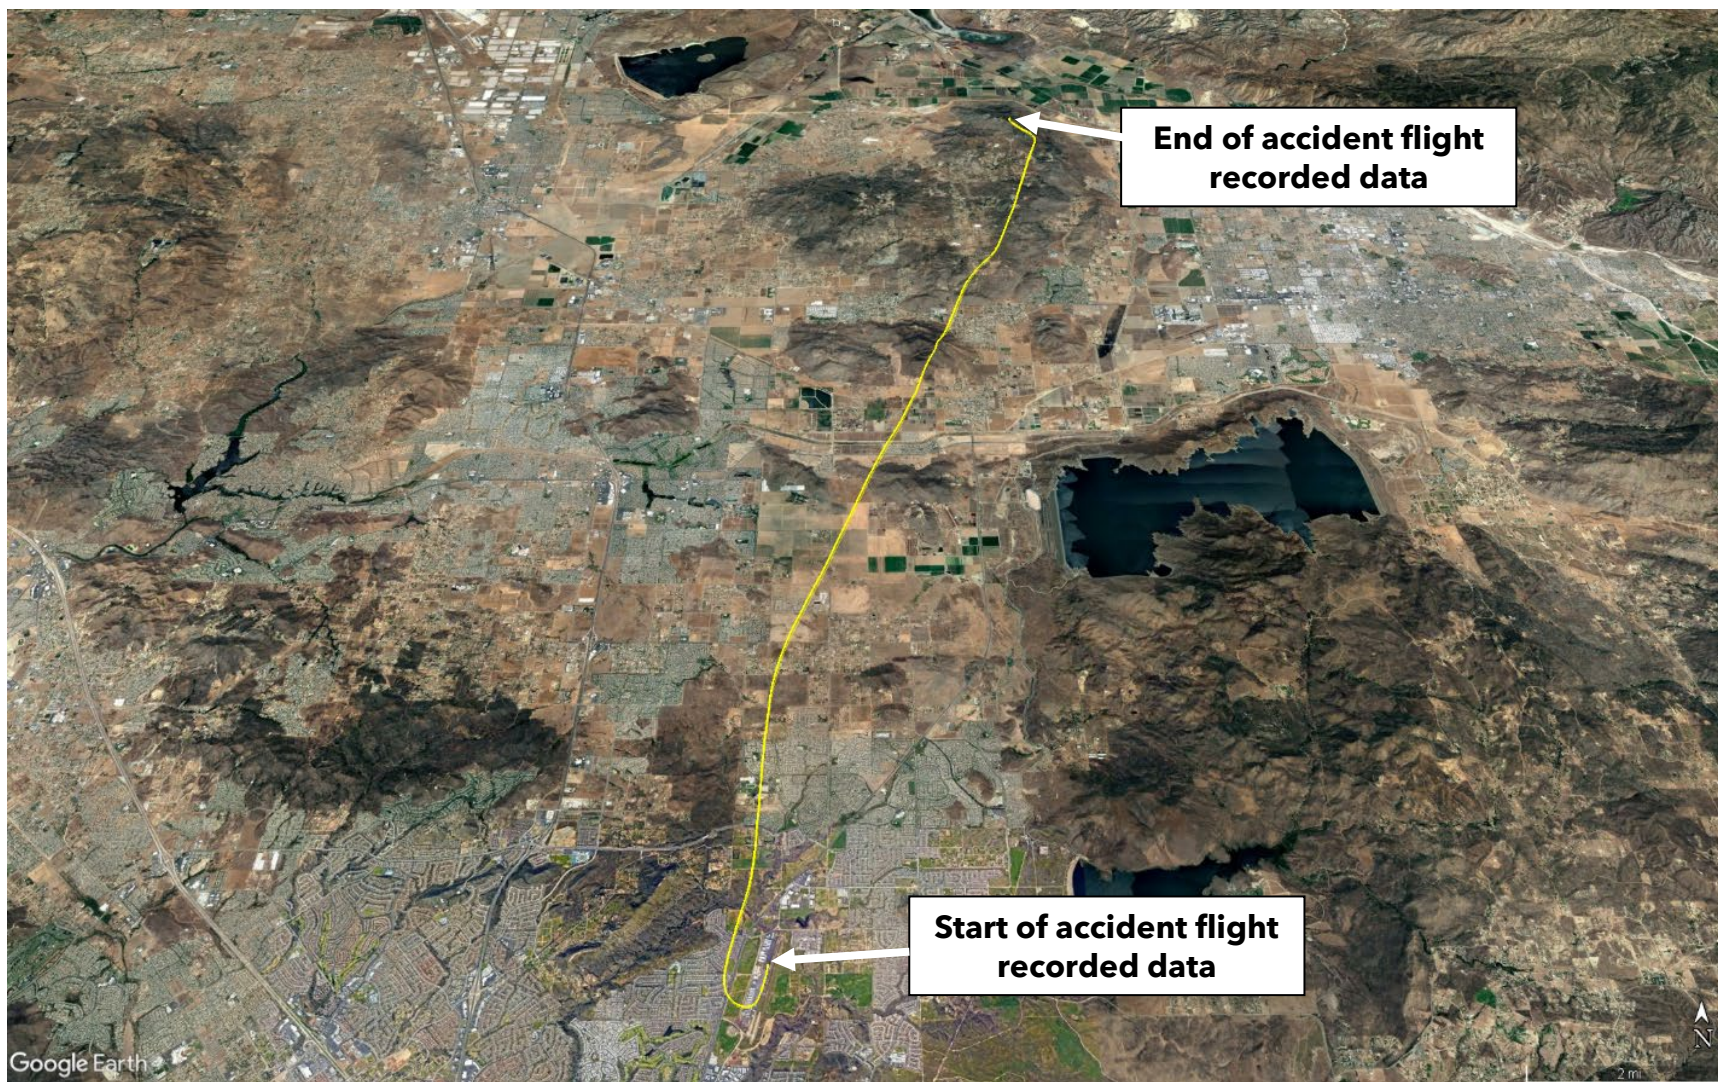
Figure 8. Start and end of accident flight recorded data.

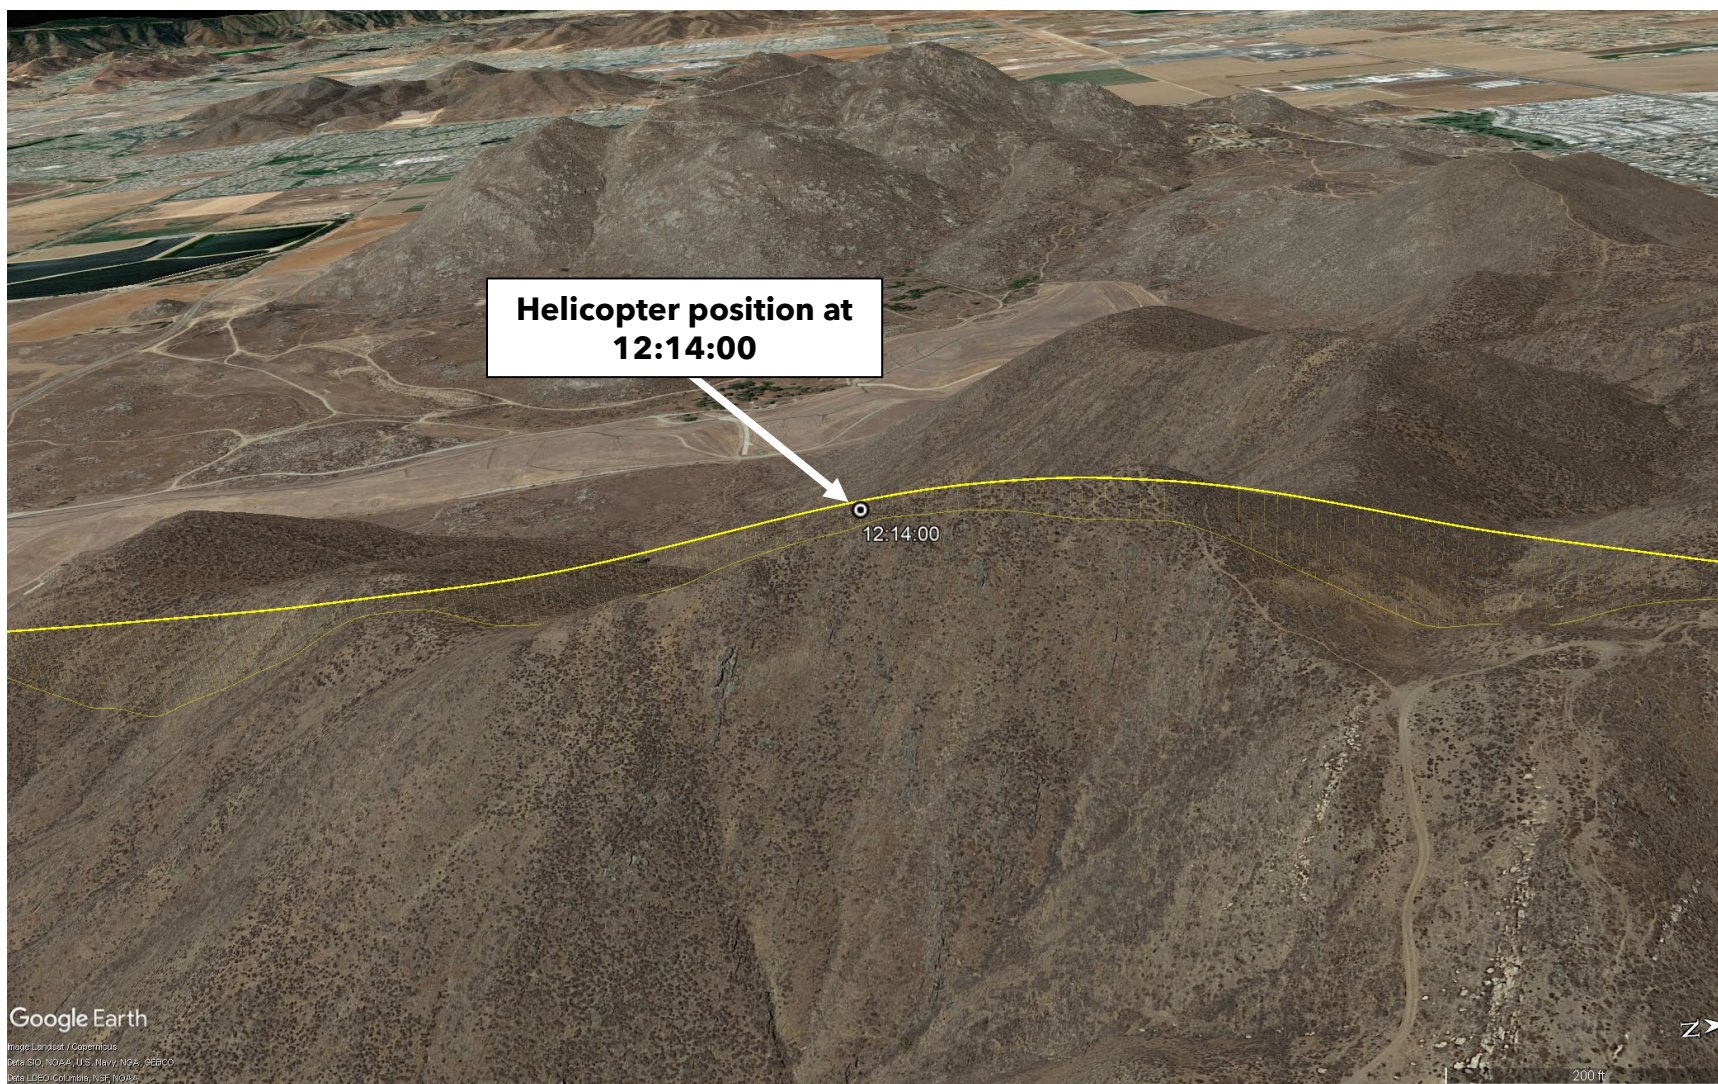
Figure 9. Helicopter position at 12:14:00 - side profile view. See Figure 5 for forward-facing camera view at this time.

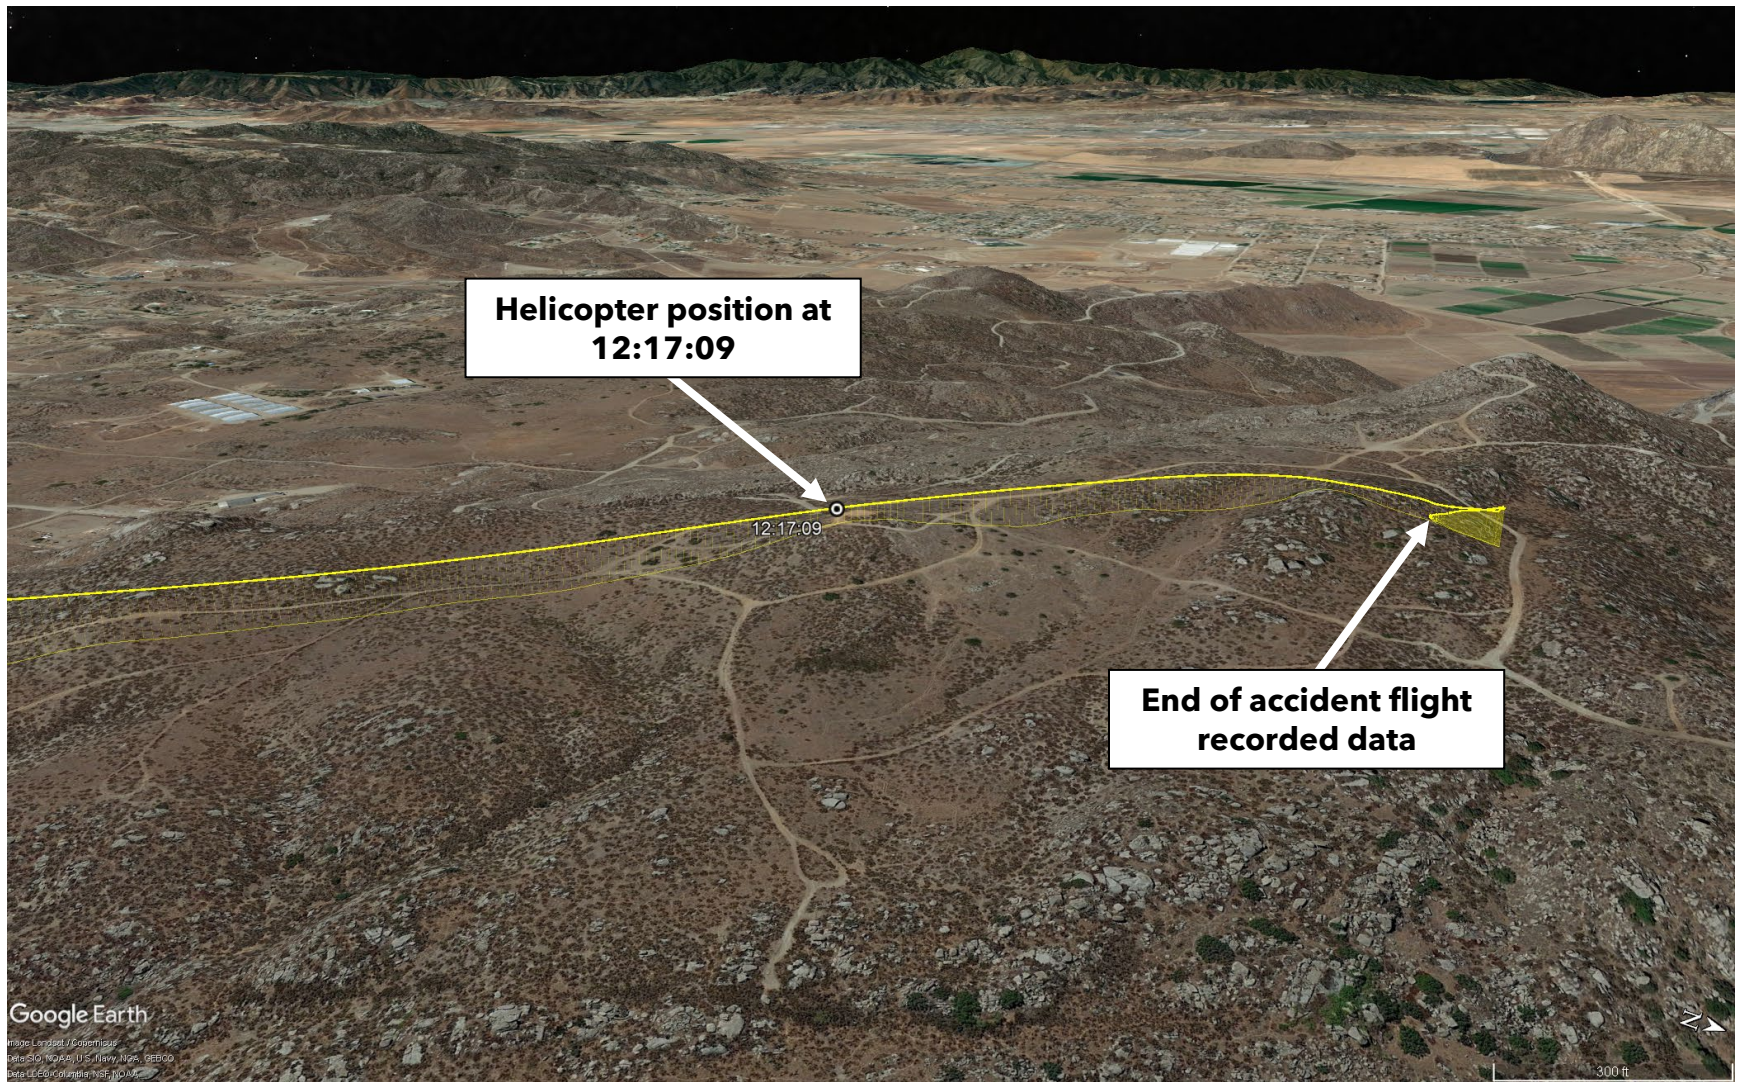
Figure 10. Helicopter position at 12:17:09 - side profile view. See Figure 6 for forward-facing camera view at this time.

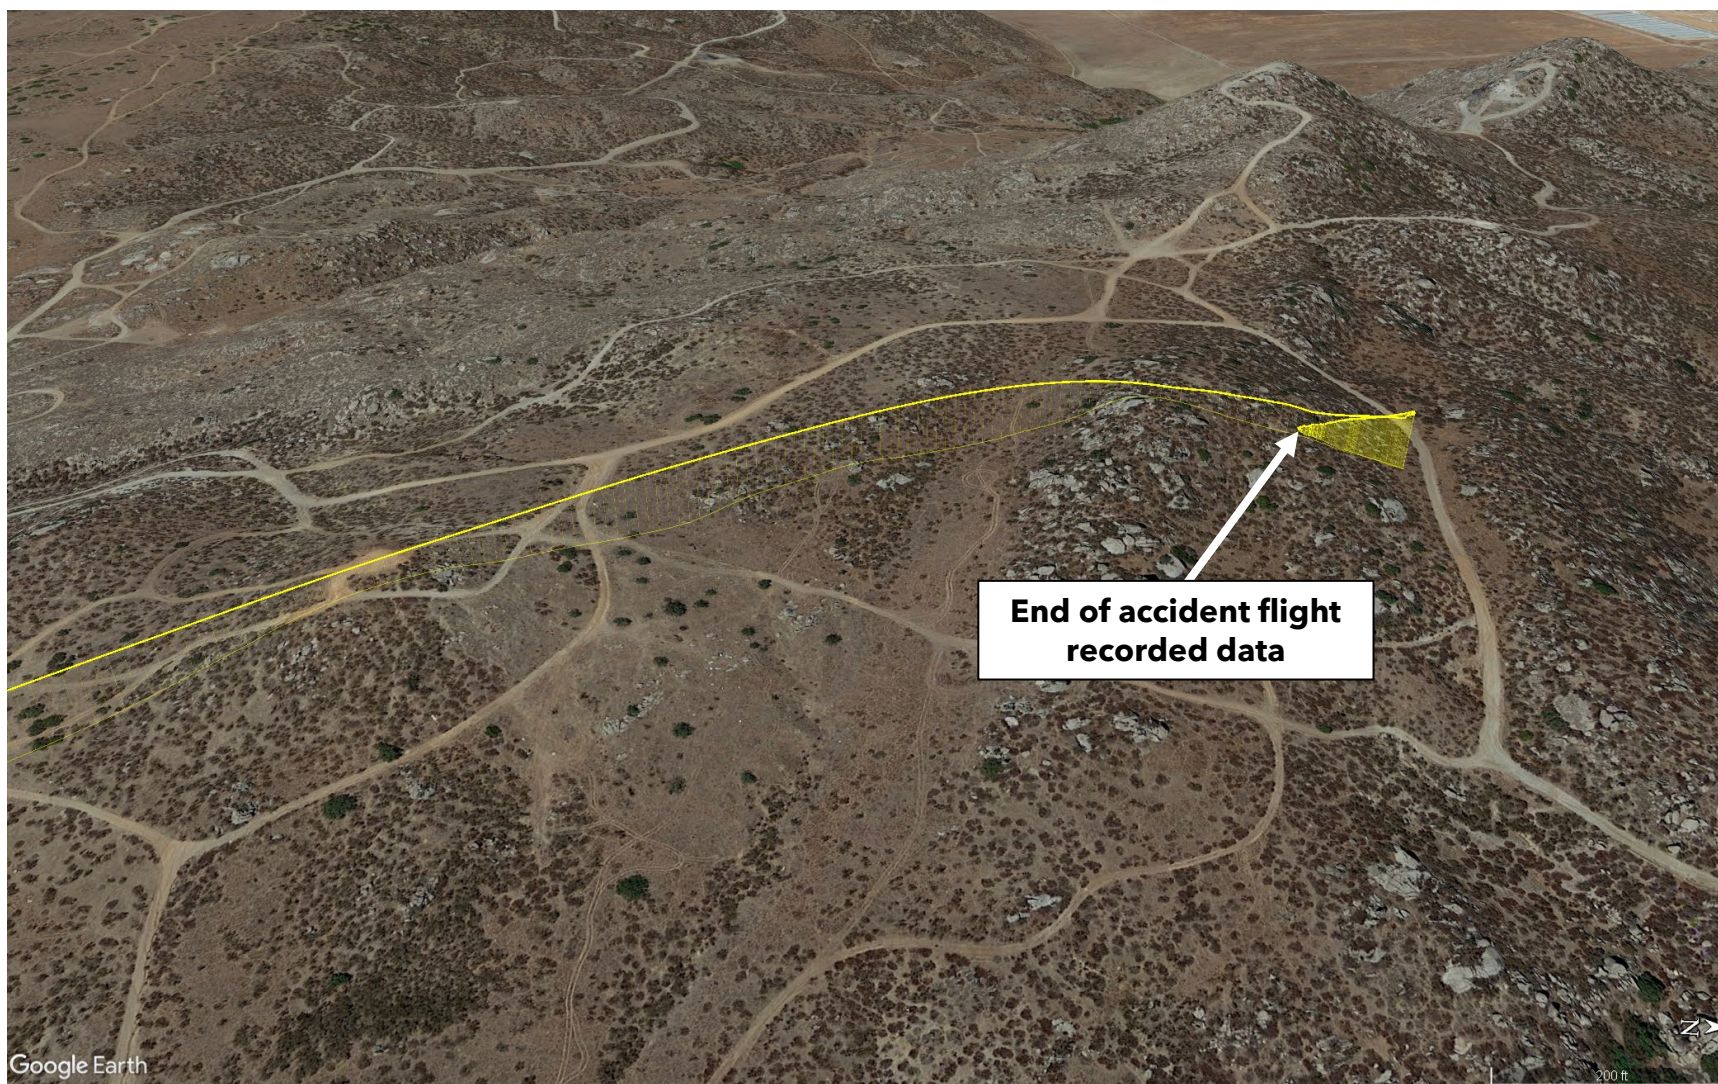
At 12:17:18, the helicopter impacted the ground and came to rest shortly thereafter.

Figure 11. End of accident flight recorded data - side profile view.
