ANC23FA031

**INVESTIGATION PHOTOGRAPHS**

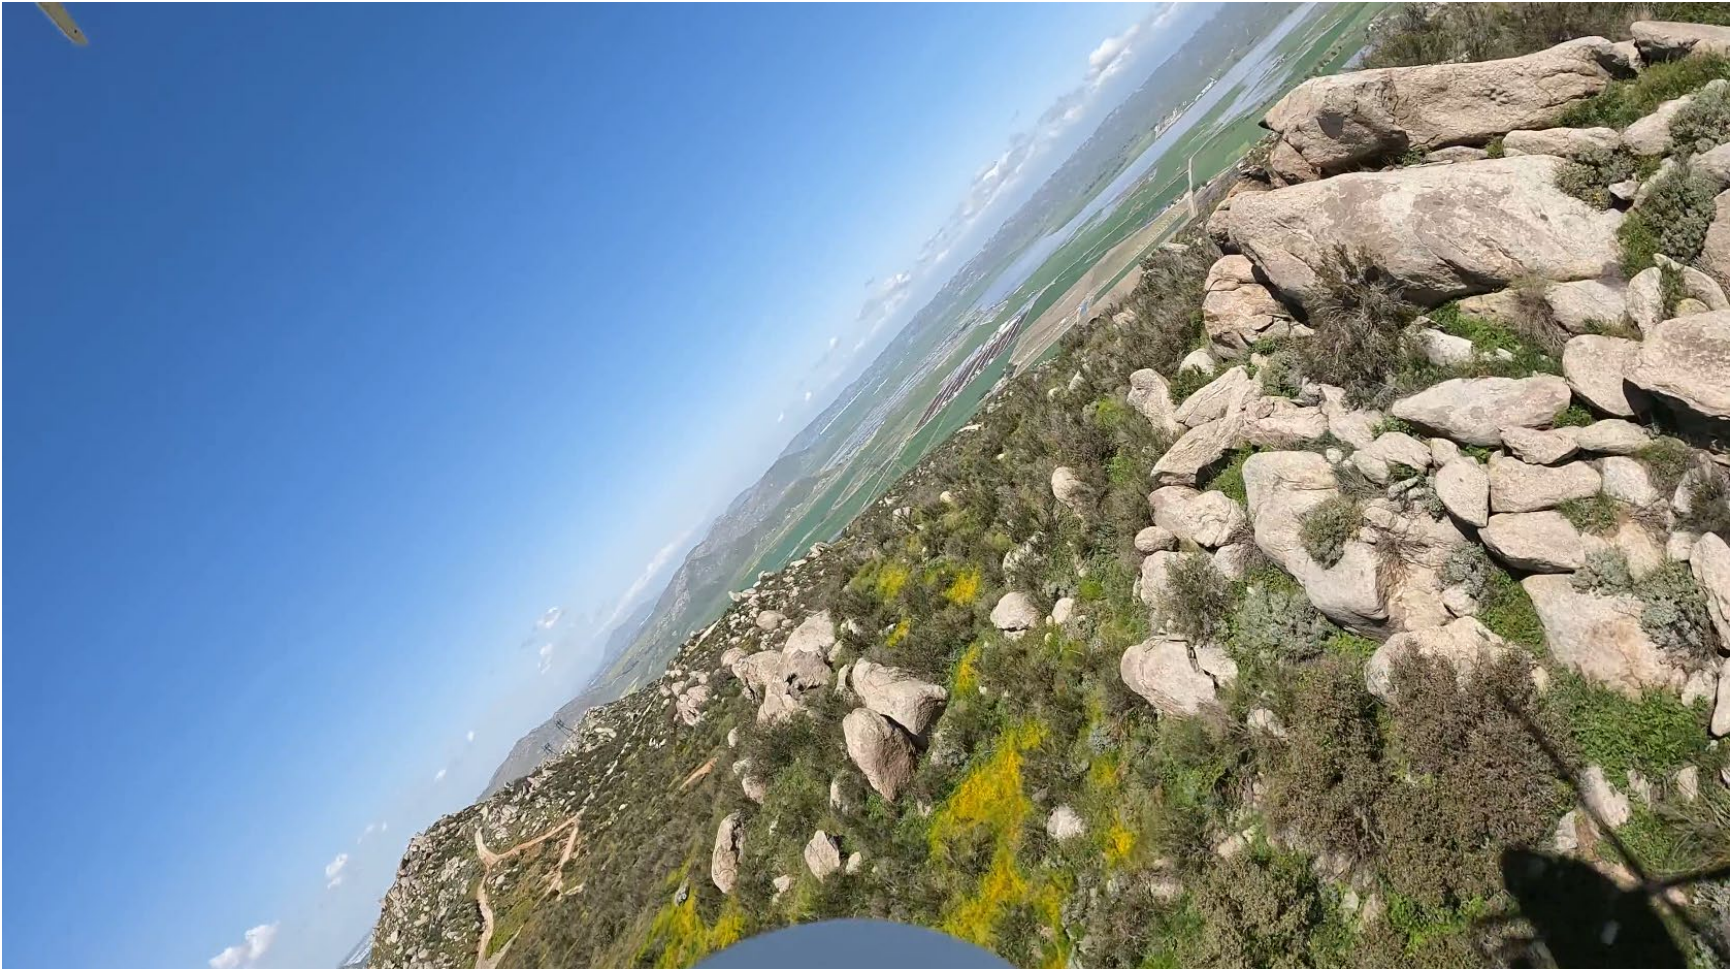
**Photograph 1 - Video frame seconds before impact with terrain from attached Go-Pro camera on helicopter.**

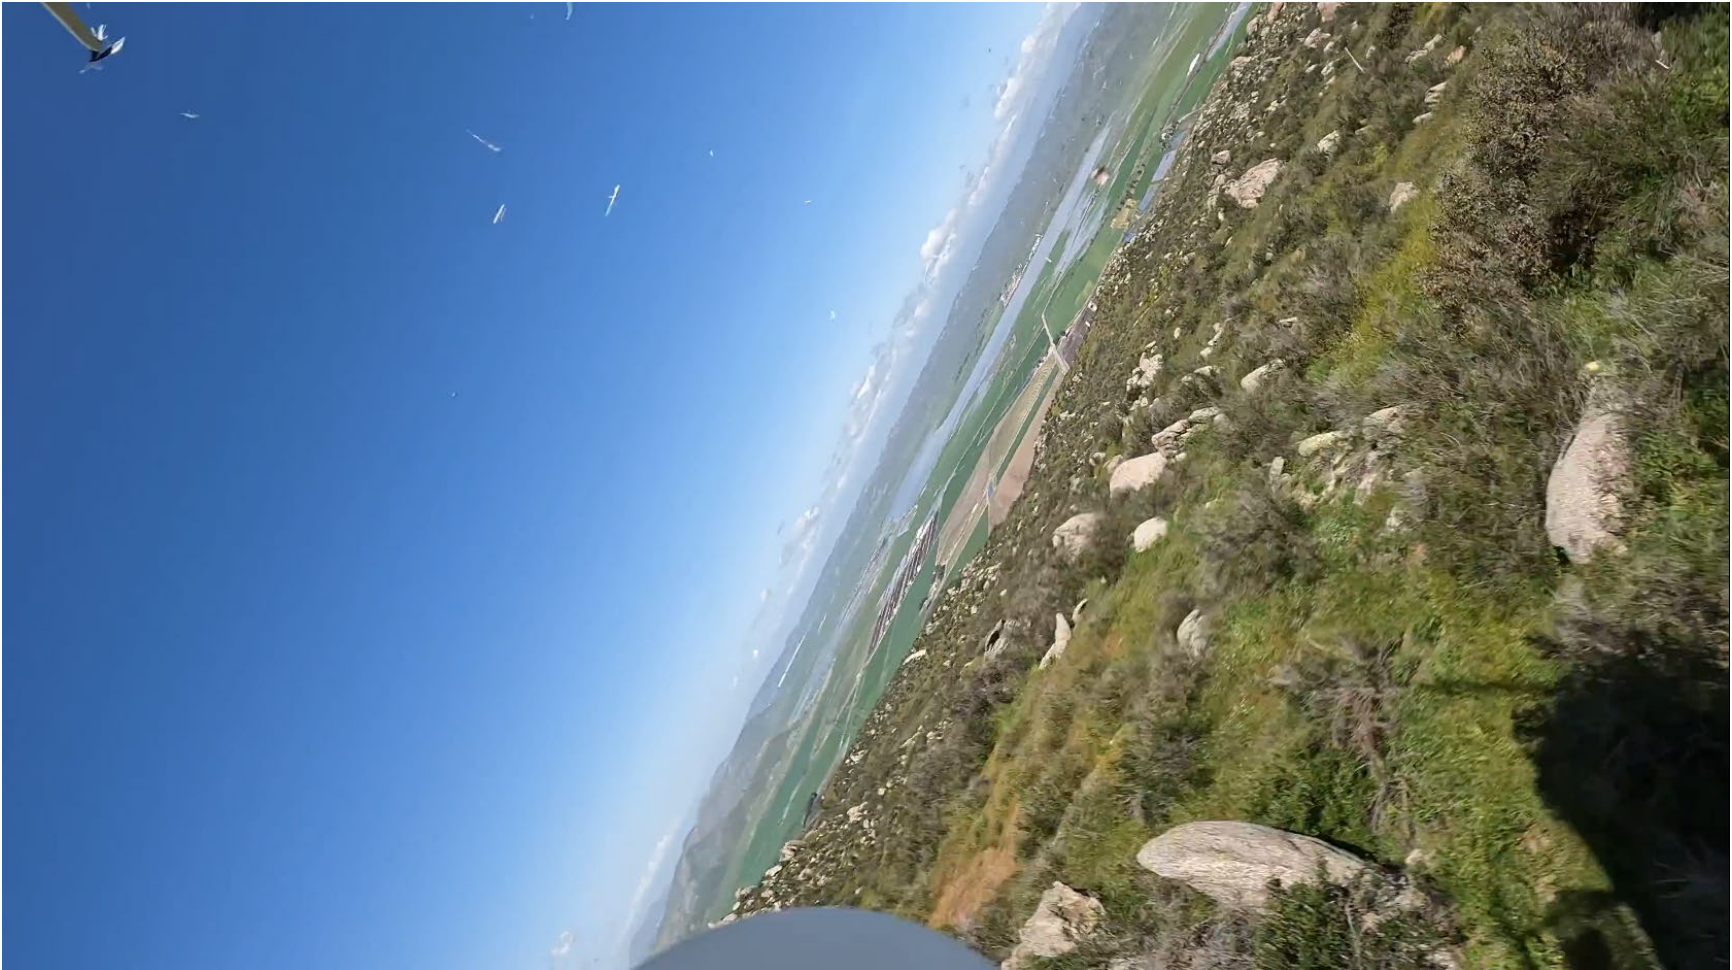
**Photograph 2 - Video frame from attached Go-Pro camera. Fragments of the main rotor blades can be seen at the top of the frame.**

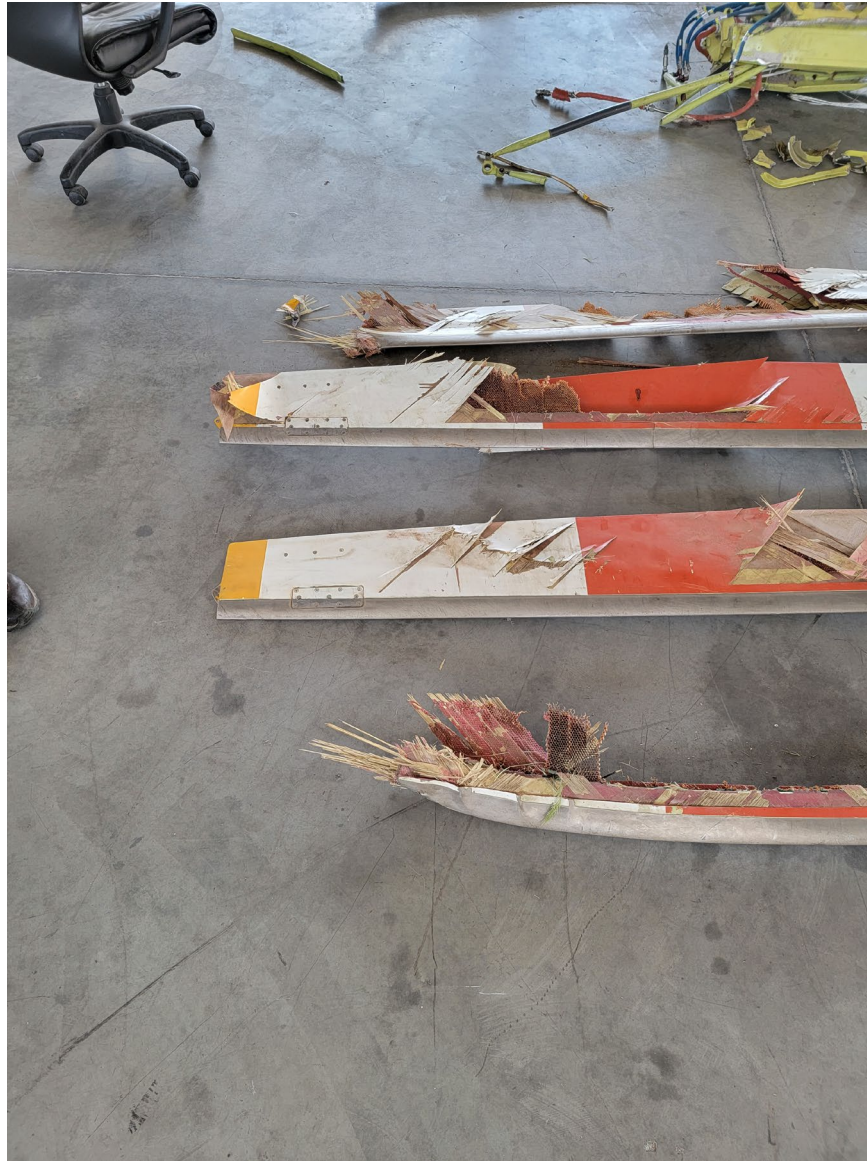
**Photograph 3 - Main rotor blade tip damage (Courtesy of NTSB)**

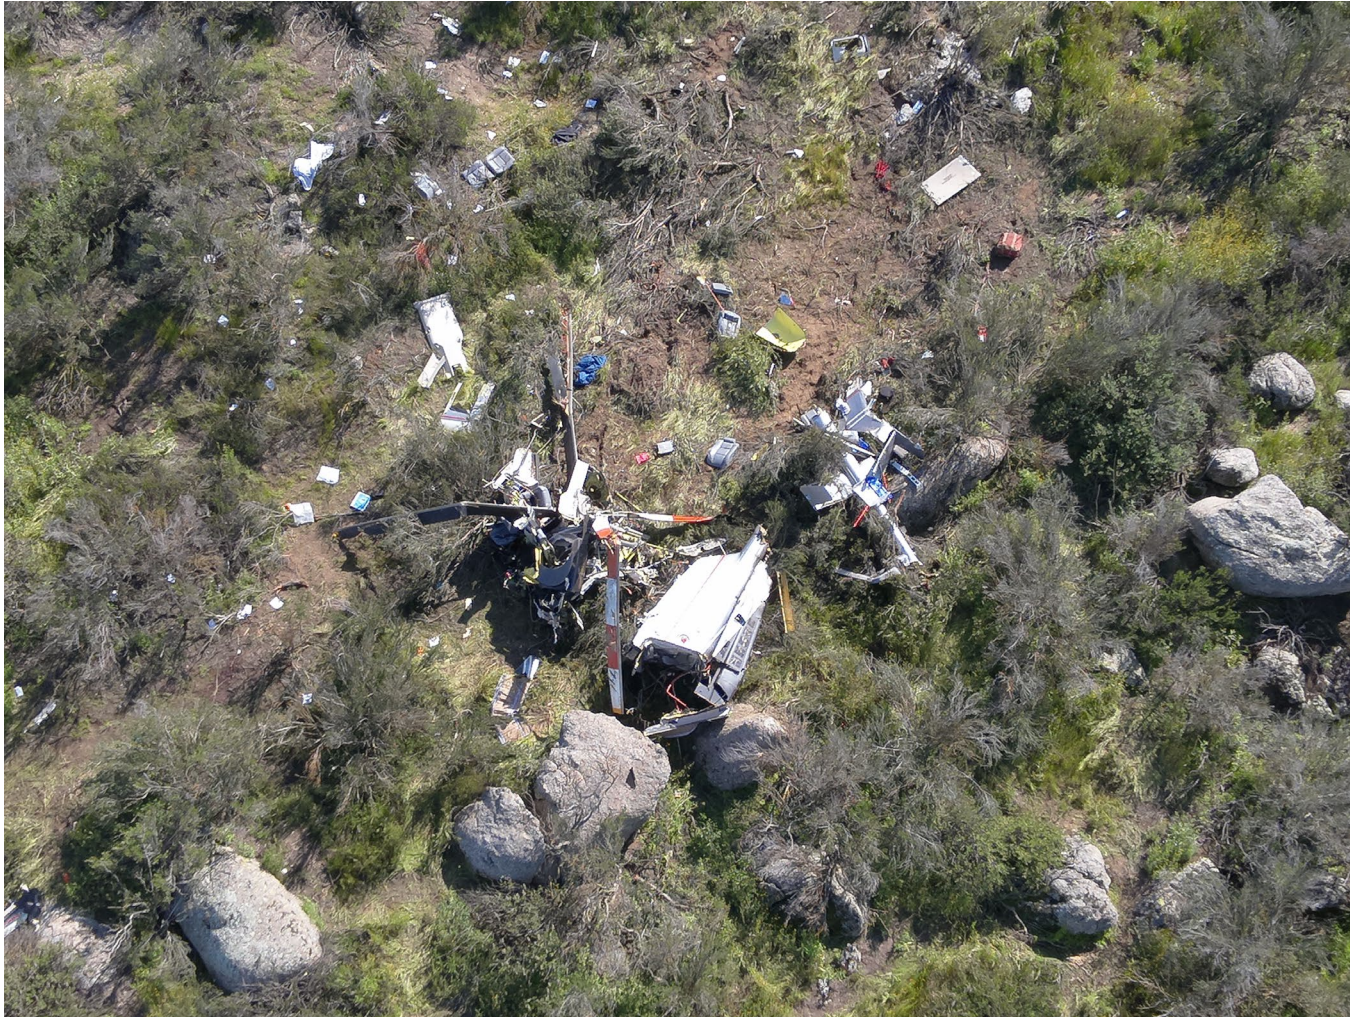
**Photograph 4 - Aerial view of accident site. (Courtesy of Sheriff's Department)**
