National Transportation Safety Board

ANC23FA031

WRECKAGE EXAMINATION

Location: Nuevo, CA
Date: 3/24/2023
Time: 1217L
Helicopter: Bell 407

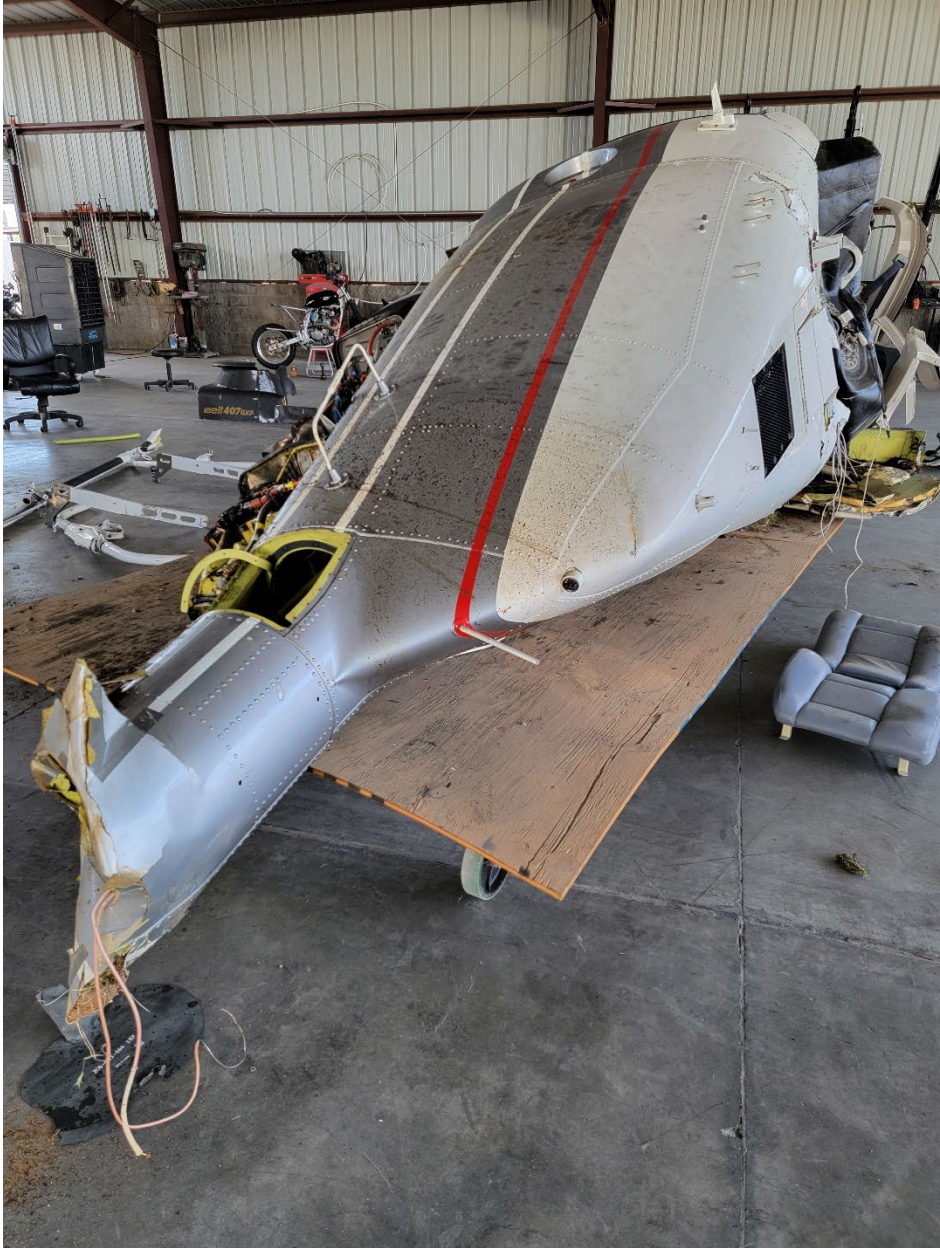
Overview of fuselage damage. Fuselage was intact from tail boom attachment point to the last row of seating in the passenger compartment. Separating from under the main fuel tank and up along the passenger seating compartment. From the last row of seating only the floor portion of the fuselage remains to include the forward fuel tank, flight control closet, crew seats to the about the start of the aft portion of the chin bubble.

Figure 1 Right rear of fuselage of accident helicopter

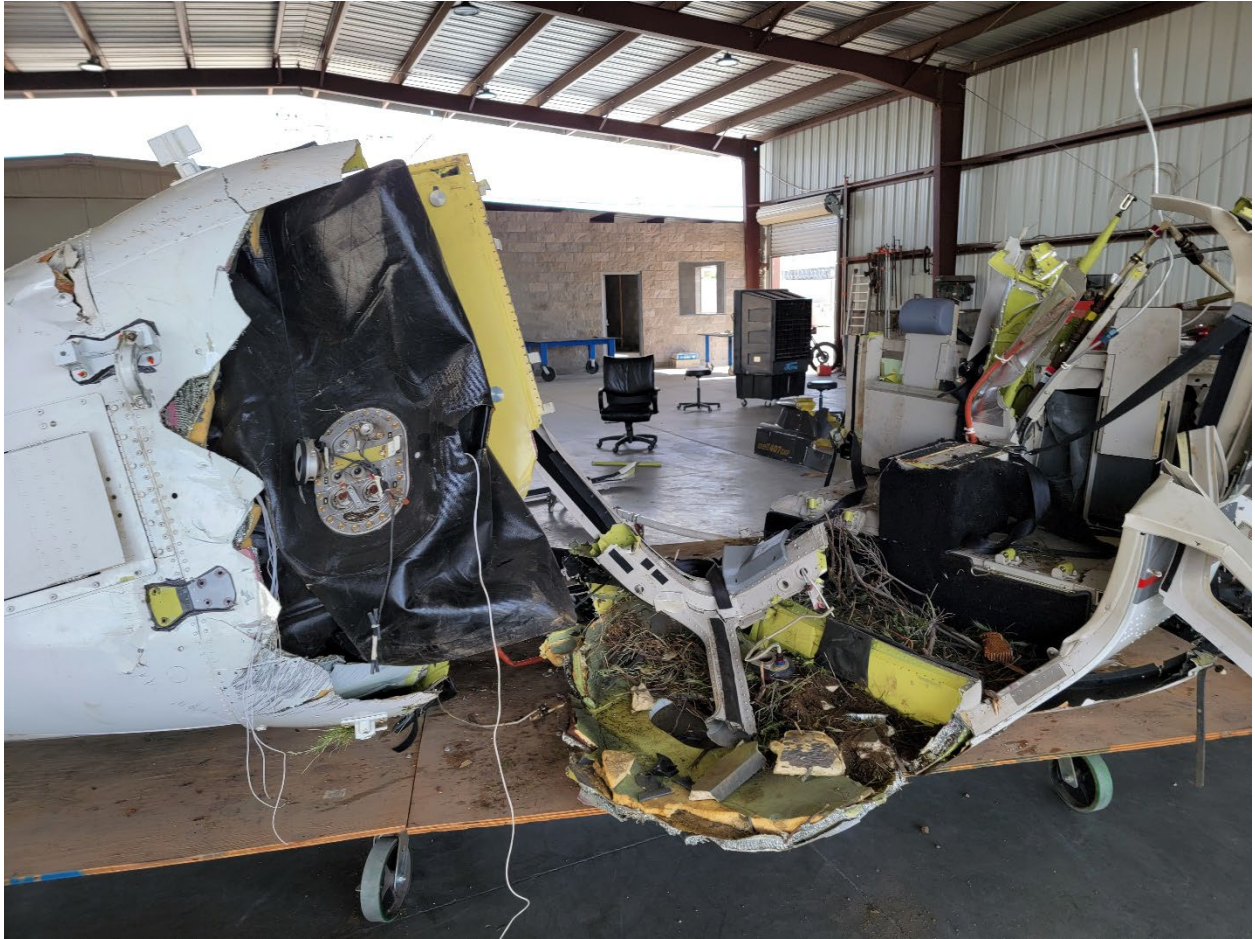
Figure 2 Under side aft of passenger compartment and right side of passenger compartment,

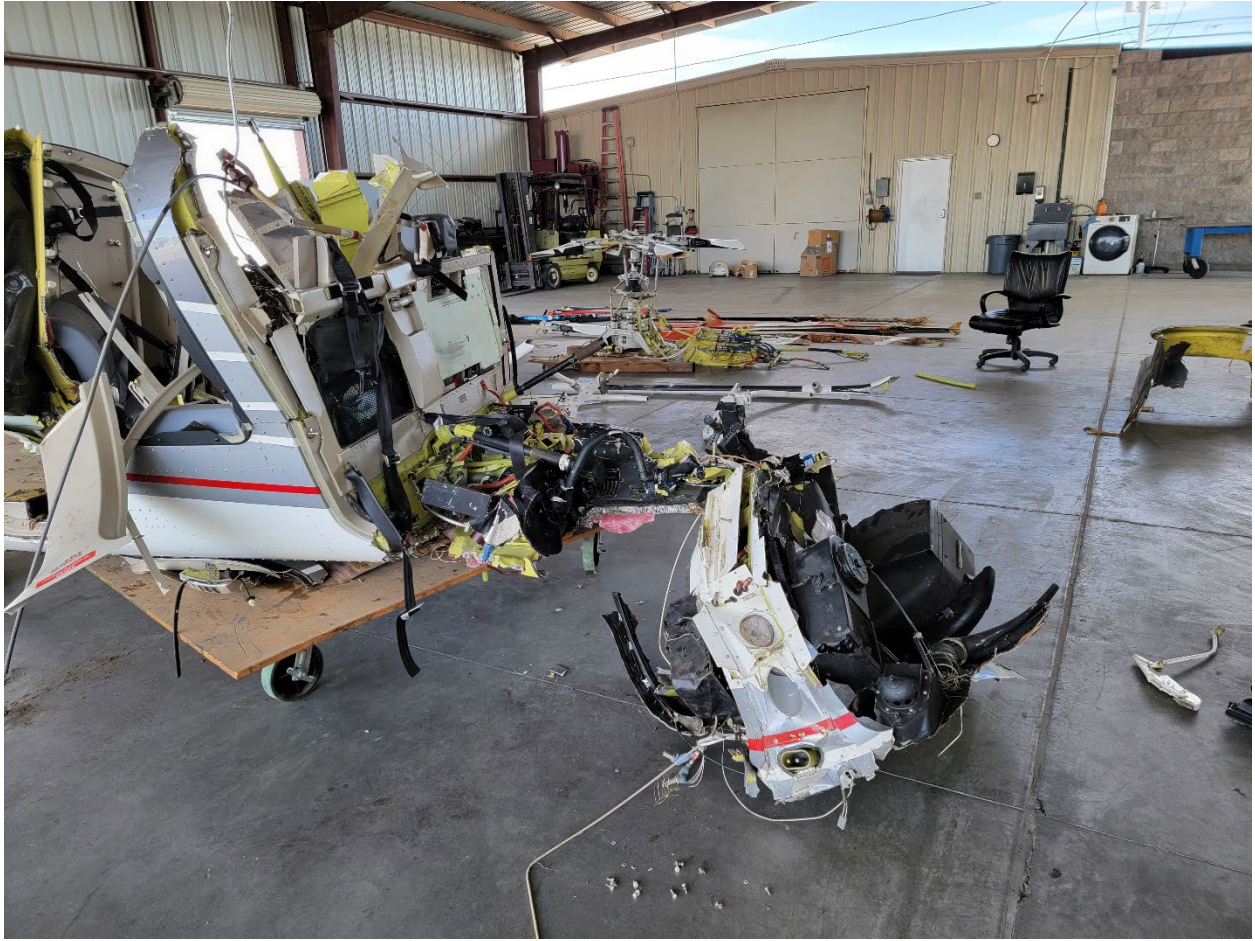
Figure 3 Right side view of cockpit.

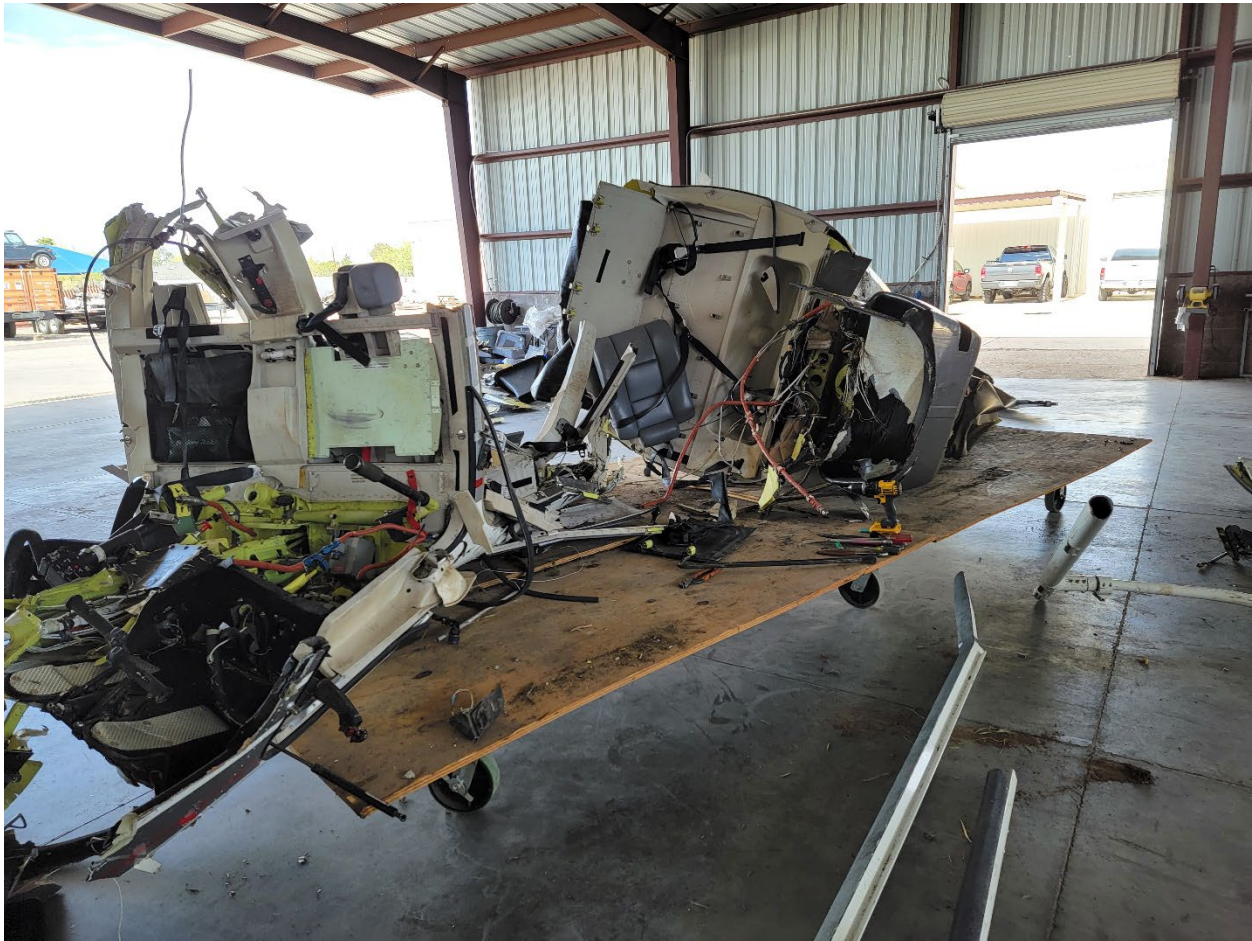
Figure 4 Left side of cockpit and passenger compartment

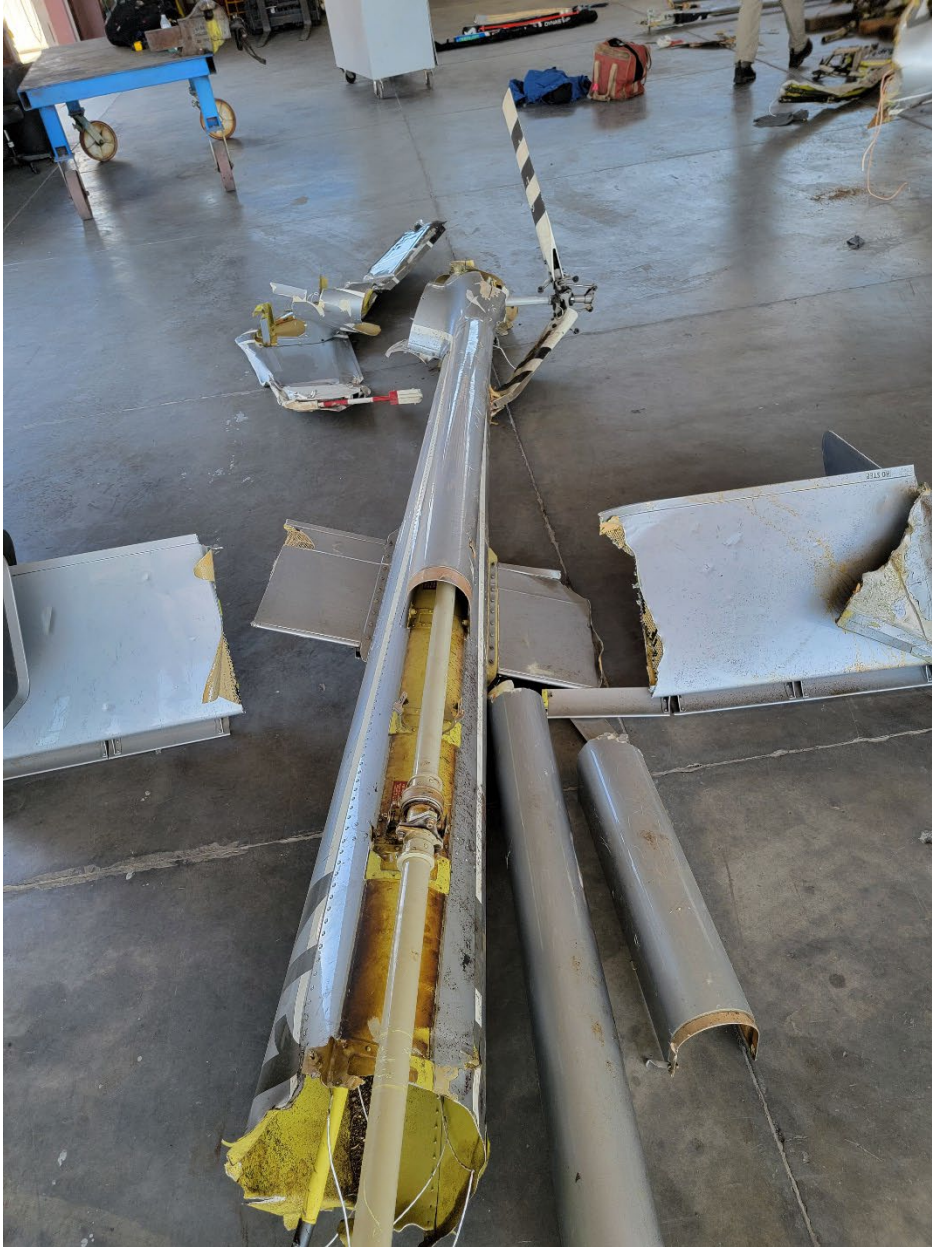
Tail boom separated about 2 feet from the tail boom attachment point on fuselage. Separation from impact with terrain and overload. Tail rotor moved freely and moved when twisting the tail rotor drive shaft. Chip detector was removed and was clean. One tail rotor blade was undamaged, one had tip damage from contact with the vertical fin from impact with terrain.

Figure 5 View of tail boom.

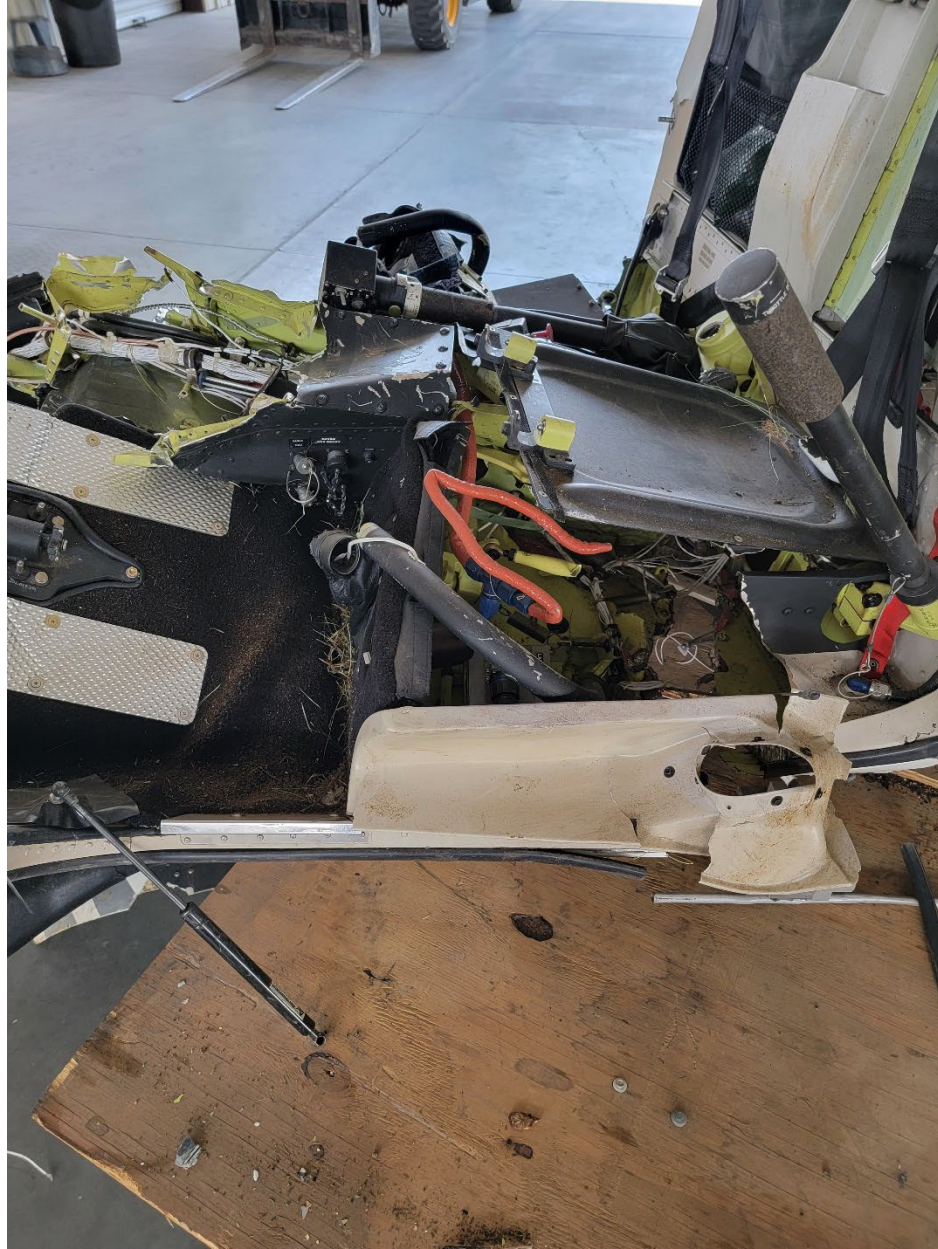
- Collective- Left side (co-pilot) collective stick was undamaged, Right-side collective stick was separated at the base from overload/impact damage. Collective flight control tubes were intact from the collective to the push tube extending out of the vertical flight control closet. Collective was moved up and down and the flight control tube moved.

Figure 6 View of left collective.

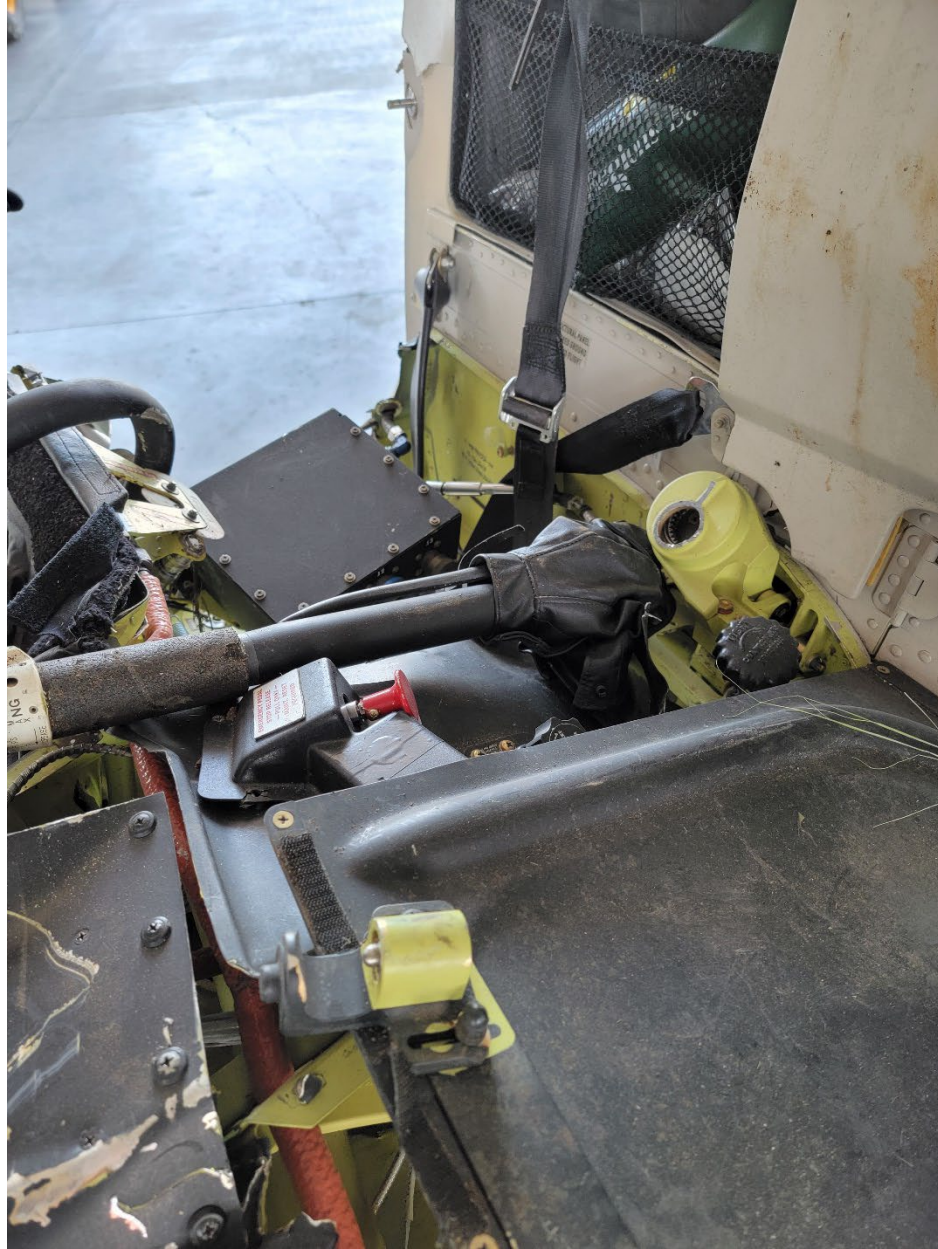
Figure 7 Right side collective

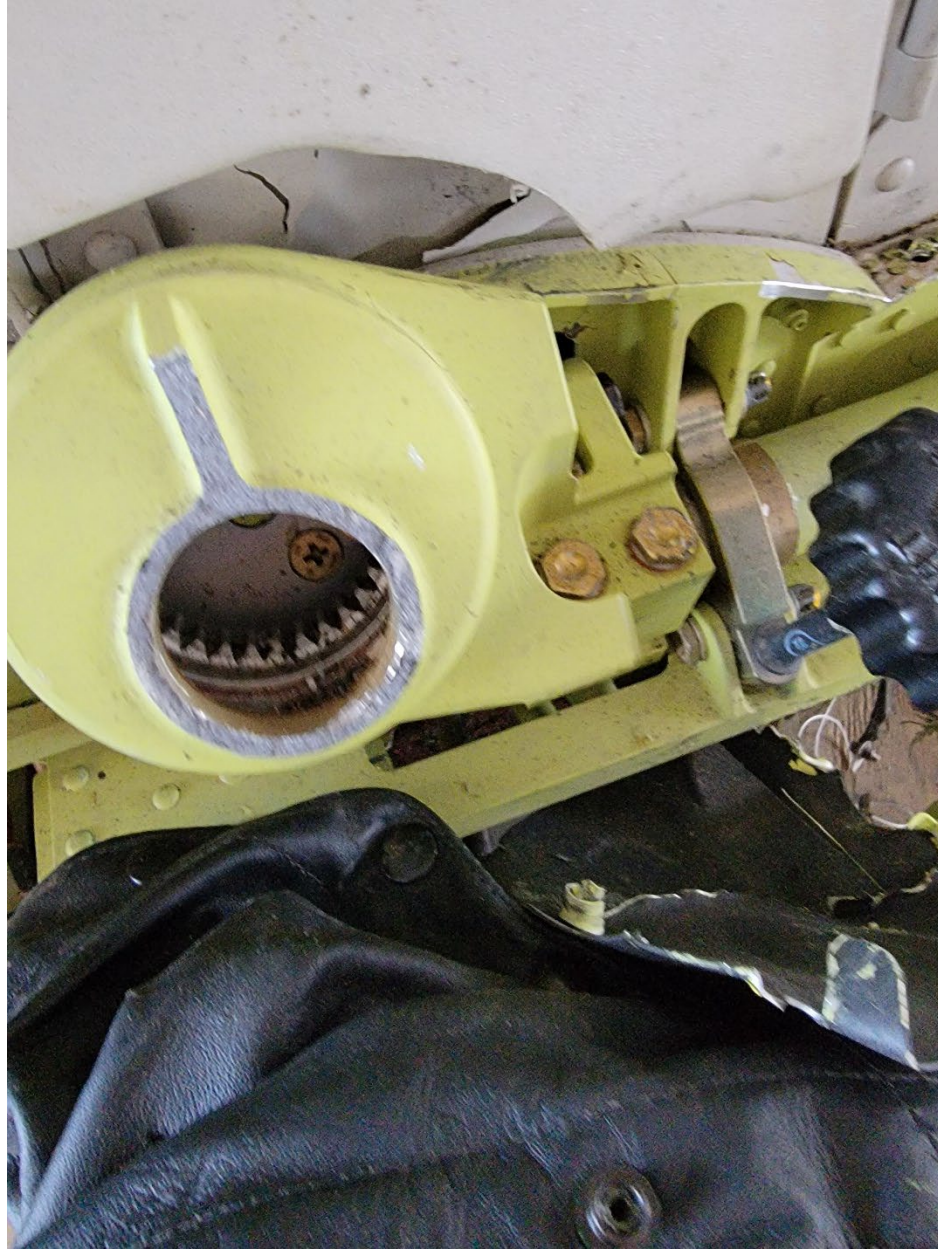
The attachment from the control tube coming out of the vertical flight control closet to the collective servo was separated by overload/impact damage. Collective flight control continuity was established from the collective to main rotor with separations from overload damage. No pre-impact anomalies were observed in the collective flight controls and all observed fractures were consistent with overload forces at impact. The cockpit area where much of the controls are located exhibited significant damage with corresponding damage to the controls. The helicopter was equipped with dual controls. Main rotor flight control continuity for collective systems was confirmed from input sticks to the main rotor hub assembly.

Figure 8 Attachment point for right-side collective.

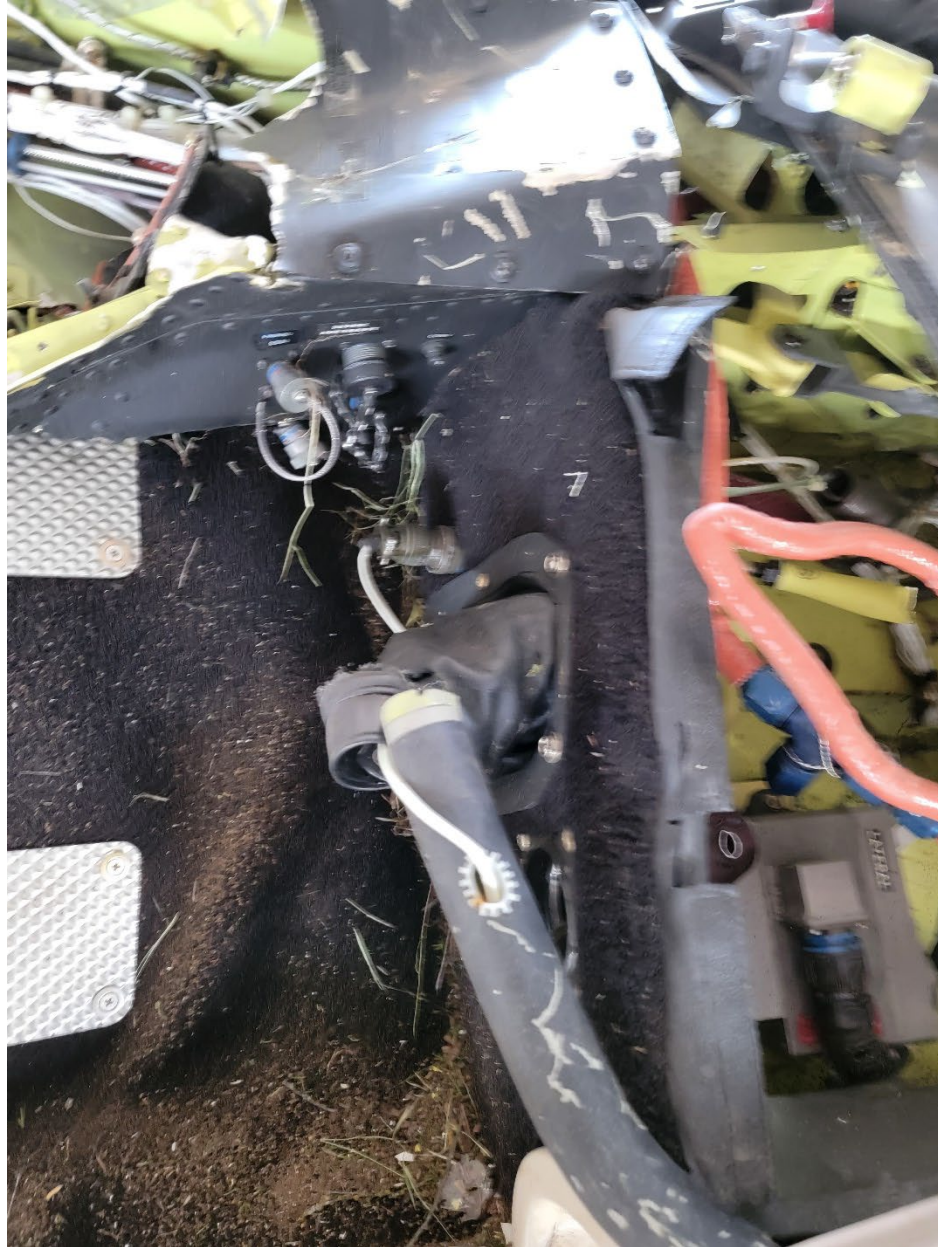
- Cyclic - Both cyclic sticks were separated near their attachment point. Separation from overload / impact damage. Flight control tubes from the cyclic stick attachment point were intact to about 2 feet up the vertical flight control closet with signs of separation from overload. No pre-impact anomalies were observed in the main rotor cyclic flight controls and all observed fractures were consistent with overload forces

Figure 9 Left side cyclic attachment point.

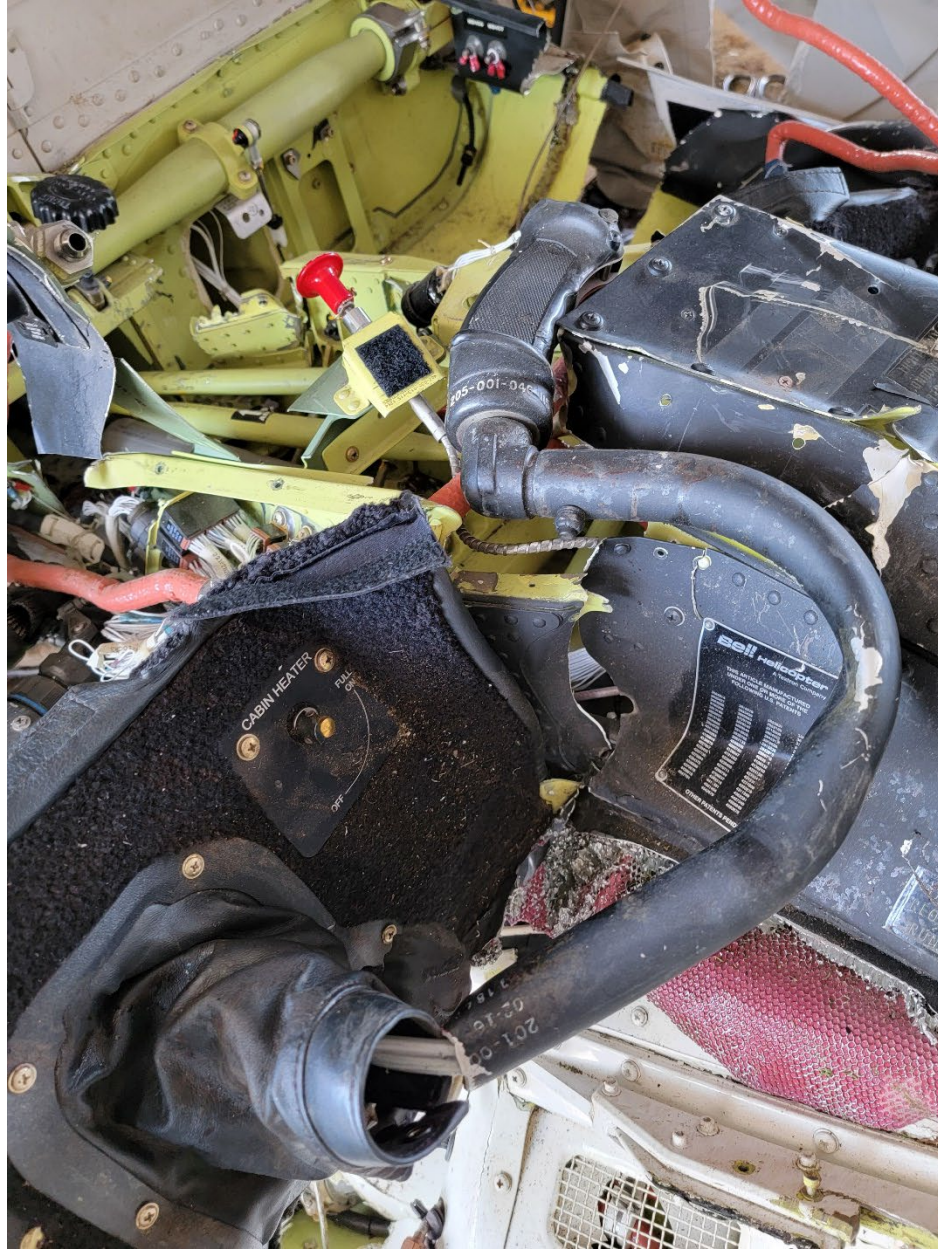
Figure 10 Right side pilot's cyclic stick.

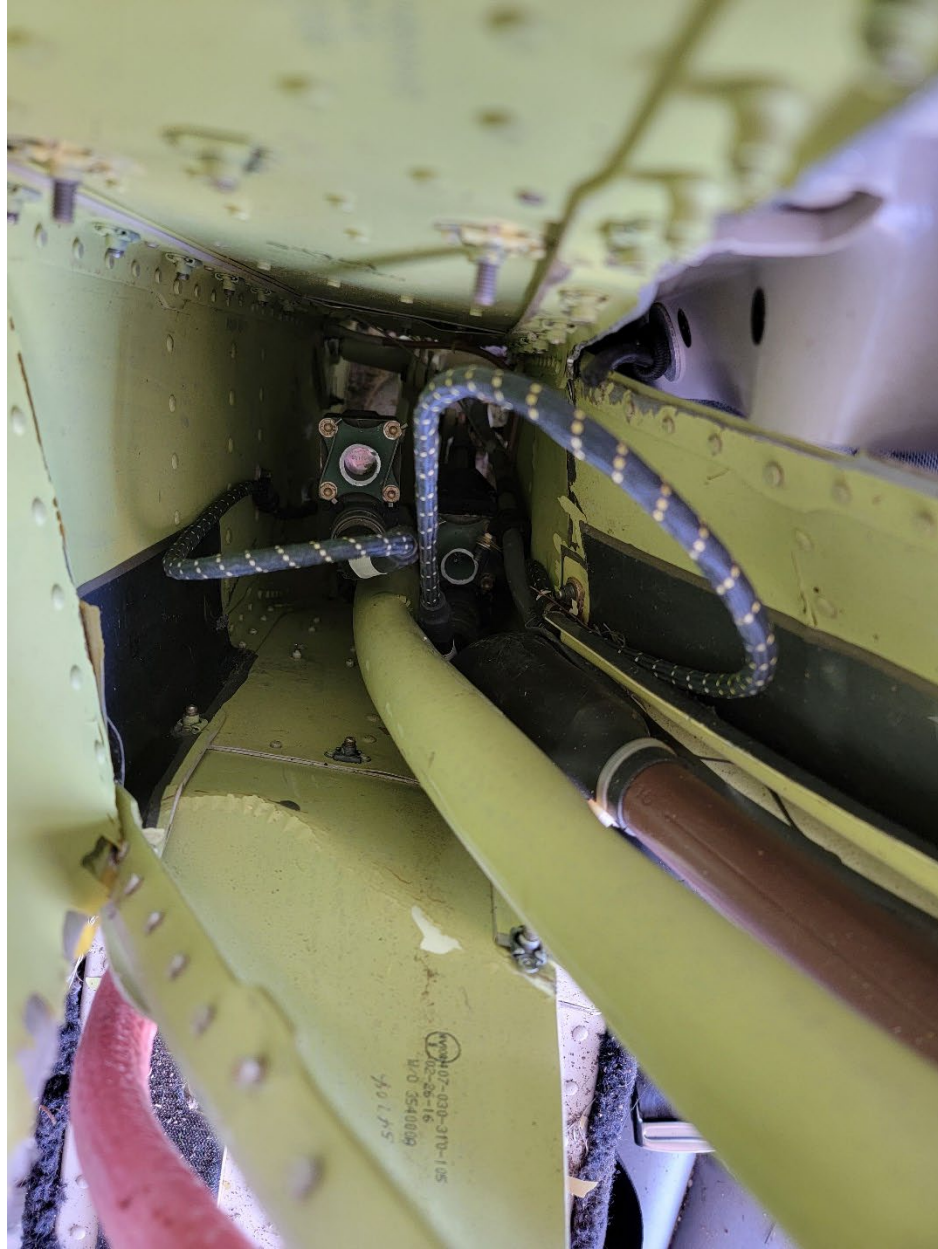
Figure 11 View looking down the vertical flight control closet.

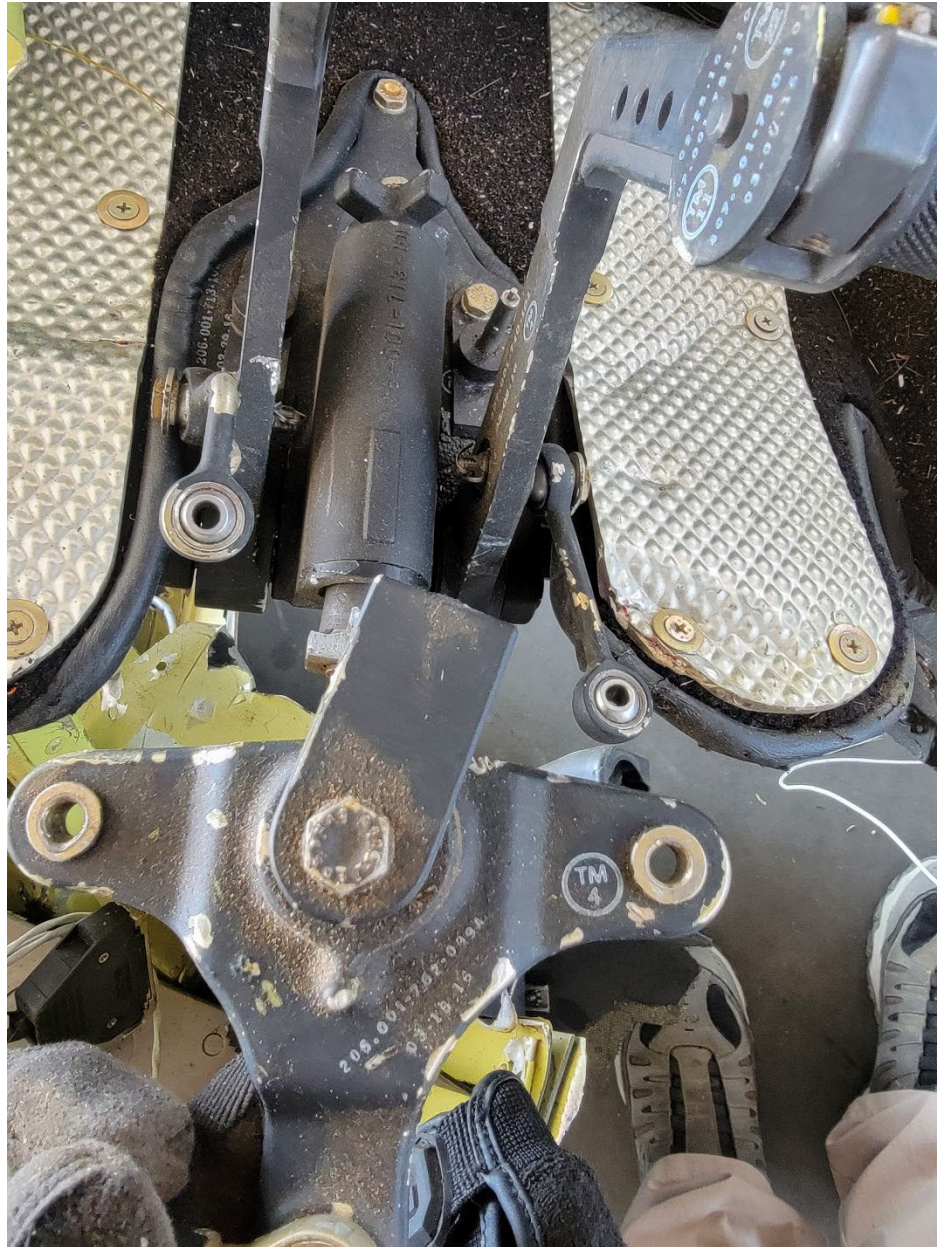
- Yaw- No pre-impact anomalies were observed in the yaw pedal fight controls and all observed fractures were consistent with overload forces

Figure 12 Left side yaw control pedals.

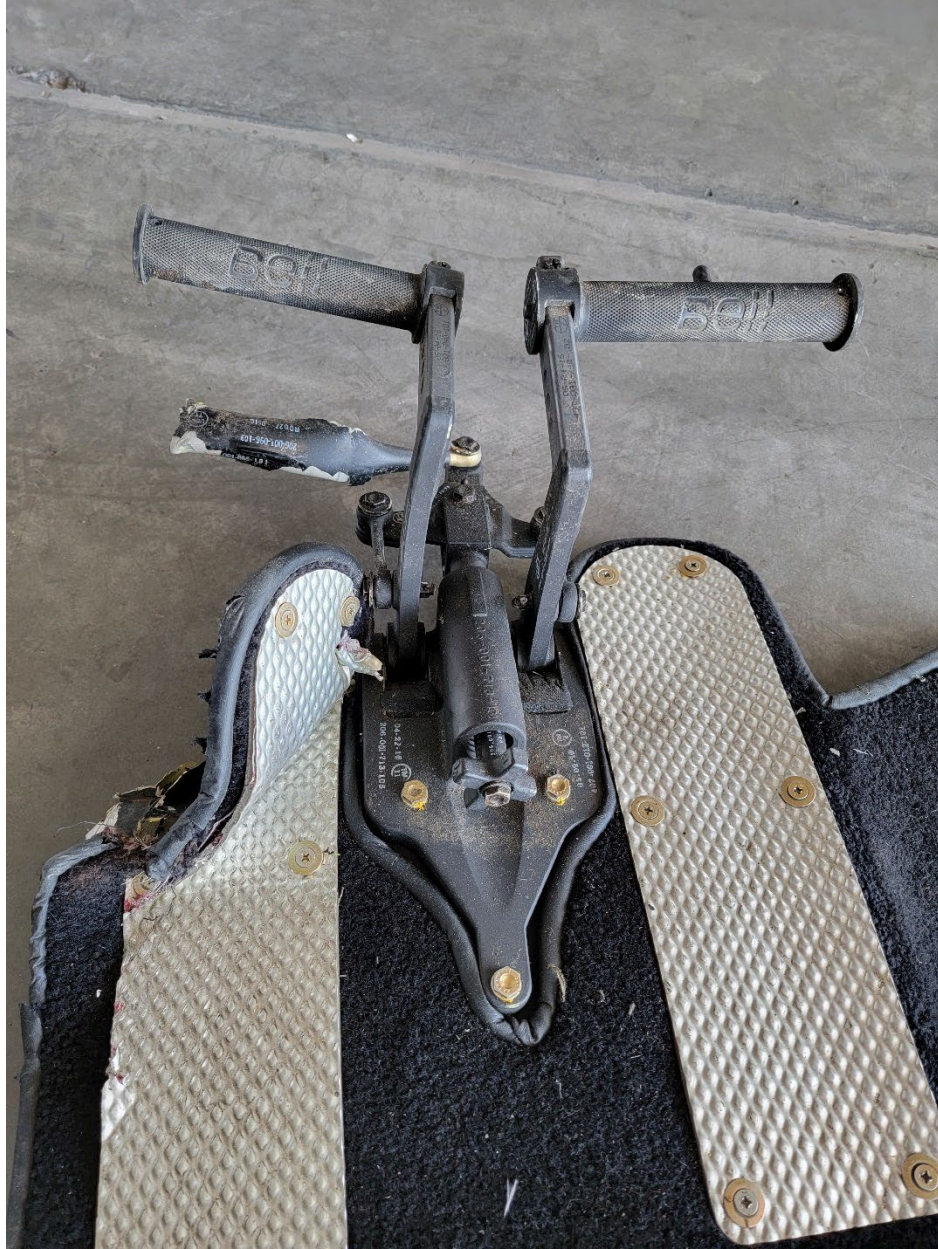
Figure 13 Right side yaw pedals.

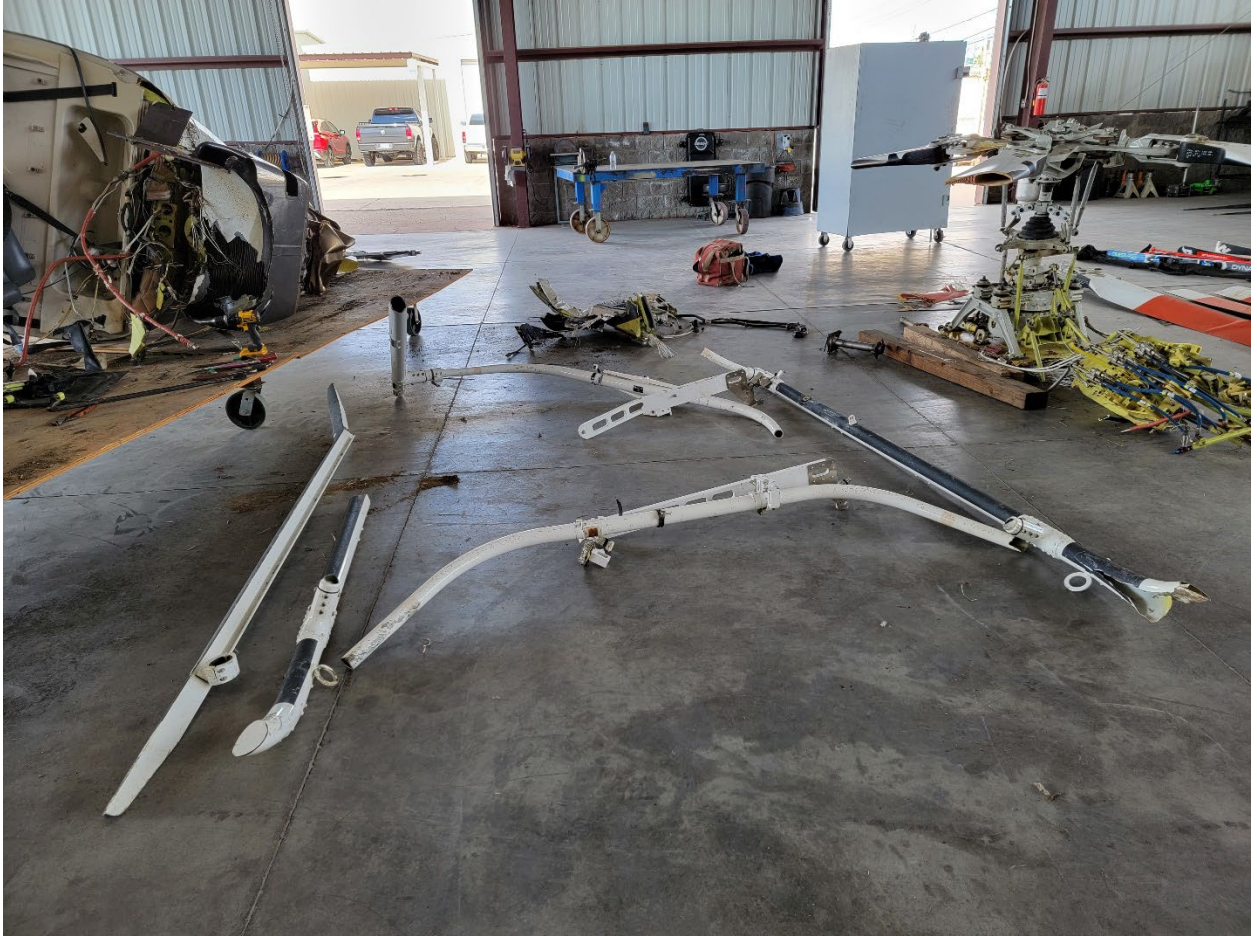
No pre-impact anomalies were observed with landing gear and all observed fractures were consistent with overload forces at impact.

Figure 14 Front view of high skid landing gear from accident helicopter.

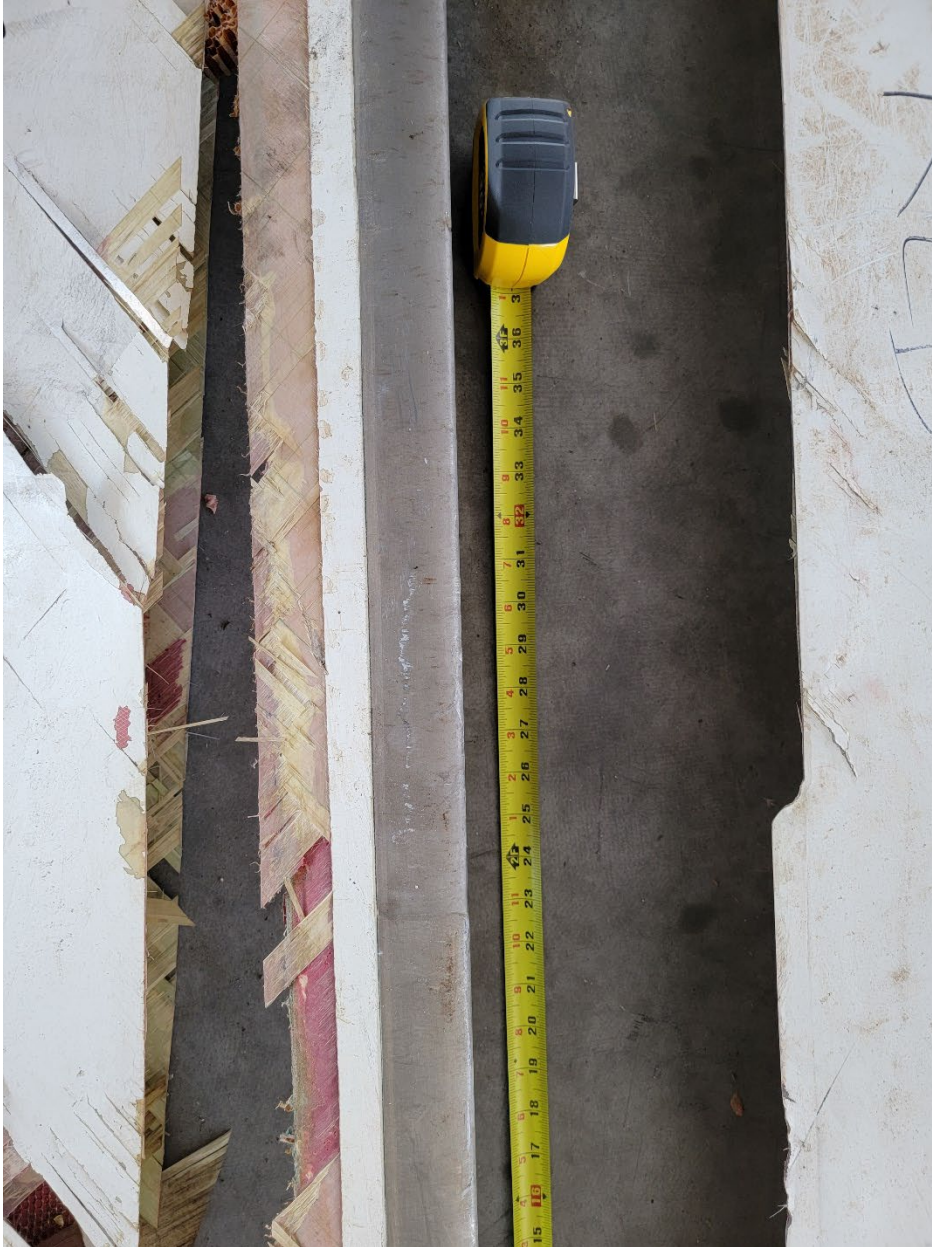
Figure 15 Witness marks on green rotor blade with white paint transfer from impact with heli utility basket.

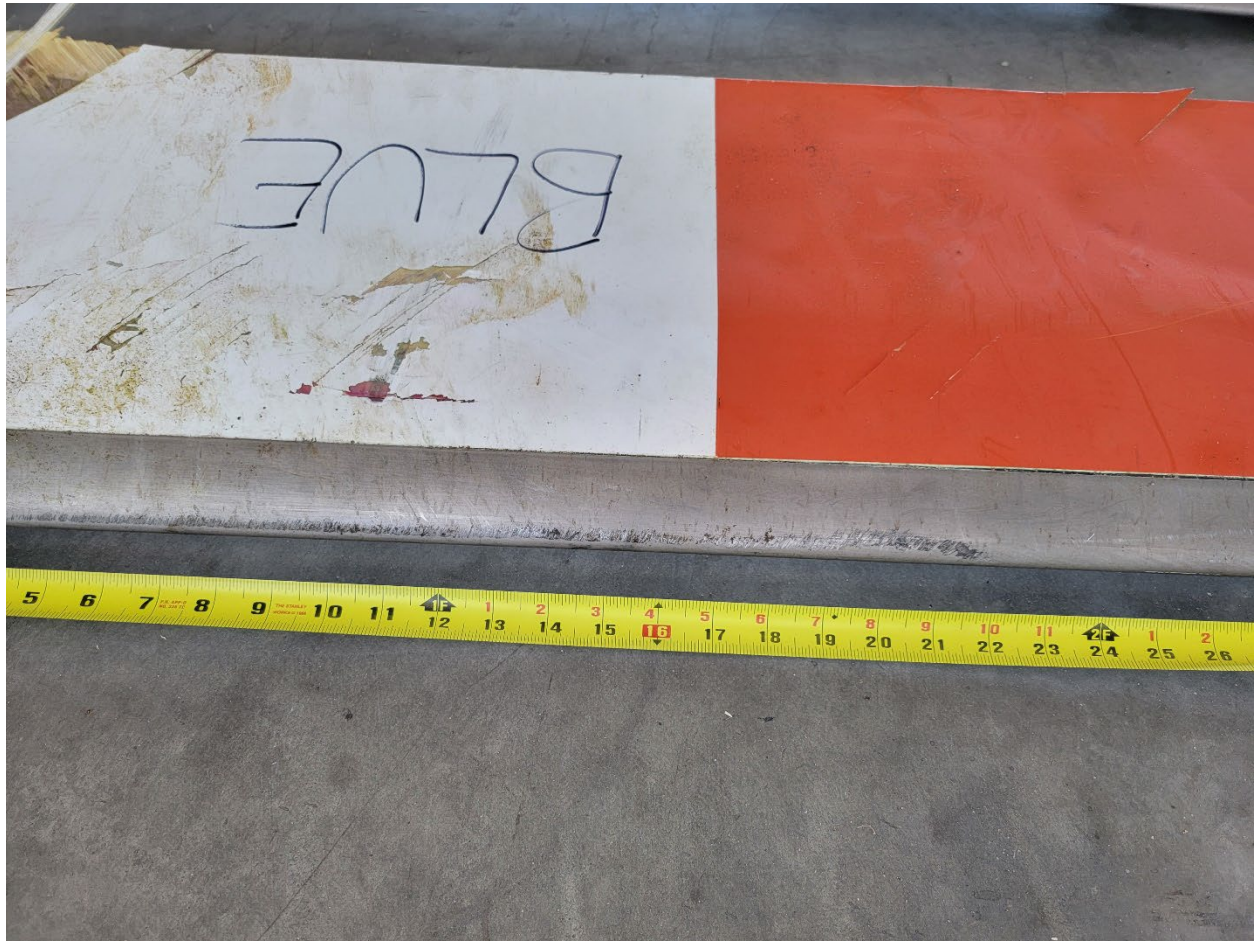
Figure 16 Witness marks on blue rotor blade with black paint transfer from impact with heli utility basket.

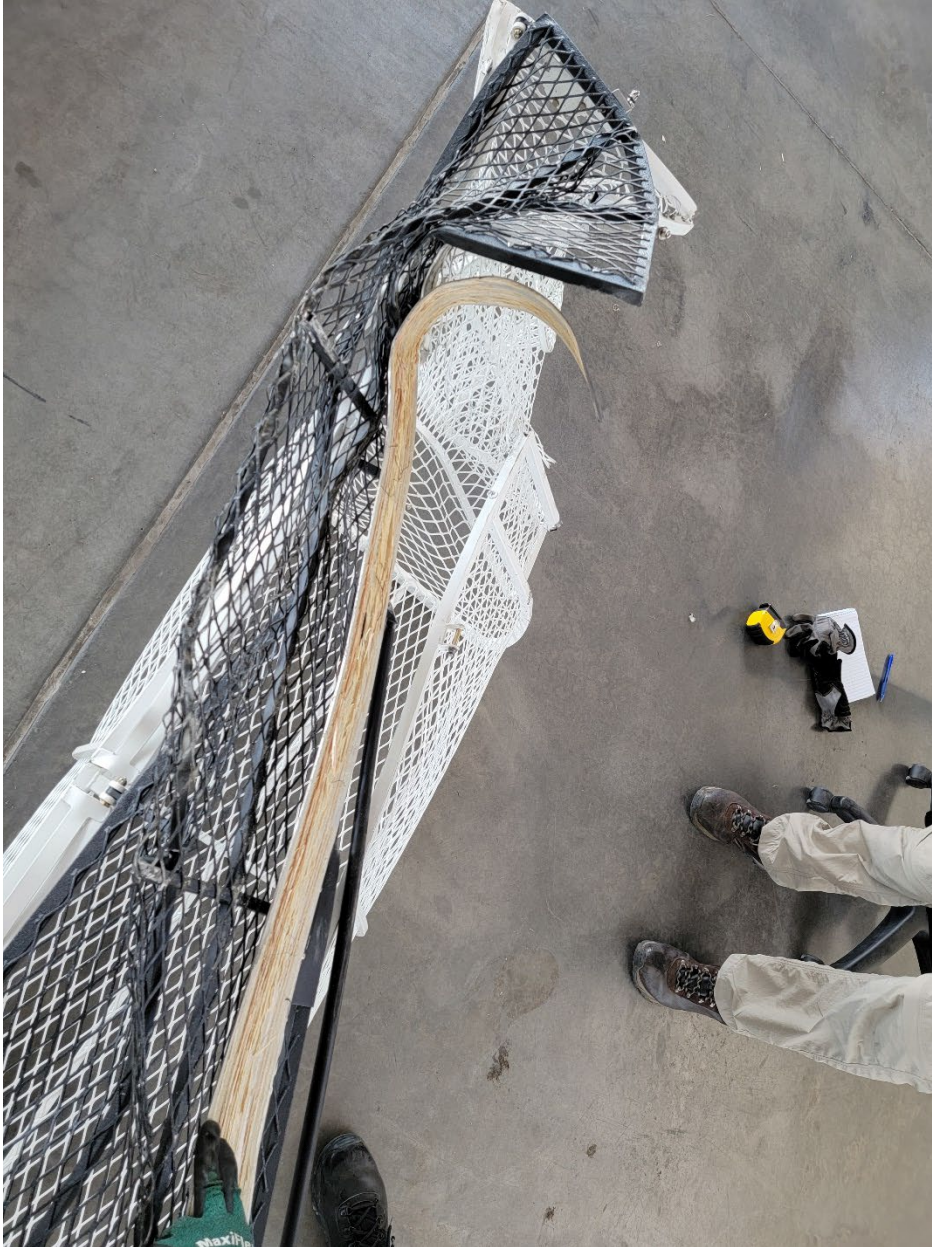
Figure 17 View of heli utility basket with down ski layed on top.

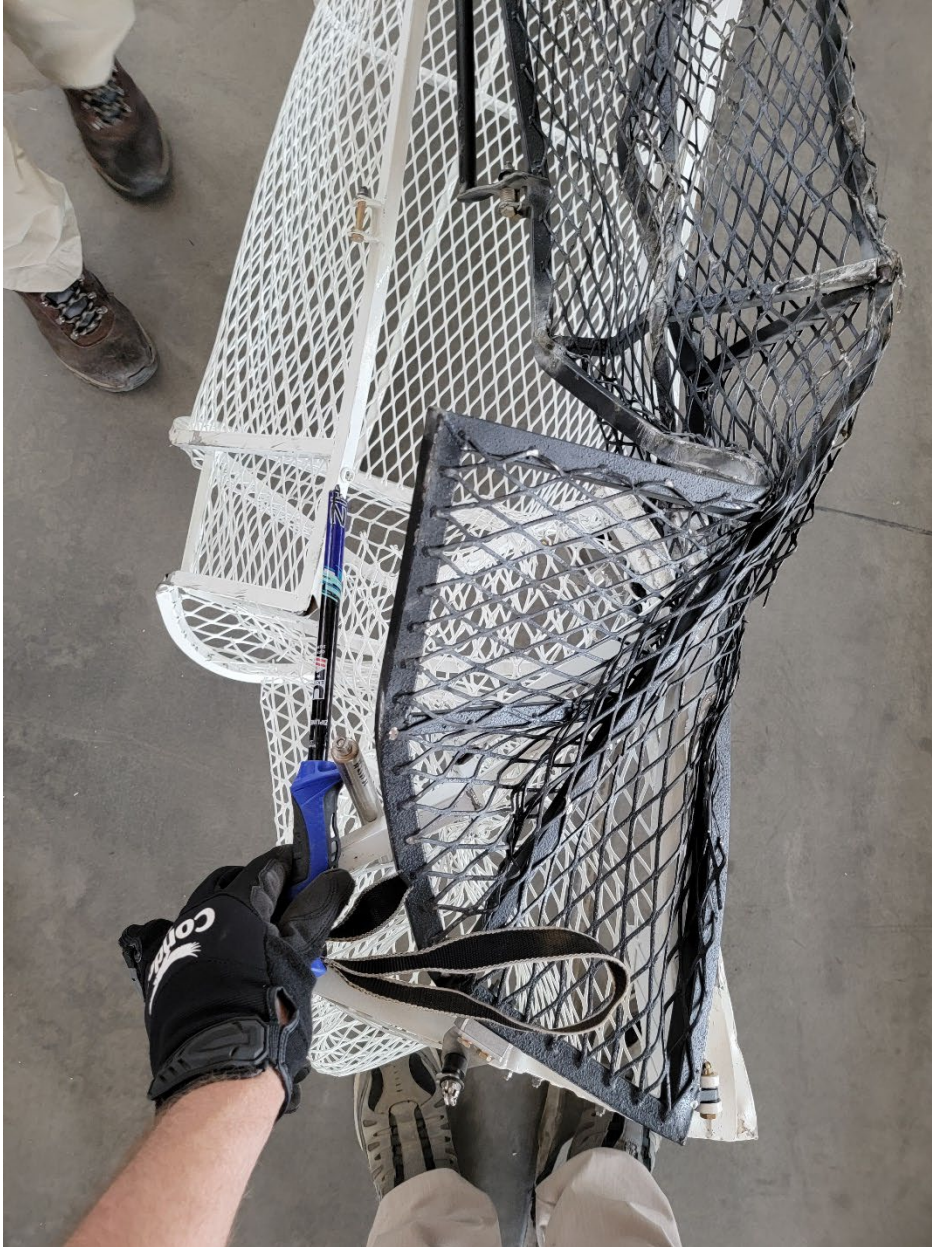
Figure 18 View of heli utility basket with broken ski pole.
