National Transportation Safety Board

ANC23FA031

WRECKAGE EXAMINATION

Location: Nuevo, CA
Date: 3/24/2023
Time: 1217L
Helicopter: Bell 407

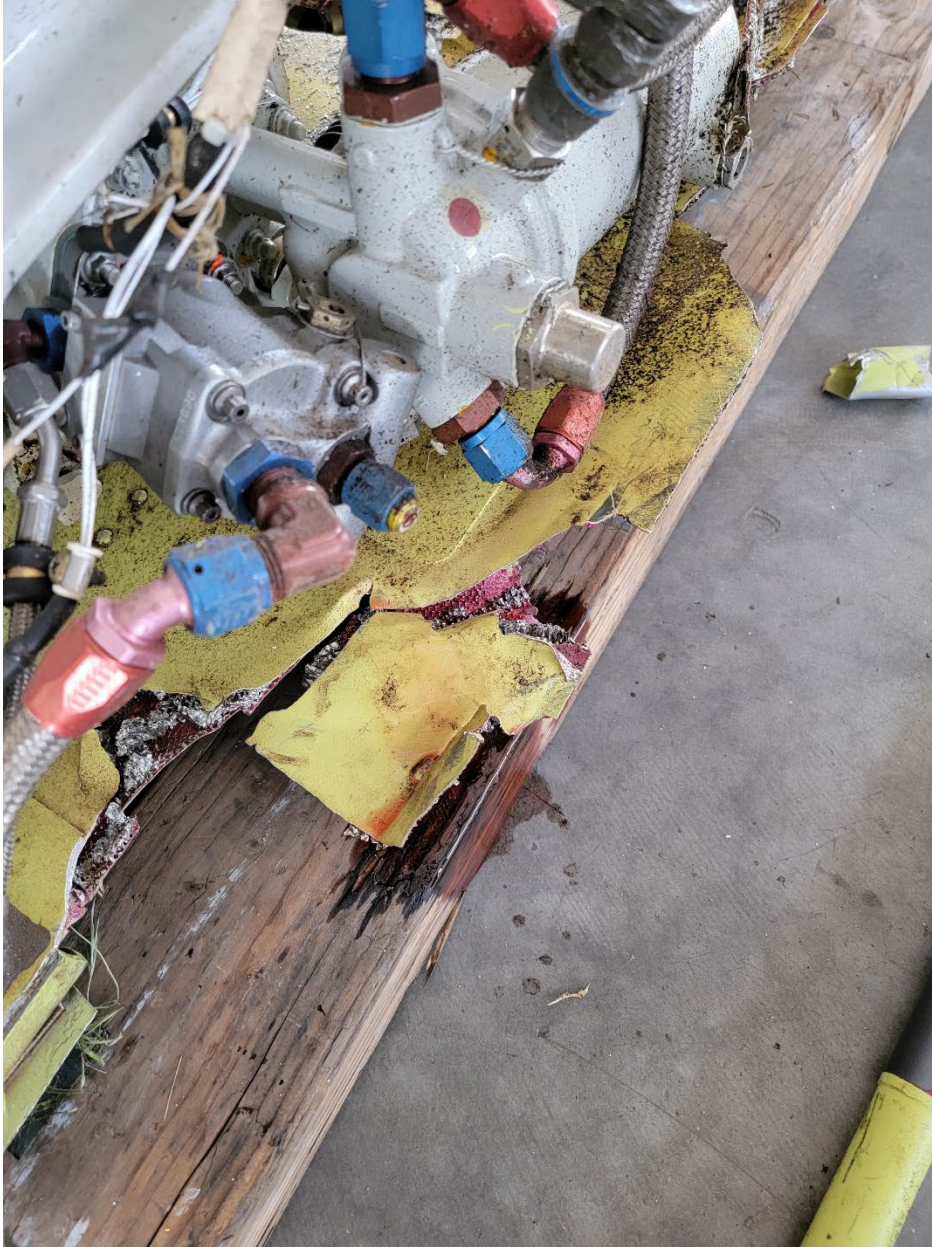
The main rotor head was turned, and the hydraulic pump pushed fluid out from a broken fitting. The fitting was damaged from impact. Hydraulic pressure and return impending filter bypass buttons were not extended. Hydraulic reservoir still had fluid and the screen was clean.

Figure 19 Hydraulic pump, fluid in pictures was from turning the main rotor head.

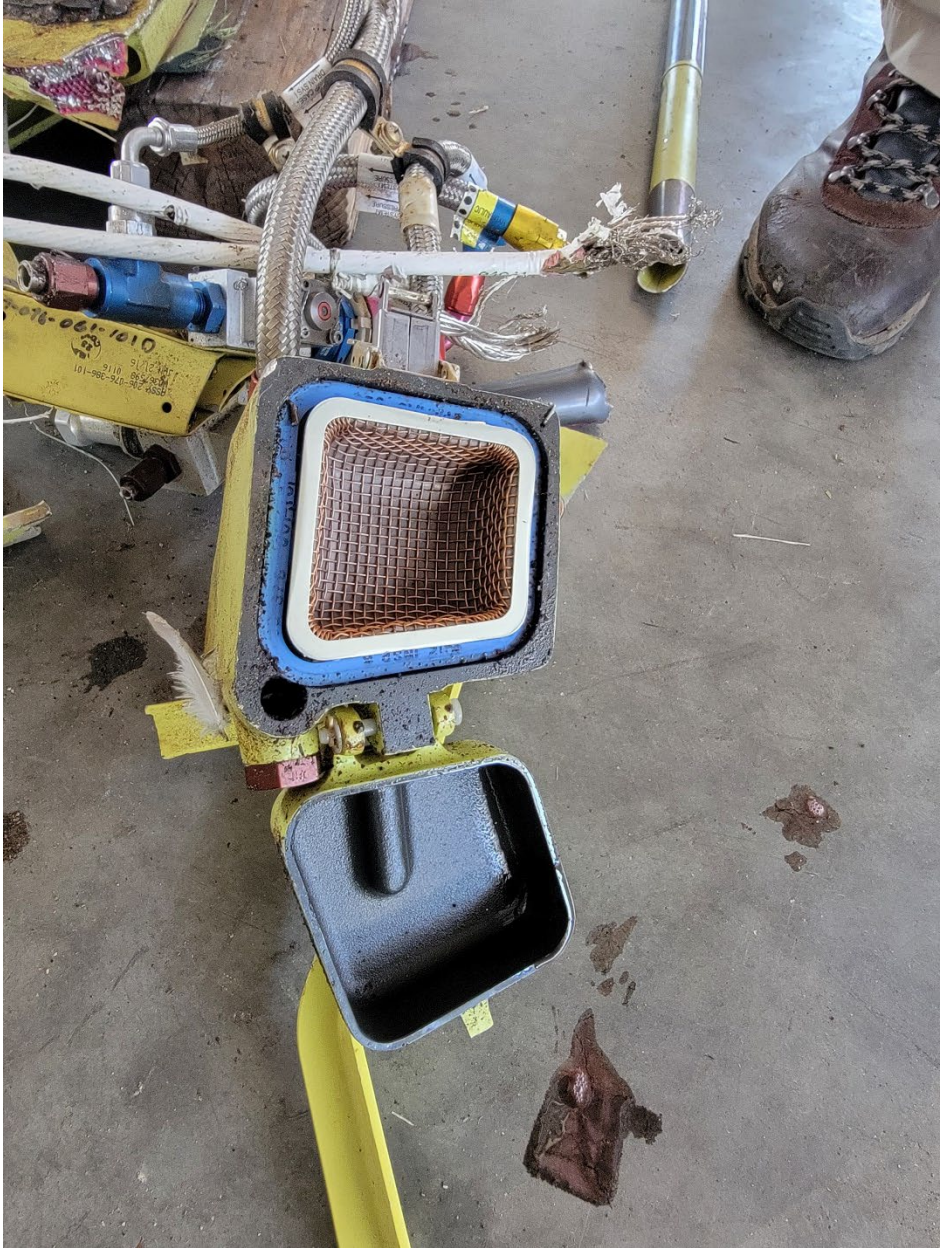
Figure 20 Hydraulic fluid reservoir.

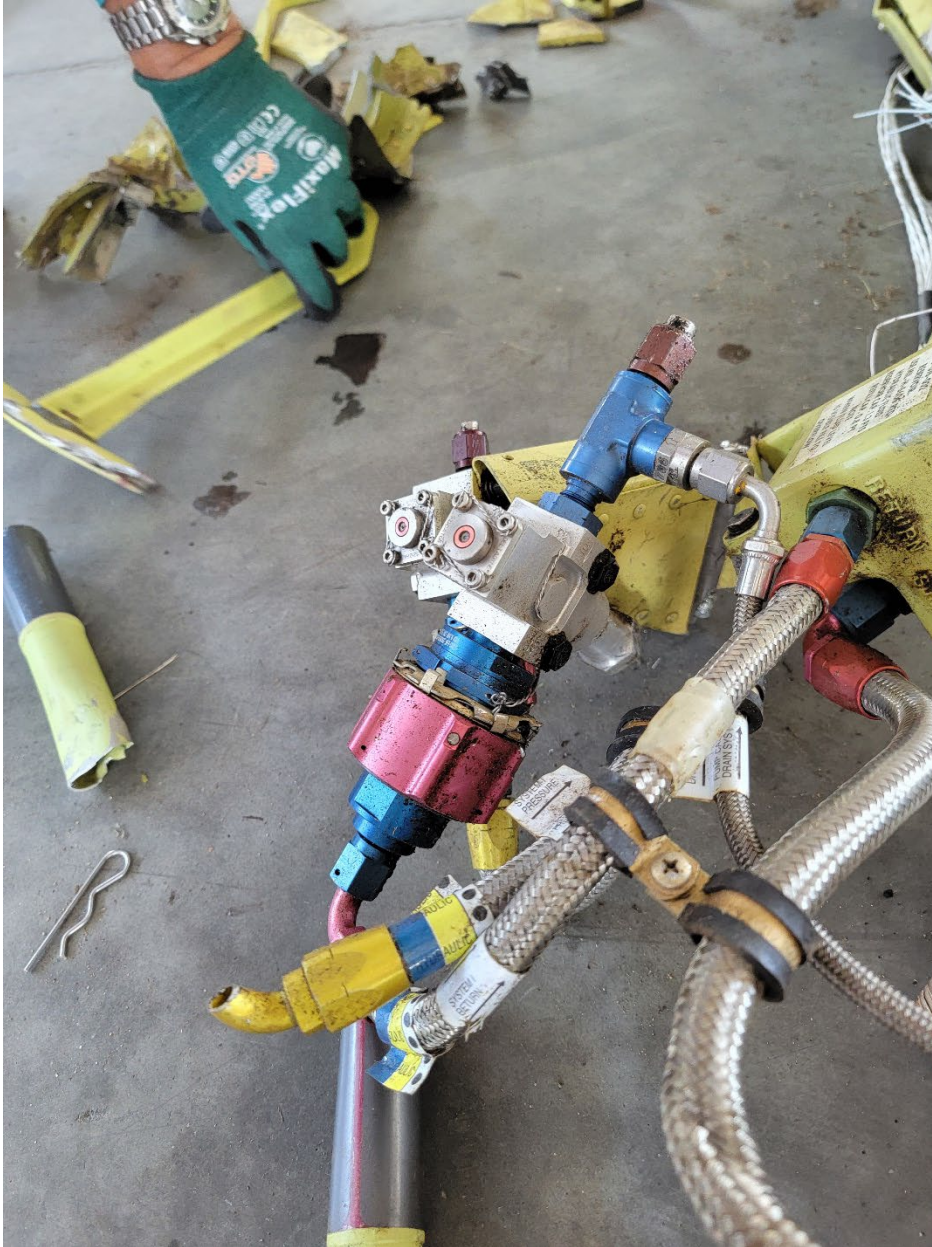
Figure 21 Hydraulic pressure and return impeding filter bypass buttons.

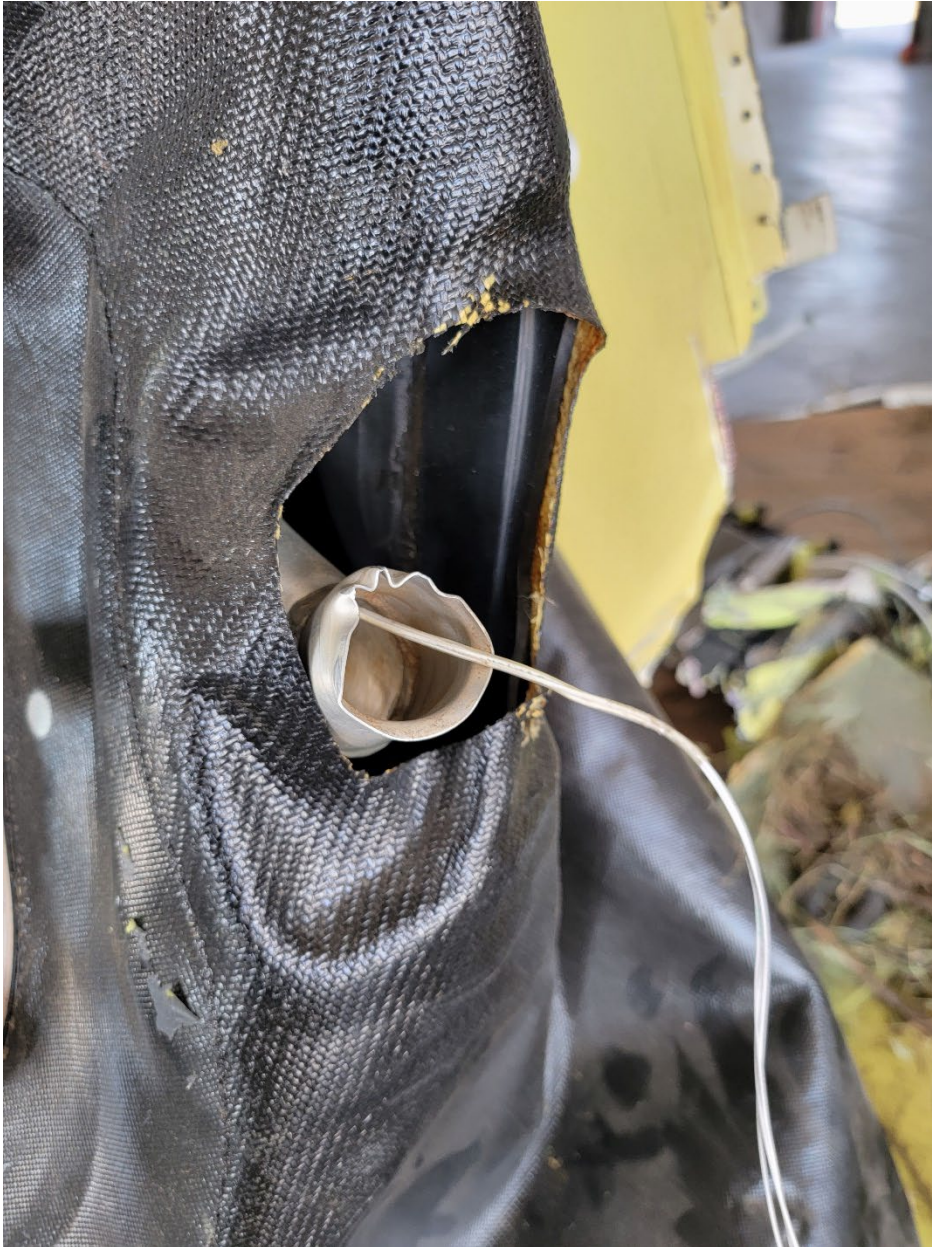
Fuel lines from engine to the main fuel tank were intact. The bottom of the main fuel cell where the forward fuel tank line connects was separated from impact damage. Fuel was present in the main fuel cell. Collective throttle control was intact from the collective stick attachment point to a throttle cable that separation from overload.

Figure 22 Bottom of main fuel cell. Forward fuel tank connection.

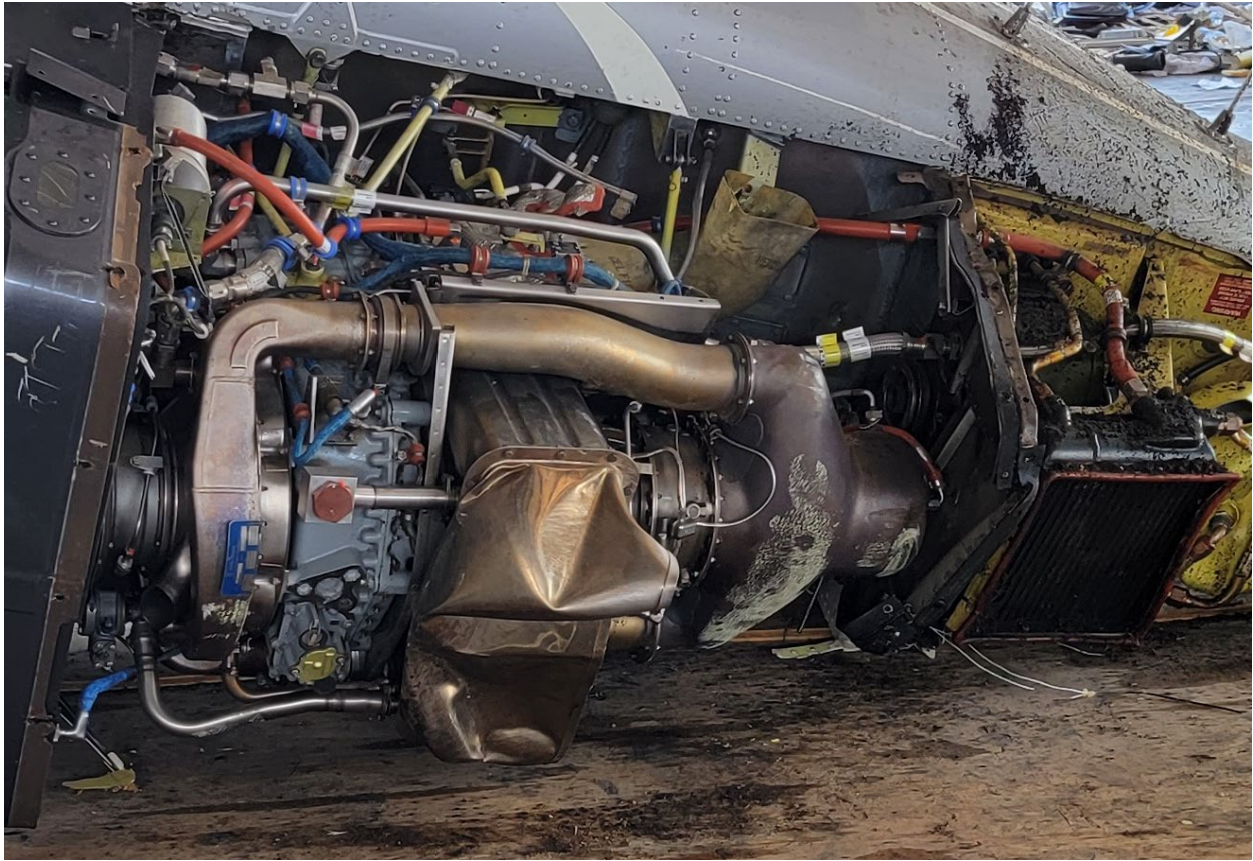
There was impact damage to the outer combustion cannister, and the exhaust duct was crushed down around the exhaust collector. All engine mounts appeared to be intact, with minor deformation.

Figure 23 Top side of engine.

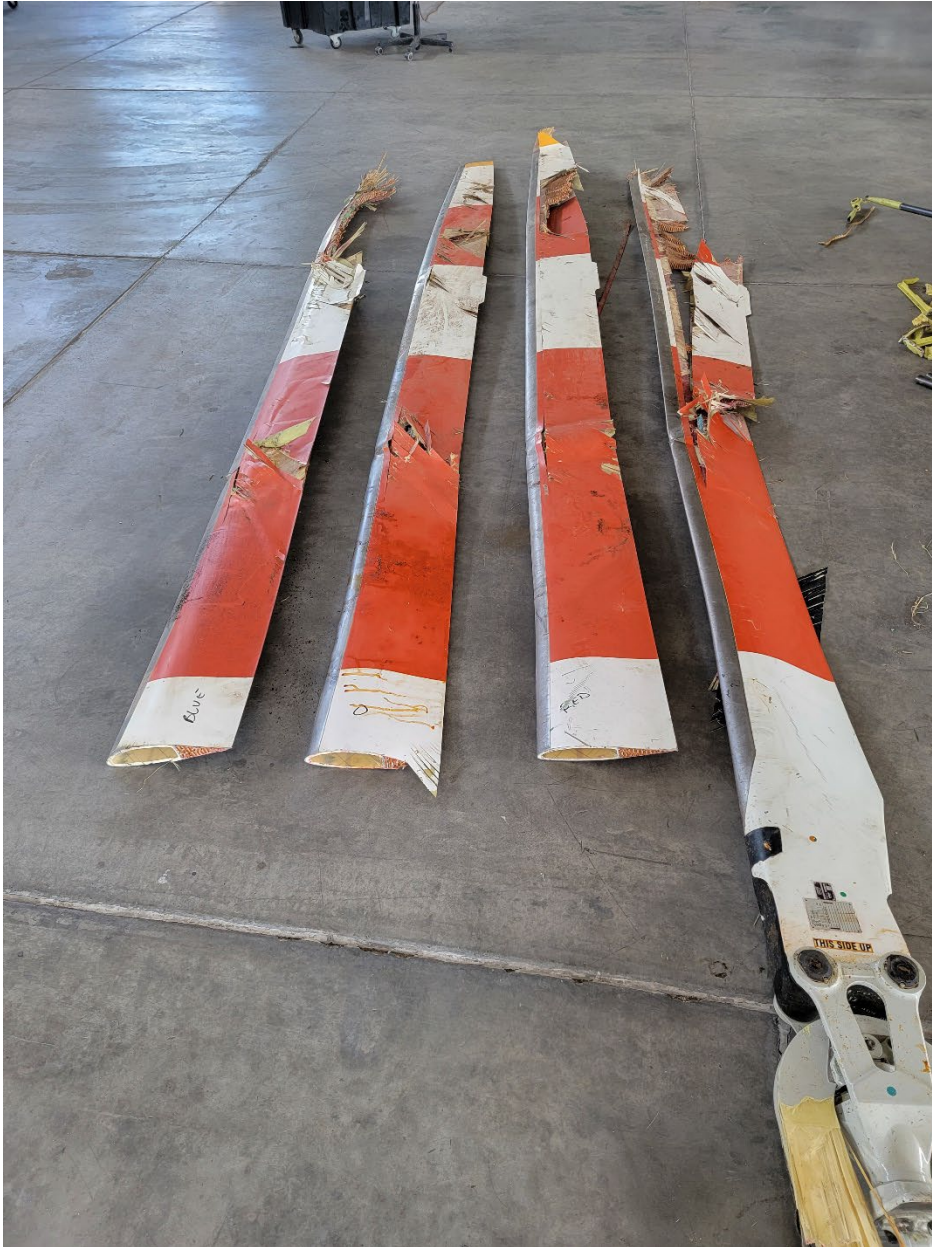
Figure 24 Top side of main rotor blades.

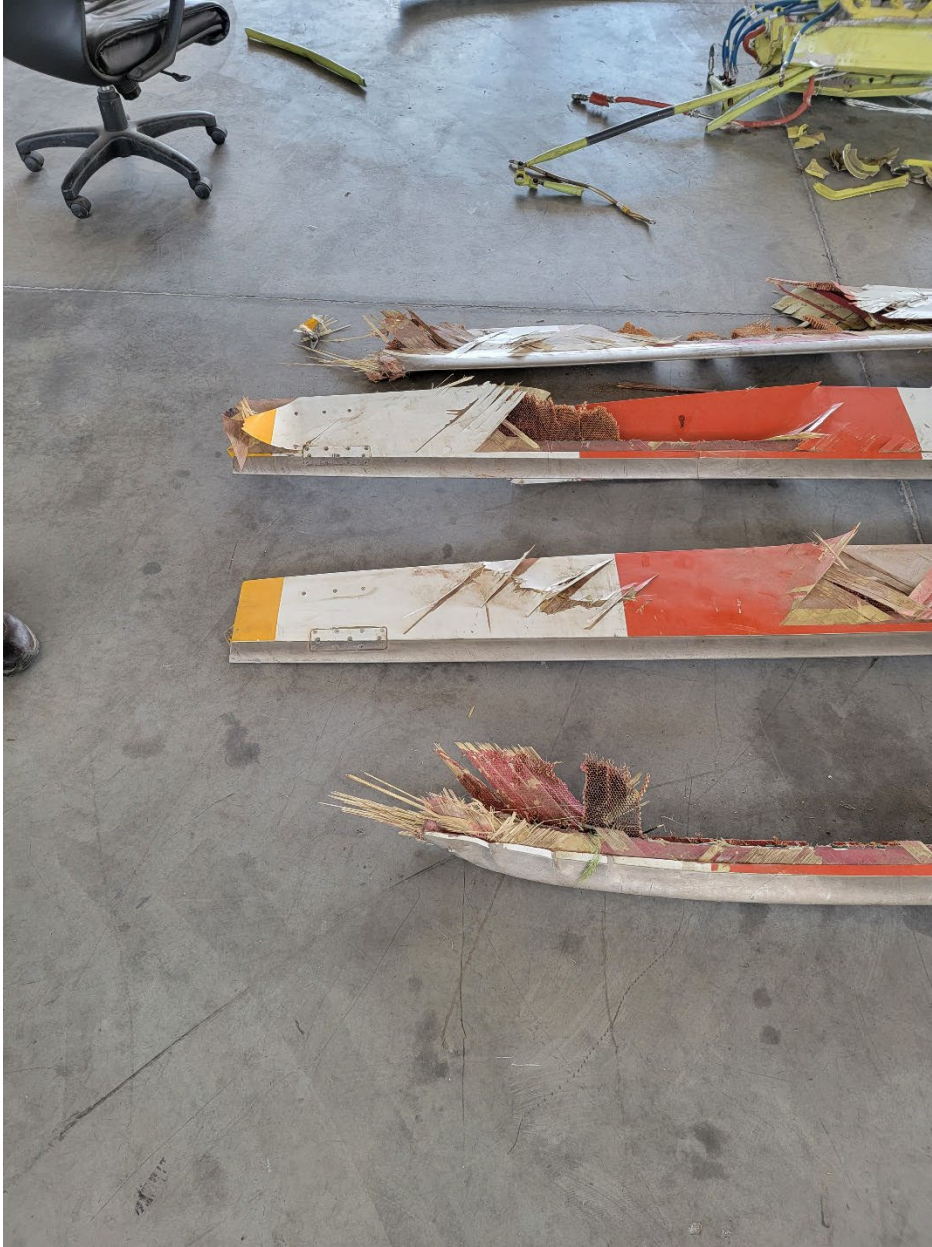
Figure 25 Top side tip damage to main rotor blades.

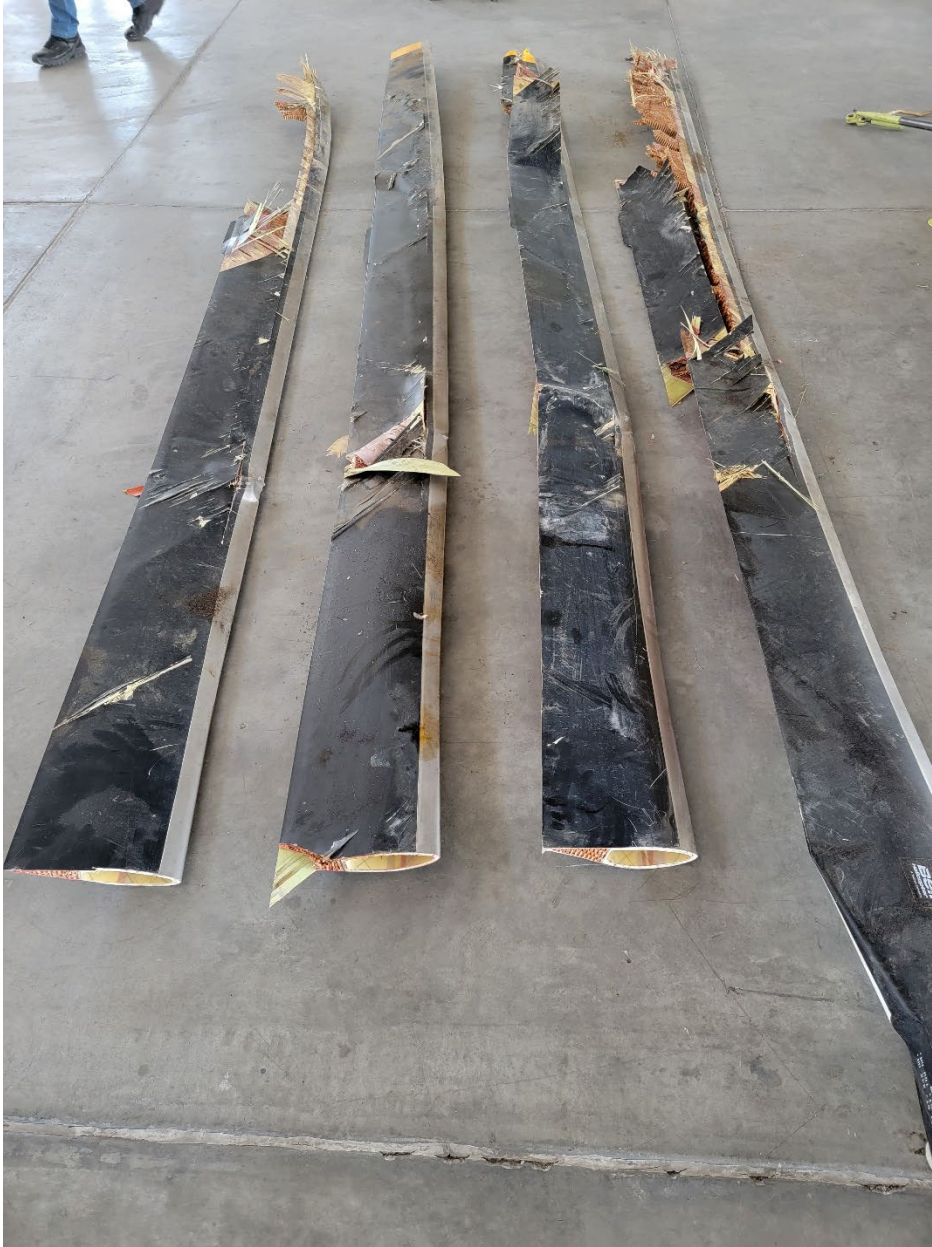
Figure 26 Bottom side of main rotor blades.

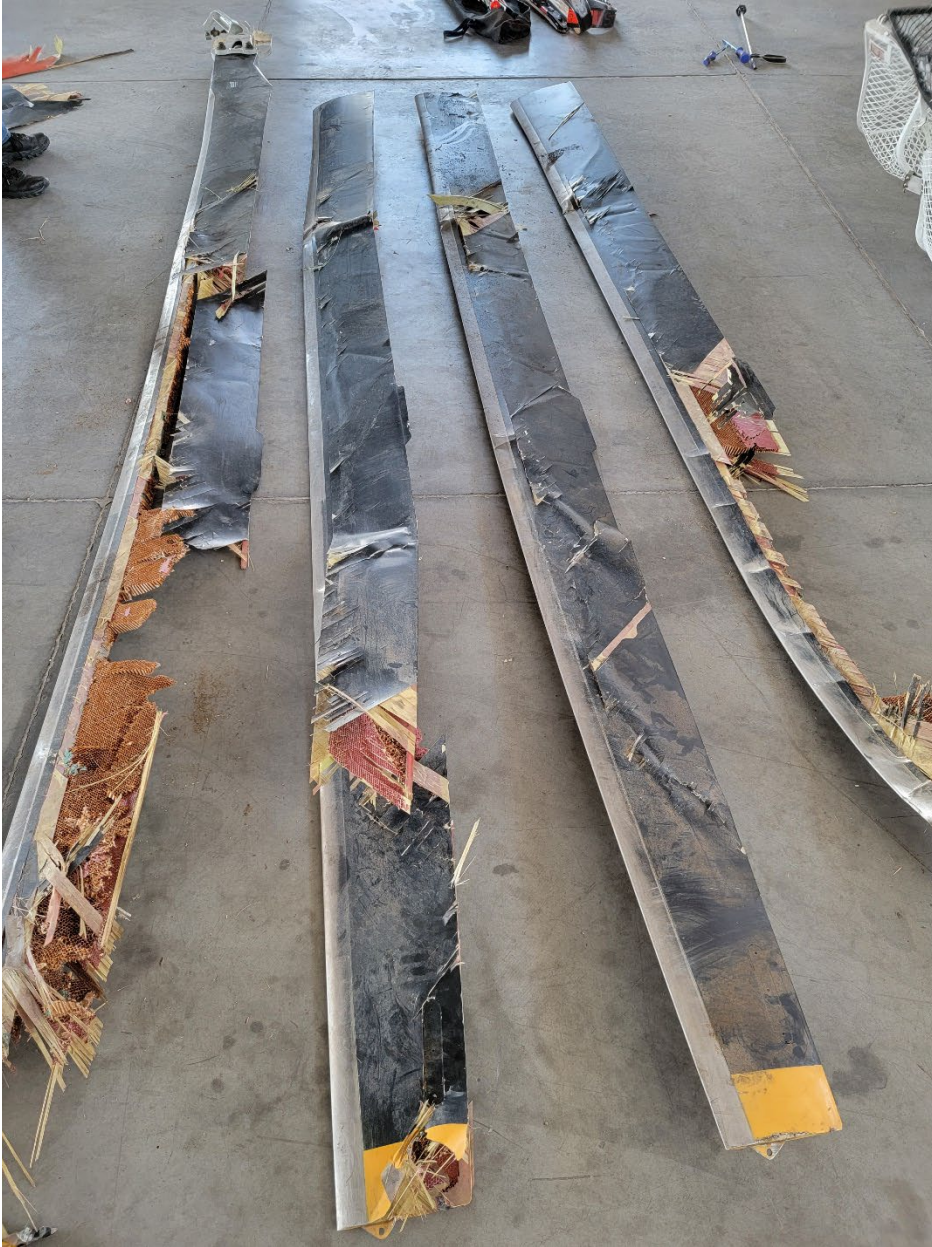
Figure 27 Bottom side from tips of main rotor blades.
