# National Transportation Safety Board

ANC23LA060

## **ENGINE EXAMINATIONS**

Location: Igiugig, Alaska  
Date: August 8, 2023  
Time: 1843 Local  
Airplane: Piper PA12S N2262G

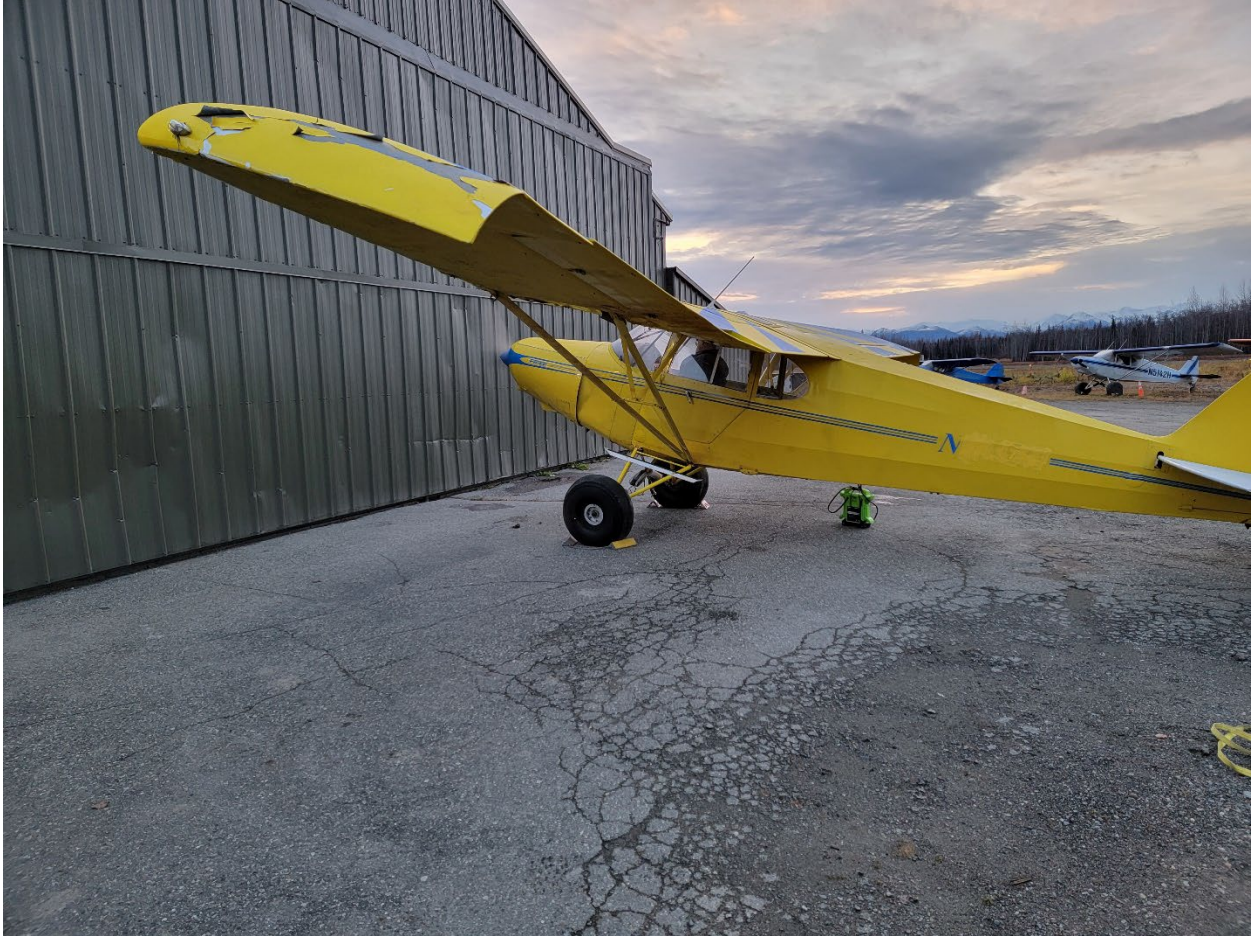
**Figure 1 Accident airplane during test run of the engine.**

Both magnetos were secure. All sparkplugs and sparkplug leads were secure. After adding fuel to the left wing fuel tank the engine started normally. The engine idled smoothly at 600 rpm. After the engine was warmed up, it accelerated normally to a static rpm of 2250 rpm. The engine had good oil pressure. Carburetor heat functioned normally. The engine performed normally with no abnormalities observed.

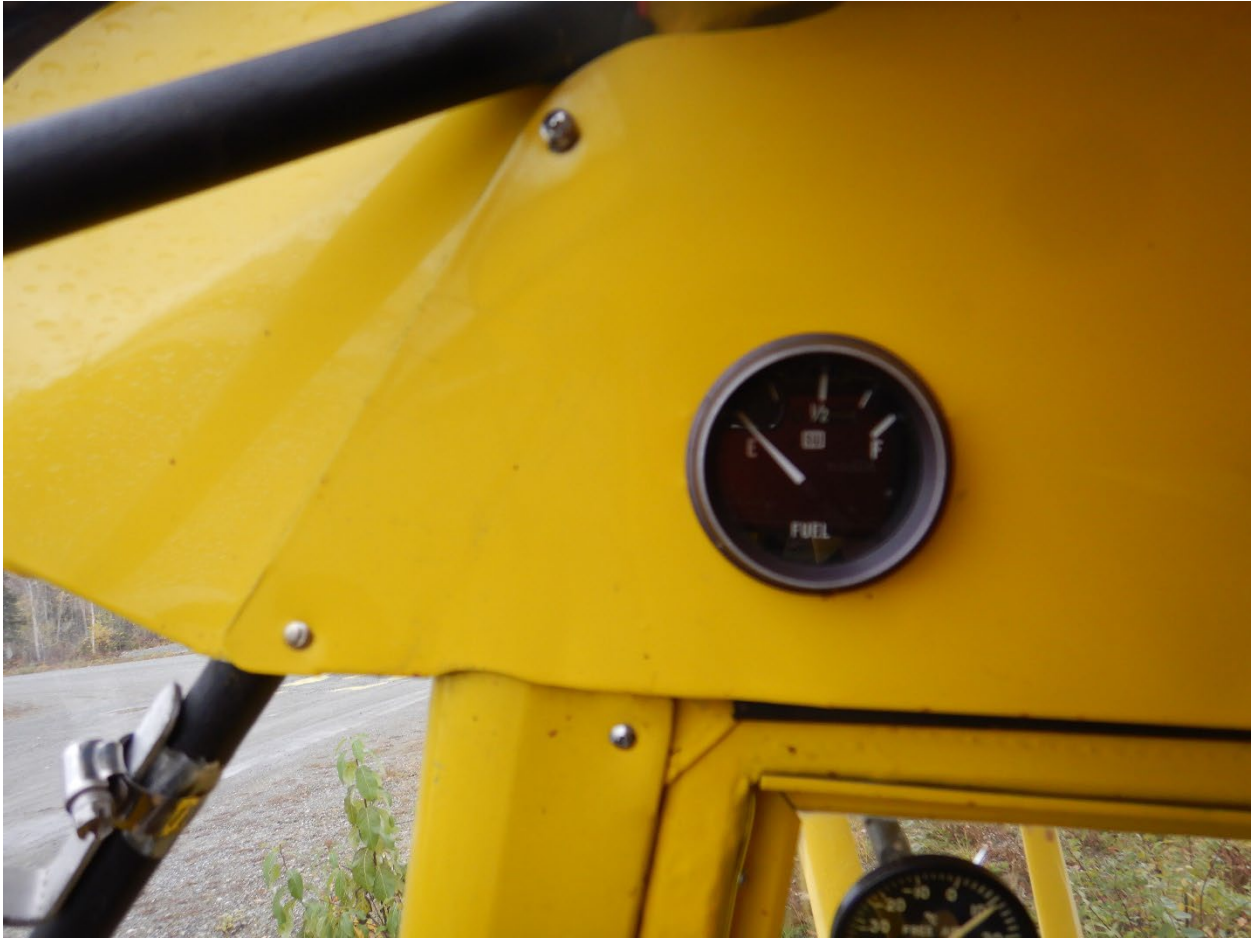
The fuel gauge for the right wing fuel tank indicated empty and no fuel was observed inside the tank (*figure 2*). The fuel gauge for the left wing fuel tank indicated the fuel tank was half full of fuel but no fuel was observed inside the tank (*figure 3*). Using a flashlight and a wooden stick no fuel was observed in either fuel tank. Three gallons of fuel was added to the left fuel tank. The fuel selector position lever in the cockpit was observed just outside the detent of the “both” fuel tank position (*figure 4*).

**Figure 2. Right wing fuel tank gauge.**

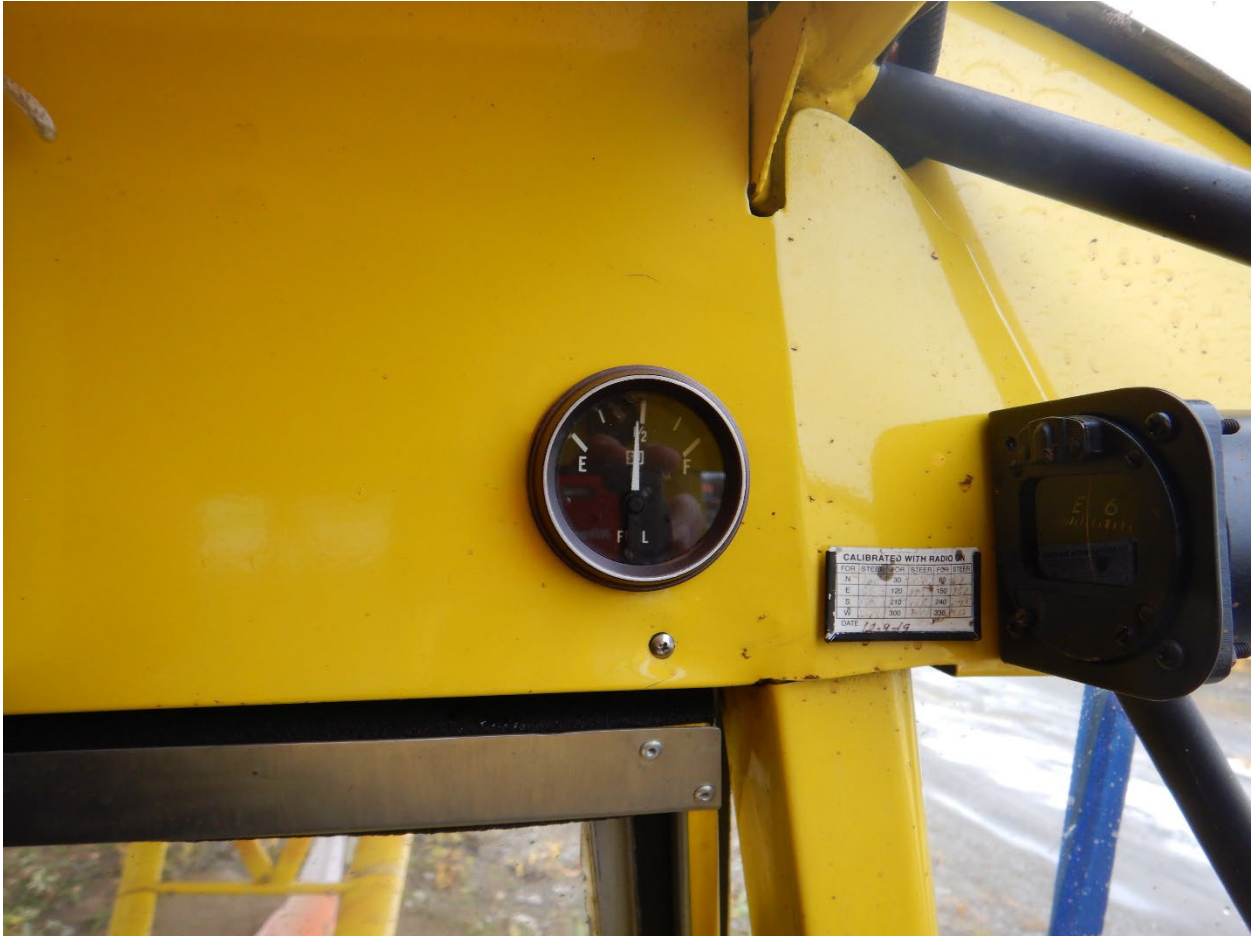
**Figure 3. Left wing fuel tank gauge.**

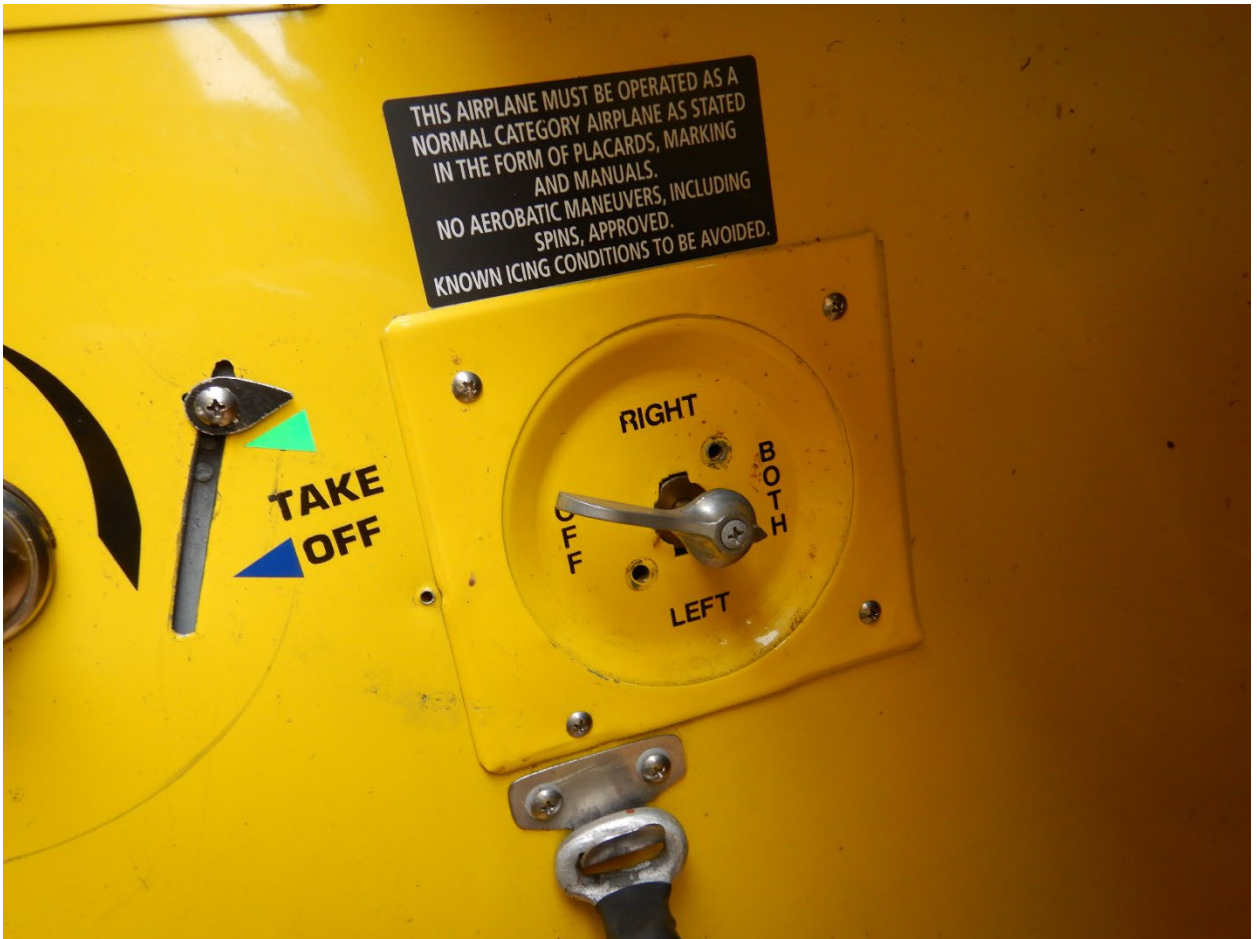
**Figure 4. Fuel tank selector inside the cockpit.**
