ANC23LA060

**INVESTIGATION PHOTOGRAPHS**

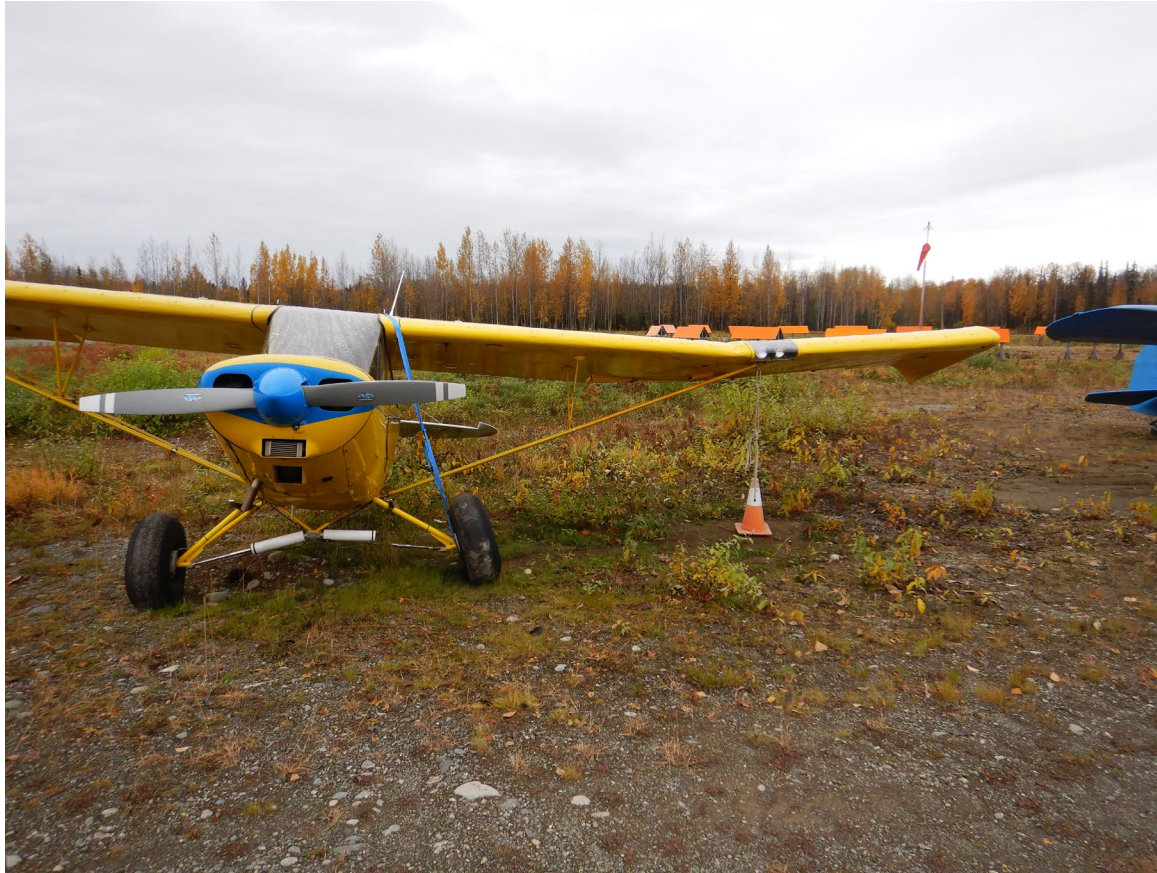
**Photograph 1 - Damage to the left wing of the accident airplane at the recovery site.**

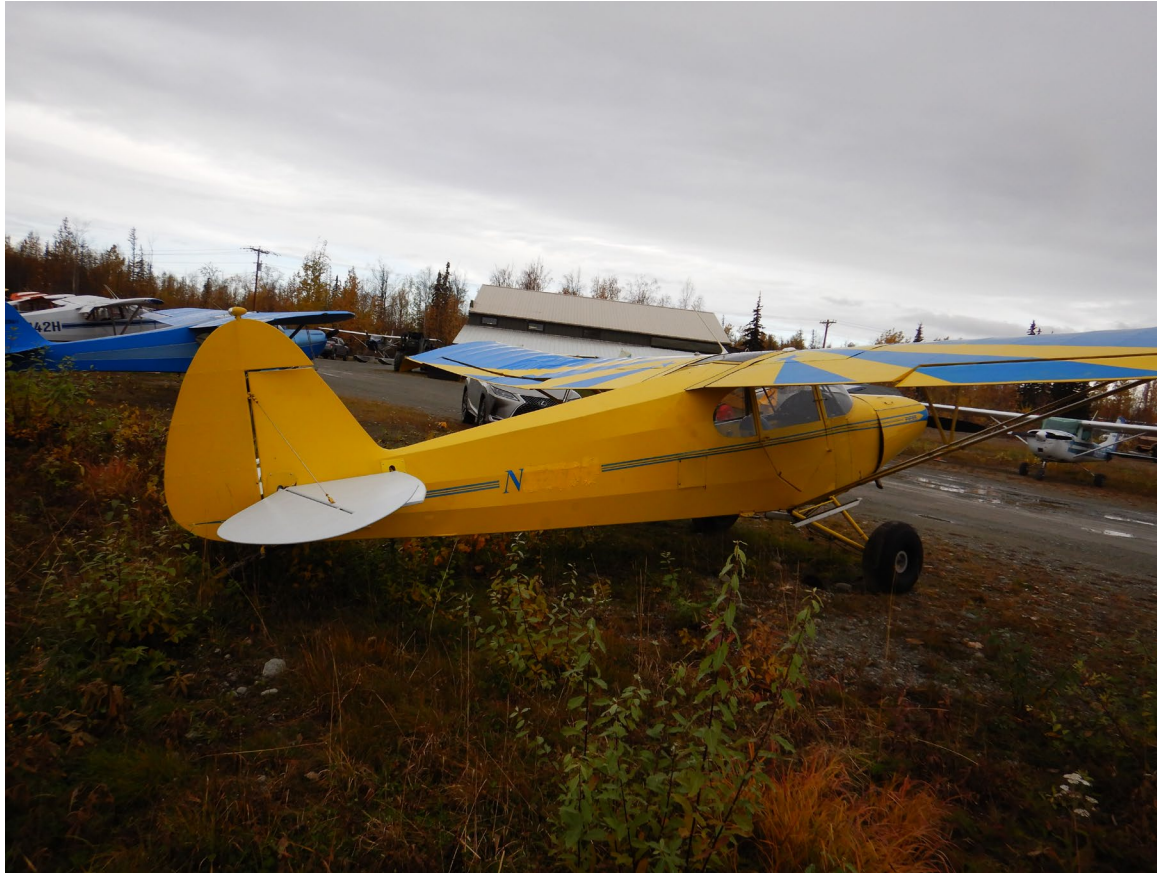
**Photograph 2 - Right side of accident airplane at recovery site.**

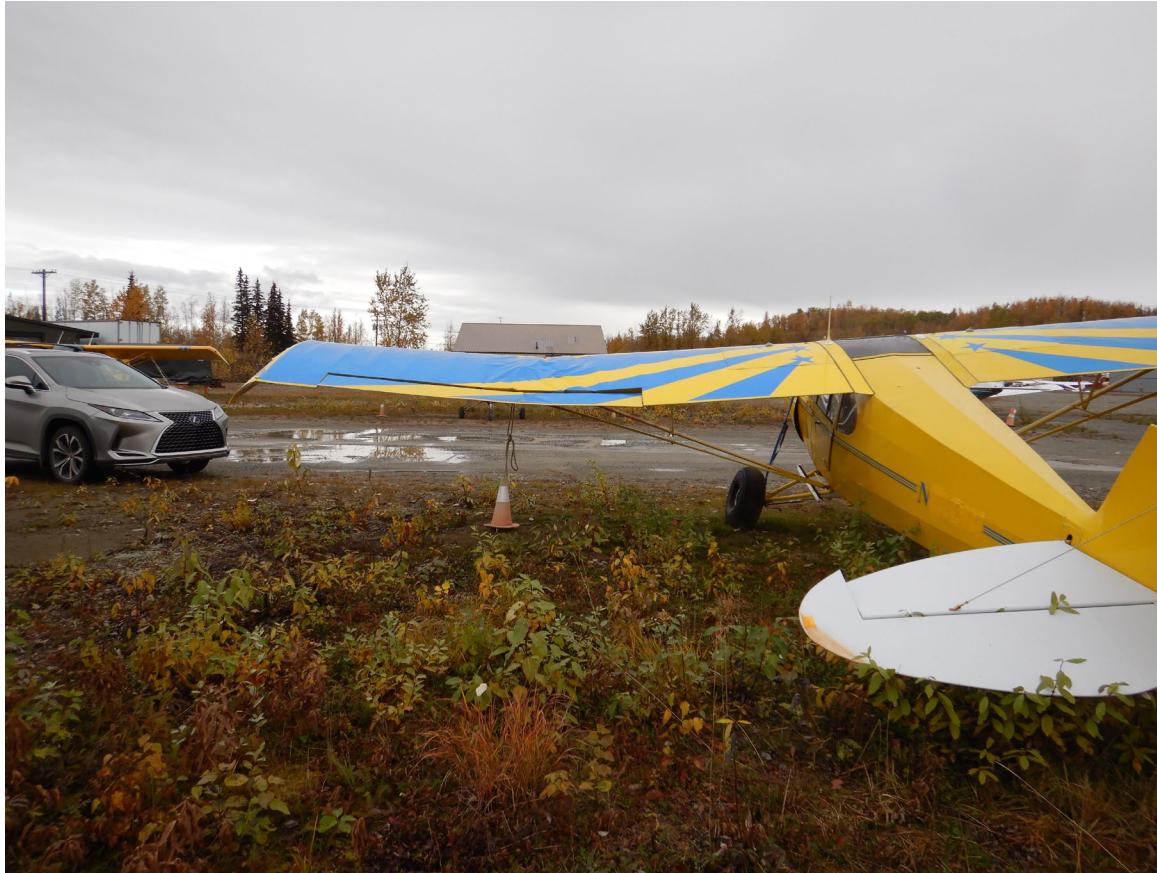
**Photograph 3 - Damage to the left wing of accident airplane at recovery site.**
