ANC23LA067

INVESTIGATION PHOTOGRAPHS

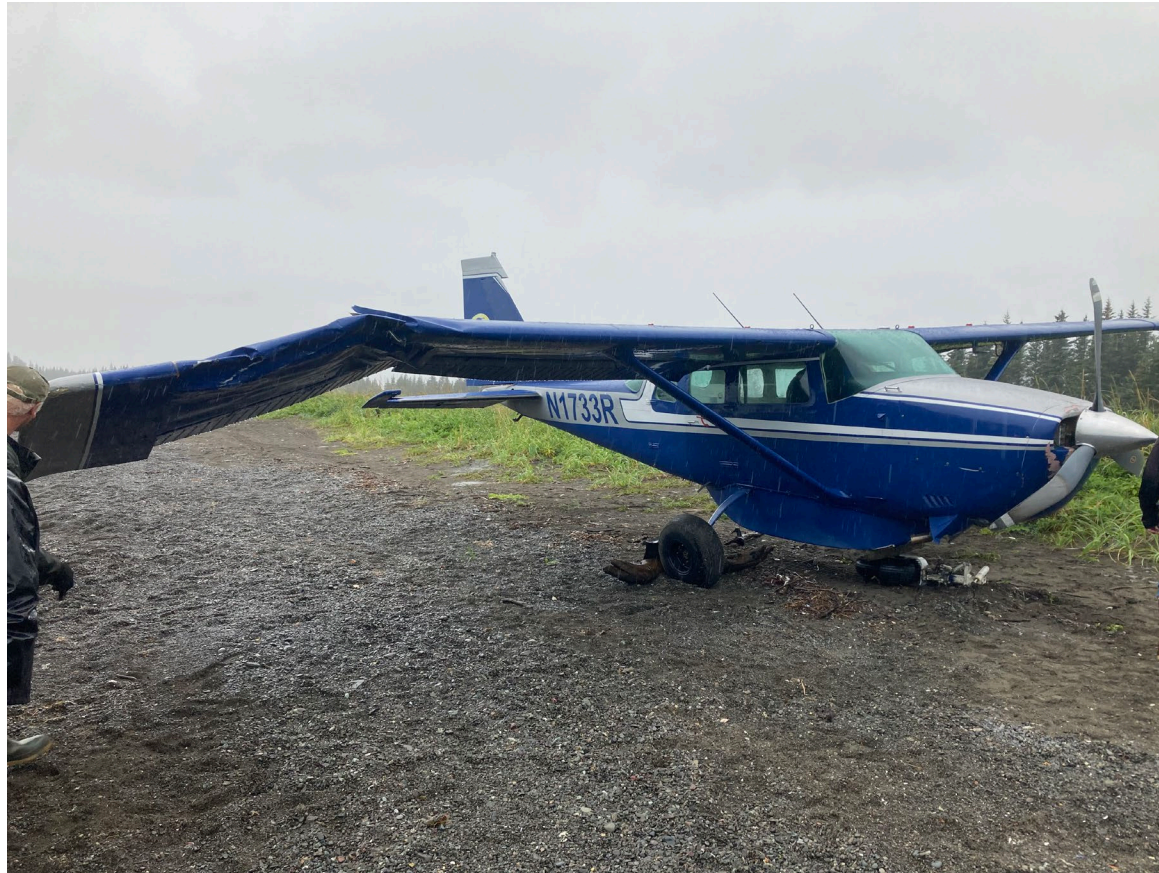
Photograph 1 - View of fuselage and right wing after recovery (Courtesy of Operator)

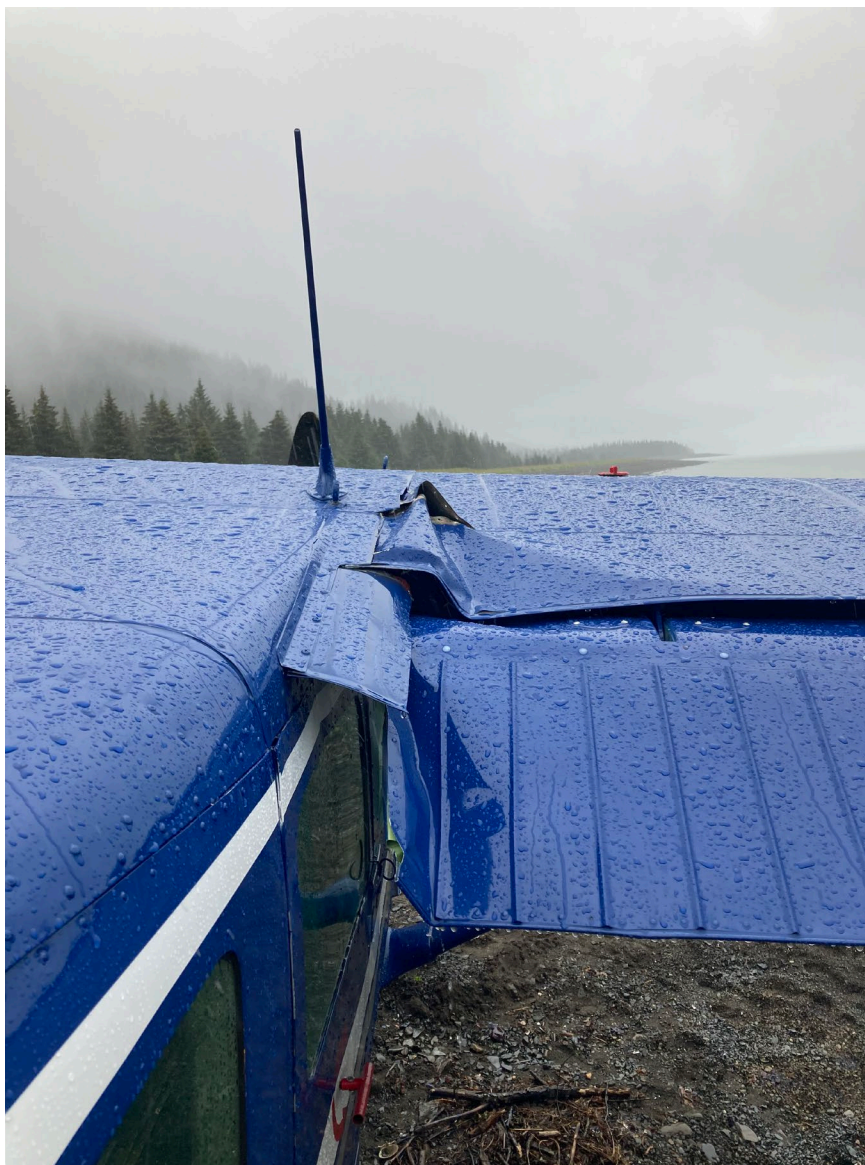
Photograph 2 - View of right side wing root (Courtesy of Operator)

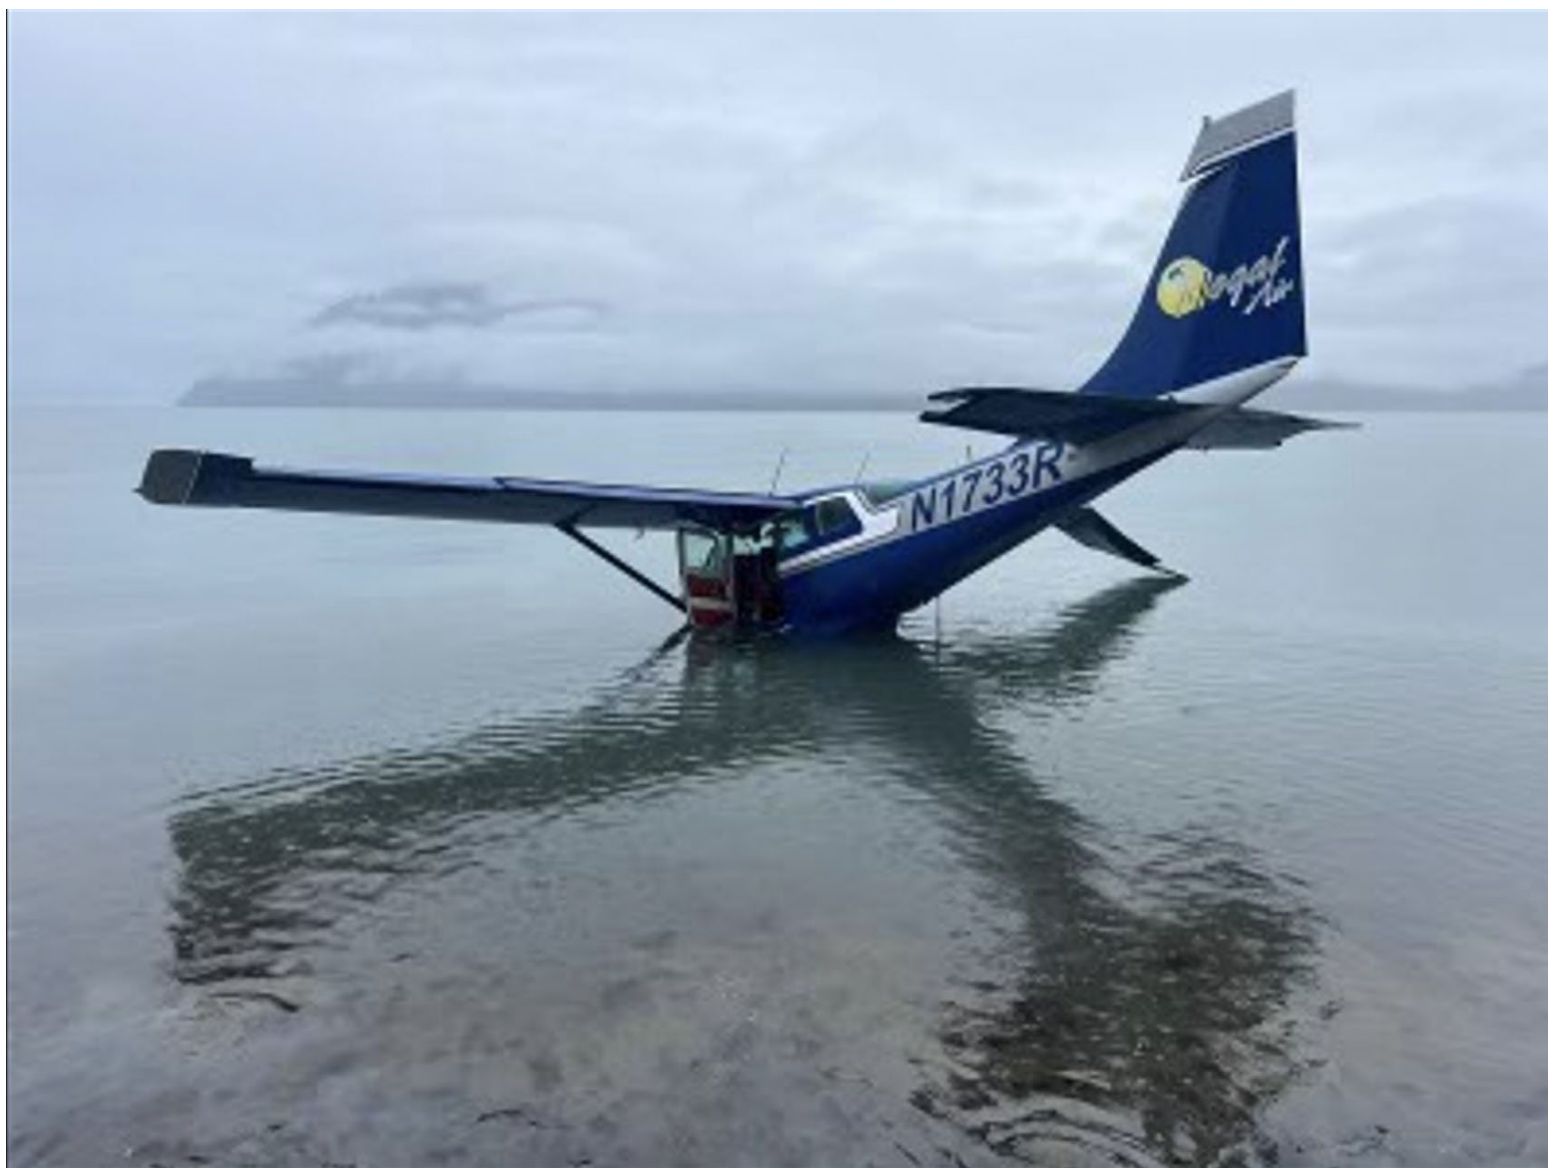
Photograph 3 - View of the airplane in the water where it came to rest. (Courtesy of Operator)
