FIELD NOTES

SUBJECT Bombardier Field Notes - Accident Site Visit - Challenger 605 N605TR (MSN 5715) - Impact with Terrain on Approach to Runway 11 at Truckee Tahoe Airport (KTRK) on July 26th, 2021

FROM Bombardier Air Safety Investigation Office (ASIO)

ASIO CASE REF. NO. CL600-2B16 (604 Variant).5715.26-7-21

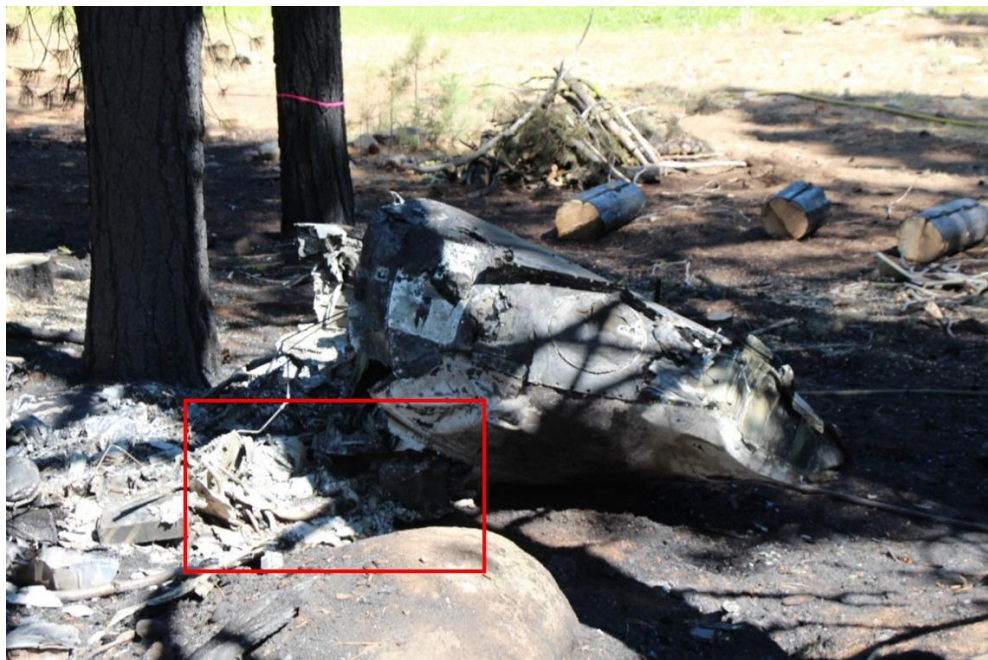
Figure 3: Approximate Location of FDR and CVR in Wreckage

The FDR and CVR were found in the vicinity of the tail section, approximately in the area outlined in red in Figure 3. The FDR and CVR are normally installed in the tail section of the aircraft (Figure 4).

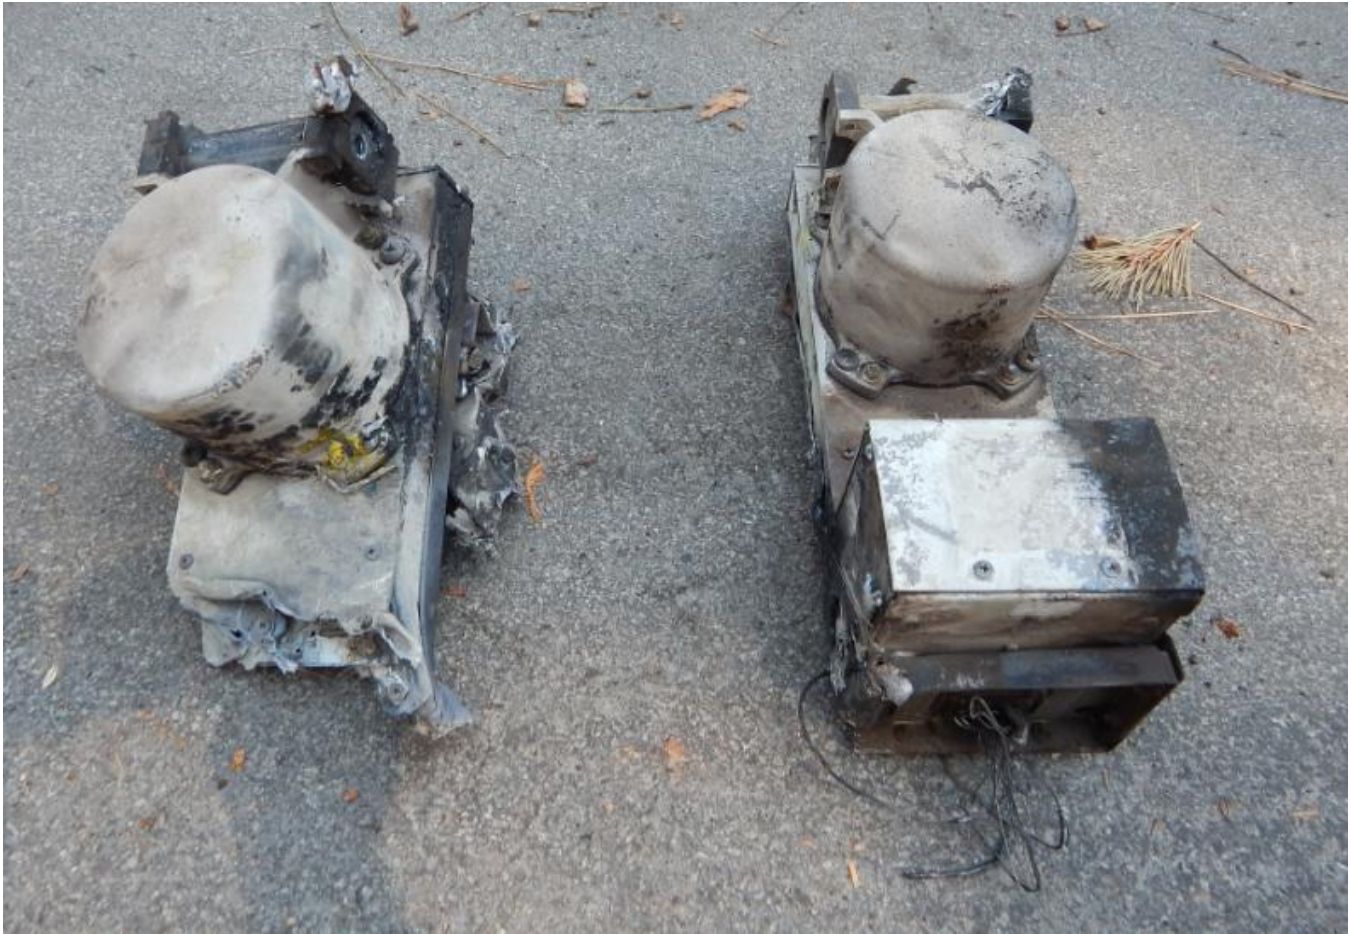
Figure 5: CVR and FDR Recovered from Wreckage

Both FDR and CVR were damaged and had been subjected to post-impact fire. Both units had been discolored (no longer orange). The chassis of one unit was broken in half. Both Crash Survivable Memory Units (CSMU) appeared to be intact and not compromised. Due to the damage, it was not immediately apparent which unit was the FDR and which was the CVR. The units recovered from the wreckage are shown in Figure 5.

At Bombardier's recommendation, both Underwater Locating Devices (ULD) were removed from the units prior to shipping to the NTSB recorder laboratory in Washington, D.C. Each ULD contains a battery which might be a hazard for shipping.

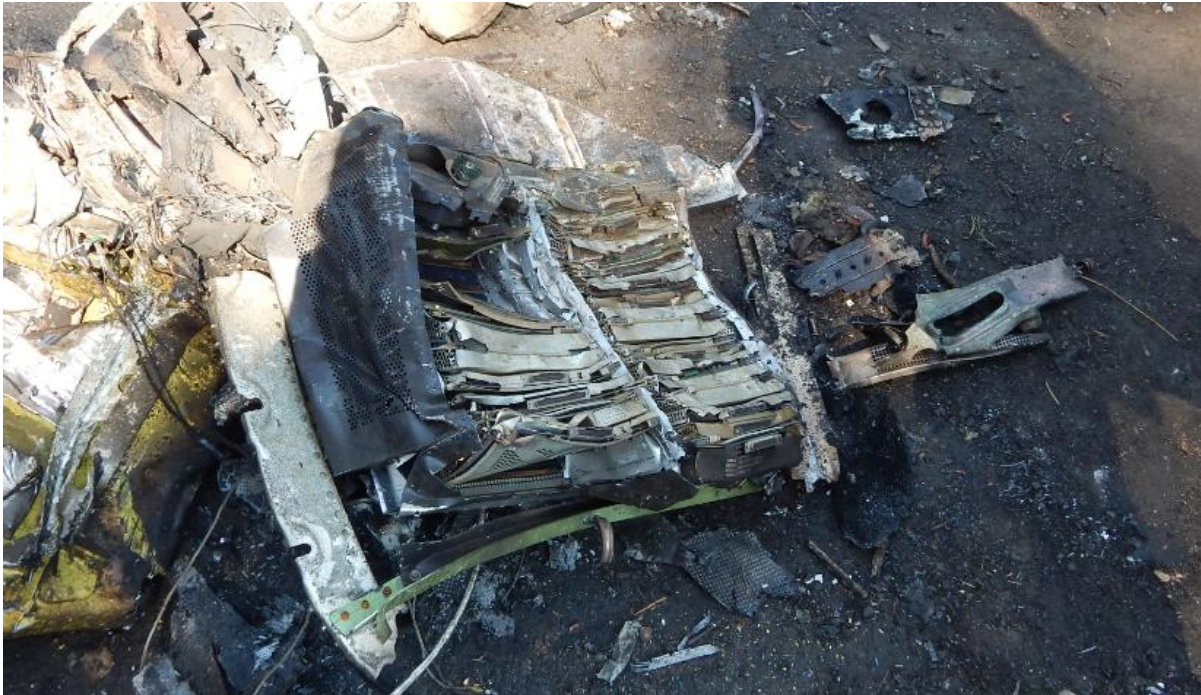
Figure 6: IAPS

The IAPS, P/N 822-0781-001, was found on the road at the top of the wreckage site (Figure 6). The IAPS contains a card which holds the Maintenance Diagnostic Computer (MDC), item 5 in Figure 7. The MDC retains maintenance fault history and a log of flight deck effects messages, among other things, which may be useful for the investigation. While not intended to be crash-protected, the data may still be recoverable. The IAPS was shipped to the NTSB recorder laboratory in Washington D.C. Bombardier recommends that the IAPS be sent to Rockwell Collins for examination and attempted retrieval of data from the MDC.

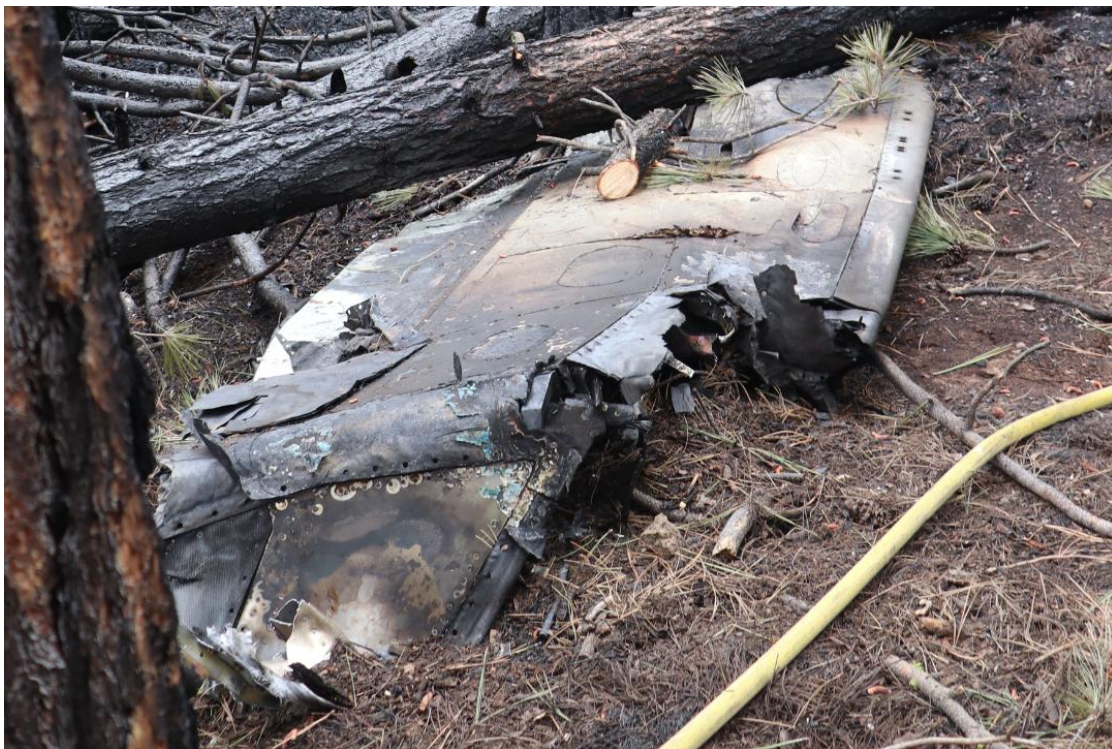
Figure 8: Left Wing, Winglet, Aileron

1. Left outboard wing - 12-foot section, starting 15 feet outboard (Figure 8)
2. Left winglet (Figure 8)
3. Left outboard flap (Figure 9)
4. Left Aileron (Figure 8)
5. Right wing - 8 feet, from mid outboard flap to aileron (Figure 10)
6. Right winglet (Figure 11)
7. Right inboard flap (Figure 12)
8. Right outboard flap (Figure 13)
9. Right aileron - outboard two feet - still attached to right wing (Figure 14)
10. Left outboard horizontal stabilizer - 3.5 feet (Figure 15)
11. Left outboard elevator - approximately half span (Figure 16)
12. Right horizontal stabilizer (Figure 17)
13. Right elevator - still attached to the right horizontal stabilizer (Figure 17)
14. Vertical stabilizer (Figure 18)
15. Rudder - bottom 18 inches - still attached to vertical stabilizer (Figure 19)

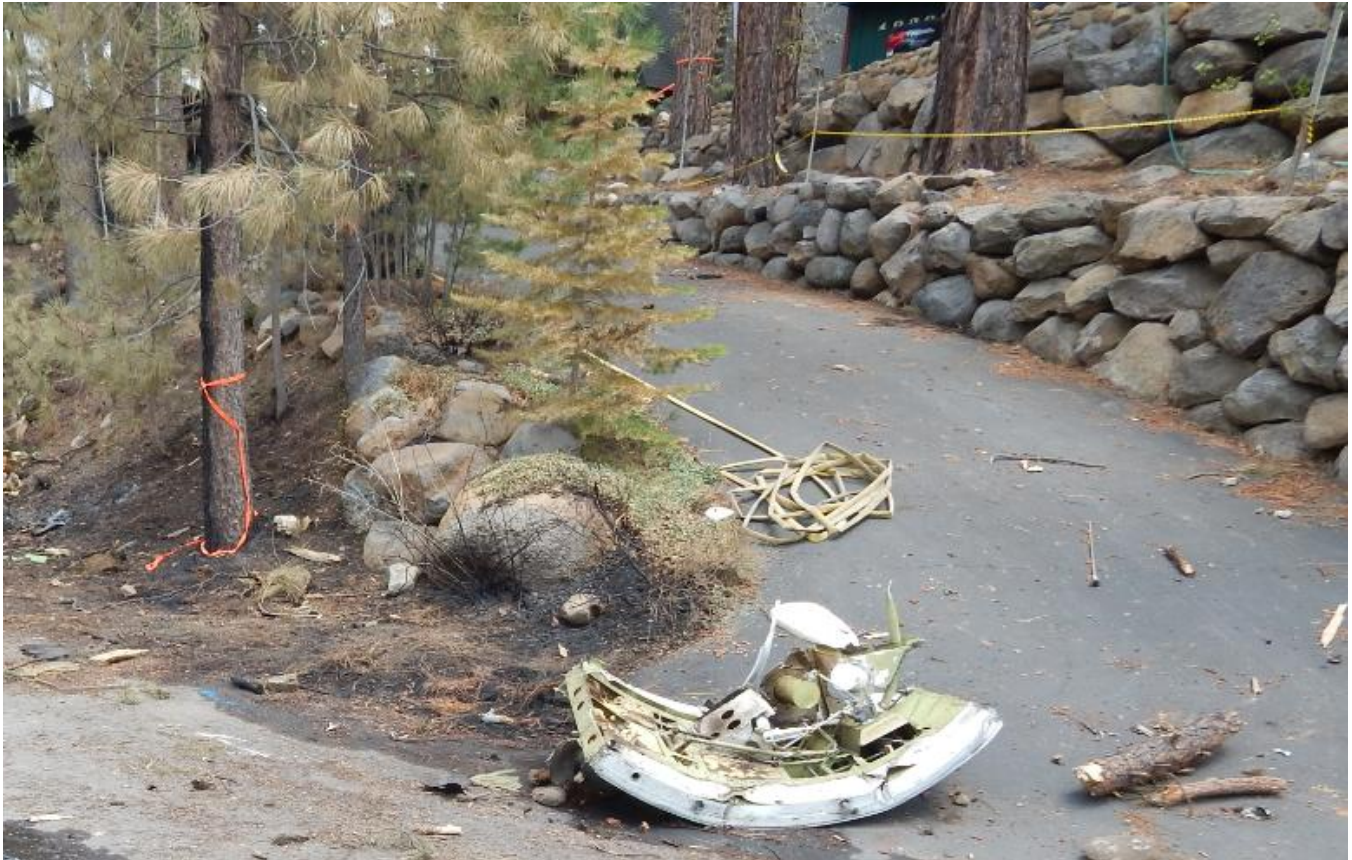
Figure 20: Main Cabin Door

The main cabin door was observed located just above the wreckage site, on Reynold Way, near the driveway for 10309 Reynold Way (Figure 20).

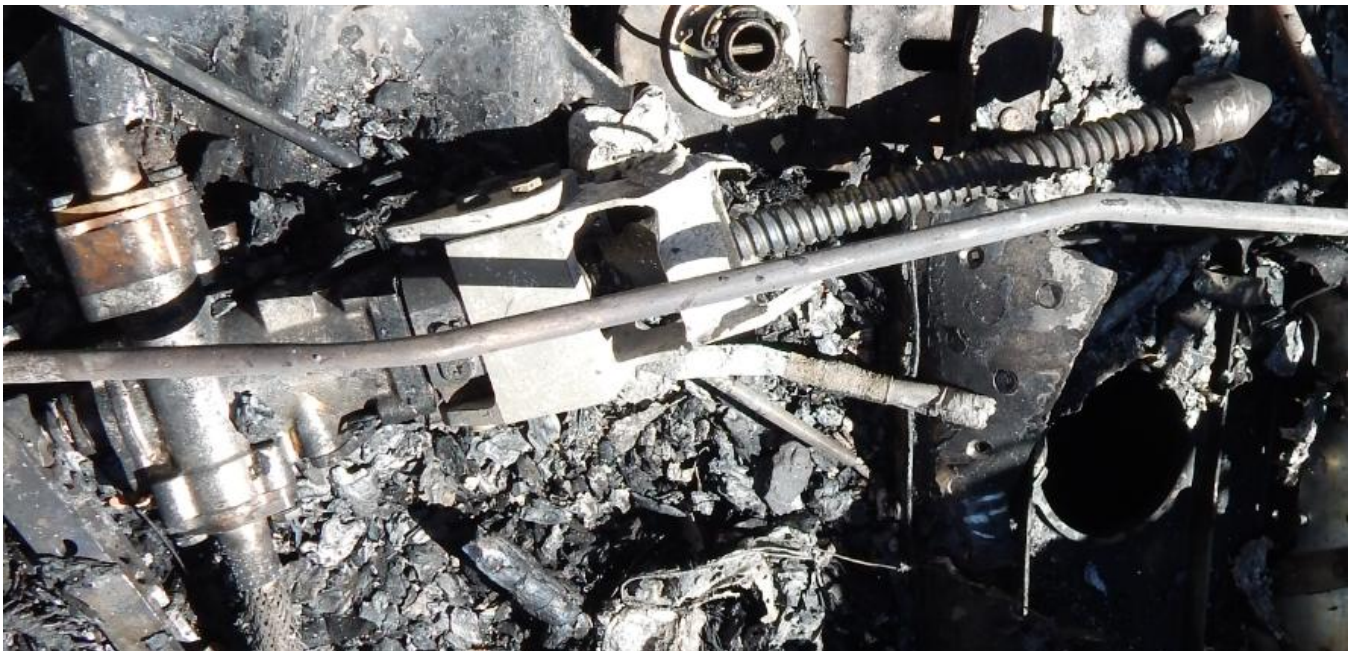
Figure 21: Thrust Reverser Actuator

A thrust reverser actuator assembly was found in the wreckage near the right engine (Figure 21). The thrust reverser actuator was in the stowed position. There are four thrust reverser actuator assemblies on each engine. It was not possible to conclusively determine which side and position the thrust reverser actuator assembly came from.

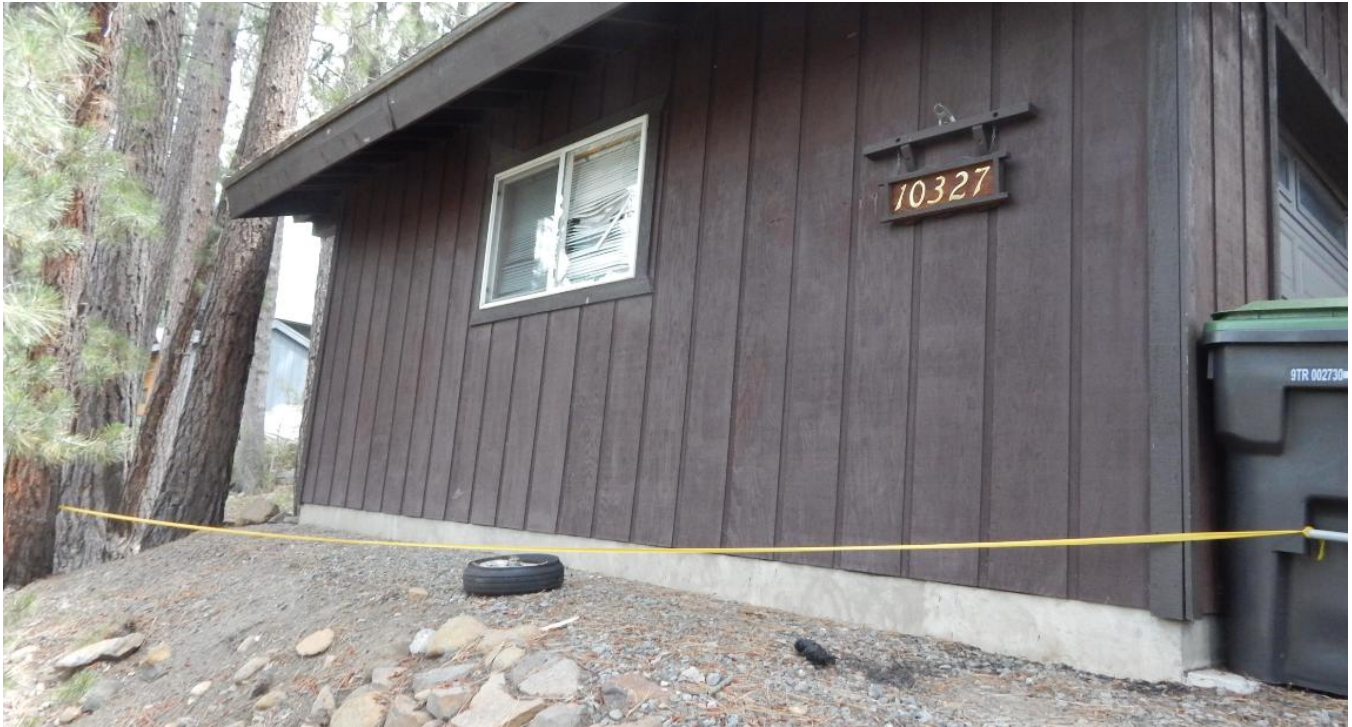
Figure 22: Nose Landing Wheel and Tire Assembly

One nose landing gear wheel and tire assembly was found under a street-facing window at 10327 Reynold Way. The window was broken. It was reported that the wheel and tire assembly had struck the window during the accident sequence.

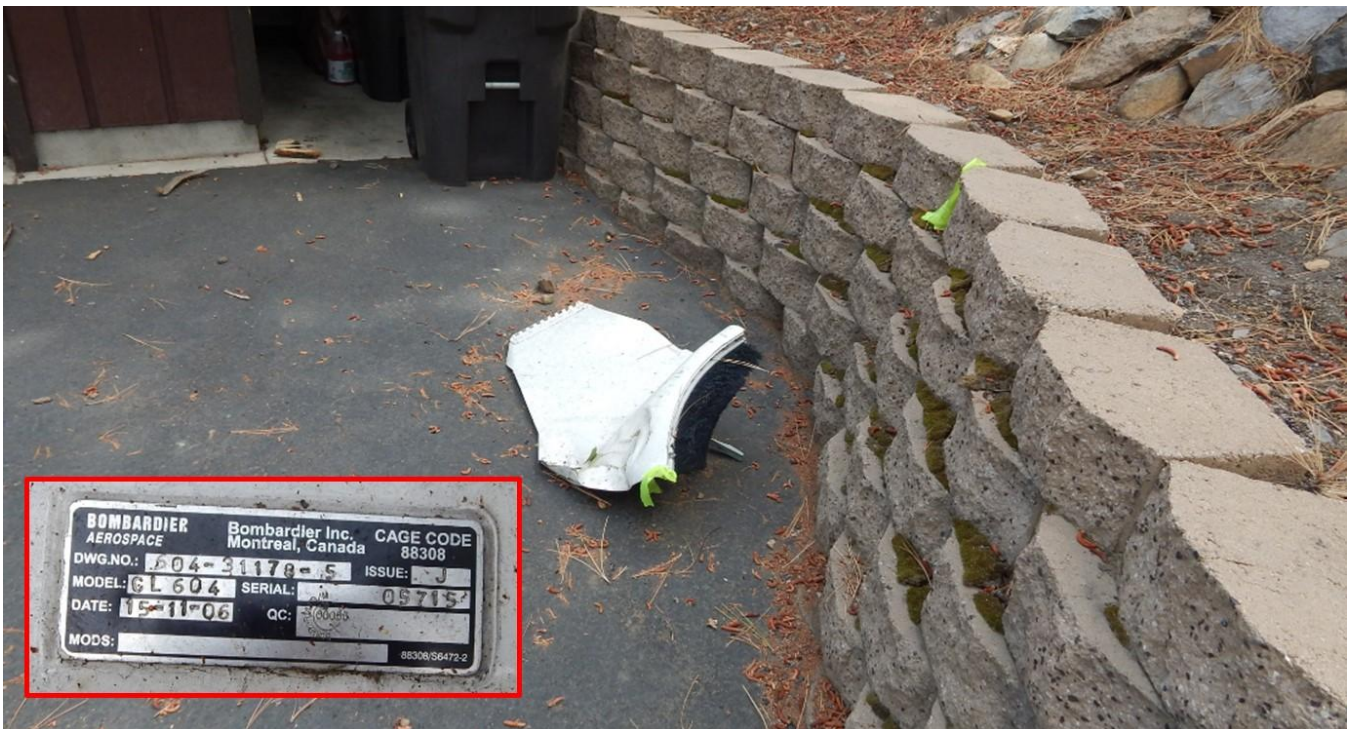
Figure 23: Left Main Landing Gear Door

The left main landing gear door was found at the top of the driveway leading to 10327 Reynold Way. The right main landing gear door was found on Reynold Way, at the bottom of the driveway leading from 10327 Reynold Way.

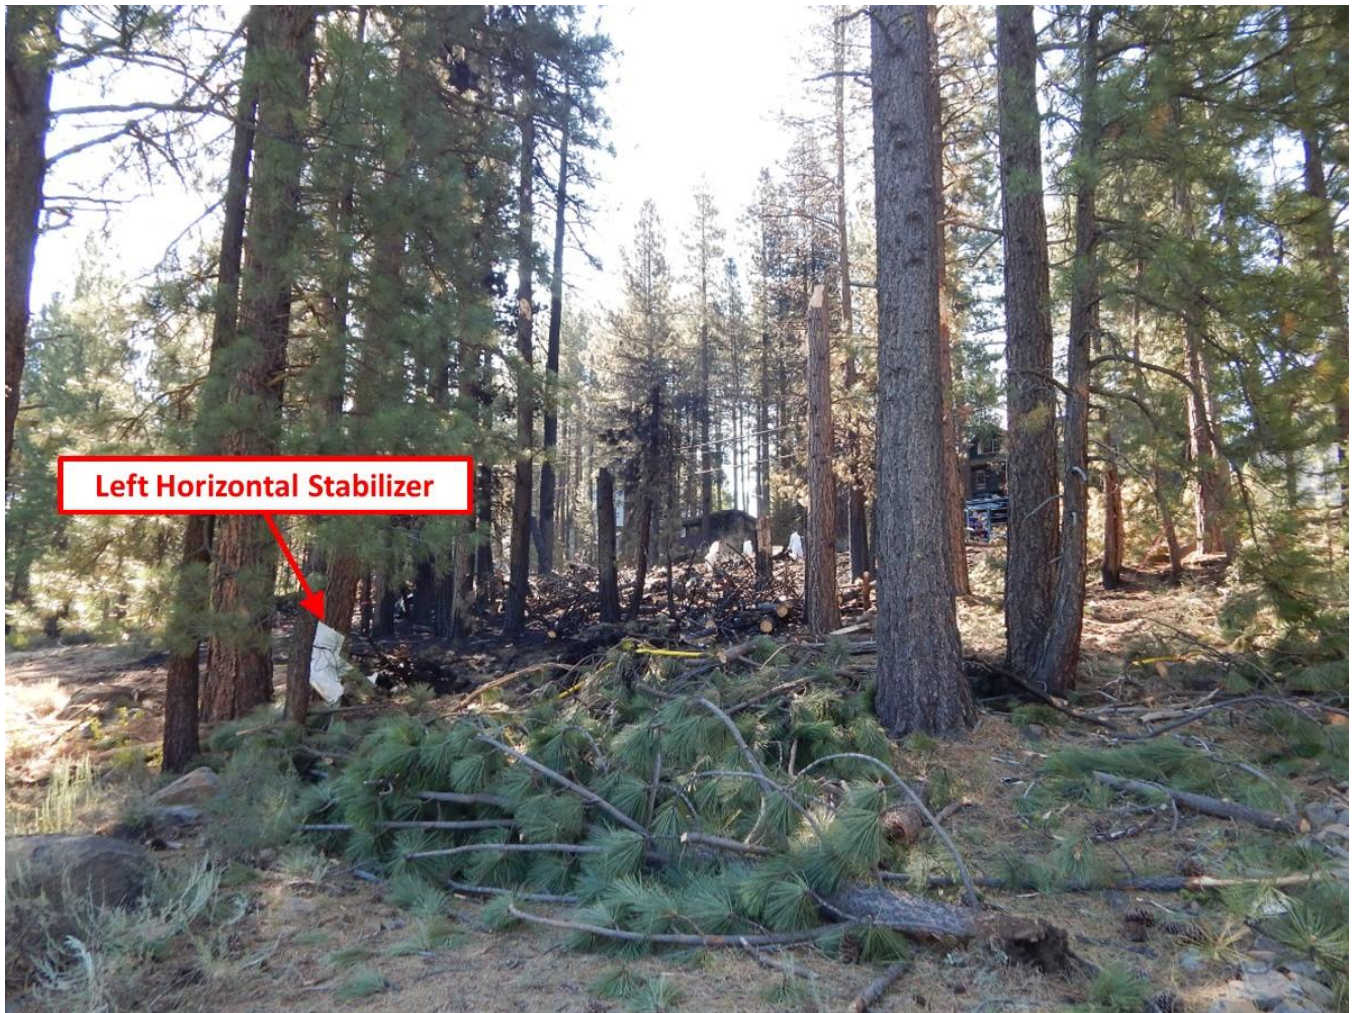
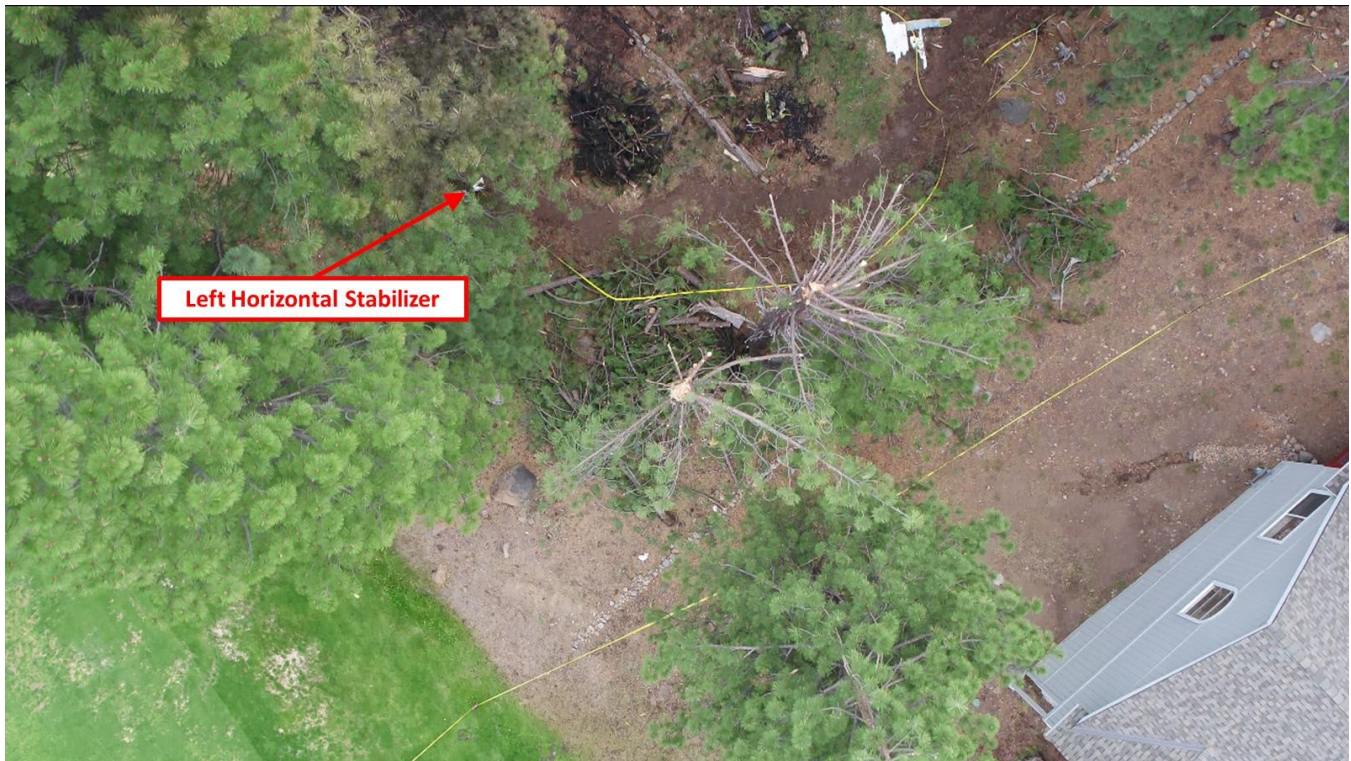
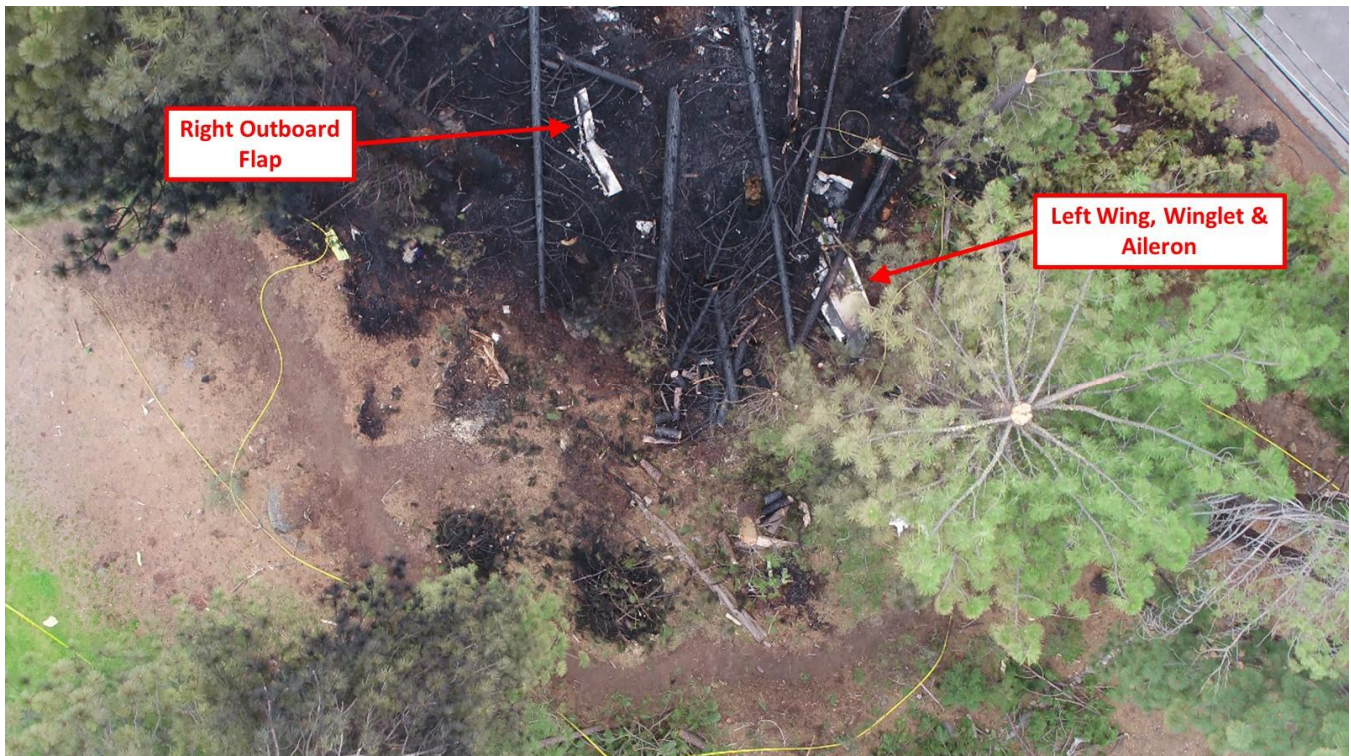
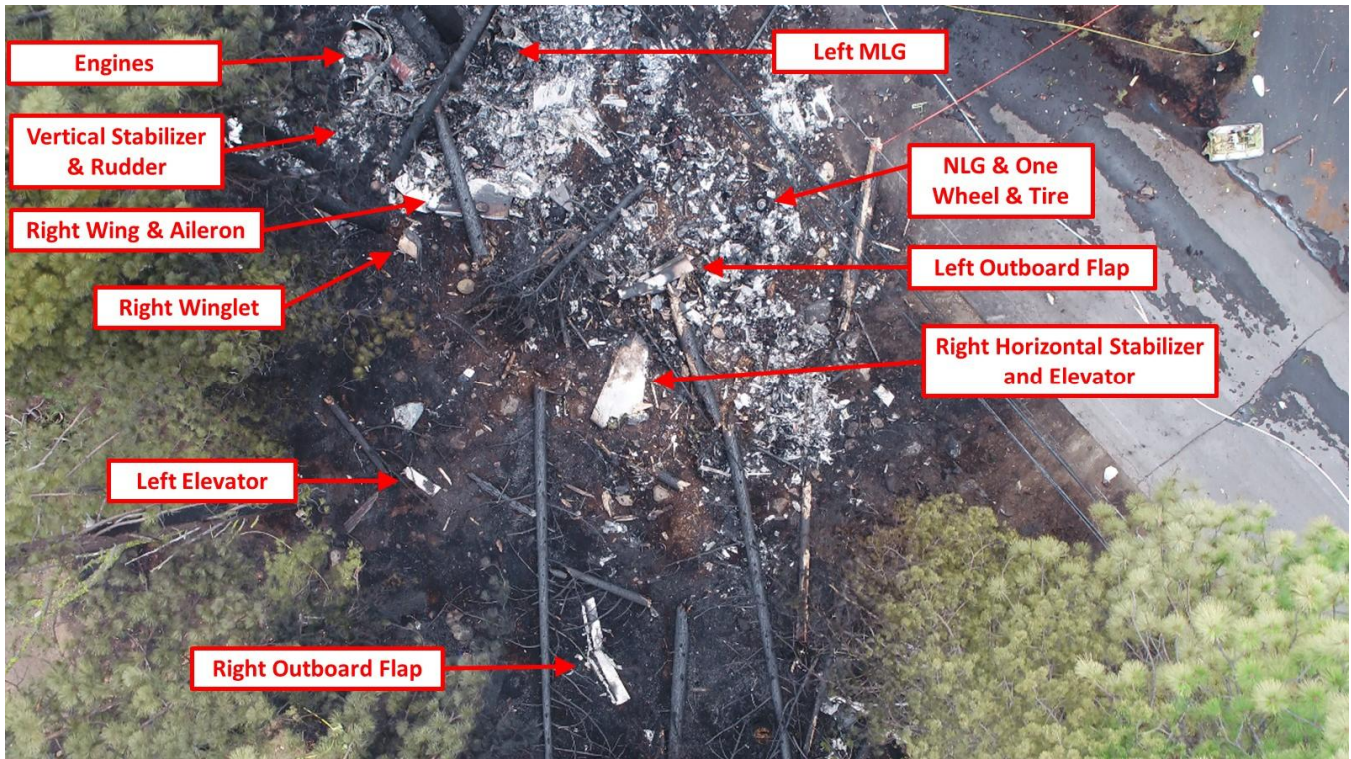
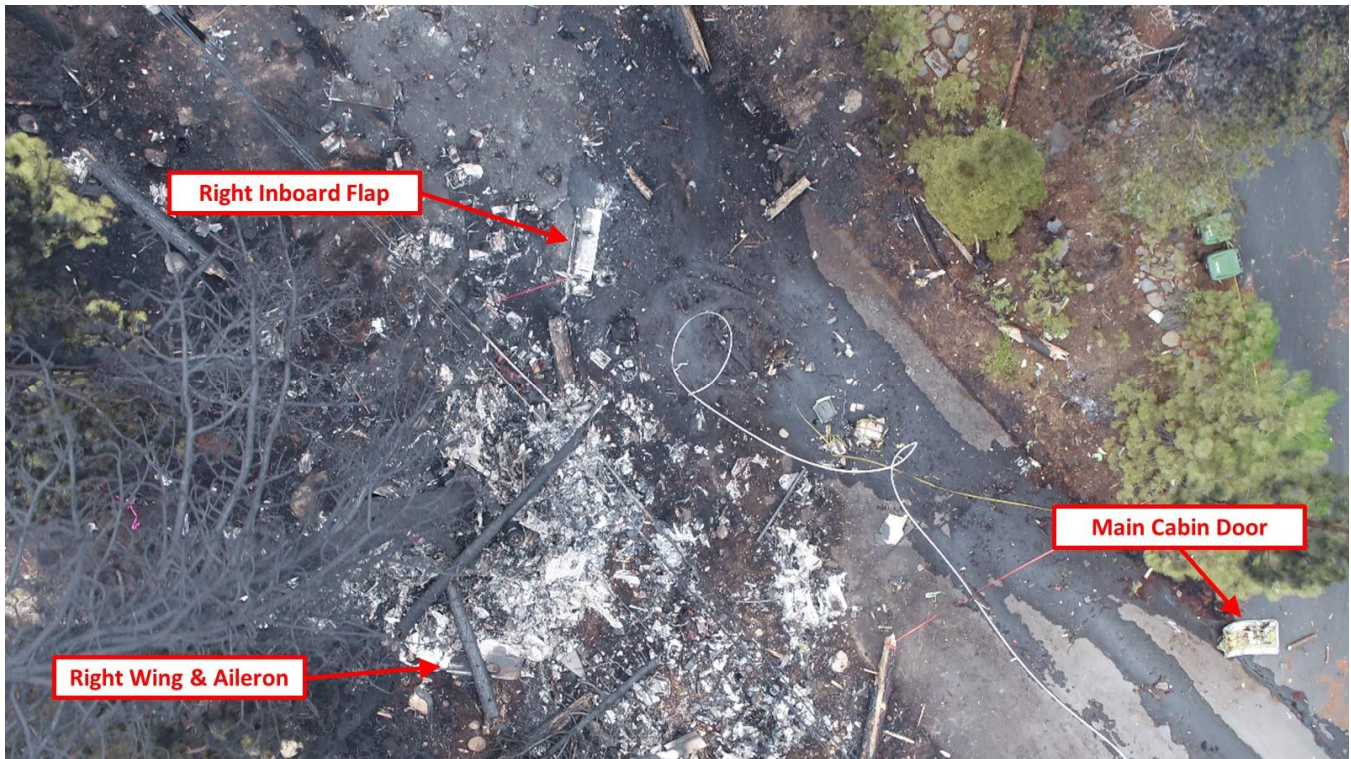
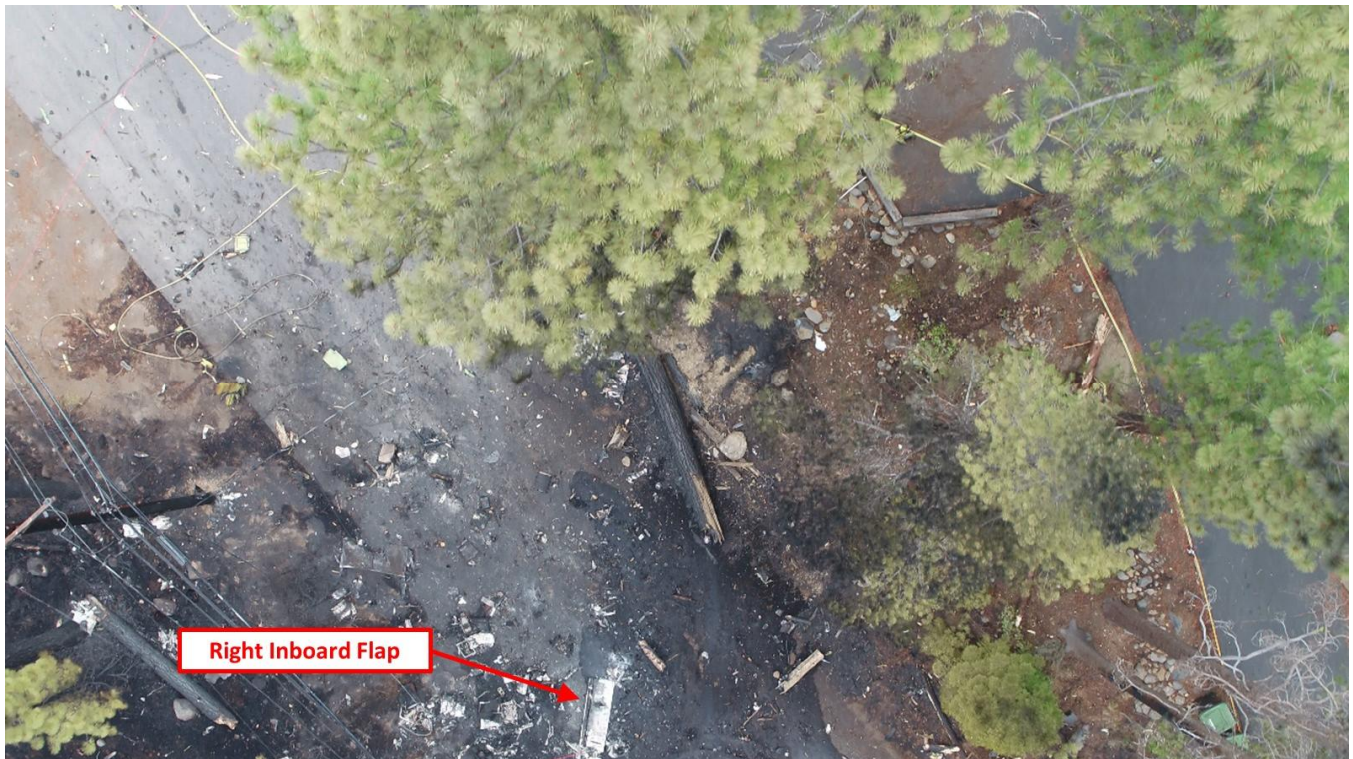
Major aircraft components are identified on Figure 25 through Figure 31. Figure 25 is a view of the wreckage site from the ground, looking forward along the flight path. Figure 26 through Figure 31 are a series of consecutive screenshots taken from drone video looking down at the wreckage site and moving forward along the flight path. The drone video was provided to the ASIO by the NTSB and had been recorded the day before (July 27th) the ASIO arrived on site.

The damage to the trees around the wreckage site indicates that the aircraft entered the trees at a fairly steep angle, most likely 30 degrees nose-down or more, and at a very high bank angle, most likely somewhere between 60 and 120 degrees. As the aircraft entered the trees, it continued to roll until inverted or nearly inverted.

The distribution of wreckage around the site indicates that the aircraft was most likely left wing down when it entered the trees and inverted, or nearly inverted, when it impacted with the ground.

Based on what was identified in the wreckage, it is highly likely that all of the aircraft was contained in the wreckage site, i.e. there were no components which departed the aircraft in flight prior to impact.
