NATIONAL TRANSPORTATION SAFETY BOARD

AIR TRAFFIC CONTROL SPECIALIST'S REPORT

DCA10FA083

Location: 100 nautical miles North of Louis Armstrong New Orleans International Airport (MSY) New Orleans, Louisiana
Date/Time: August 9, 2010, 1134 Central Daylight Time (CDT) /1634 Coordinated Universal Time (UTC) ¹
Aircraft: Shuttle America Flight (TCF) 7630, an Embraer 175 (E170)
FAST 13, a US Air Force Northrop T-38 Talon

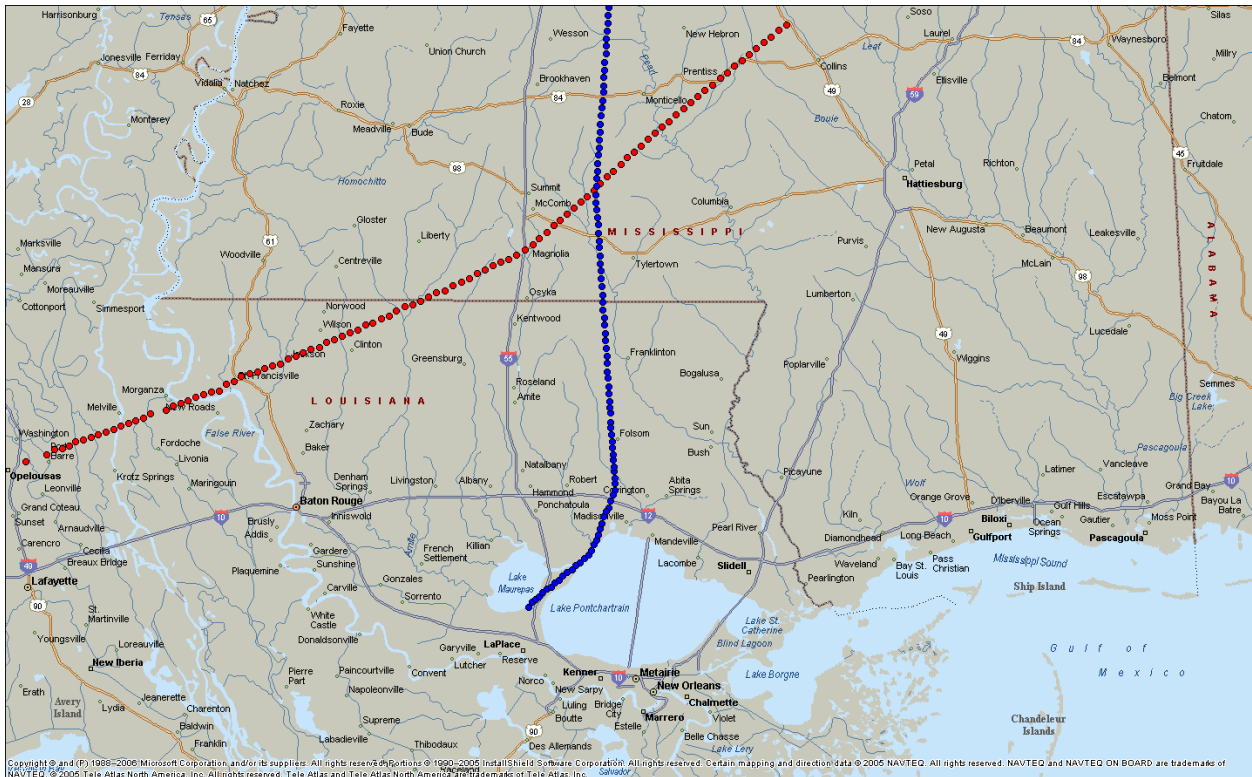
Figure 1

At 1134:17, TCF7630 was southbound at flight level (FL) 290 and FAST13 was southwest bound at FL280. The aircraft were on a converging course. (see figure 1) The Citronelle, Alabama Air Route Surveillance raw radar data indicates that at 1134:27 FAST 13 began a brief climb to FL286 before returning to FL280 at 1134:57. During this 30 second period, TCF7630 and FAST 13 courses converged momentarily before diverging after the aircraft passed each other. During FAST13's ascent to FL286, TCF7630 received a Traffic Alert and Collision Avoidance System (TCAS) warning resolution advisory (RA). The TCAS RA, of which pilots are required to comply with, directed the pilot to climb. The pilot of TCF7630 complied with the TCAS RA and immediately climbed to FL296 before returning to the previously assigned altitude of FL290 once the conflict was clear. (see figure 2)

Flight track of TCF7630 displayed in blue and FAST13 displayed in red

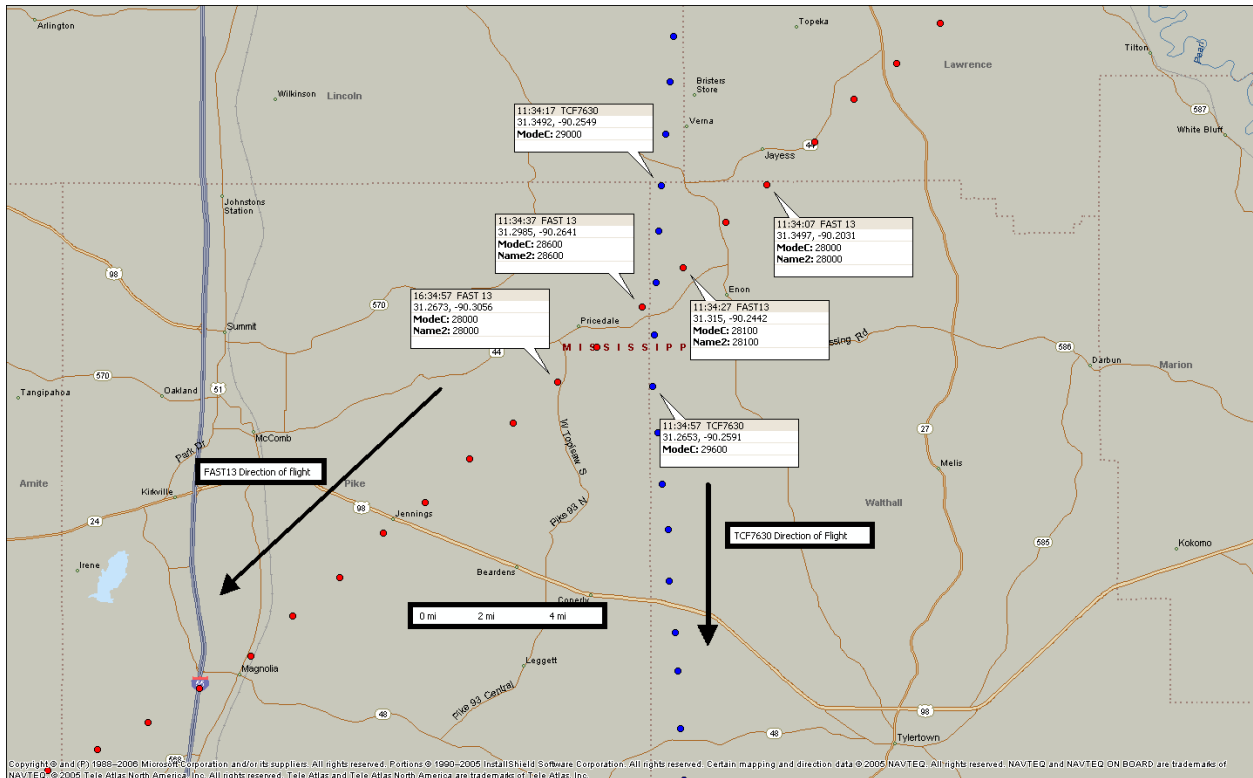
Figure 2

Flight track of TCF7630 shown via blue dots and FAST13 shown in red dots
