**NATIONAL TRANSPORTATION SAFETY BOARD
Office of Aviation Safety
Washington, DC 20594**

**ATC GROUP CHAIRMAN'S FACTUAL REPORT
DCA05MA004**

A. AIRCRAFT ACCIDENT

Location: Kirksville, Missouri
Date: October 19, 2004
Time: 1937 central daylight time / 0037 Coordinated Universal Time¹
Aircraft: Corporate Express Airlines Jetstream 32, CEA5966

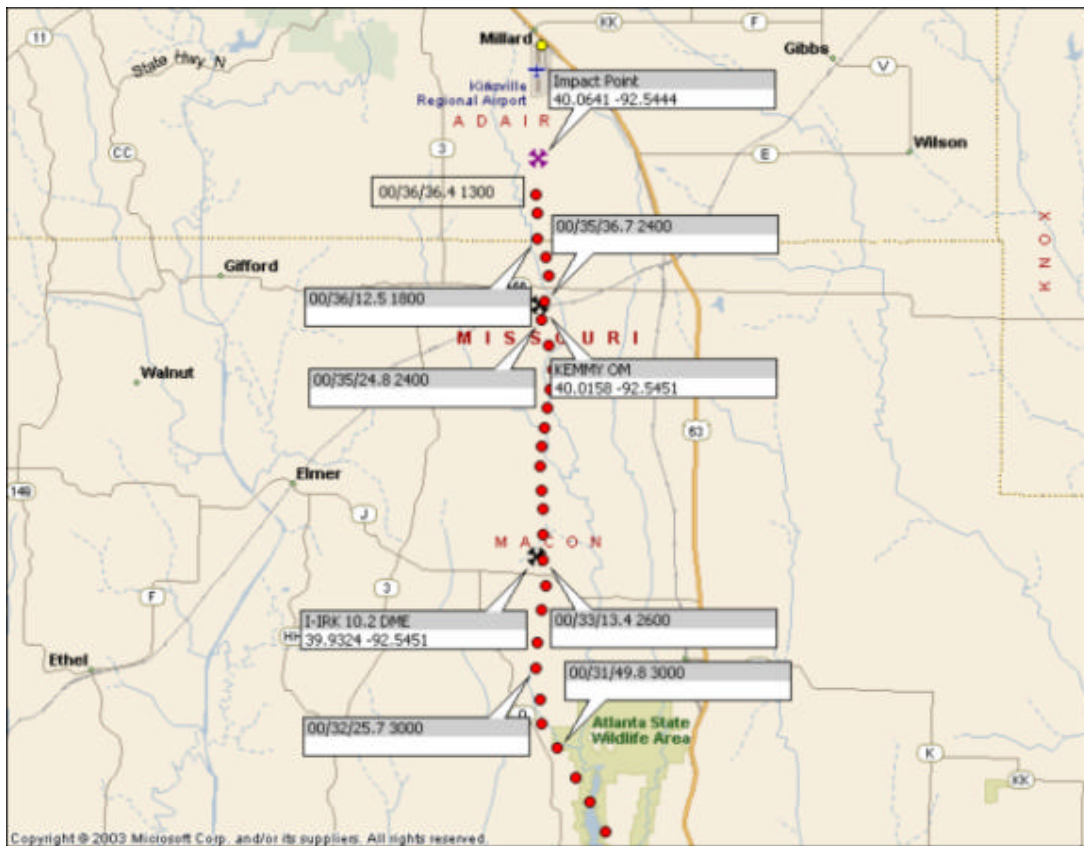
According to recorded radar data obtained from the Kirksville air route surveillance radar, which is located about 14 miles north of the accident site, the last target for CEA5966 was observed at 0036:36 UTC, descending through 1,300 feet. The aircraft was the subject of a minimum safe altitude warning (MSAW) alert between 0033:12 and 0034:00 caused by descent from 3,000 feet, the minimum IFR altitude for the general area, to 2,500 feet, the outer marker crossing altitude for the approach. The alert terminated, and the aircraft crossed the outer marker at 2,400 feet before commencing further descent.

Figure 1: CEA5966 Radar Targets During LOC-DME 36 Approach

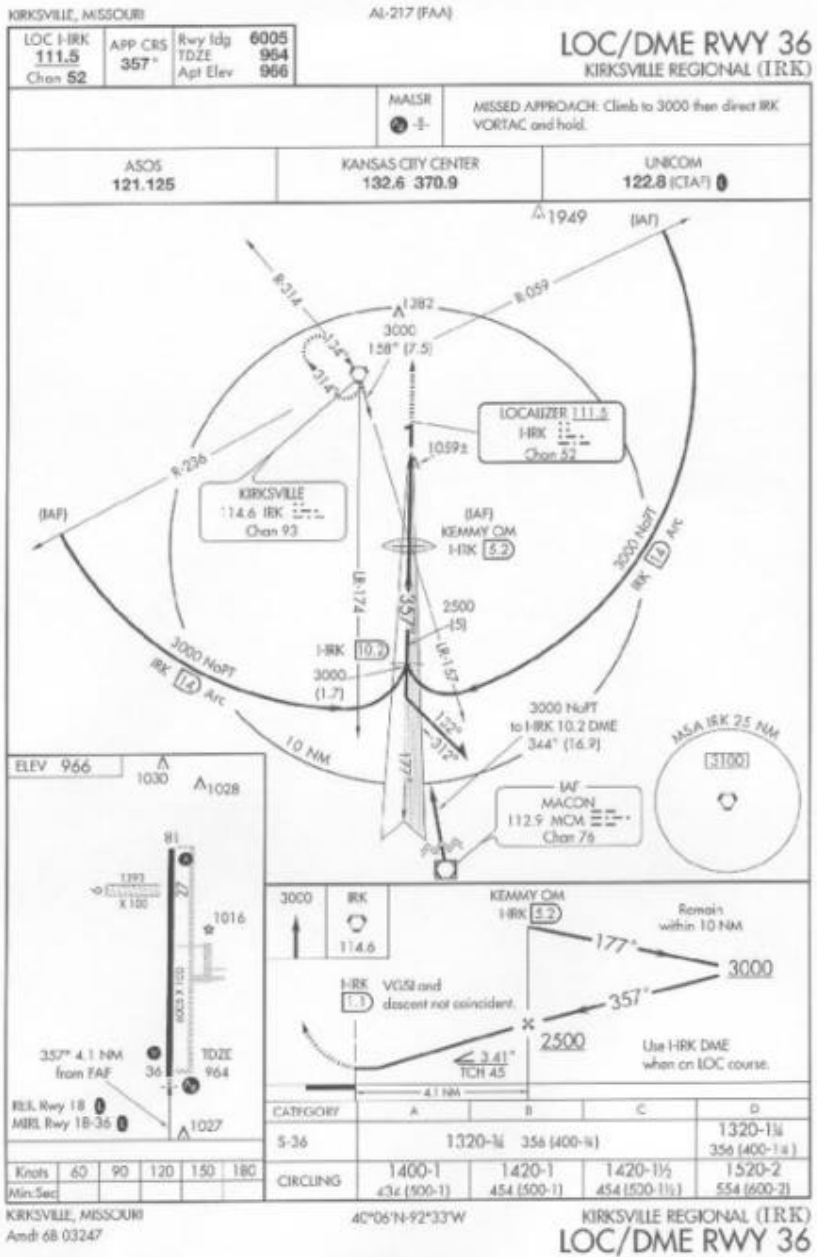
Figure 2. LOC-DME 36 Instrument Approach Chart

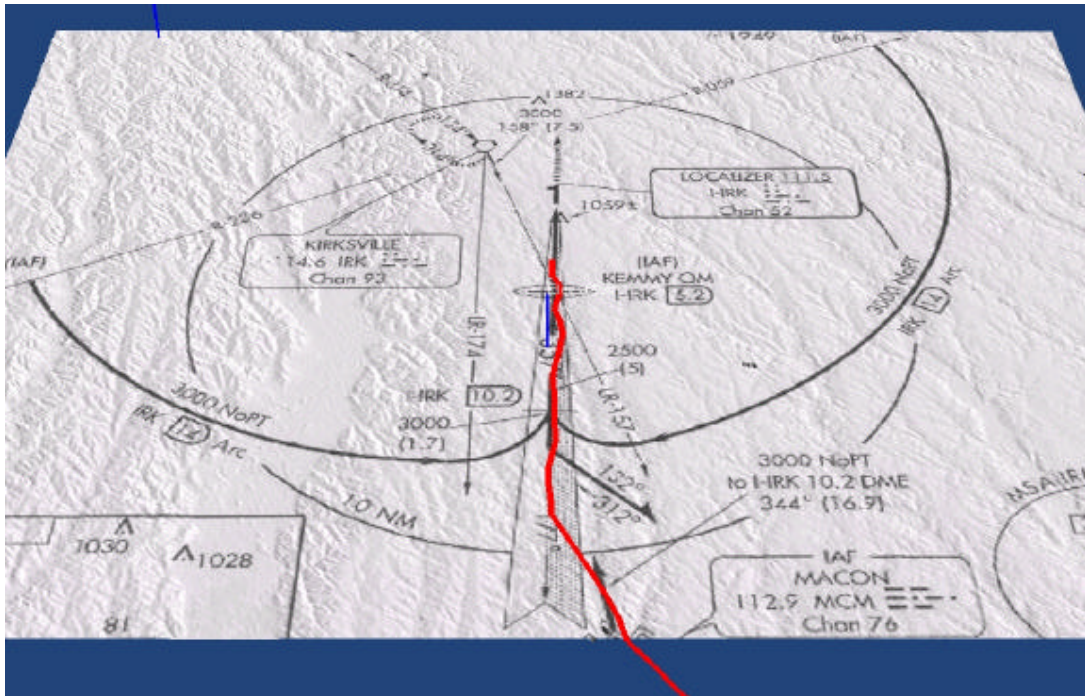
Figure 3. CEA5966 Radar Track on LOC-DME 36 Approach
