# NATIONAL TRANSPORTATION SAFETY BOARD

## AIR TRAFFIC CONTROL FACTUAL REPORT

WPR09MA159

**Aircraft:** N128CM, a Pilatus PC12/45

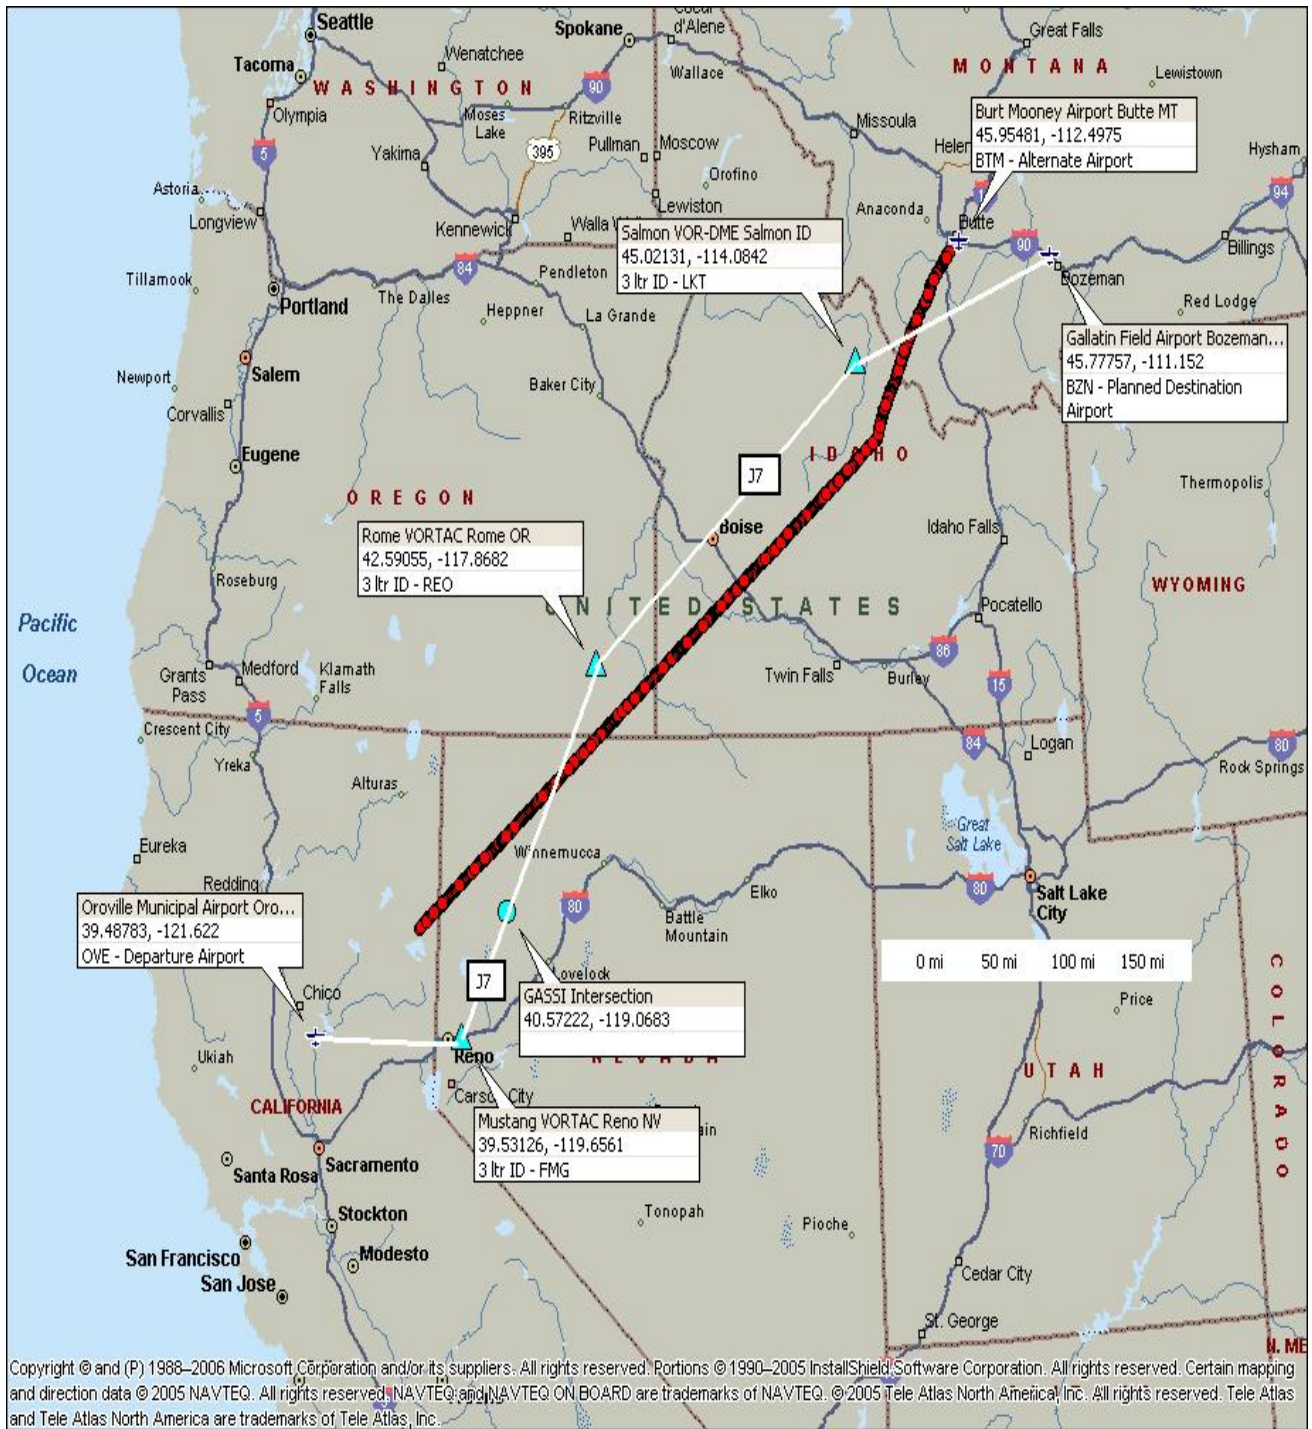
Figure 1

N128CM departed OVE at 1210 MDT under visual flight rule conditions (VFR) and contacted Oakland Air Route Traffic Control Center (ARTCC) to activate his IFR flight plan to Gallatin Field Airport (BZN), Bozeman, Montana. N128CM was radar identified by Oakland ARTCC 4 miles northwest of OVE and directed to maintain VFR until reaching 9,000 feet msl<sup>5</sup>. At 1213, ATC activated N128CM's IFR flight plan and cleared him to BZN via radar vectors heading 250 [degrees] and a climb to 11,000 feet msl. N128CM was advised to expect direct routing to the Mustang NAVAID fix, (FMG), momentarily. ATC directed N128CM to stop his turn on a heading of 290 degrees followed by a radar vector heading of 340 degrees. At 1217, ATC cleared N128CM direct Mustang via a right turn and advised N128CM that after Mustang, the pilot was cleared to BZN as filed. This was followed with a shortcut in routing to the GASSI intersection located on J7 with a climb to FL230 and then to FL250. At 1228 N128CM was cleared to proceed direct to BZN by Oakland ARTCC. (See figure 1)

Radar flight track of N128CM from northern California to the Burt Mooney Airport (BTM) is indicated by the red dots. The white line indicates the proposed route of flight based on the filed flight plan: OVE to FMG via J7 to LKT to BZN.

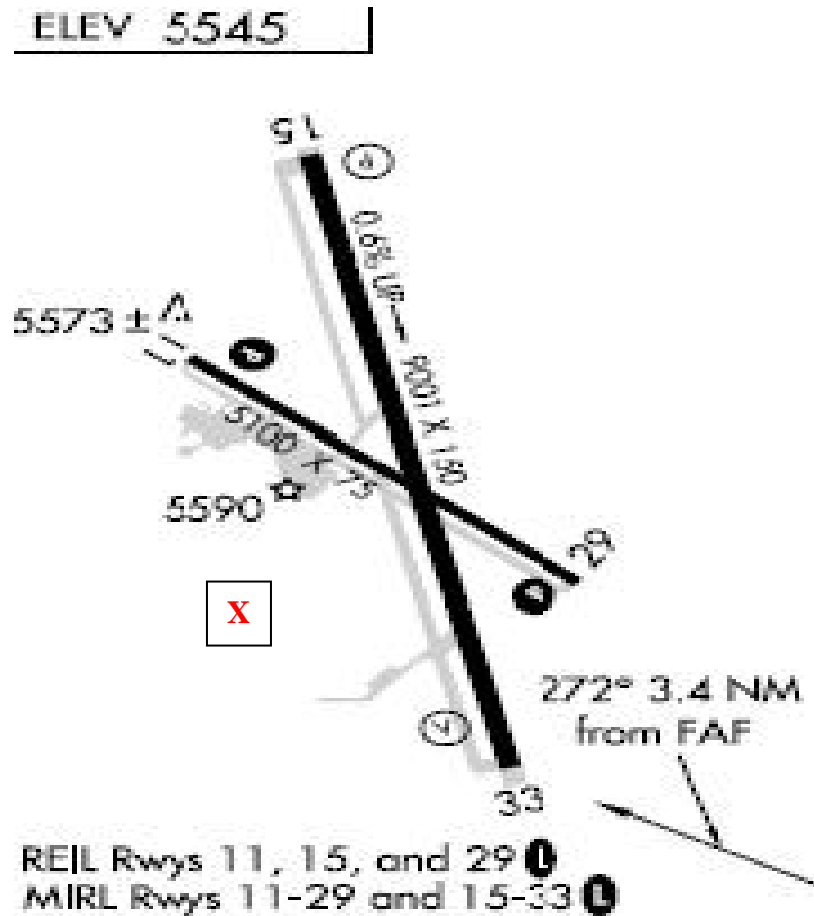
Figure 2

The Denver Flight Service Station (FSS) notified Salt Lake ARTCC that N128CM had crashed at 1433. (See figure 2)

The Bert Mooney Airport at Butte, Montana. The approximate accident site of N128CM indicated by the red X.

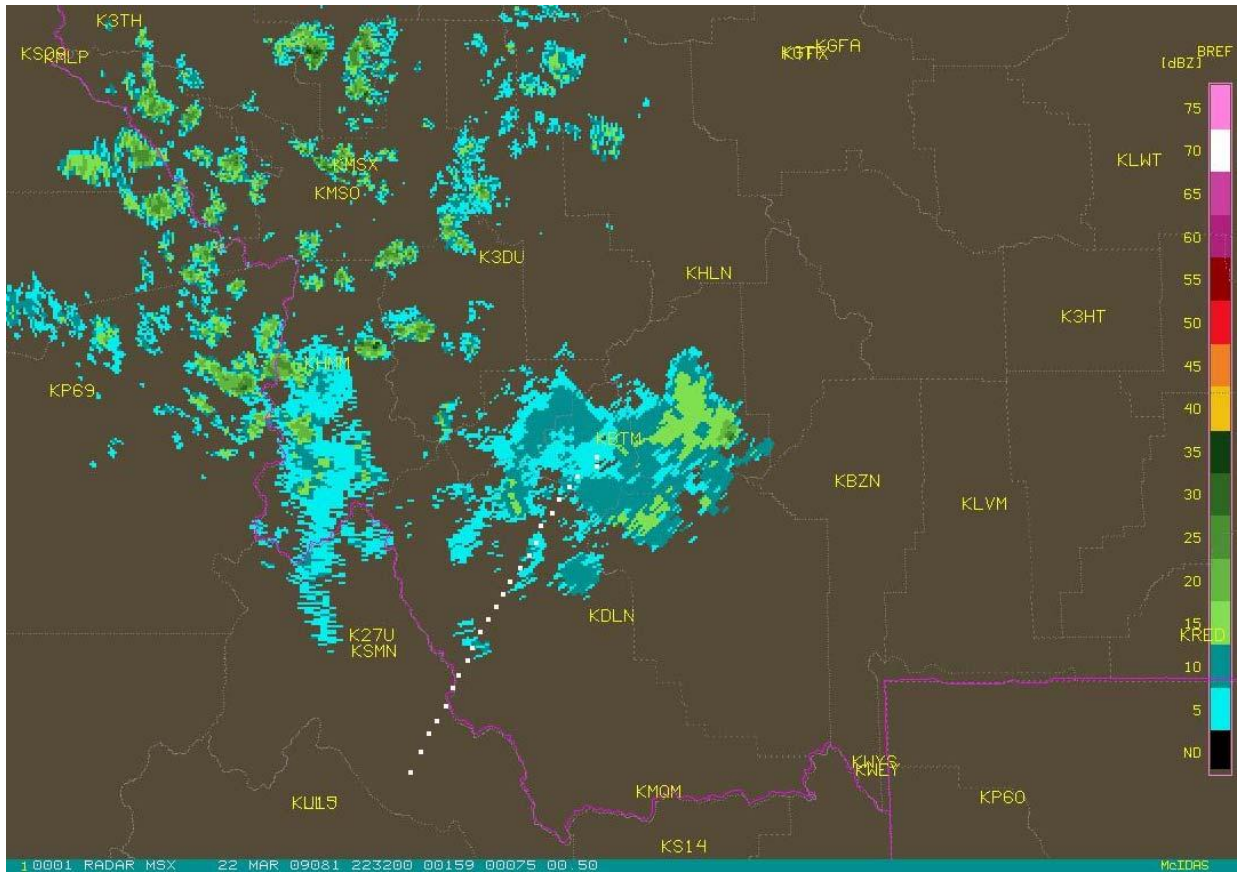
Figure 3.

The NEXRAD weather depicted at 1430 MDT displayed no reflections greater than 30dBZ along the route of flight for N128CM. Accordingly, no weather information was issued by Salt Lake ARTCC ATC to N128CM. (See figure 3)

Reflected precipitation as displayed by the WSR-88 NEXAD radar in the vicinity of BZN and BTM on March 22, 2009 at 1430 MDT. The white dots indicate the flight path of N128CM.
