National Transportation Safety Board

WPR22LA251

AIR TRAFFIC CONTROL

Group Chair Factual Report

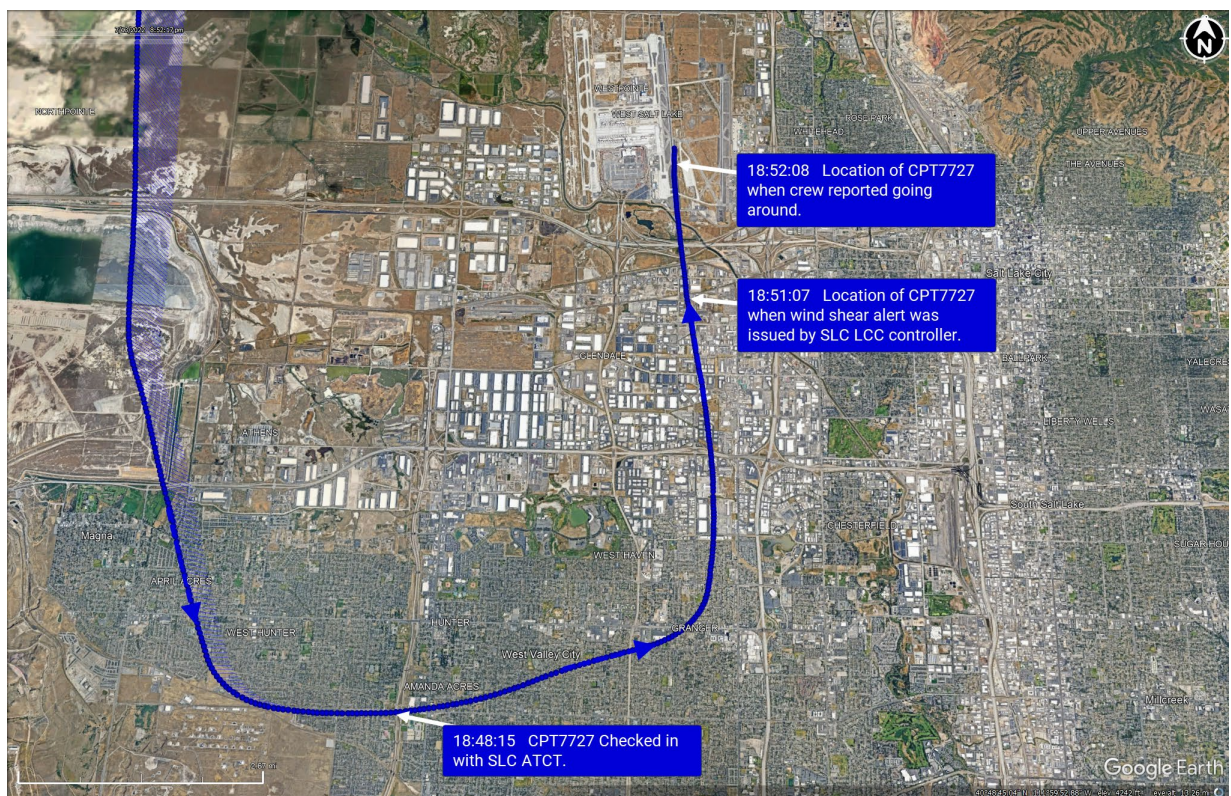
Figure 2. CPT7727's route of flight after checking in with the SLC airport traffic control tower.

Figure 2 is a satellite imagery overlaid with CPT7727's Automatic Dependent Surveillance-Broadcast (ADS-B)⁸ flight track data. The figure illustrates CPT7727's route of flight after checking in with the SLC tower. The blue dots indicate the airplane's ADS-B targets, and the arrows indicate the direction of flight. The boxes provide the time and any pertinent information that occurred at those locations.

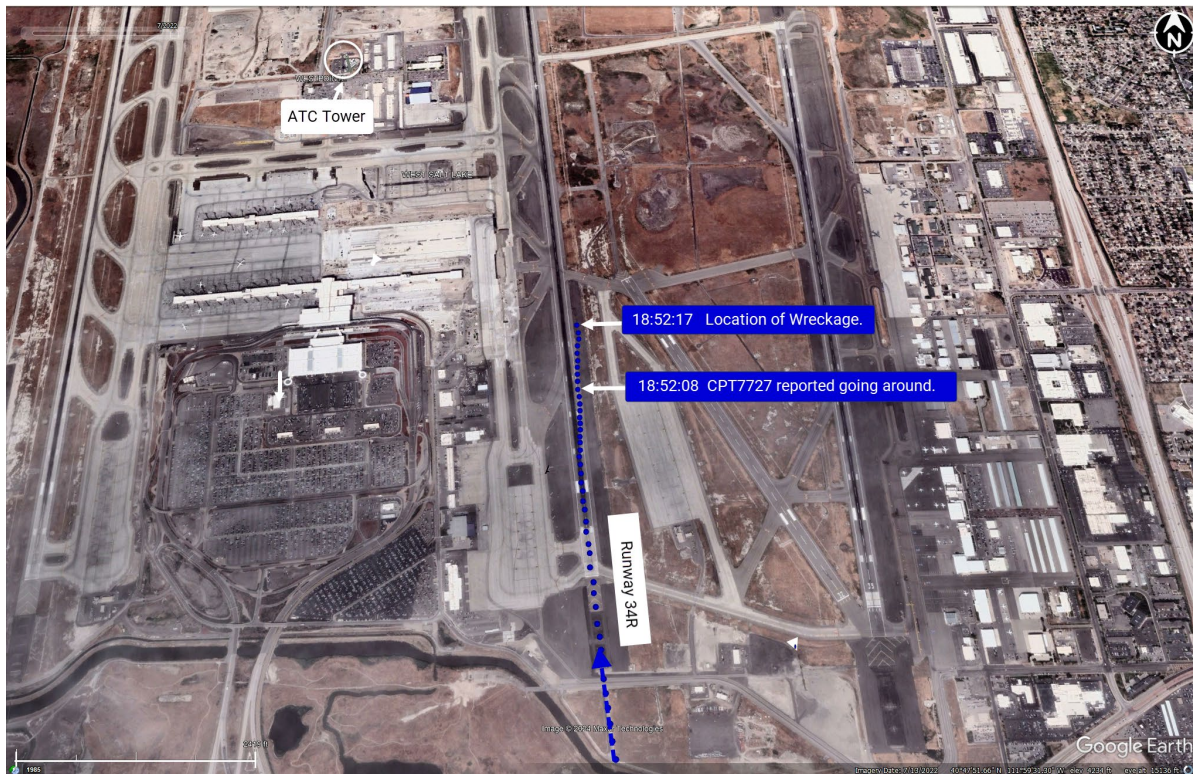
Figure 3. Location where the crew of CPT7727 reported going around and the location of the wreckage.

Figure 3 is a satellite imagery overlaid by CPT7727's ADS-B flight track data. The figure illustrates the location where the crew of CPT7727 reported going around and the location of the wreckage. The blue dots indicate the airplane's ADS-B targets, and the arrows indicate the direction of flight. The boxes provide the time and pertinent information that occurred at those locations.
