# National Transportation Safety Board

DCA23LA185

## **AIR TRAFFIC CONTROL**

Group Chair's Factual Report

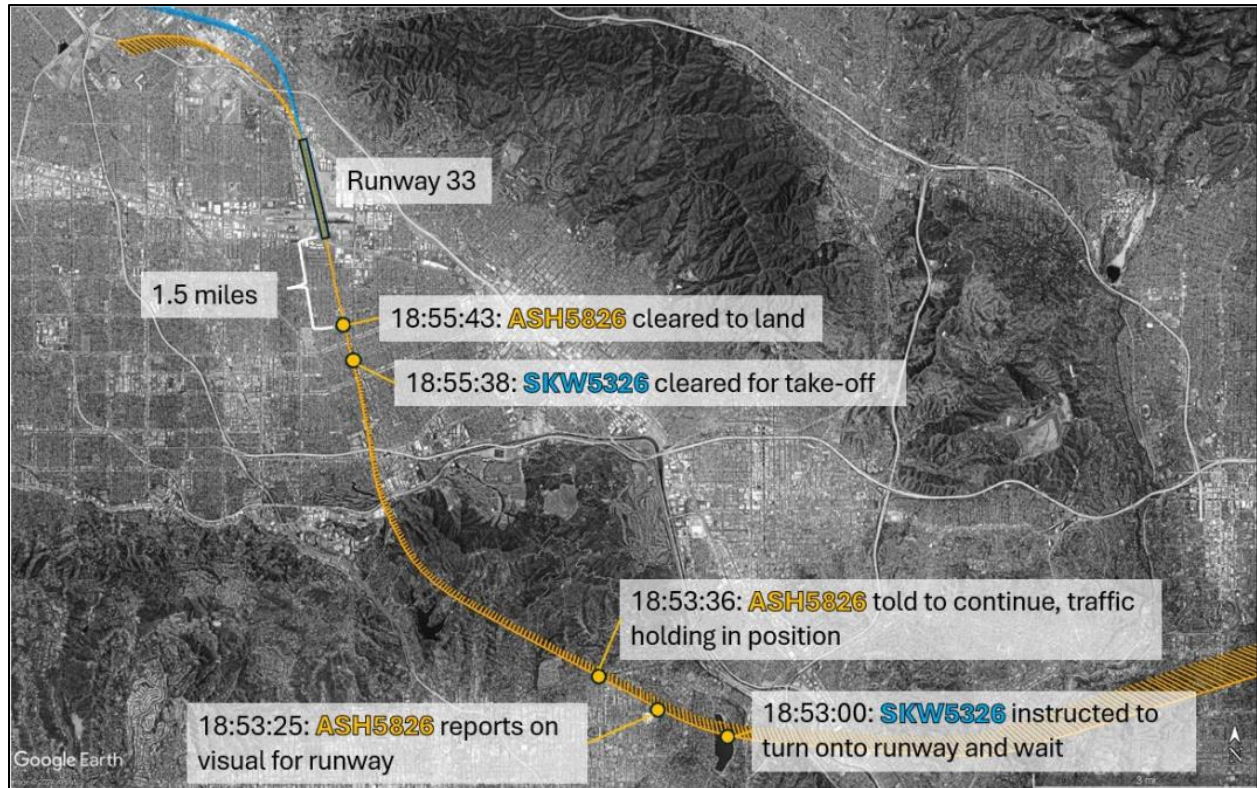
**Figure 2. Flight paths for ASH5826 (orange) and SKW5326 (blue) with pertinent transmissions.**

Figure 2 was retrieved from the Aircraft Performance Study. The graphic<sup>8</sup> provides information on the aircraft locations and associated ATC communications for specific times indicated. The ADS-B flight paths for ASH5826 are indicated in orange and SKW5326 are indicated in blue.

At 1853:25, the crew of ASH5826 contacted the BUR ATCT and reported they were on the visual runway 33.

At 1853:36, the LC controller advised the crew of ASH5826 that traffic [SKW5326] was holding in position on runway 33 and instructed them to continue [the approach]. The crew read back the instructions as issued.

At 1855:38, the LC controller cleared SKW5326 for takeoff from runway 33. The crew readback the takeoff clearance for runway 33, as issued.

According to the Aircraft Performance Study, at this time, ASH5826 was 1.6 miles from the threshold and at 500 ft agl.

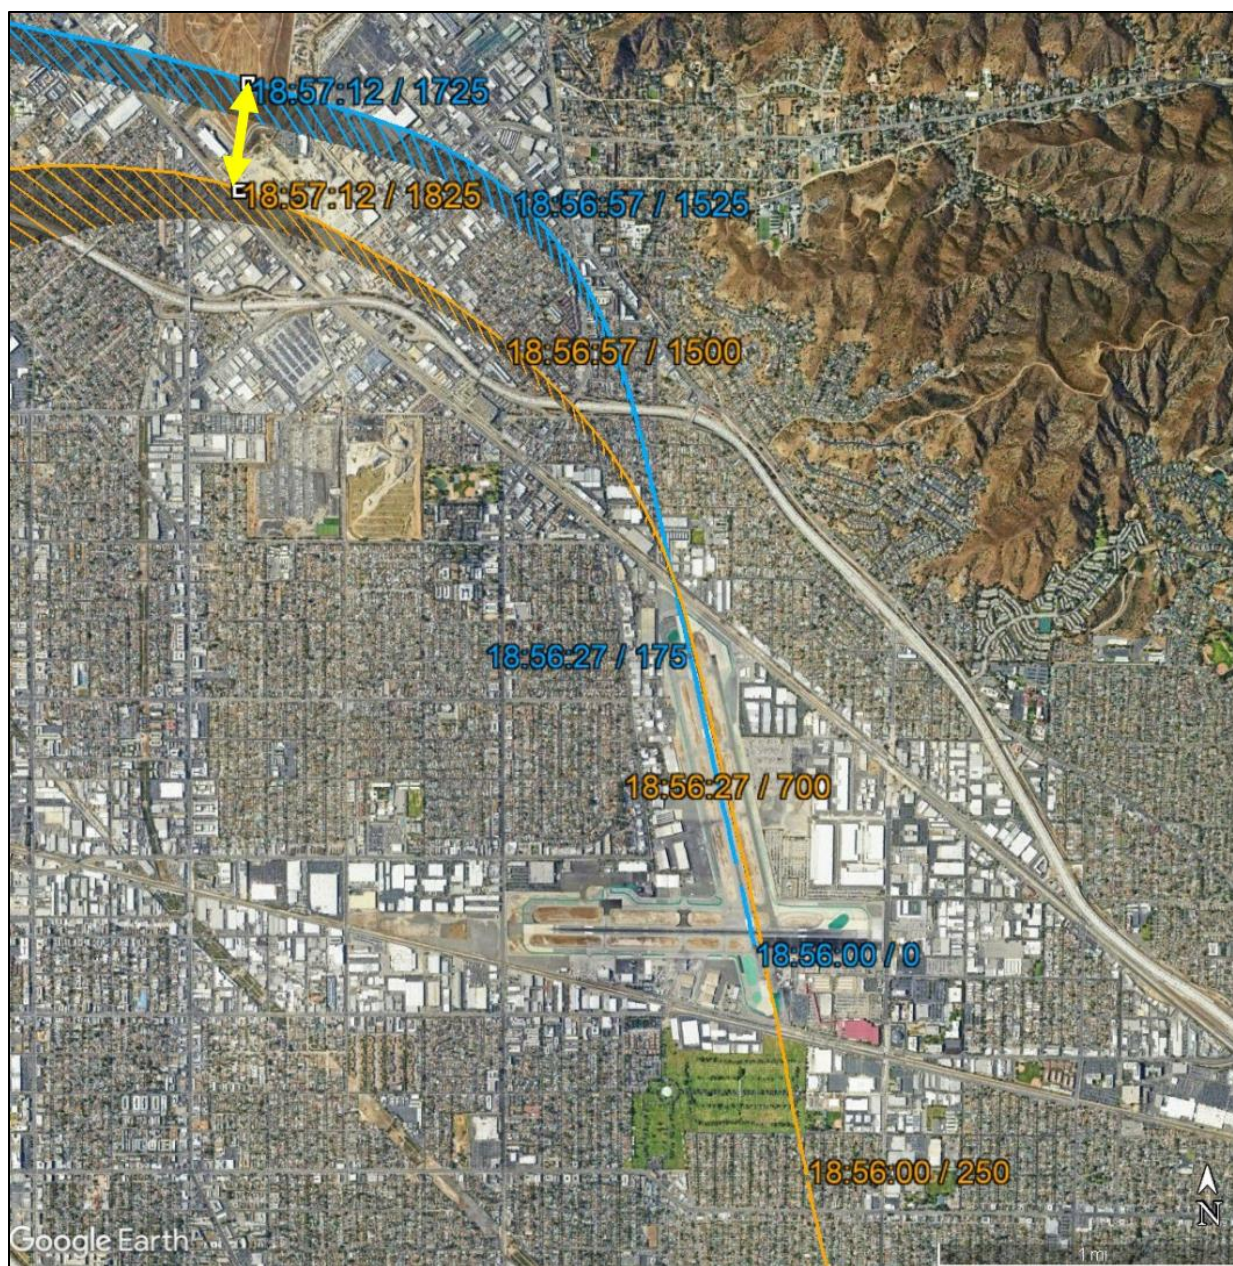
**Figure 3. Flight paths for ASH5826 (orange) and SKW5326 (blue) with times and altitudes. The yellow arrow indicates the position and time (1857:12) that the airplanes were at their closest proximity (1,680 ft horizontally) to each other.**

According to the Aircraft Performance Study, at this time, SKW5326, which had been in LUAW about 300 feet in front of the runway 33 displaced threshold, was now at a groundspeed of 27 kts and accelerating across the runway threshold, and ASH5826 was 4,200 ft from the threshold and at 300 ft agl.

Figure 3 was retrieved from the Aircraft Performance Study, . The graphic provides information on the aircraft locations and altitudes for the specific times indicated. The ADS-B flight paths for ASH5826 are indicated in orange and SKW5326 are indicated in blue. The yellow arrow indicates the position and time that the airplanes were at their closest proximity to each other.

At 1857:12, according to the Aircraft Performance Study, and as indicated by the yellow arrow in figure 3, the minimum separation of 1,680 ft horizontally occurred between ASH5826 and SKW5326.
