**NATIONAL TRANSPORTATION SAFETY BOARD**

**Specialist's Report**

**AIR TRAFFIC CONTROL**

DCA22MA009

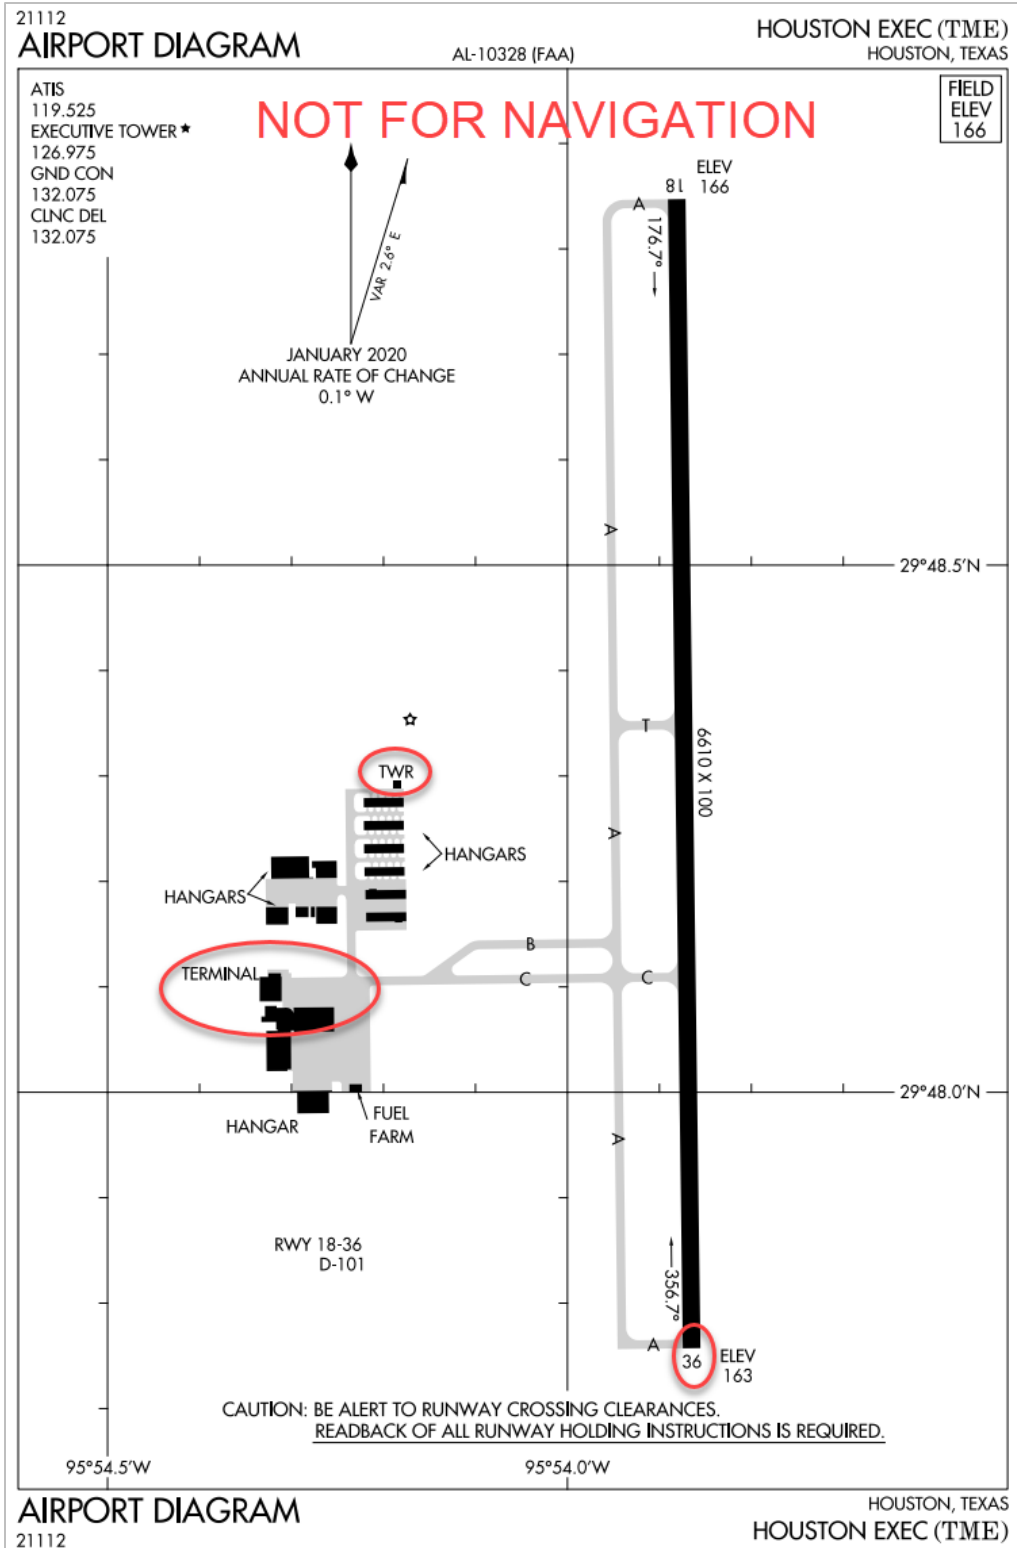
**Figure 1. TME Airport diagram depicts the location of runway 36, the terminal ramp area, and the TME ATCT.**

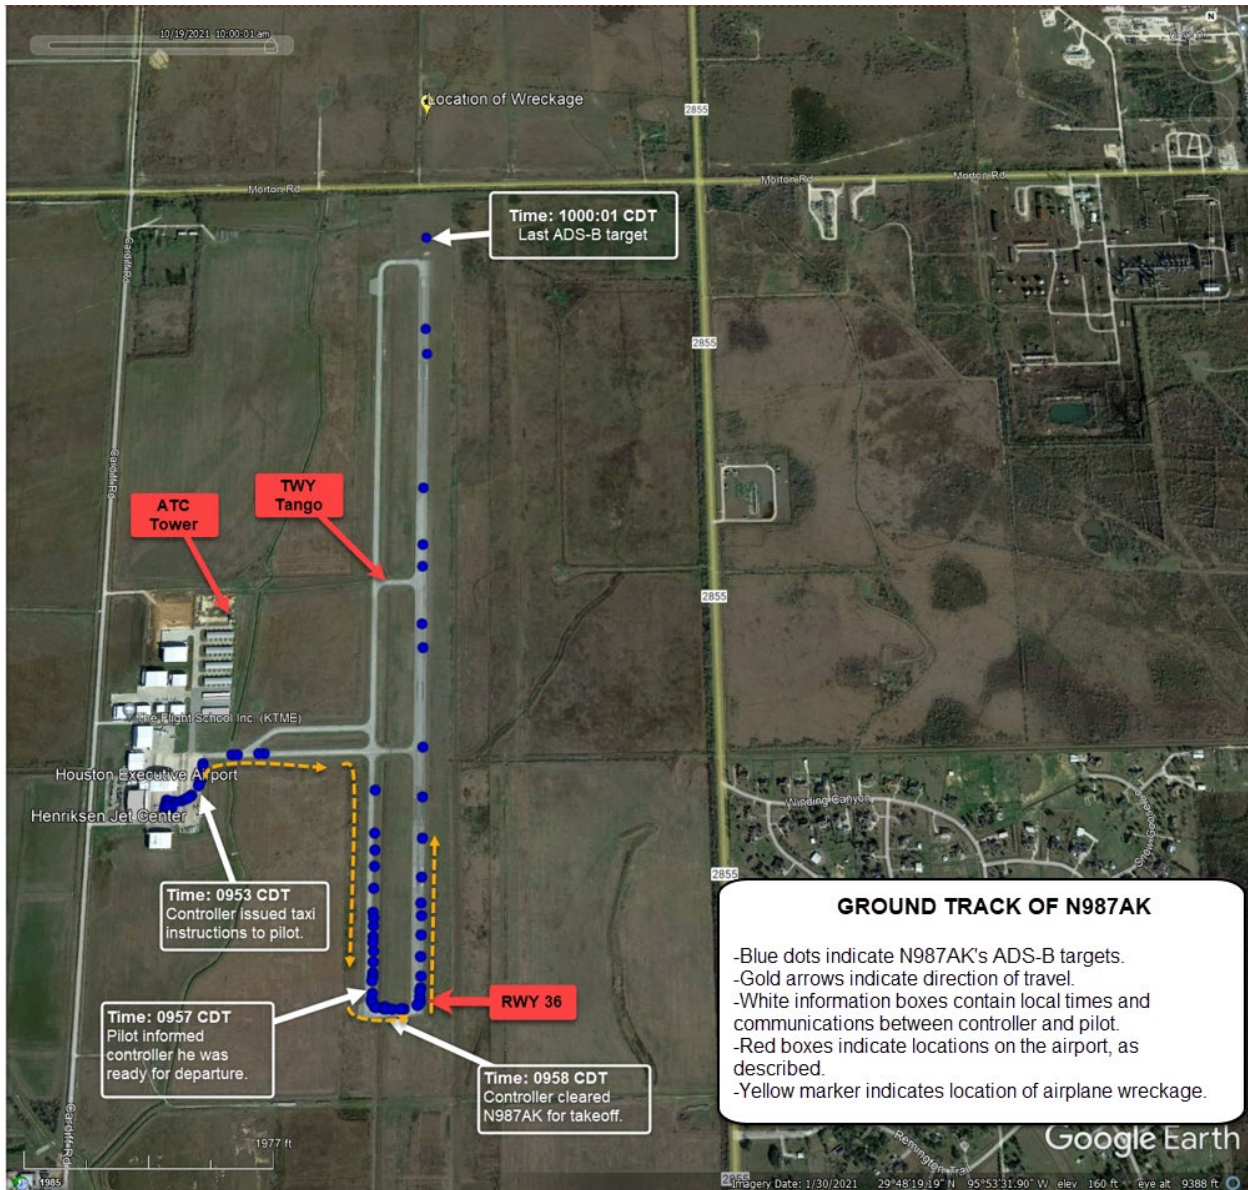
**Figure 2. Screenshot of N987AK's ground track overlaid on Google Earth.**
