## Fuel-related event

# 16 km south-east of Townsville Airport, Qld

## 9 April 2008

INFRA-08555

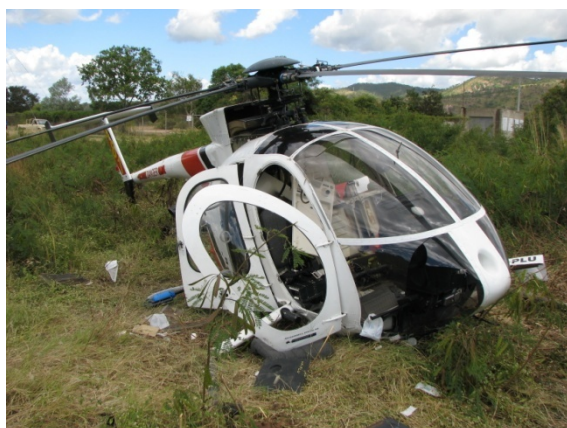
**Figure 1: Accident site**

The PIC conducted an autorotation<sup>2</sup> to touchdown. The helicopter impacted the ground at a high vertical velocity, in a right landing skid low, nose-up attitude, which resulted in serious damage<sup>3</sup> to the helicopter (Figure 1).

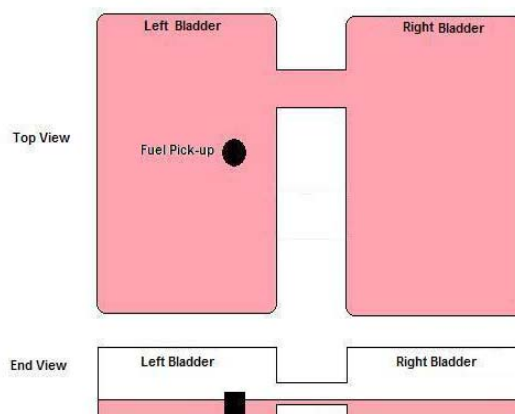
**Figure 2: Helicopter main fuel cells**

The helicopter's main airframe fuel system comprised two flexible, rubberised, bladder-type, interconnected fuel cells, located in separate fuel bays beneath the passenger compartment floor. Fuel was delivered to the engine from the left fuel cell. The operator's operations manual stated that the main fuel cells held 62.1 US gallons (235 L), or 421 lbs of usable fuel. The engine fuel pick-up point was located within the left fuel cell, left of the aircraft centreline and slightly above the tank floor (Figure 2).

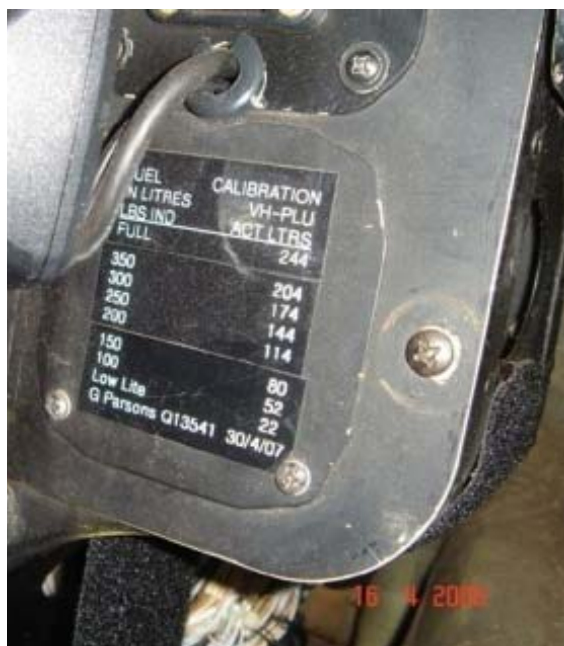
**Figure 3: Fuel calibration card**

The fuel calibration card<sup>4</sup> (Figure 3) that was attached to the helicopter (current as of 30 April 2007) advised that 80 L of fuel would indicate 150 lbs on the fuel gauge, and that 114 L would indicate 200 lbs on the fuel gauge.

The PIC reported that he did not normally conduct stringing operations when the fuel gauge reached 100 lbs (52 L in accordance with the fuel calibration card) as ‘...the helicopter gets over on a bit of an angle...’. That increased the risk of the fuel pick-up point rising above the surface of the fuel. The PIC reported that, at the time of the accident, the fuel gauge indicated about 170 lbs (about 94 L by the fuel calibration card) ‘...when they were fairly flat...’.

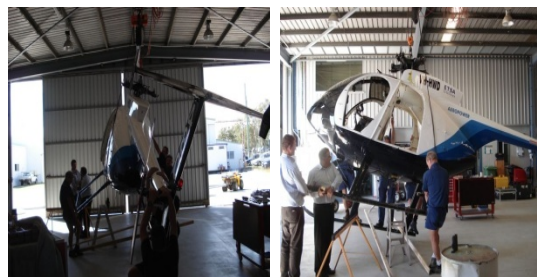
**Figure 4: Operator testing of fuel levels**

Following the accident, testing was conducted by the operator to determine the maximum nose-up and roll attitudes that could be achieved with various fuel quantities to avoid fuel starvation (Figure 4). Those results are contained in Table 1.

Fuel (litres)	Nose Up (degrees)	Lateral rotation (degrees)
80	19.5	0
80	10.5	16.3 right
80	0	20 right
100	5	22 right

The helicopter manufacturer advised that a fuel level of more than 87.4 L (about 162 lbs by the fuel calibration card) was required to avoid fuel starvation when operating with a 20° nose-up attitude, when combined with a 20° right roll.

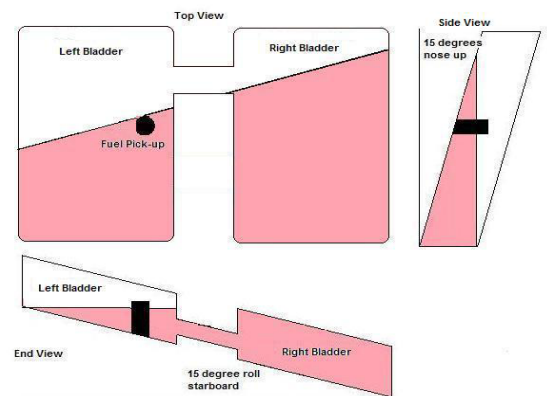
**Figure 5: Fuel pick-up schematic**

During the powerline stringing operation, transition from the hover to line pulling, created a worst-case scenario, resulting in the majority of the fuel being located at areas furthest from the fuel pick-up point (Figure 5).

A fuel cell capacity of 85 L, when subjected to the reported flight attitude of 20° nose-up and 20°

right-roll, resulted in a fuel surface level that was below the height of the fuel tank pick-up point. That condition caused a disruption in the fuel supply to the engine, which resulted in the loss of power and engine noise described by the crew and ground witnesses.

The operator subsequently published a revised Standard Operating Procedure (SOP) that contained more stringent operational requirements.
