# Power lever friction lock adjustment

[Safety Advisory Notice](#)

AO-2021-034

Friction locks fitted on the Beechcraft King Air series aircraft require careful adjustment to prevent the power levers migrating rearwards to the idle position, particularly during take-off.

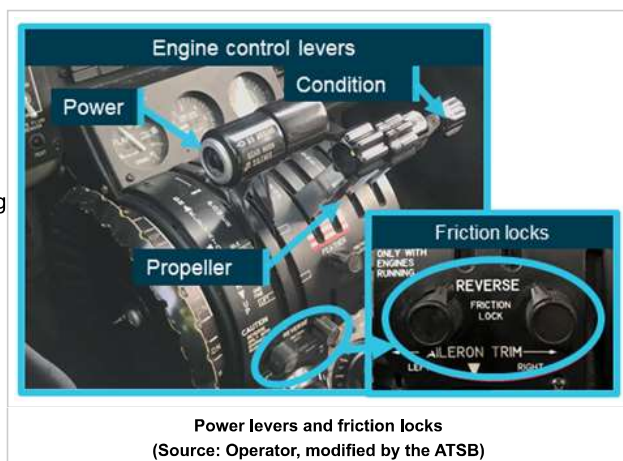
The cockpit to engine nacelle power lever control cables in King Air series aircraft were spring loaded towards idle. This was to protect the engines in the event of any power lever cable issues, and to reduce the effect of hysteresis (or backlash) in the system. The effect of the springs migrating the power levers was managed by adjusting the friction locks. The left engine was more susceptible to power lever migration as its cable connecting it to the engine was shorter when compared with the right engine.

When correctly set, the friction locks provided adequate resistance for the power levers to remain in position. However, if not adequately set, power lever migration could occur. This was typically experienced when the pilot removed their hand from the levers during take-off and could lead to the aircraft yawing towards the engine experiencing the power lever migration, a significant reduction in power, and the auto-feather system disarming.

The Australian Transport Safety Bureau advises pilots and operators of the King Air series aircraft (c90, 200, and 300) that the power lever friction locks require careful adjustment to prevent power lever migration towards the idle position, particularly during take-off. Inadvertent migration of one power lever towards idle can result in power reduction and yaw that, when occurring at low height, can result in catastrophic outcomes. Operators should ensure pre-flight checks provide opportunities to confirm friction lock settings before the take-off run, and ensure pilots have adequate knowledge of friction lock sensitivity to help prevent and recover from inadvertent power lever migration.
