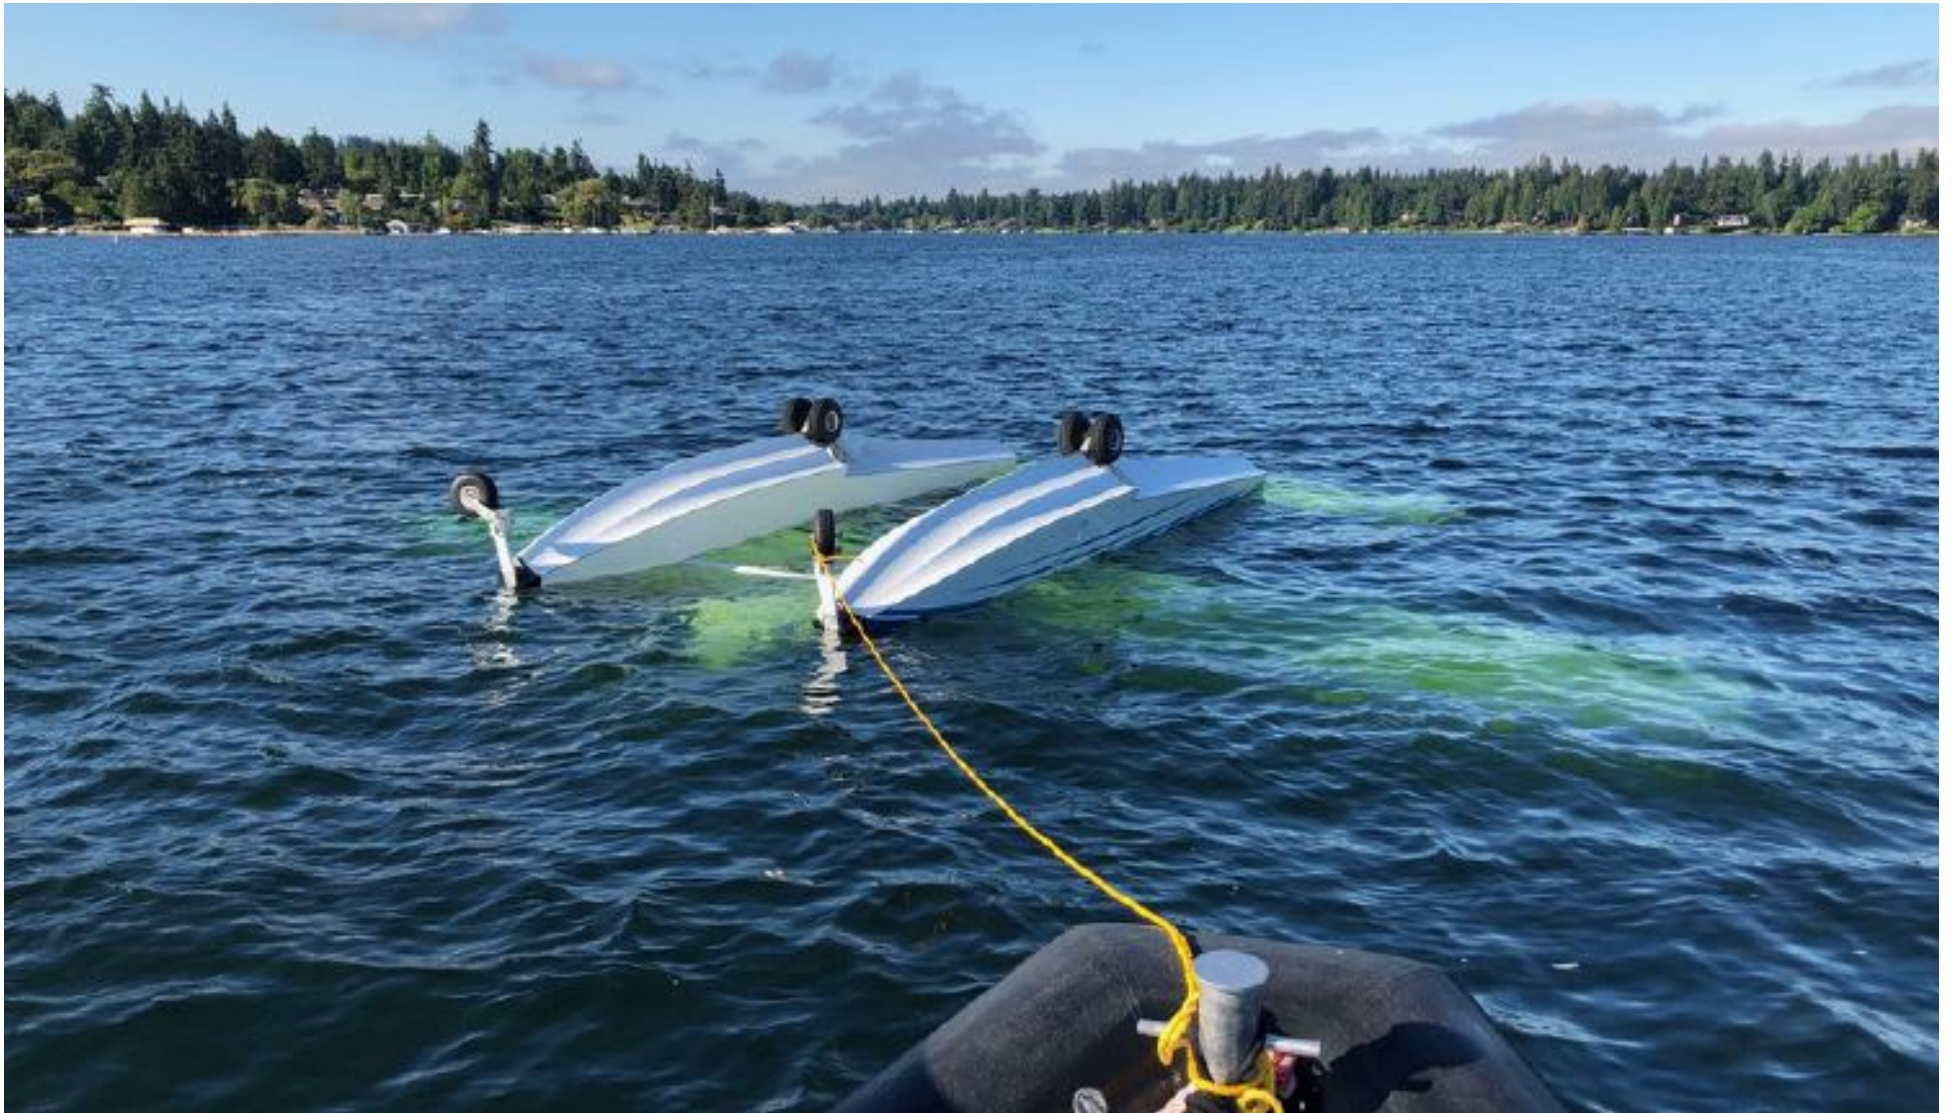
Photo 1 – View of nosed over amphibious float plane in a lake with extended landing gears (courtesy of the FAA)

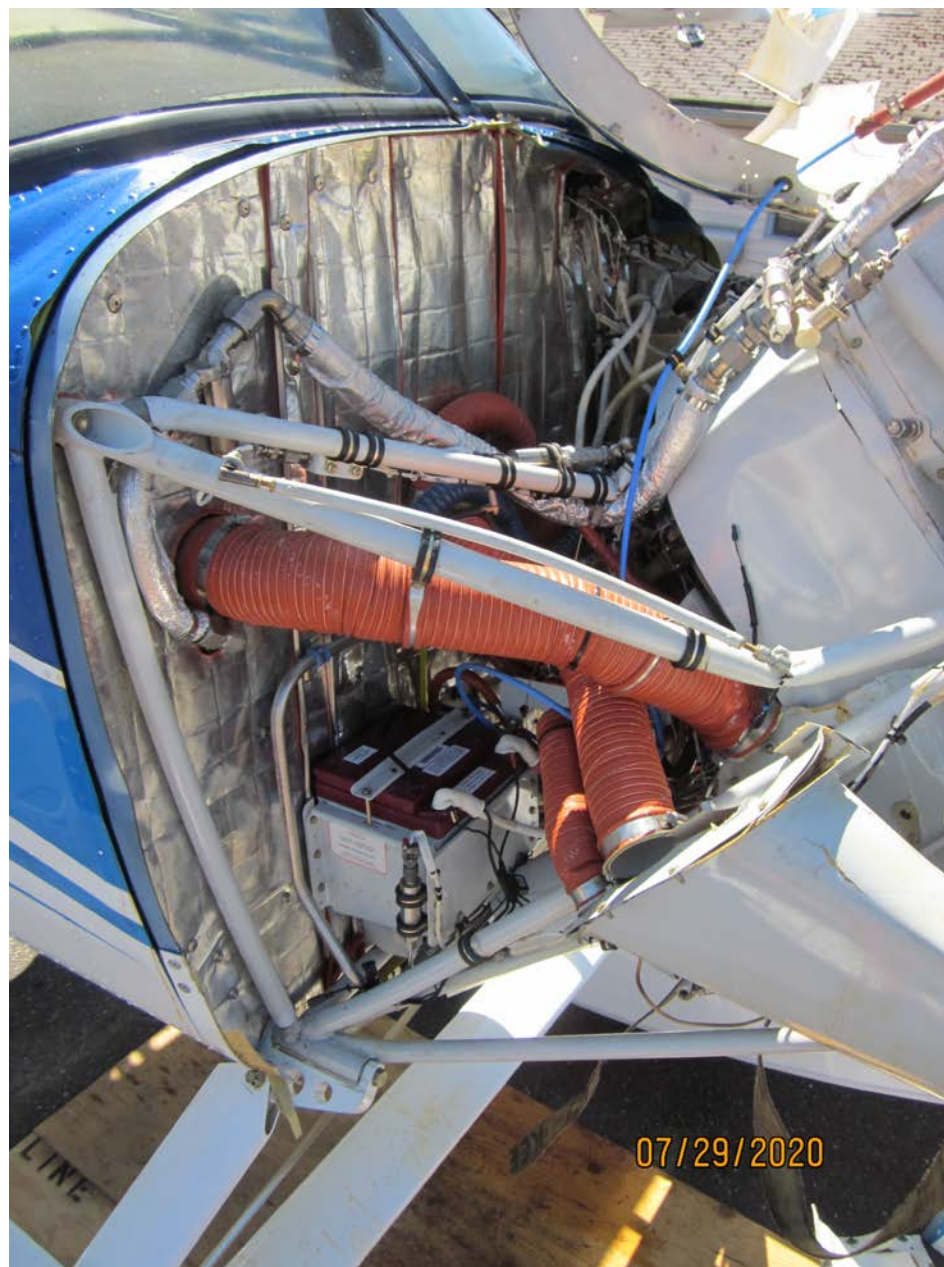
Photo 2 - View of damaged engine truss (courtesy of the FAA)
