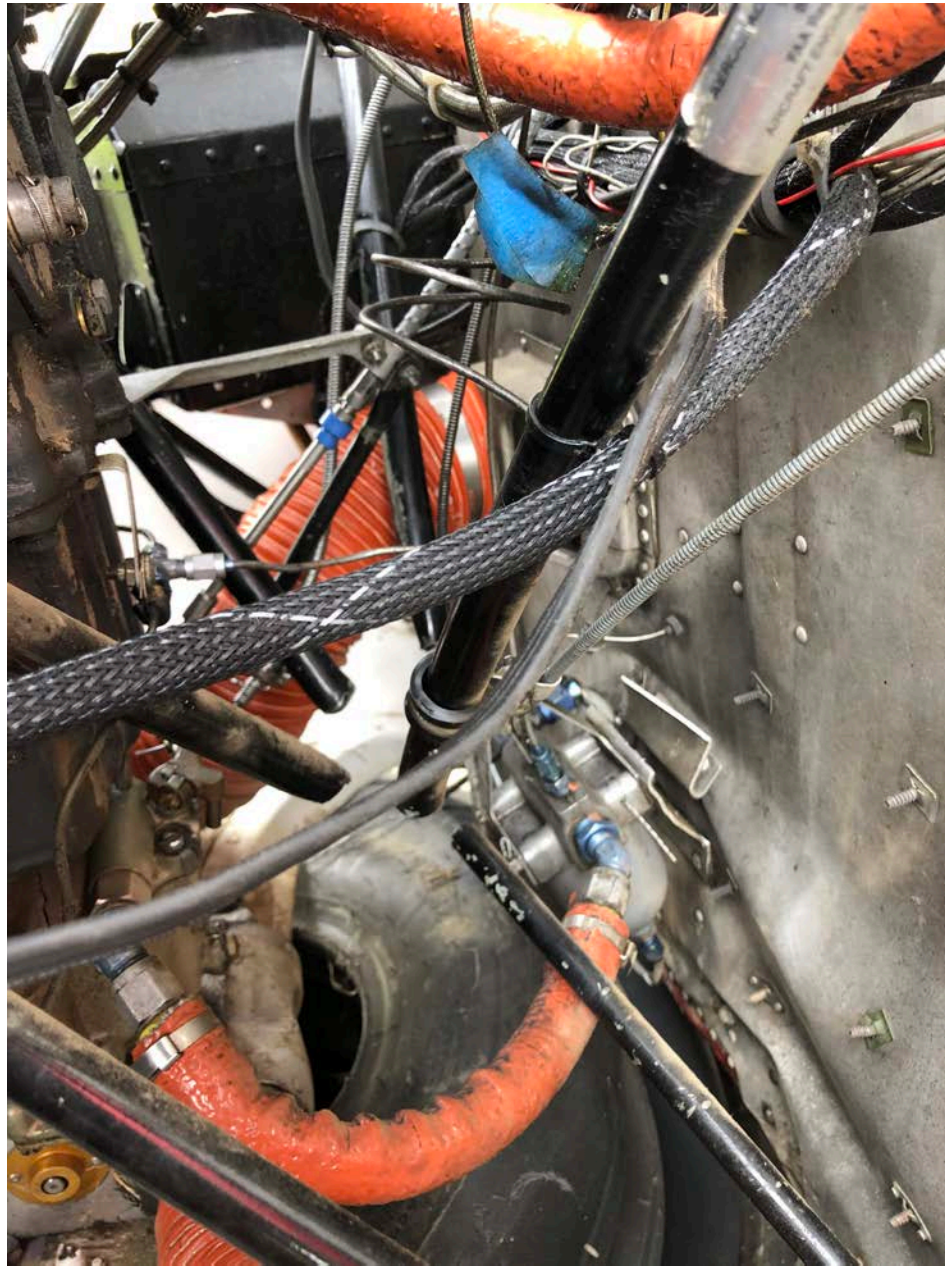
Photo 1 – View of damaged engine truss (courtesy of the FAA)
