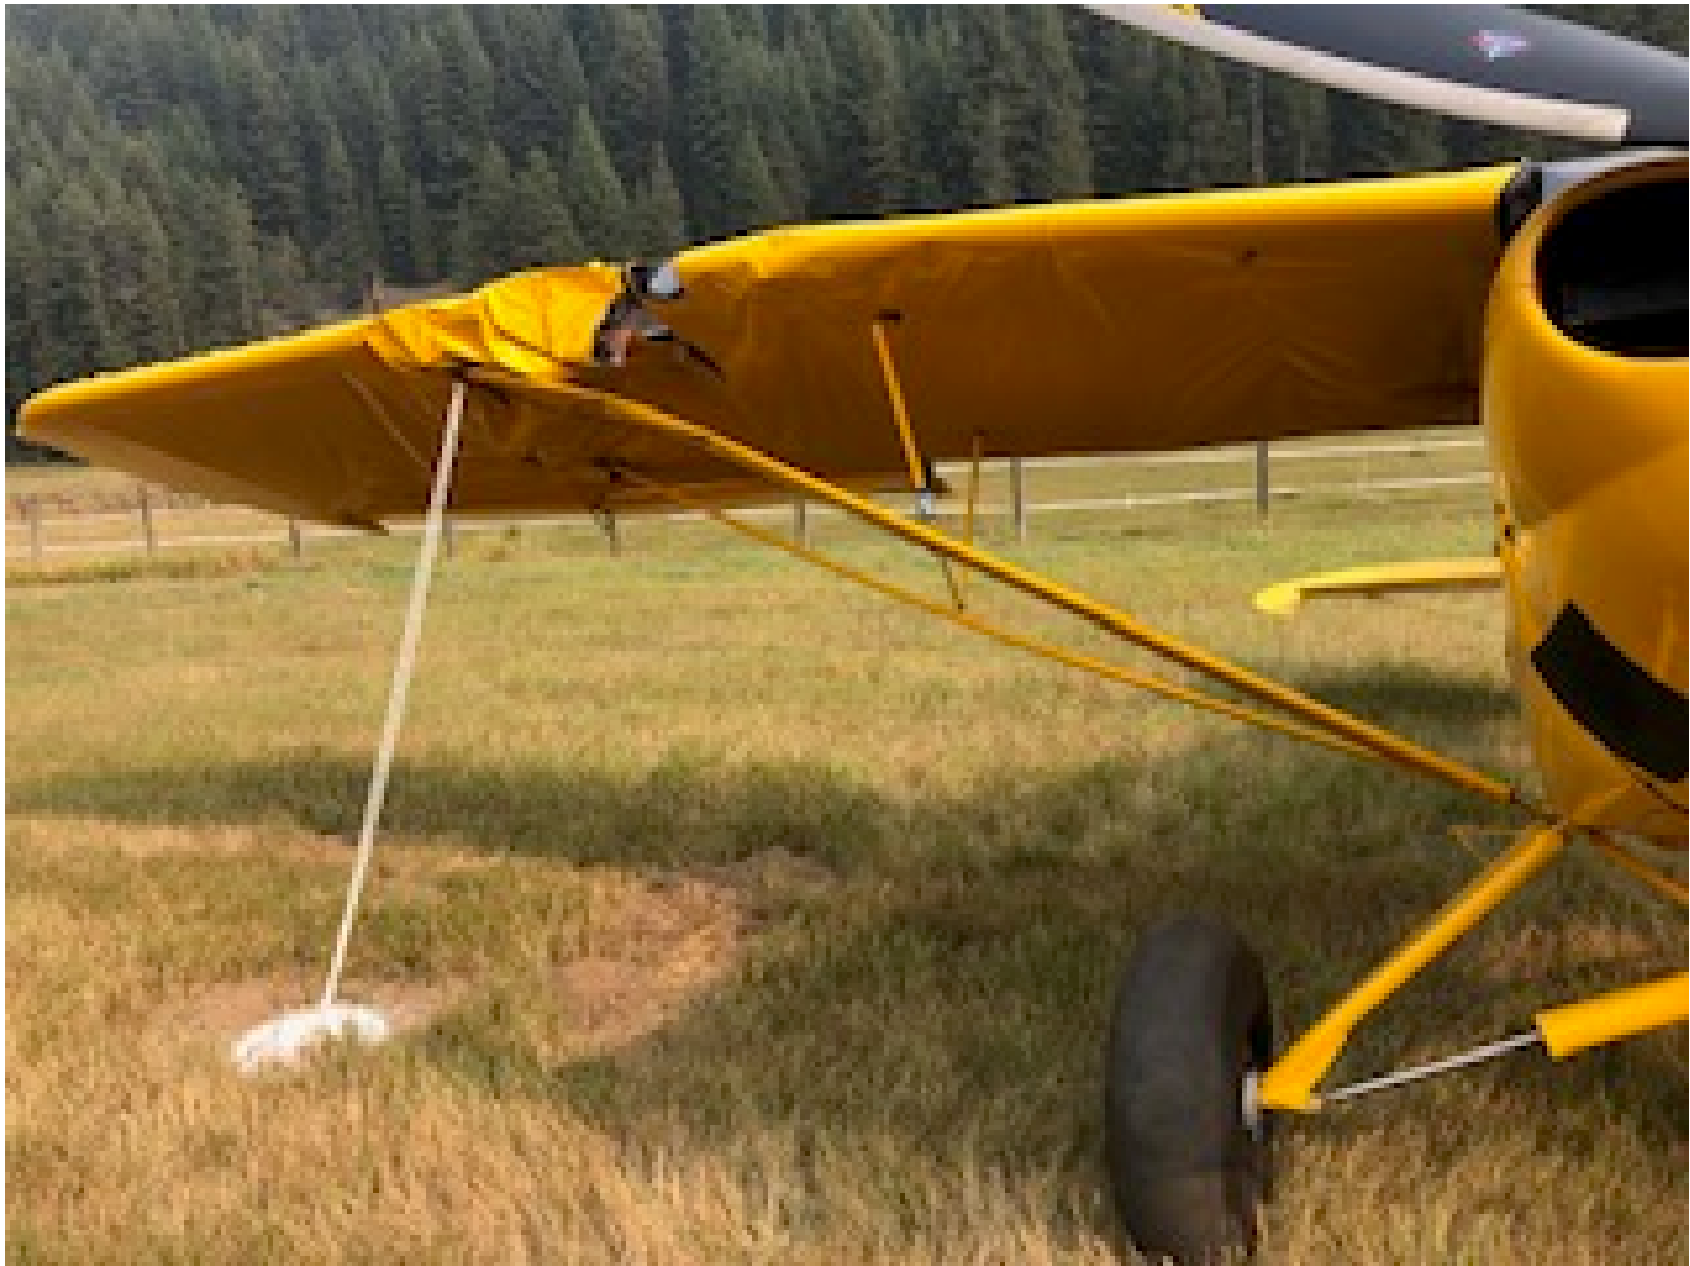
Photo 1 – View of damage to right wing and lift strut (courtesy of the pilot)
