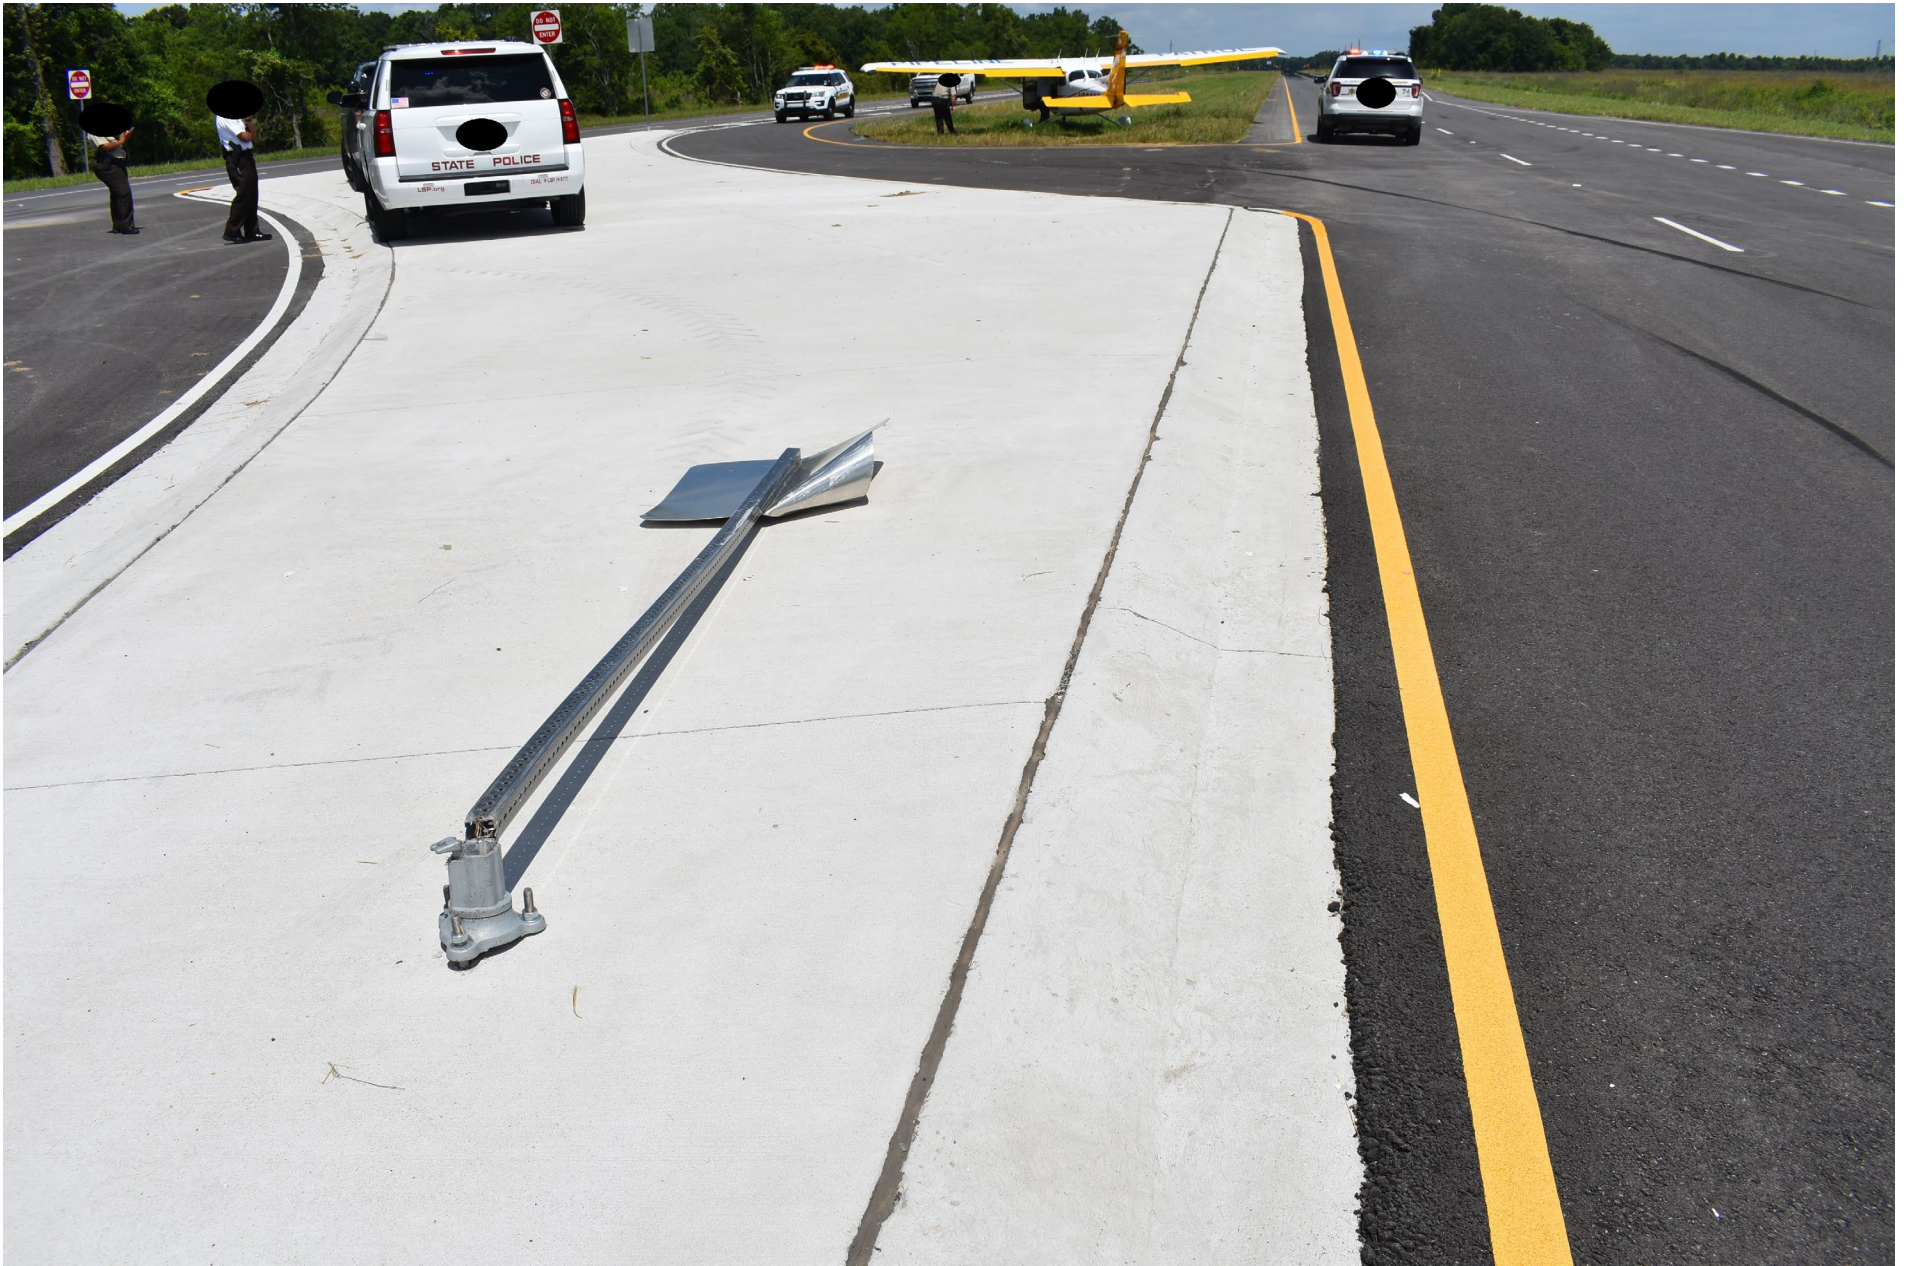
Photo 1 – Rear view of the airplane next to the road along with the road sign that was impacted by the left wing (courtesy of the Federal Aviation Administration).

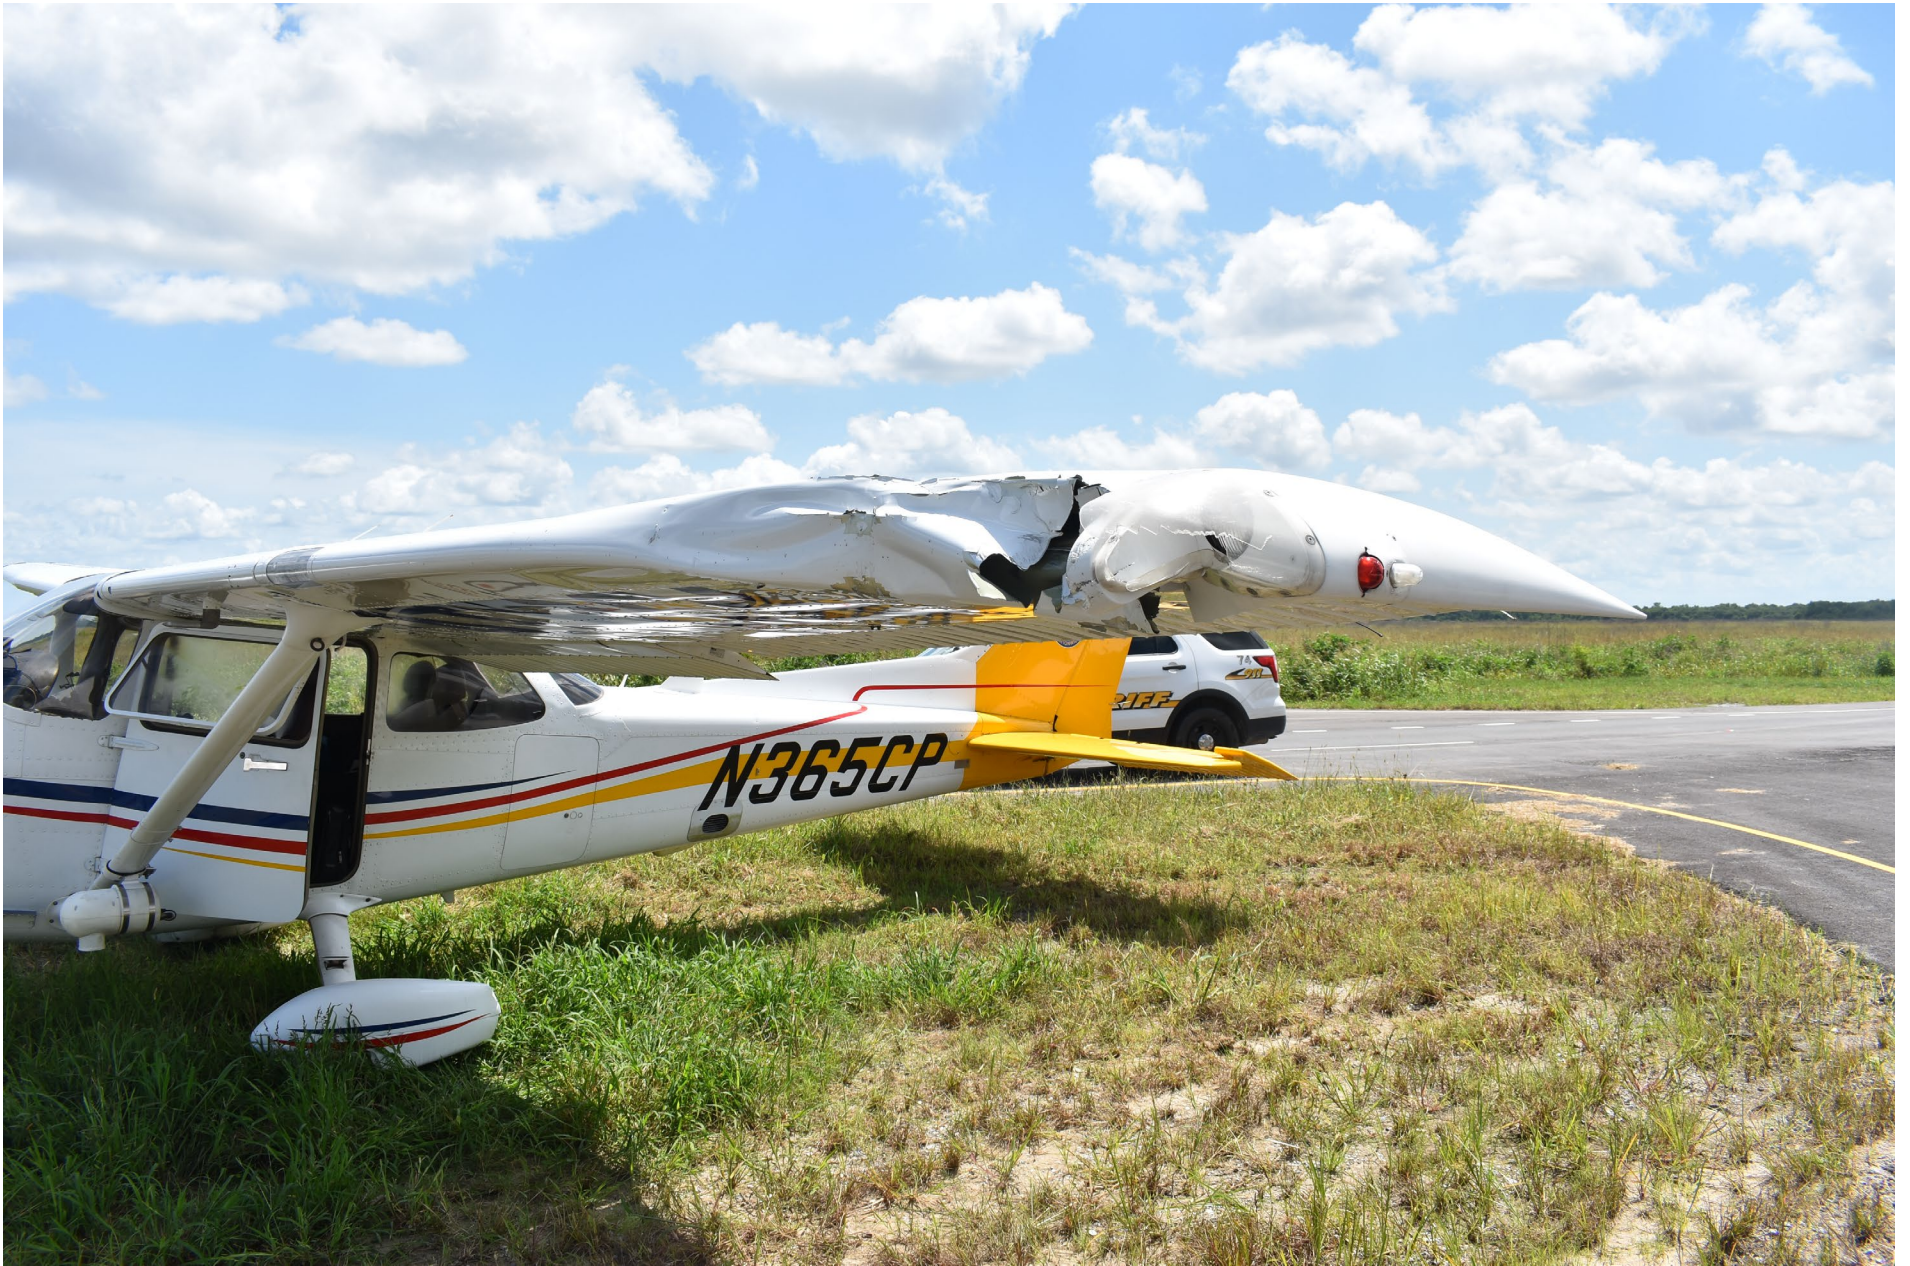
Photo 2 – View of the substantial damage sustained to the left wing (courtesy of the Federal Aviation Administration).

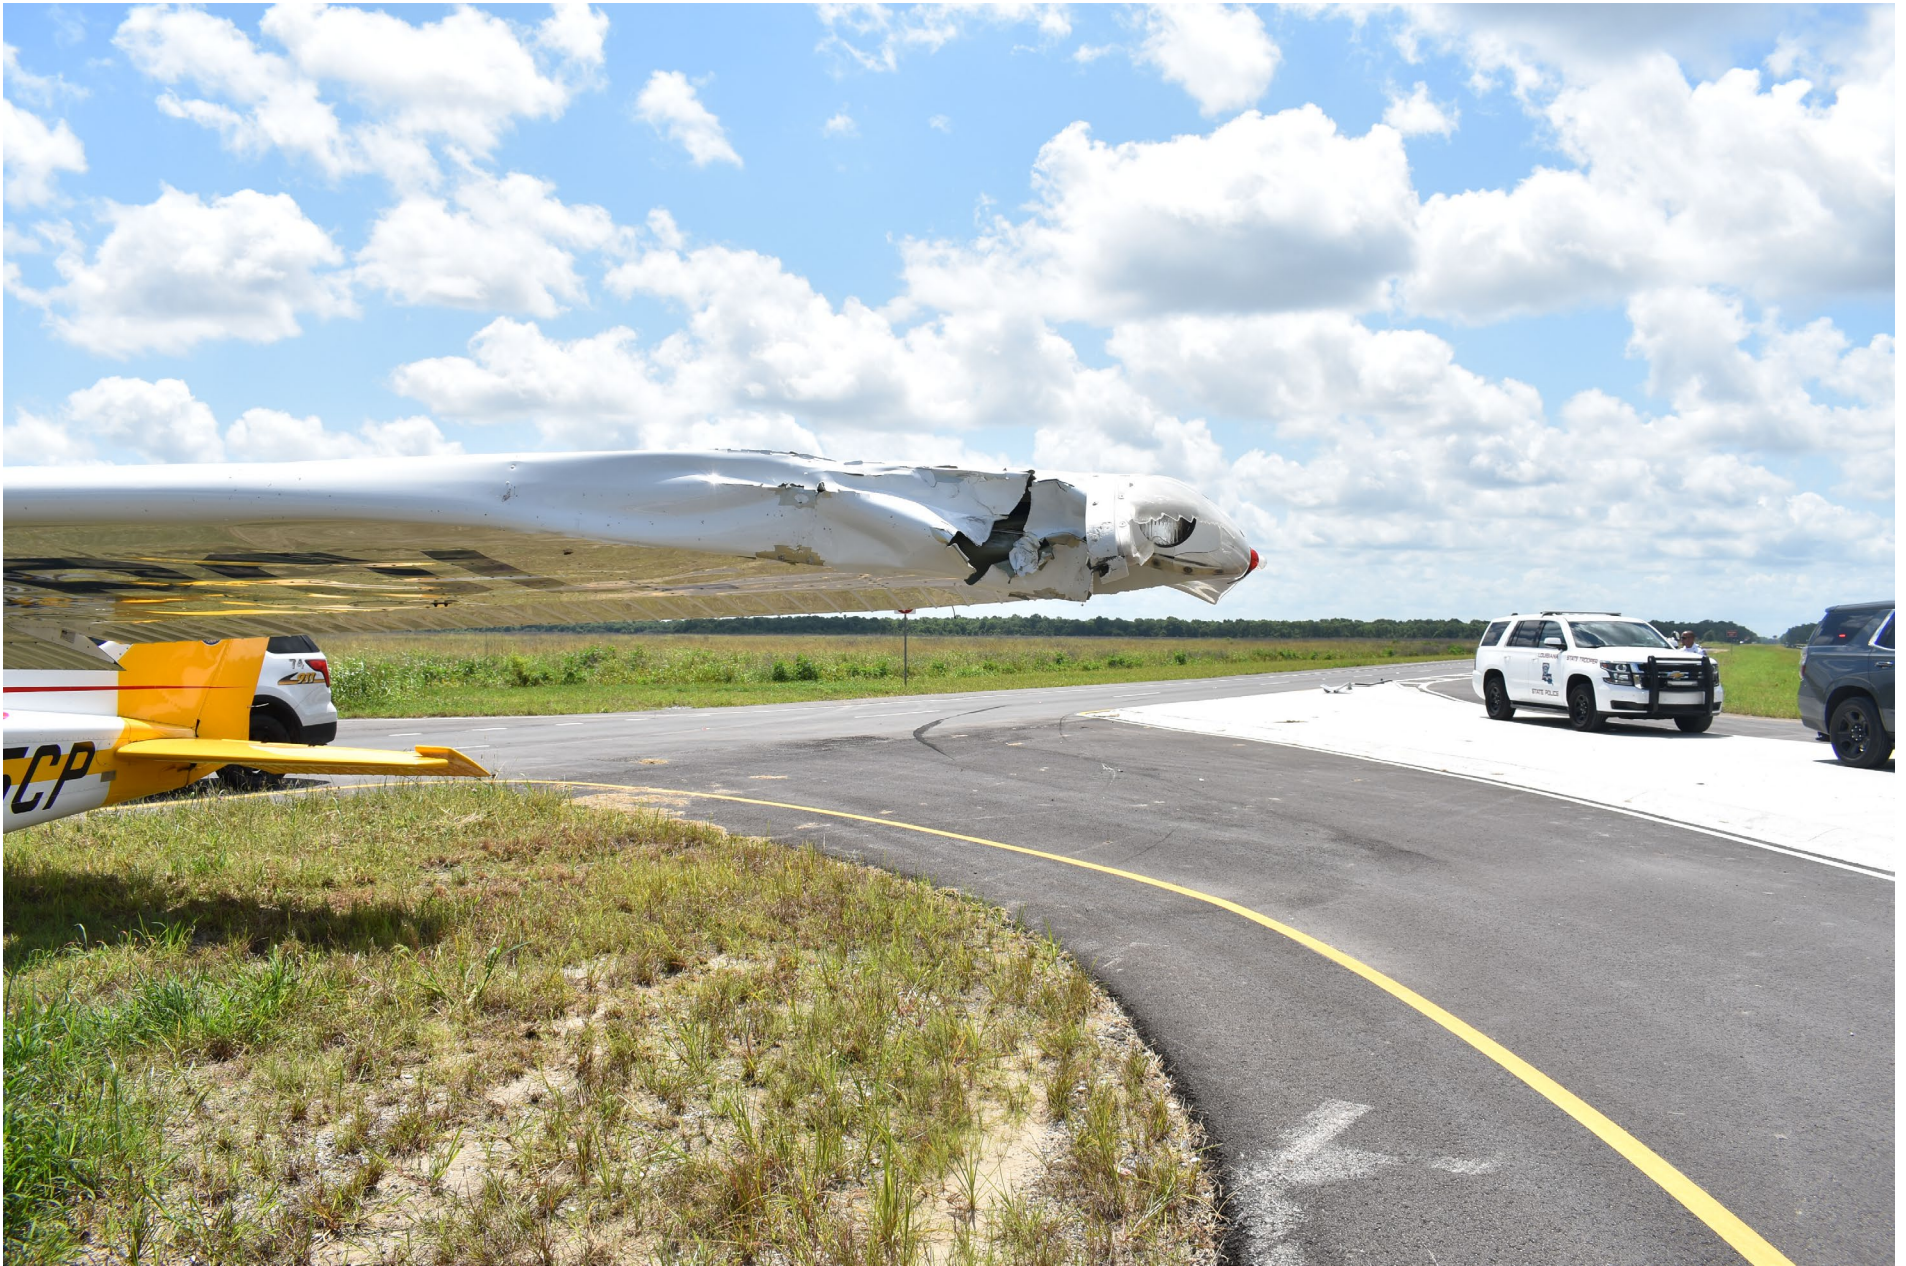
Photo 3 – View of the substantial damage sustained to the left wing and of the road used during the emergency landing (courtesy of the Federal Aviation Administration).

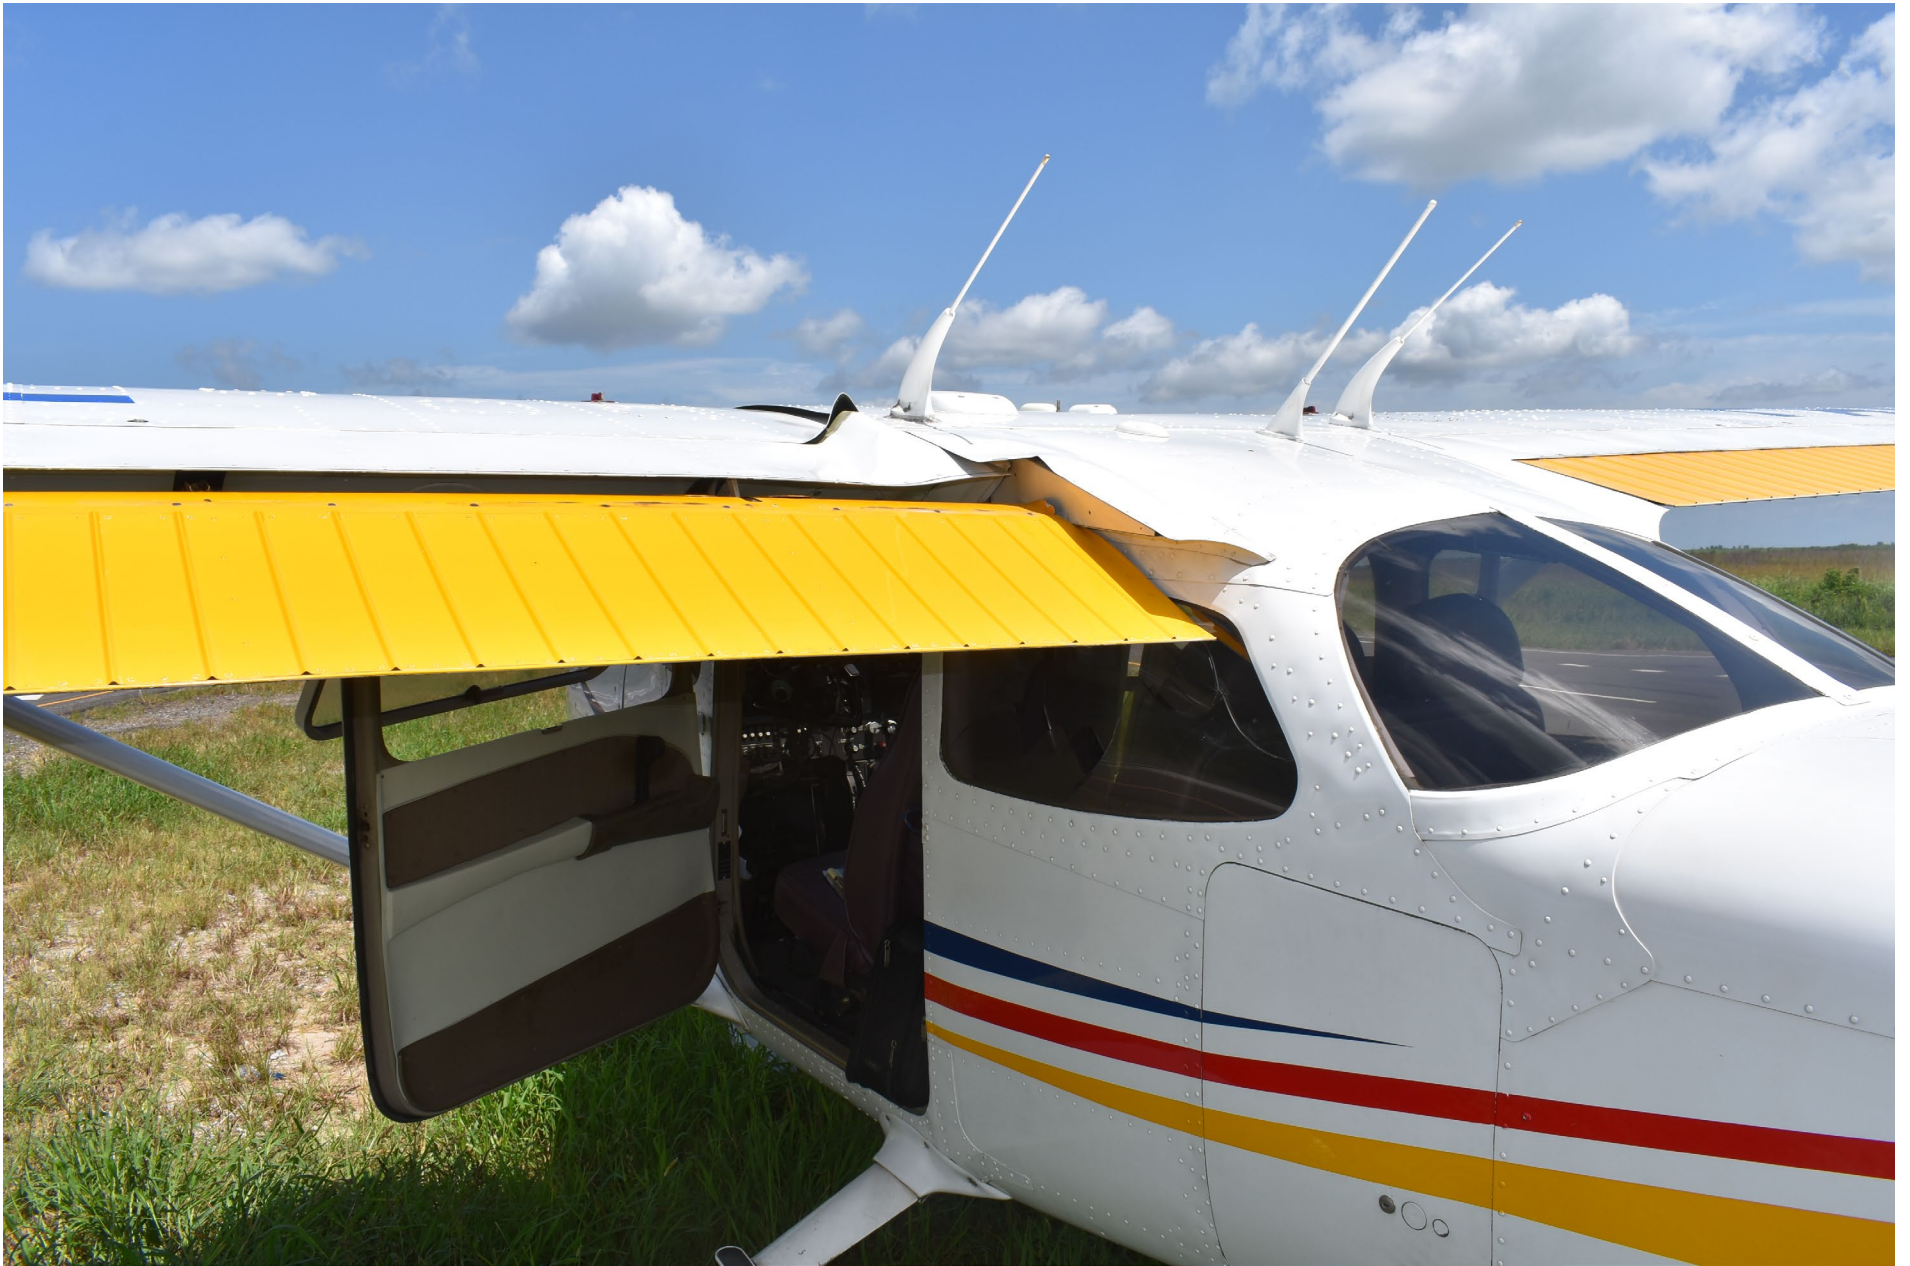
Photo 4 – View of the substantial damage sustained to the left wing (courtesy of the Federal Aviation Administration).

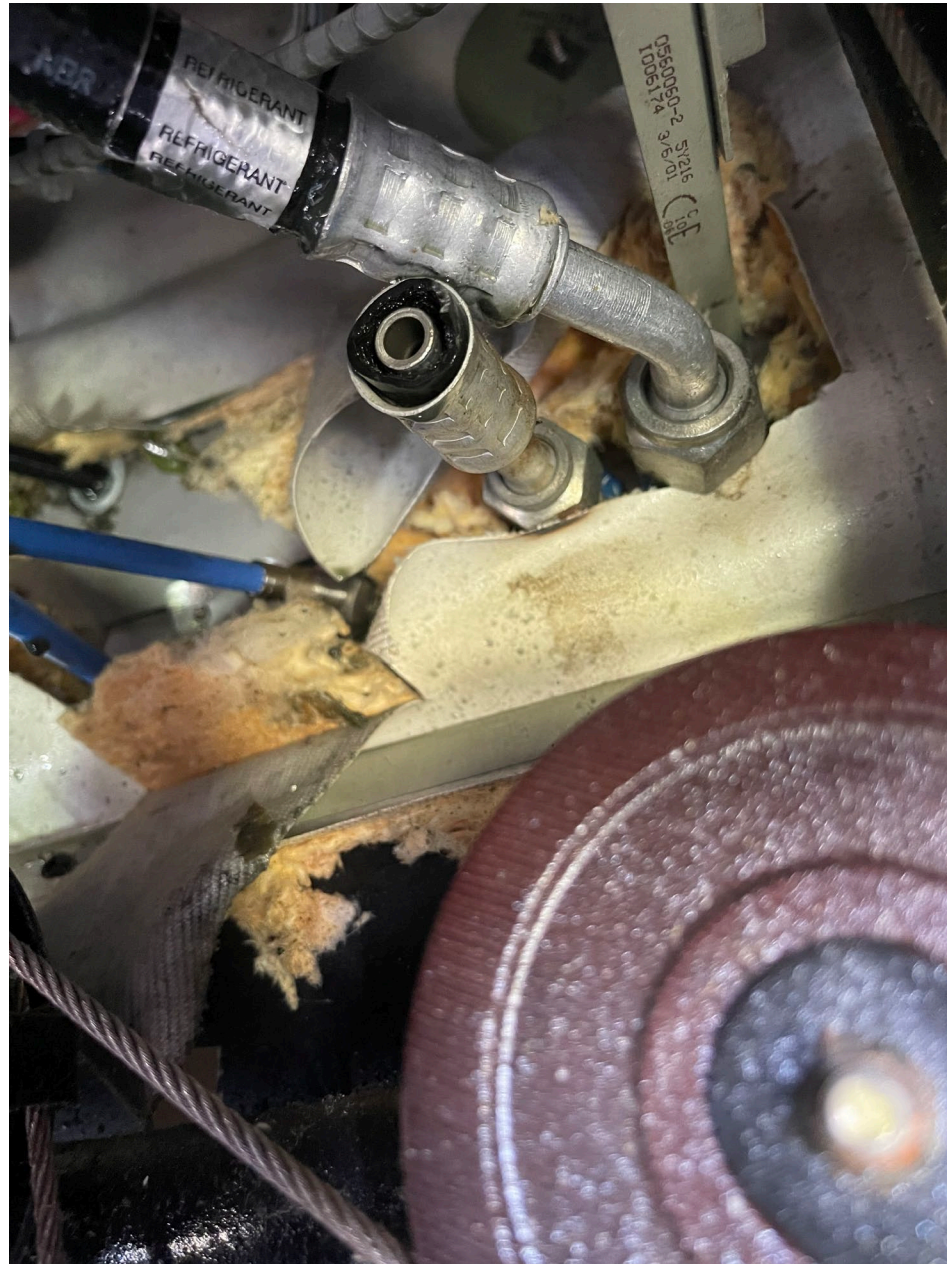
Photo 5 – View of the rubber air conditioning hose that failed at the metal crimp connection (courtesy of the Federal Aviation Administration).

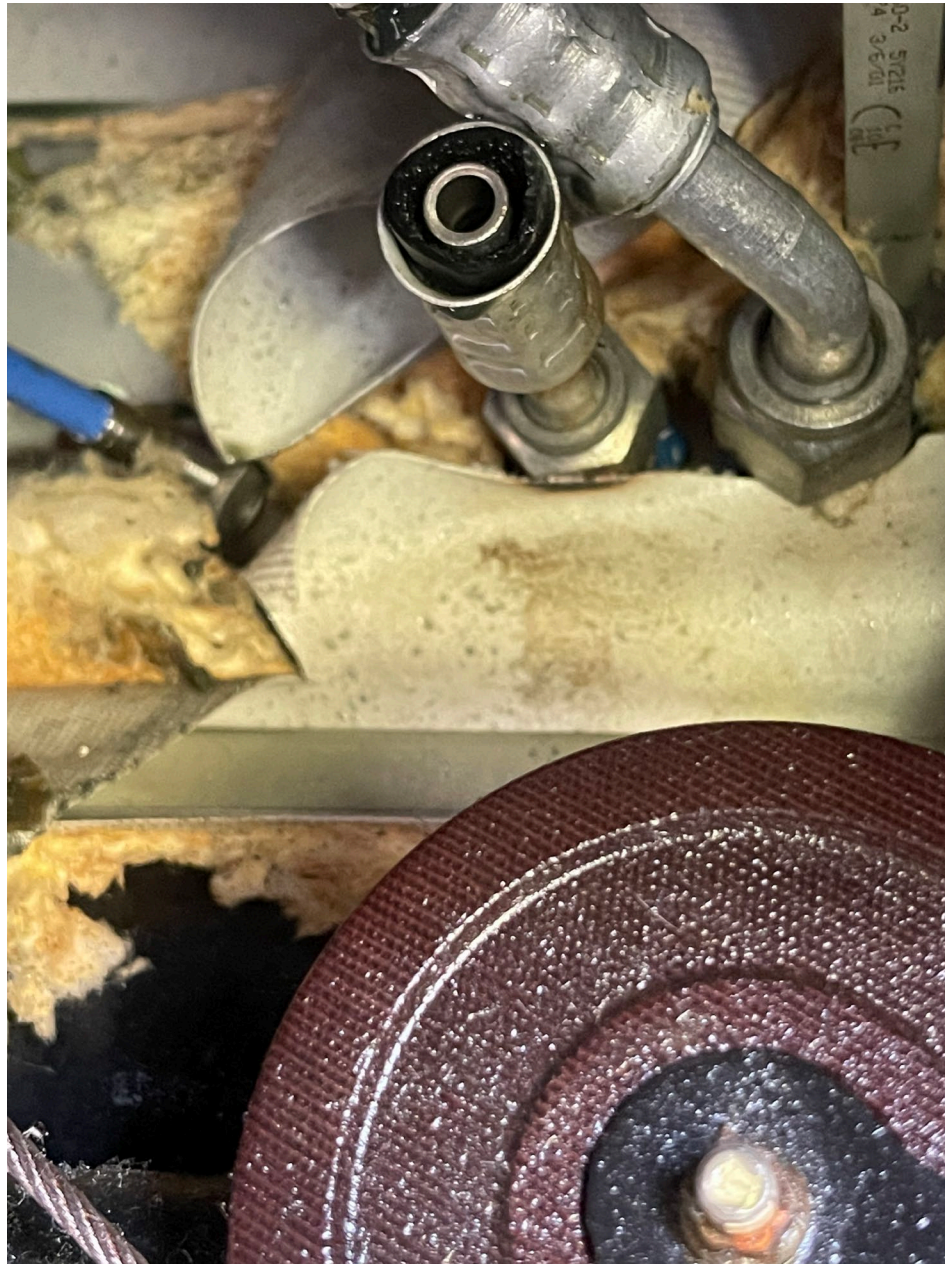
Photo 6 – Close up view of the rubber air conditioning hose that failed at the metal crimp connection (courtesy of the Federal Aviation Administration).
